SAFECOM SUMMARY

October 2015 – March 2016

CASE STUDY

Near Mid-Air Collision

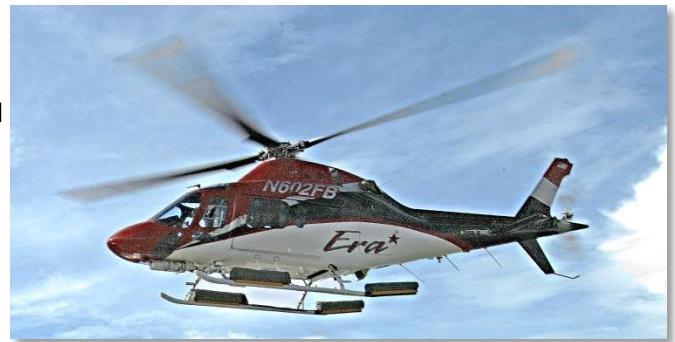
On the afternoon of December 9, 2015, a BSEE contracted Agusta A119 helicopter was inbound to the Lafayette Regional Airport from a routine offshore mission. The weather was good with no ceilings and visibility greater than six miles. Onboard were the pilot and three BSEE passengers. When the BSEE helicopter was approximately 4 miles east of the Abbeville airport the pilot and the front-seat passenger spotted an unidentified helicopter, possibly an S-76, on a collision course a quarter mile to their front at the same altitude.

Both the pilot and the BSEE inspector had been actively scanning for traffic, and the inspector had just glanced down to check the TCAS before returning to search outside. Before the inspector could shout a warning the pilot was already taking evasive action by banking to the left and climbing. The inspector estimated that the intruder aircraft flew 200-300 feet below and to the right of their aircraft. Given their speeds, the combined rate of closure was in excess of 200 knots (338 feet/second) and the time to impact was less than four seconds. (SAFECOM 16-0068).

While the BSEE aircraft's TCAS, transponder, position lights, pulse lights, and anti-collision lights were on and operational the BSEE crew did not see the intruder's lights and the TCAS did not pick up the intruder's transponder.

The BSEE crew did not hear any radio calls from the intruder aircraft and did not see the aircraft make any evasive maneuvers which suggests that the pilot of the intruder aircraft never saw the BSEE aircraft.

BSEE frequently operates in high density traffic areas where other aircraft may not be equipped with traffic avoidance aids such as TCAS or use available devices such as transponders.

- The general risk of an airspace conflict has increased from low to medium.
- All BSEE contracts require safety equipment (pulse lights, TCAS, etc.) must be operational and used.
- Pilots and all passengers must actively scan for traffic and other hazards and actively communicate those hazards to the pilot. Good CRM saved the day!
