Investigation of May 1984 Explosion And Fire
Lease OCS-G 3280, West Cameron Block 405
Gulf Of **Mexico**,
Off The Louisiana Coast

JULY 1985

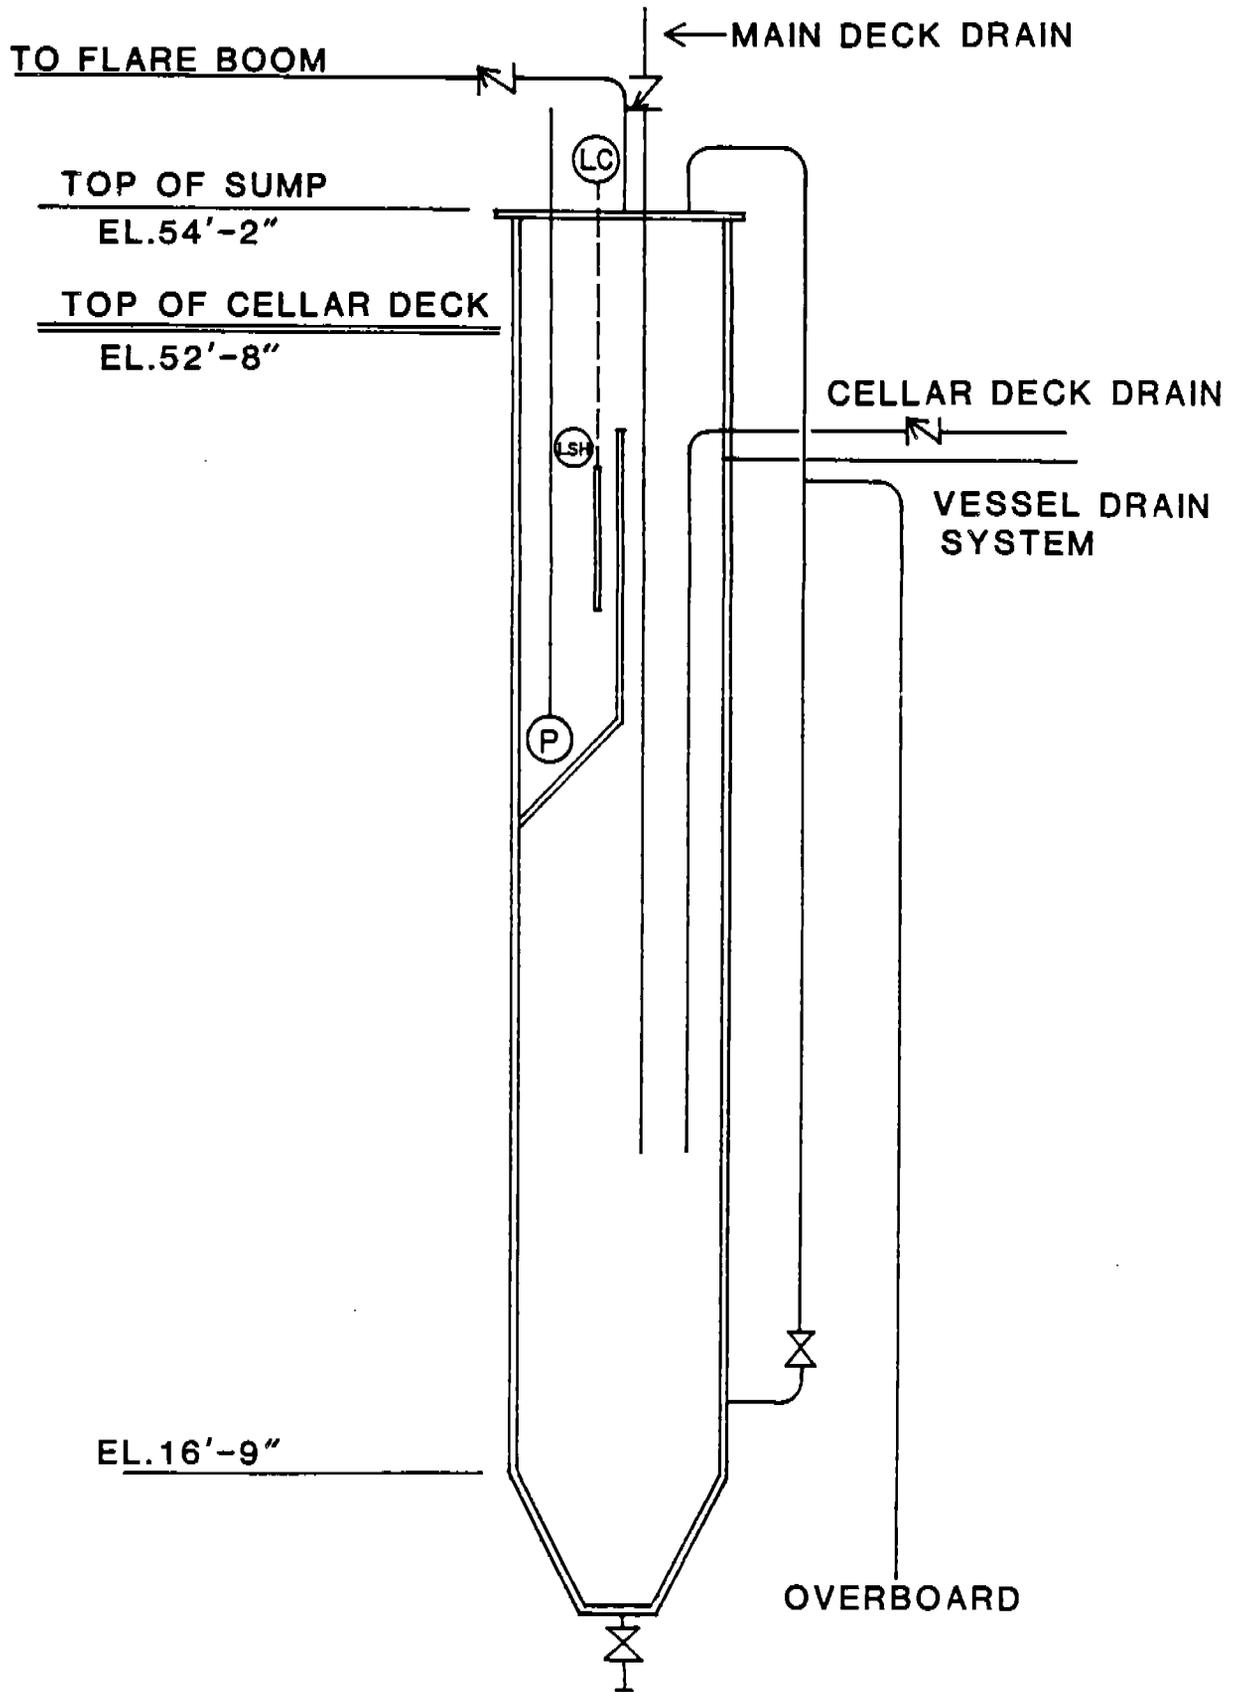
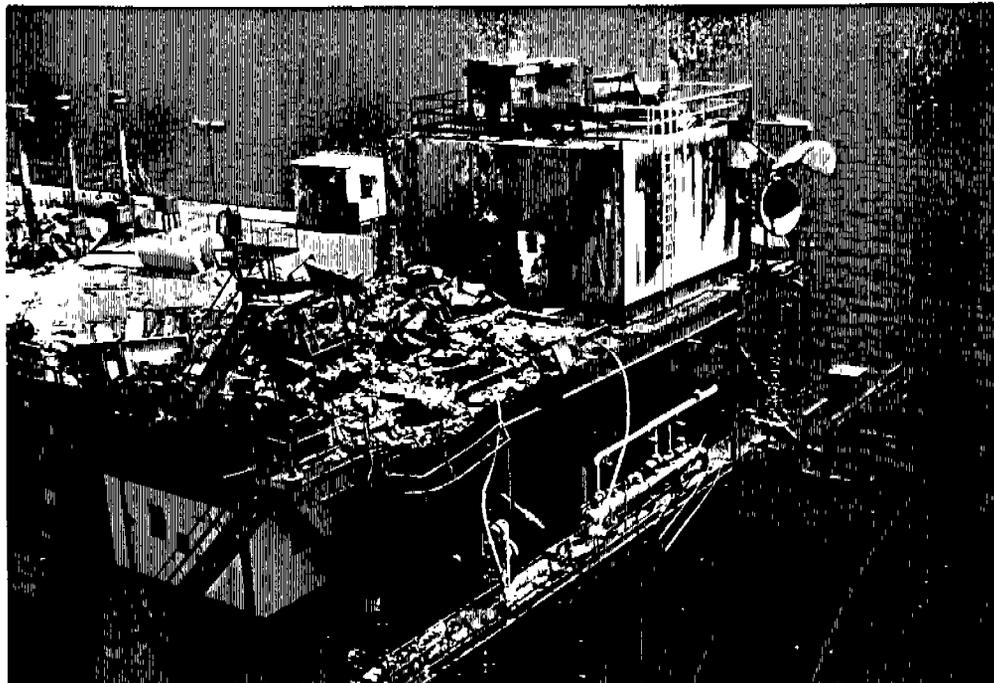
At this time, only Mr. Taylor could be accounted for; he exited through the door which he had entered, and made his way to the other side of the platform, where he actuated the emergency shutdown system. Subsequent to the initial explosion, but prior to abandonment of the platform, Mr. Taylor made several attempts to locate Mr. Stringfellow. In the course of these efforts, Mr. Taylor heard two additional explosions (for photograph of damage, see attachment 5).

The living quarters and the generator building were completely destroyed by the explosion and fire. The heliport was blown into the water and has not been recovered (see the Getty Report, attachment 7). The damage was estimated to be \$1,250,000.

DAMAGE INCURRED TO WEST CAMERON BLOCK 405, PLATFORM A

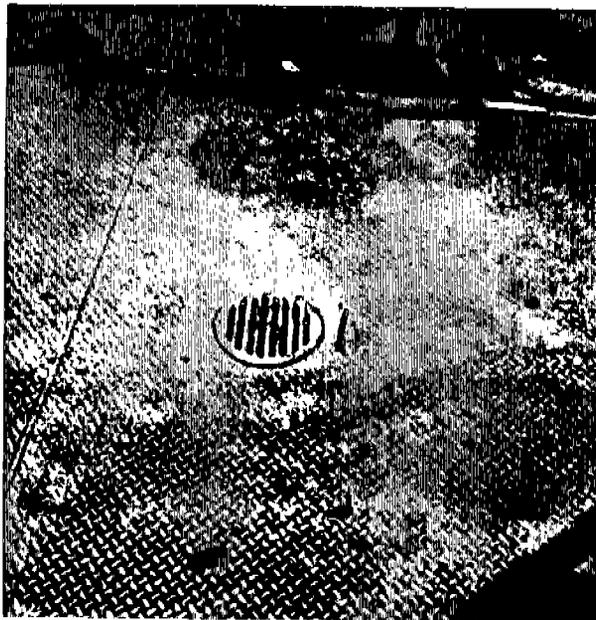
Normally, if any gases were flashed into the 6-inch deck drain line, they would be prevented from migrating through this drain system by a check valve located in a vertical run of pipe leading to the sump tank (for photograph of valving on top of sump tank, see attachment 5). However, upon investigation after the accident, it was determined that the flapper in this check valve was missing, rendering it inoperative. This allowed the gases to migrate through the deck drain system to openings under both the living quarters and generator building (for photographs of drain openings, see attachment 6). Gases migrating through the drain system accumulated under both of these buildings.

The living quarters and generator building were both placed over open drains, and the openings between the buildings and the floor were sealed. The drains from under these buildings were routed to the sump tank. Washing the produced sand out of the test separator to the sump tank without maintaining a liquid level in the sump caused gas fumes to migrate up the drain line to the open drains under the buildings. The gas fumes then migrated up through the floor and walls into the living quarters.

DRAIN OPENING UNDER GENERATOR BUILDING

1. Production platforms should be analyzed to see if open drains exist under buildings.
2. Production systems where glycol reboilers are vented into the sump system should be reviewed.
