***ASSESSMENT OF FIXED OFFSHORE  
PLATFORM PERFORMANCE IN HURRICANES  
ANDREW, LILI AND IVAN***

**December 2005**

**MMS Project No.: 549  
Energo Engineering Project No.: E05114**

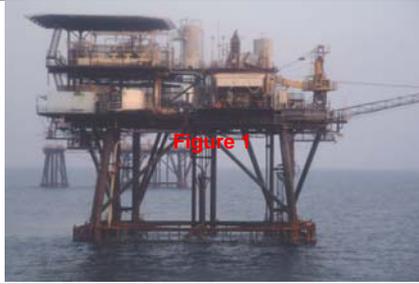
<b>Platform Damage Summary</b>			
Platform	Main Pass 144A		
Operator	Chevron		
<b>Platform Description</b>			
Water Depth	206 ft

Deck Height	65 ft		
No. of Slots	14		
No. of Conductors	12+2		
Installation Date	1968		
API 2A Assessment Category	L2		
Jacket Type	Platform		
No. of Piles	2 + 2 sets of 6 conductors		
Distance from Shore	24 mi		
Bracing Configuration	K bracing for top and bottom bay; XH bracing for middle bay		
<b>Storm Exposure</b>			
Min. Distance/Direction from Eye	36 mi		Maximum Storm Surge 1.3 ft
Maximum Wave Height	66 ft		Maximum Wind Speed 64 kts
Significant Wave Height	37 ft		Current Speed 2.5 kts
Wave Crest Elevation	41 ft		
<b>Storm Damage</b>			
Structural Damage	Yes	Evidence of Wave in Deck	No
Structural Damage Description	Many deck members in a 13' x 60' cantilever deck section sustained significant damage during the storm. All other damage to the platform were either known from previous inspections or from a marine vessel collision which occurred after the storm in November 2004.

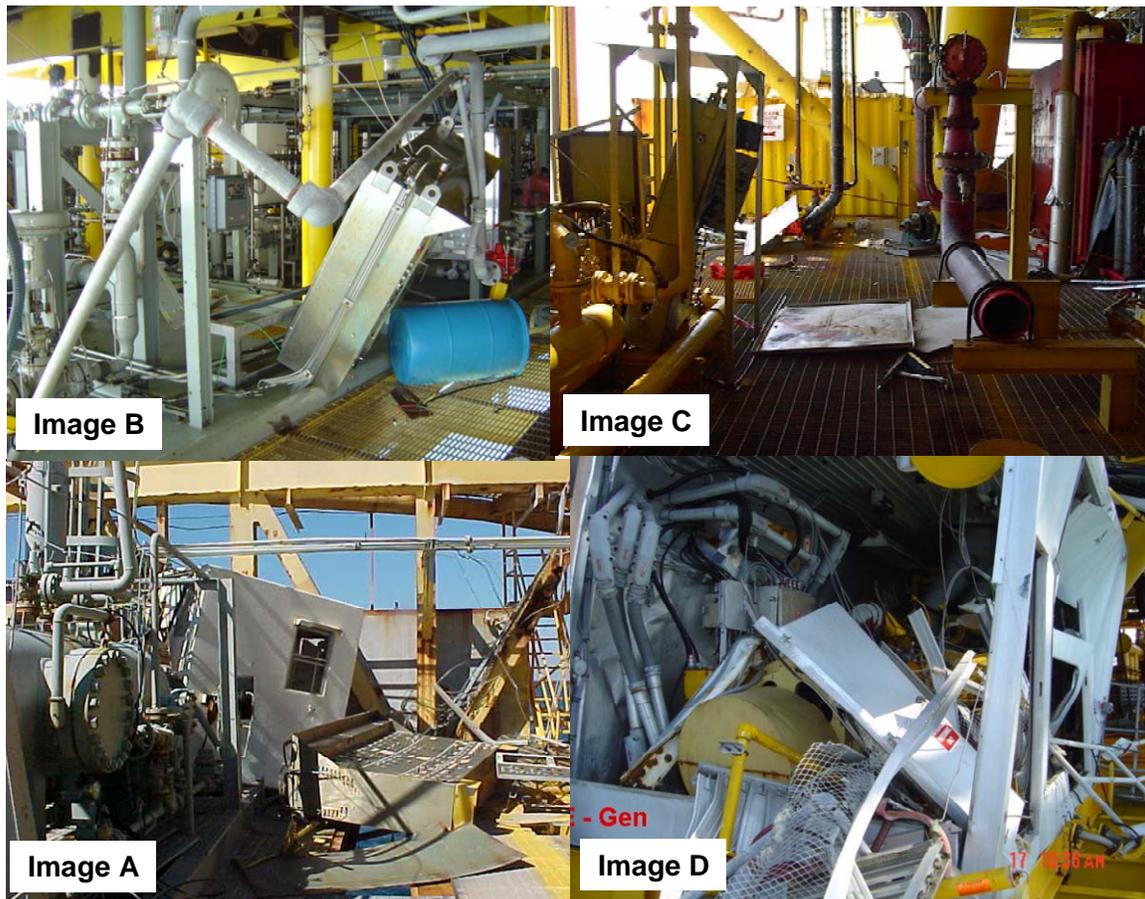
**Figure 2.6 – Typical Non-Structural Topside Damage Caused by Wave-in-Deck**

One other observation regarding the wave-in-deck damage was the apparent wave and wave crest heights during Ivan. Many of the platforms that had evidence of wave in deck observed damage in the upper regions of the cellar deck. For example in the case of the Pompano platform, the deck damage was observed at an elevation of +63 feet above the water level. This equates to a postulated 105 ft maximum wave height when using present design calculation methods. This estimate is well above the hindcast estimates for maximum wave. For the Pompano location, the hindcast estimates put the maximum wave height at approximately 80 feet [O'Connor, 2005]. These sorts of discrepancies between the calculated wave heights based on damage and the hindcast estimates are highlighted in the Section 2.5.

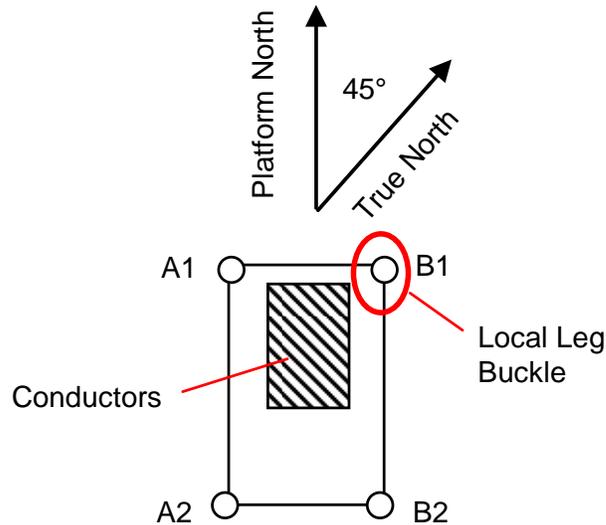
**Figure 2.9 – Platform Orientation of MP 306F Platform**

Another platform that sustained local leg buckling was MP 306F. This platform also sustained major damage to the main jacket bracing. The platform is a 4 pile with 4 skirt piles and there is no batter in the Row A and B direction. Rows A and B sustained major damage to the upper three bays of X-bracing. The platform orientation is shown in Figure 2.9. Similar to the SP 62 platforms, the buckled leg was on the Northern leg or leeward side of the platform with respect to the storm track.

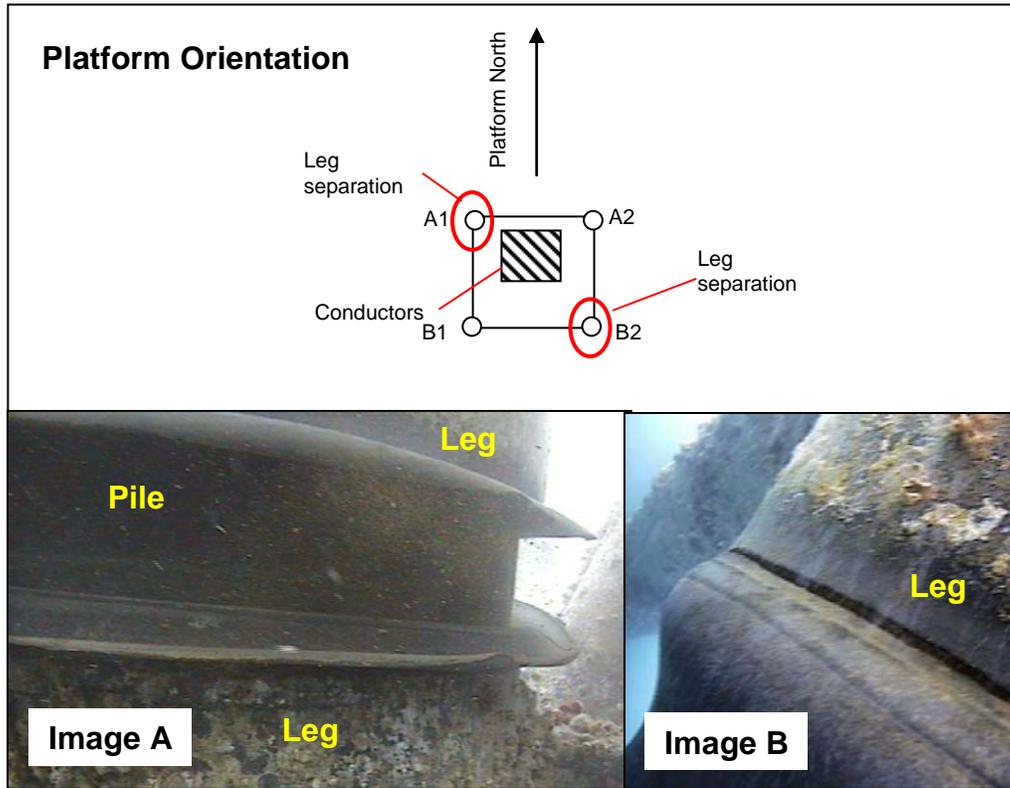
**Figure 2.10 – Platform Orientation of MP 281 A Platform and Photos of Leg Damage**

MP 281 A sustained leg buckling and separation on the two diagonally opposed legs. The platform is a four pile platform and the A1 and B2 legs were observed to be separated. The X-bracing was also separated at two locations near the leg damage. The specific orientation was not shown in the documents but the inspection report shows the conductors to be on the north face of the platform. The orientation of the platform and photos of the observed damage are shown in Figure 2.10. Note that the wave action and subsequent movement of the platform caused the leg to expand outward at the both ends. Similar damage was seen in Lili [Puskar, 2004]. This is shown in Figure 2.10, Image B.

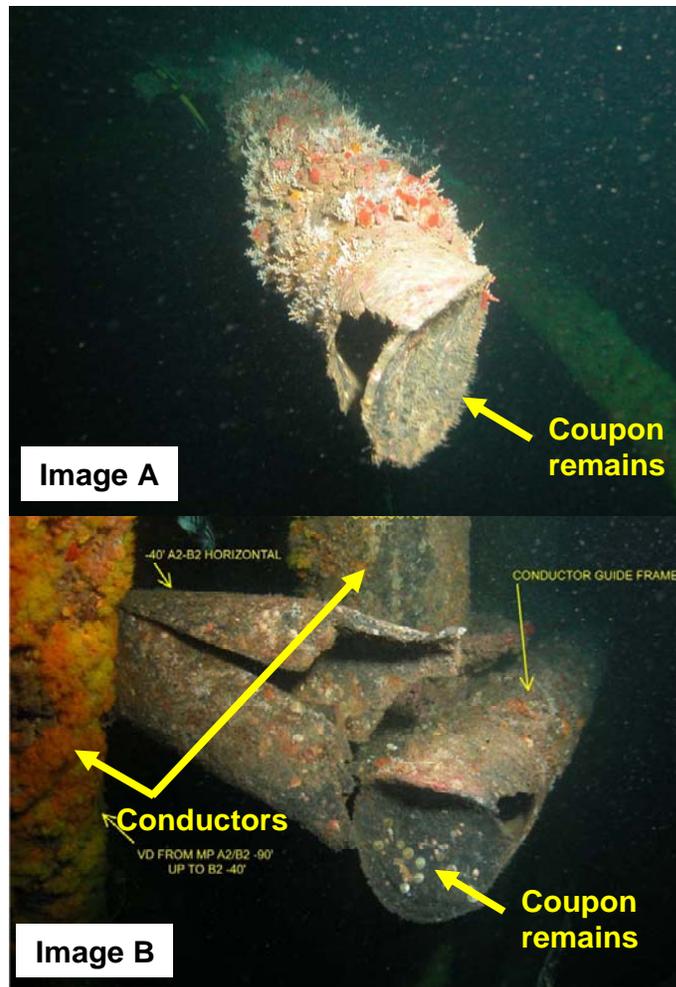
**Figure 2.13 – Typical Conductor Guide Damage**

Several of the platforms sustained damage to non-primary structure that resulted in considerable down time and costly repairs. Examples include conductor trays located near the waterline (e.g. -40 ft) that sustained cracks or fell-out, and sump caisson and riser clamps that failed. There is little design guidance in API or other industry standards for these secondary structures.

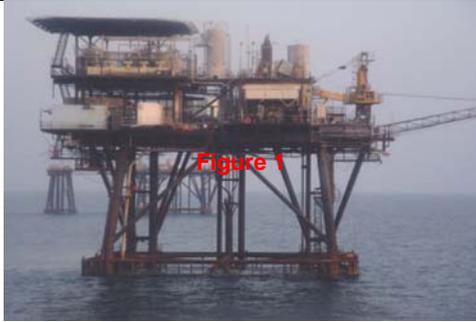
<b>Platform Damage Summary</b>			
Platform	<b>Main Pass 144A</b>		
Operator	<b>Chevron</b>		
<b>Platform Description</b>			
Water Depth	<b>206 ft</b>

Deck Height	<b>65 ft</b>		
No. of Slots	<b>14</b>		
No. of Conductors	<b>12+2</b>		
Installation Date	<b>1968</b>		
API 2A Assessment Category	<b>L2</b>		
Jacket Type	<b>Platform</b>		
No. of Piles	<b>2 + 2 sets of 6 conductors</b>		
Distance from Shore	<b>24 mi</b>		
Bracing Configuration	<b>K bracing for top and bottom bay; XH bracing for middle bay</b>		
<b>Storm Exposure</b>			
Min. Distance/Direction from Eye	<b>36 mi</b>	Maximum Storm Surge	<b>1.3 ft</b>
Maximum Wave Height	<b>66 ft</b>	Maximum Wind Speed	<b>64 kts</b>
Significant Wave Height	<b>37 ft</b>	Current Speed	<b>2.5 kts</b>
Wave Crest Elevation	<b>41 ft</b>		
<b>Storm Damage</b>			
Structural Damage	<b>Yes</b>	Evidence of Wave in Deck	<b>No</b>
Structural Damage Description	Many deck members in a 13' x 60' cantilever deck section sustained significant damage during the storm. All other damage to the platform were either known from previous inspections or from a marine vessel collision which occurred after the storm in November 2004.

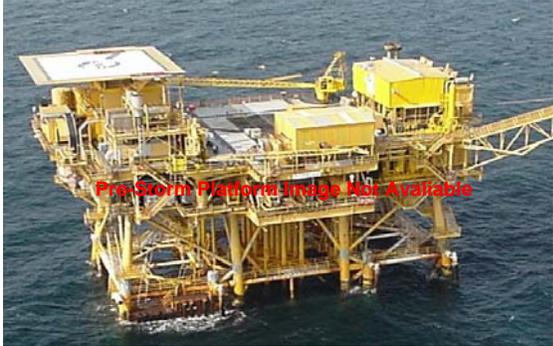
<b>Platform Damage Summary</b>			
Platform	<b>Main Pass 311 B</b>		
Operator	<b>Apache Corporation</b>		
<b>Platform Description</b>			
Water Depth	246 ft

Deck Height	52 ft		
No. of Slots	18		
No. of Conductors	15		
Installation Date	1980		
API 2A Assessment Category	L2		
Jacket Type	Platform		
No. of Piles	8 piles and 8 skirt piles		
Distance from Shore	19 mi		
Bracing Configuration	Long frame: XH for center bays; / for outer bays; Tran Frame: XH bracing		
<b>Storm Exposure</b>			
Min. Distance/Direction from Eye	38 mi	Maximum Storm Surge	1.1 ft
Maximum Wave Height	67 ft	Maximum Wind Speed	61 kts
Significant Wave Height	38 ft	Current Speed	2.4 kts
Wave Crest Elevation	41 ft		
<b>Storm Damage</b>			
Structural Damage	Yes	Evidence of Wave in Deck	No
Structrual Damage Description	1. 6"L x 4"W x 2"D dent on a small vertical member (VM) on row A near the water line. 2. 1.5"W x 19.25"L crack at end of VM at the connection of X-brace vertical diagonal. VM appears to have torn away from the X-brace resulting in a large crack near the weld, propogating outward along the length of the vertical diagonal. 3. 18"L x 18"W x 4"D dent on a HZ at the (-)46.5' elev. connecting leg B1 to leg A1. Notes in inspection report indictate that this is not anticipated to have been caused by the storm.

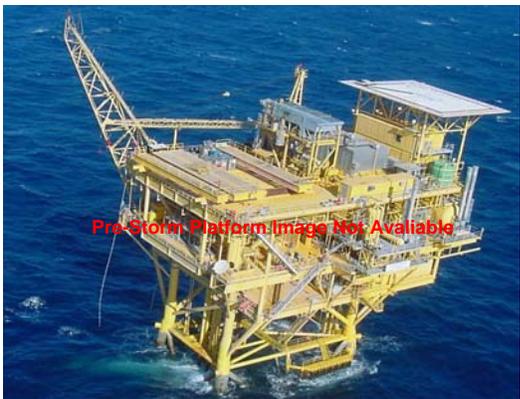
<b>Platform Damage Summary</b>			
Platform	Main Pass 281 A		
Operator	Dominion E & P		
<b>Platform Description</b>			
Water Depth	307 ft

Deck Height	52.82 T.O.S Cellar deck		
No. of Slots	9		
No. of Conductors	6		
Installation Date	1997		
API 2A Assessment Category	L1		
Jacket Type	Platform		
No. of Piles	4		
Distance from Shore	57 mi		
Bracing Configuration	The platform has XH long frame and tran frame bracing.		
<b>Storm Exposure</b>			
Min. Distance/Direction from Eye	5 mi	Maximum Storm Surge	1.3 ft
Maximum Wave Height	74 ft	Maximum Wind Speed	75 kts
Significant Wave Height	41 ft	Current Speed	1.8 kts
Wave Crest Elevation	44 ft		
<b>Storm Damage</b>			
Structural Damage	Yes	Evidence of Wave in Deck	Yes
Structural Damage Description	1. Two members were found to be flooded; VD A1(+12' to A2(-)65' and VD A1(+12' to B1(-)65'. 2. A2 jacket leg has complete separation 360 degrees around the jacket leg at (-)58' level. 3. B2 jacket leg has complete separation 360 degrees around the jacket leg at (-)6' level. 4. VD A1(+12' to A2(-)65' has a bulge 2' below the X-brace, a break at -47' level and another bulge at -64' level. 5. VD A1(+12' to B1(-)65' has a bulge 1' below the X-brace, a break at the -40' area and a second bulge at the -62' level.

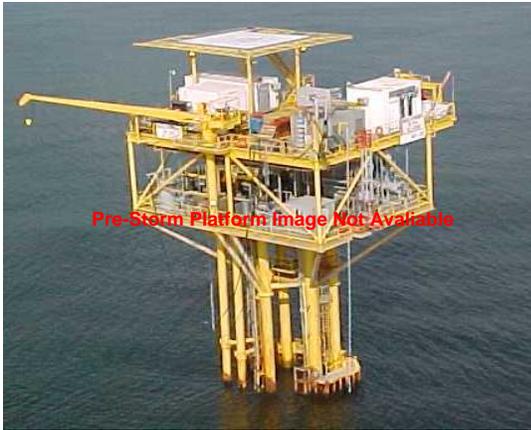
<b>Platform Damage Summary</b>			
Platform	Main Pass 138 A		
Operator	Newfield Exploration Company		
<b>Platform Description</b>			
Water Depth	158 ft

Deck Height	55 ft		
No. of Slots	6		
No. of Conductors	Not Documented		
Installation Date	Not Documented		
API 2A Assessment Category	L2		
Jacket Type	Platform		
No. of Piles	4		
Distance from Shore	16 mi		
Bracing Configuration	A sea-horse type platform with XH bracing at the bottom bay on all four faces.		
<b>Storm Exposure</b>			
Min. Distance/Direction from Eye	46 mi		Maximum Storm Surge 1.6 ft
Maximum Wave Height	58 ft		Maximum Wind Speed 59 kts
Significant Wave Height	33 ft		Current Speed 2.7 ft
Wave Crest Elevation	37 ft		
<b>Storm Damage</b>			
Structural Damage	Yes	Evidence of Wave in Deck	Yes
Structural Damage Description	1. A diagonal brace on row 2 from the cellar deck (2A) to the main deck (2B) broke loose at the weldment on the cellar deck level. The brace is bowed. 2. A 24" major diagonal on row B from (-)7'-6" level to the (-)80' level had a 22"L x 9"W x 2"H dent at the (-)56' elevation. 3. A 16" HZ at the (-)80' level on row B from leg B1 to B2 had a 3"W x 12"L x 0.5"H hump close to leg 2.
