BSEE Panel Report 2023-001

Investigation of July 25, 2020, Flowline Jumper Failure

Lease OCS-G34536

Green Canyon Area Block 40

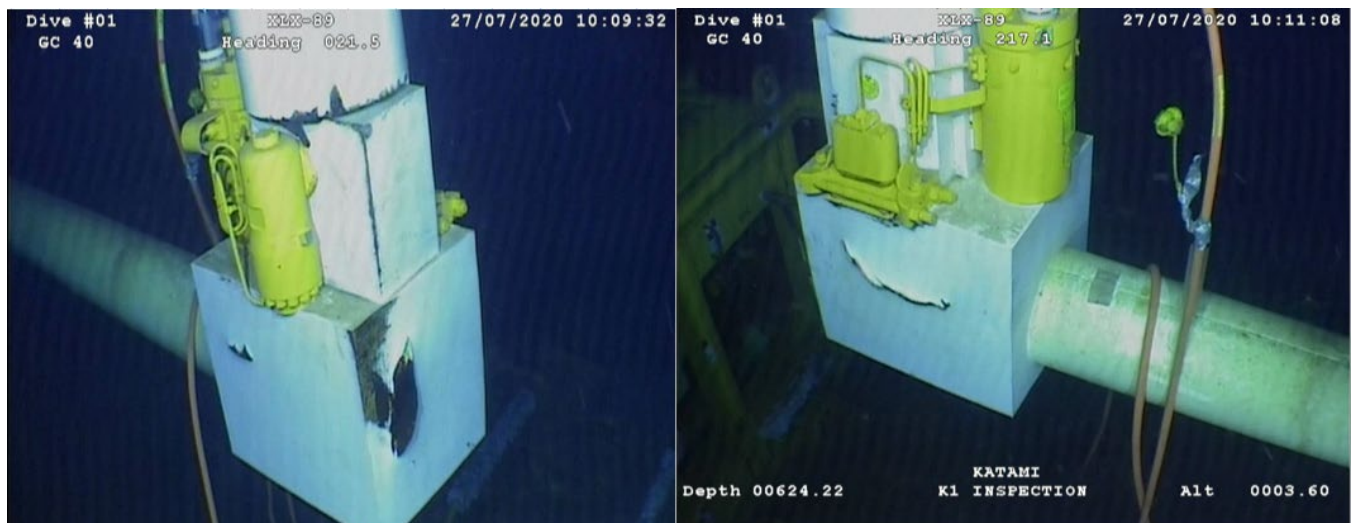
Figure 6: Images from ROV video on July 27, 2020

On July 27, 2020, an ROV deployed from a motor vessel in GC Block 40 performed an inspection of the subsea components downstream of the K1 Tree. ROV live video surveillance identified the potential leak source at or around the MPFM/Blind Tee connection area (Figure 6).
