Safety Alert No. 484

April 16, 2024

Improperly Depressurizing Piping to Remove a Hydrate Causes Injury

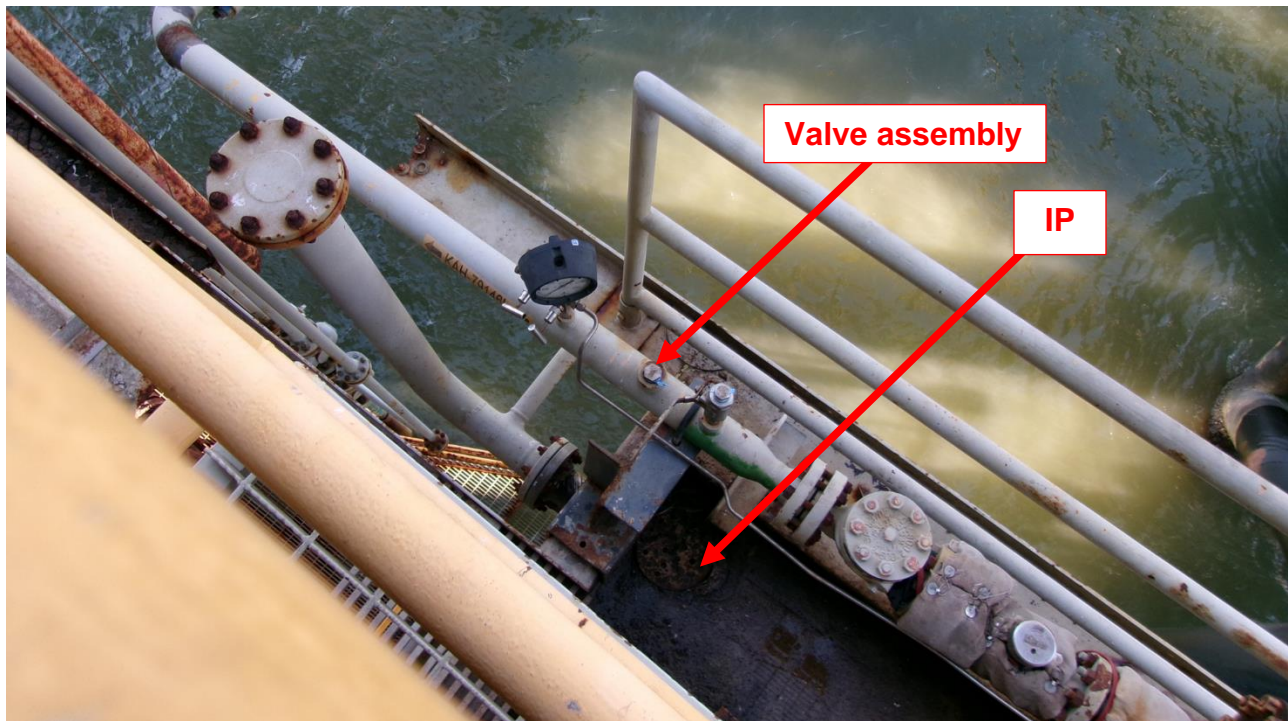
Figure 1: Location of Injured Person (IP) and valve assembly

without properly isolating the pipeline from the bleed point, through a ball valve assembly attached to the 3-inch gas lift piping. The ball valve assembly consisted of a threadolet, threaded steel pipe nipples, two 1-inch ball valves inline, and a 90-degree elbow that pointed upward. With approximately 900 psi trapped behind the valve, the assembly separated from the threadolet, striking one of the platform operators under the left arm pit area, causing bruising and swelling. The injured offshore worker was sent for medical treatment and was later released to full duty. The valve assembly could not be found and is suspected to have fallen overboard after striking the worker.

Hydrates can form inside a pipe from a concentration of impurities, natural gas, flow conditions, high pressure, and low temperature. At the time of the incident, the operators onboard the facility were injecting methanol at a rate of 5 quarts per day to prevent hydrate formation. A Job Safety Analysis (JSA) was not performed, so the hazards of relieving pressure to remove a hydrate were never discussed. The cause of the dislodged valve assembly is still under investigation.

- Isolating all energy sources; then bleeding pressure upstream and downstream of the hydrate simultaneously, maintaining the same amount of pressure so that the hydrate does not move and cause a pressure surge, which could damage associated piping.
- Verifying that JSAs identify potential hazards and mitigating those hazards for the task being performed.
- Ensuring that when changes to equipment are made all hazards are identified and mitigated through the Management of Change process, and updating facility information and informing all personnel affected by the change(s).
- Using gas dehydration systems to remove water vapors to reduce the risk of hydrate formation inside of piping.
- Verifying current platform configurations are reflected on piping and instrumentation diagrams.
