SAFETY BULLETIN

Safety Bulletin No. 002
March 3, 2017

Fatality During Pipe Handling

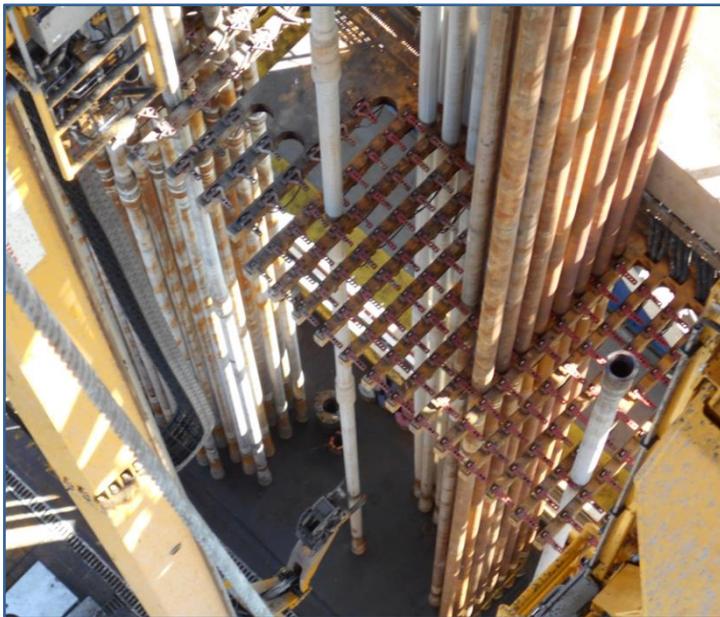
An incident resulting in a single fatality occurred onboard a drillship in the Gulf of Mexico during pipe-handling operations. A floor hand, standing in the setback area, died when he was struck in the head by the bottom end of a 6⁵/₈-inch drill pipe as it was being moved from its storage location to the main drill center.

After the victim reported that the latches were in an open position, the assistant driller began the process of removing a drill pipe stand with the main pipe racker. However, as the pipe racker arms retracted, the stand was obstructed by a closed latch on the lower fingerboard. The stand of pipe began to bow as it was pulled against the closed fingerboard latch. The victim was standing in the setback area. The stored energy from the stand being bowed was released and it recoiled toward the setback area striking the victim. From the start of the sequence to the time the victim was struck, six to eight seconds had passed.

The BSEE panel investigation concluded that this fatality was the direct result of the finger board latch not opening properly and the victim being in the setback area when the stand being held under tension released. Multiple tasks were assigned to the victim that required that he enter the setback area. His inexperience and lack of consistent training about when it was permissible to enter the setback area may have contributed to the victim's decision to step into the setback area when he did.

- Evaluate all tasks included in an operation when making work assignments and evaluate how each planned task relates to the others.
- Review Short Service Employee programs to orient personnel new to a position.
- Review on-the-job training programs. Consider formalizing the programs to provide continuity between those conducting the training and the content of the training.
- When using a spotter to verify the position of finger board latches, review where that task can be safely performed. Consideration should be given to the spotter's proximity to the moving pipe stands. No tasks should be assigned to a spotter that places the spotter in setback areas during pipe handling operations.
