Safety Alert No. 459

## Lack of training with Hydraulic Torque Wrench contributes to fatality aboard the drillship

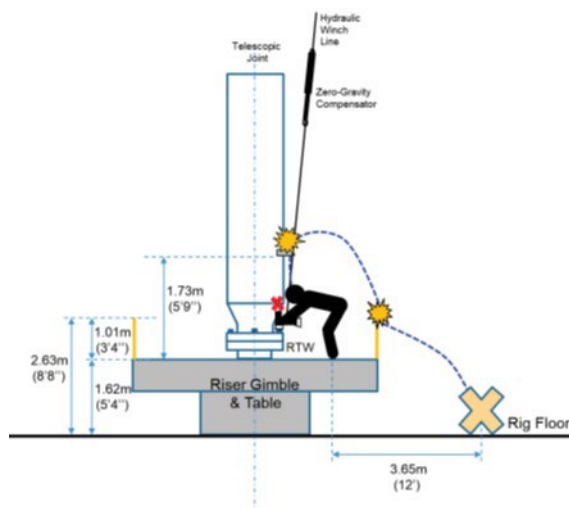
Figure 1. Floorhand Bolt Removal

The incident investigation found that the rig crew was using a HTW to extract the bolts from a telescopic riser joint (TJ) flange. During the operation, the HTW socket became stuck between the bolt head and the tapered edge of the TJ. After failing to manually dislodge the HTW using physical exertion, the rig crew utilized a Hydraulic Utility Winch (HUW) to supply upward force and applied tension to free the HTW.

After applying the upward force, the HTW became unstuck under tension and shot upwards leading to the crewmember being struck.

- Ensure the Job Safety Analysis captures the limitations of the HTW when in use.
- Verify all employees understand the Job Safety Analysis and have been formally trained on operating both the HTW and HUW.
- Emphasize the initiation of Stop Work Authority if an imminent danger is observed.
- Expand the Drill Floor Observer's responsibilities to monitor all aspects of jobs occurring on the rig floor.
- Consider utilizing a HTW with a compatible design that corresponds with the beveled edge of the TJ.
- Explore options for employing a load indicator or a similar design mechanism onto the HUW package.
- Ensure pre-job reviews, and promote the sharing of feedback from previous experiences.

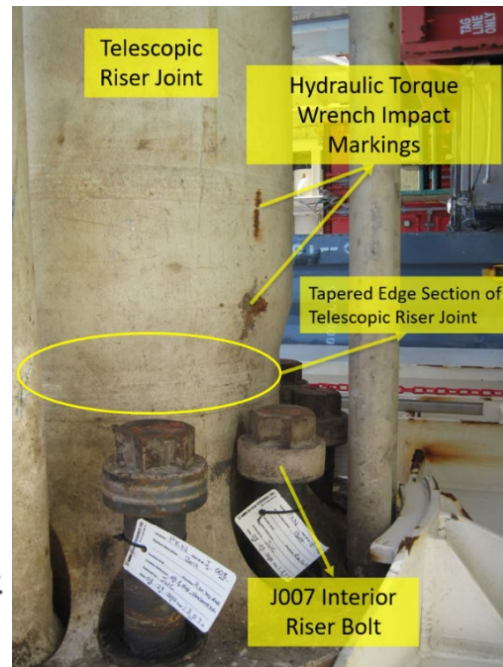
Figure 2. Riser Bolt and Telescopic Riser Joint

- Lack of recognizing the stuck-HTW potential on the TJ beveled edge.
- Lack of comprehensive understanding of the Task Risk Assessments associated with the riser pull.
- Failure to effectively communicate all learnings from the previous riser pulls.
- Lack of formalized training for the utilization of the HTW and HUW.
- Adverse designs of the HTW and the HUW.
- Contributing Causes:
  - Failure to initiate Stop Work Authority.
  - Discrepancies with the Drill Floor Observer roles and responsibilities.
