Safety Alert No. 460

Overhaul Ball Crashes to Deck Resulting in High Potential, Near-Miss Fatality

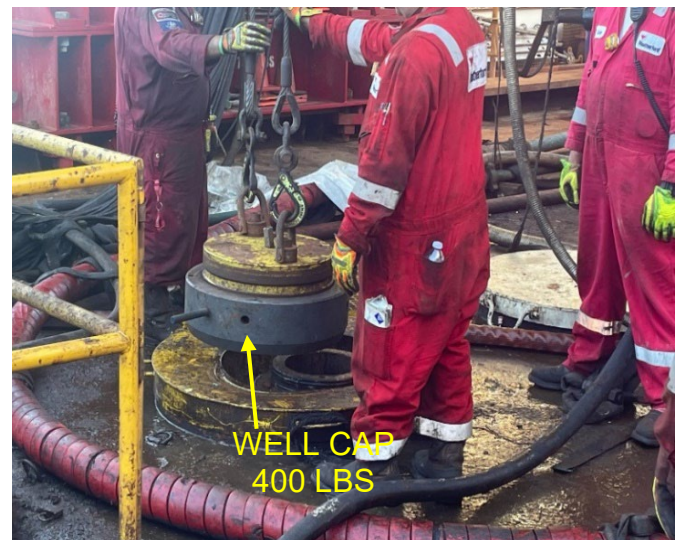
Figure 1.

- A crane was moving a 400-pound well cap (Figure 1) from one well access panel to an adjacent panel when a wedge socket on the auxiliary line snagged on the flange of a C-channel located at the edge of the platform's rig deck.
- The lift required running the crane's auxiliary line within inches of the edge of the platform rig structure. The wedge socket above the headache ball snagging on the C-channel flange that ran across the length of the edge of the deck (Figure 2). This snag temporarily held all the weight of the load and rigging, resulting in a false reading on the auxiliary winch. The load cell sending a weight signal to the operator was located below the snagged wedge socket. The crane operator did not detect that the auxiliary winch was no longer holding the weight of the load.
