Results of the Long-Term Subsea 10,000hr Testing

Final Report

Prepared for:
**Bureau of Safety and Environmental Enforcement / Pipeline and
Hazardous Materials Safety Administration**
Houston, Texas

SES Document No.: 1461191-PL-RP-04 (Rev 0)

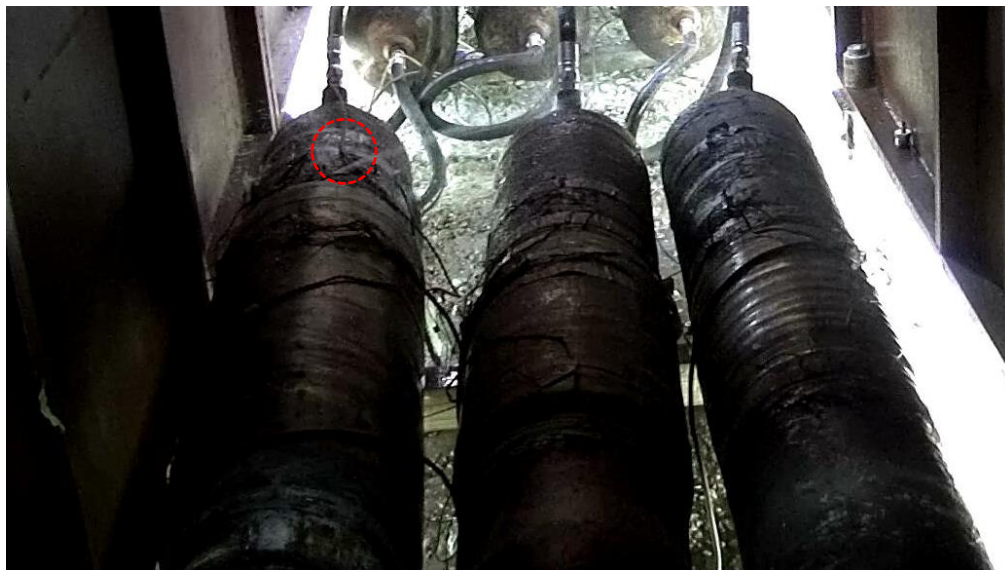
Figure 4-10: Photograph of failure (circled) during cycling of Manufacturer A’s Tension sample.

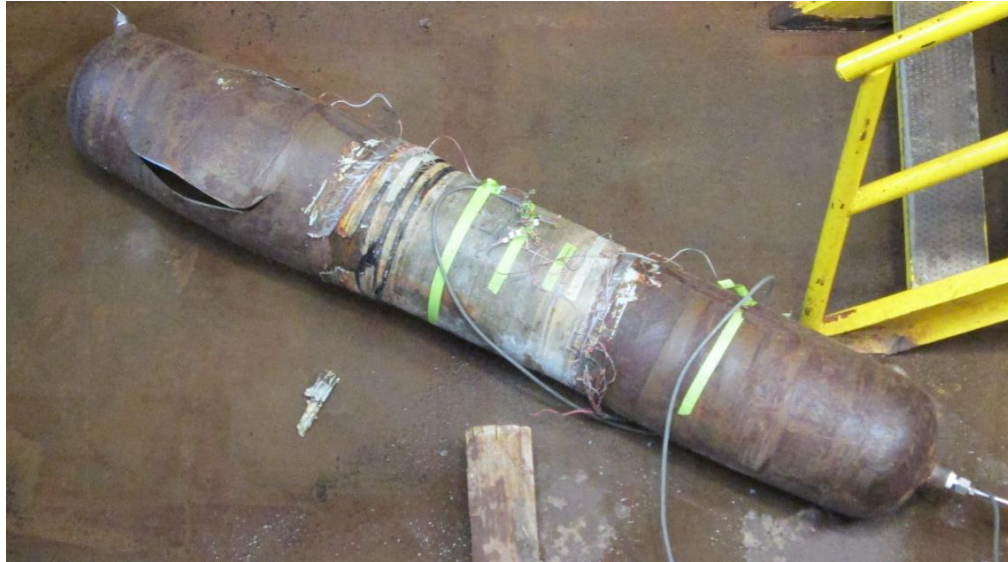
Manufacturer B's burst sample (OFF-B-B-J1-1) reached a maximum pressure of 4,037 psi (163% SMYS) before failure occurred outside of the repair in the base pipe (Figure 5-2). There was no visible damage to the outer surface of Manufacturer B's repair following the test. Figure 5-3 displays the internal pressure vs. elapsed time for the burst test. The three (3) hold points at 36%, 72%, and 100% SMYS are visible in the plot. The hoop strain measurements in Figure 5-4 indicate significant deformation in the base pipe and corrosion region during the test (corrosion region gage 2H was the only operable gage during the burst of this sample). The gages on the outside of the composite repair measured little in the way of hoop strain during the test.

Figure 5-2: Manufacturer B's burst sample post-test – failure outside the composite

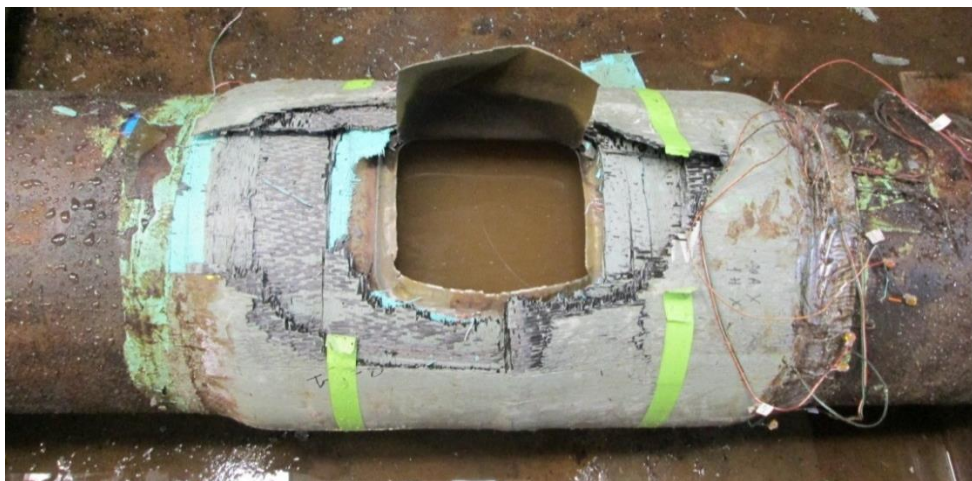
The Manufacturer C’s burst sample (OFF-C-B-J1-1) reached a maximum pressure of 3,615 psi (146% SMYS) before failure occur in the simulated corrosion defect as shown in Figure 5-5. Figure 5-6 displays a plot for the internal pressure vs. elapsed time during the burst. Similar to Manufacturer B’s sample, the hoop strain measurements in Figure 5-7 also indicated deformation in the base pipe with little change on the surface of the composite repair. No gages in the simulated defect were operable during the burst.

Figure 5-5: Manufacturer C’s burst sample post-test – failure in simulated corrosion region

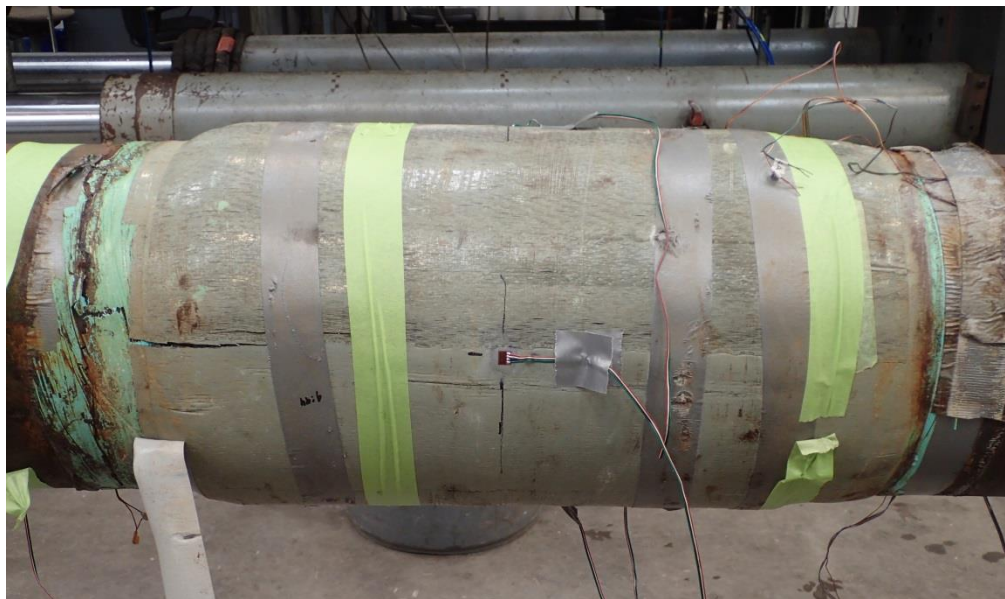
Figure 5-17: Manufacturer C's tensile sample (OFF-C-T-J3-3) post test with cracks near edges

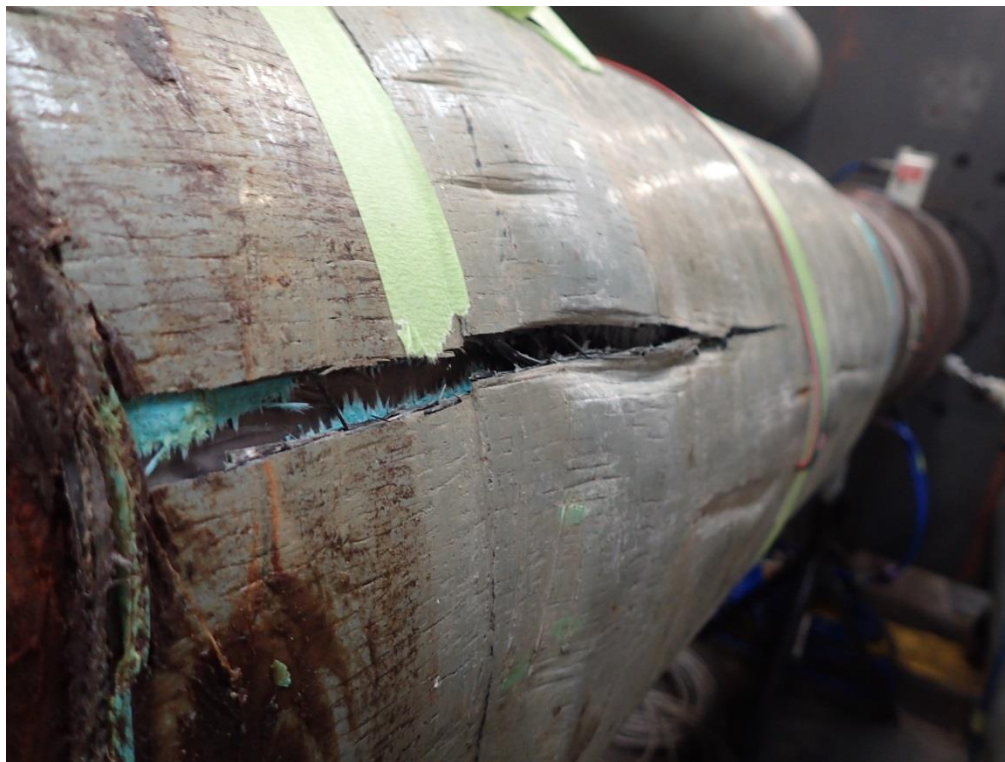
Axial strain measurements in Figure 5-19 indicate the base pipe in this sample reached nearly 10,000 microstrain before failure. The one operable axial strain gage in the corrosion defect reached over 8,000 microstrain before it became inoperable at an applied load of 490 kips. Similar to the previous Manufacturer C tension sample, there was little to no increase in axial strain on the outer surface of the repair. This Manufacturer C repair also exhibited cracks in the repair post-test as shown in Figure 5-20.

Figure 5-20: Manufacturer C’s delamination sample (OFF-C-DL-J3-5) post test with large crack in composite repair

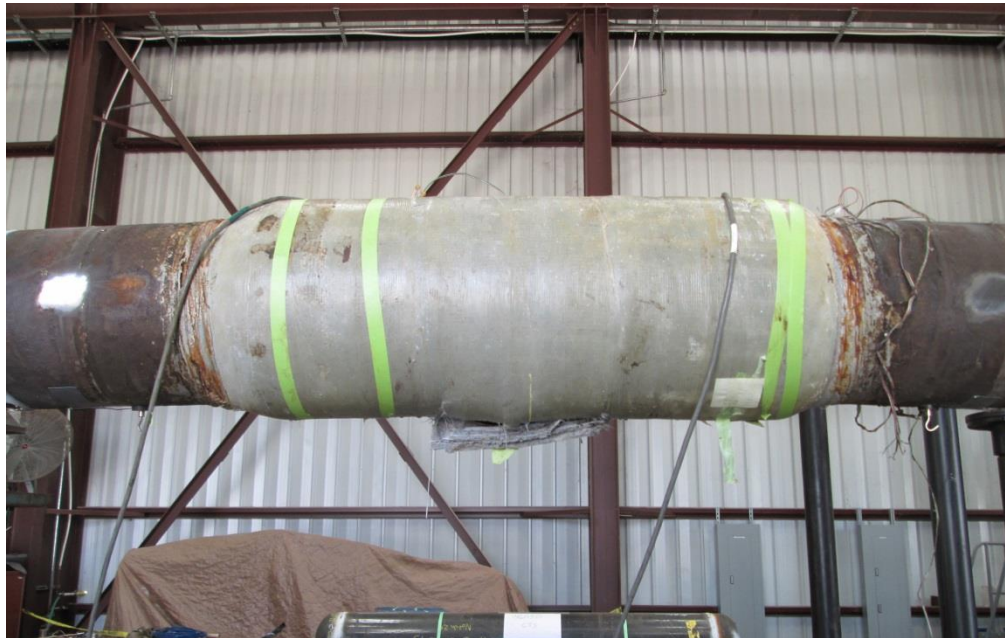
Similar to Manufacturer C’s sample, failure occurred at the corrosion defect which ruptured through the composite repair as pictured in Figure 5-5-27.

Figure 5-27: Failure at the corrosion defect in Manufacturer A’s bending sample (OFF-A-BE-J1-4)

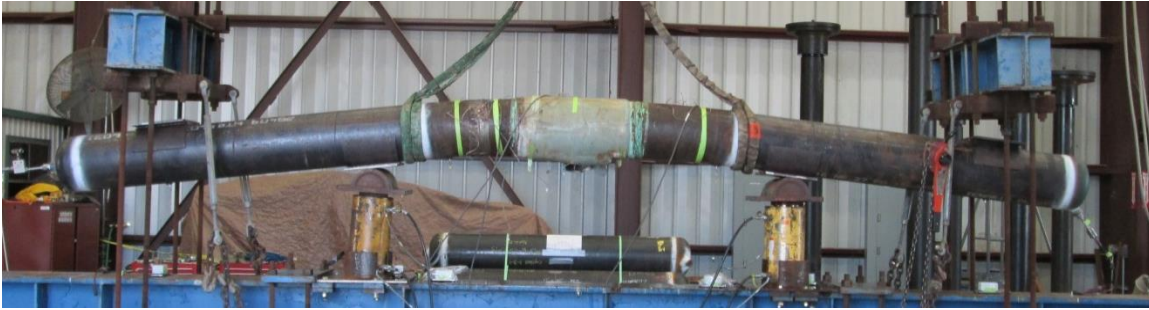
Figure 5-37: Permanent shape of Manufacturer C's bending sample (OFF-C-BE-J1-4) post-test (no bending load applied to sample at time of photograph)

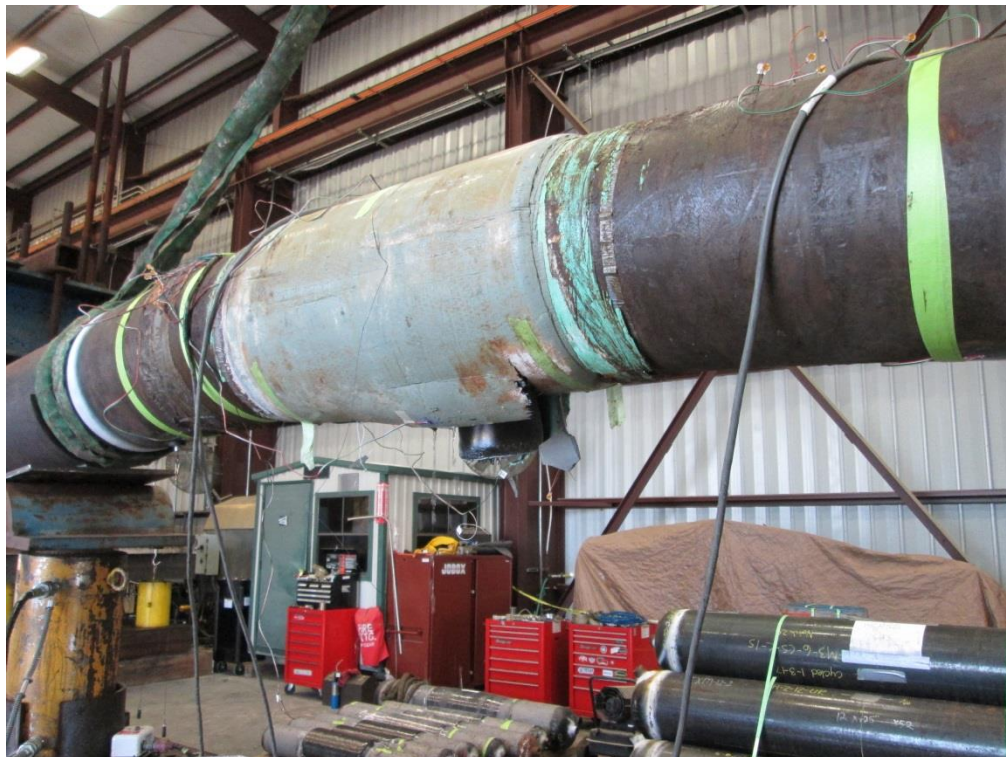
Figure 5-38: Failure at the corrosion defect in Manufacturer C's bending sample (OFF-C-BE-J1-4)

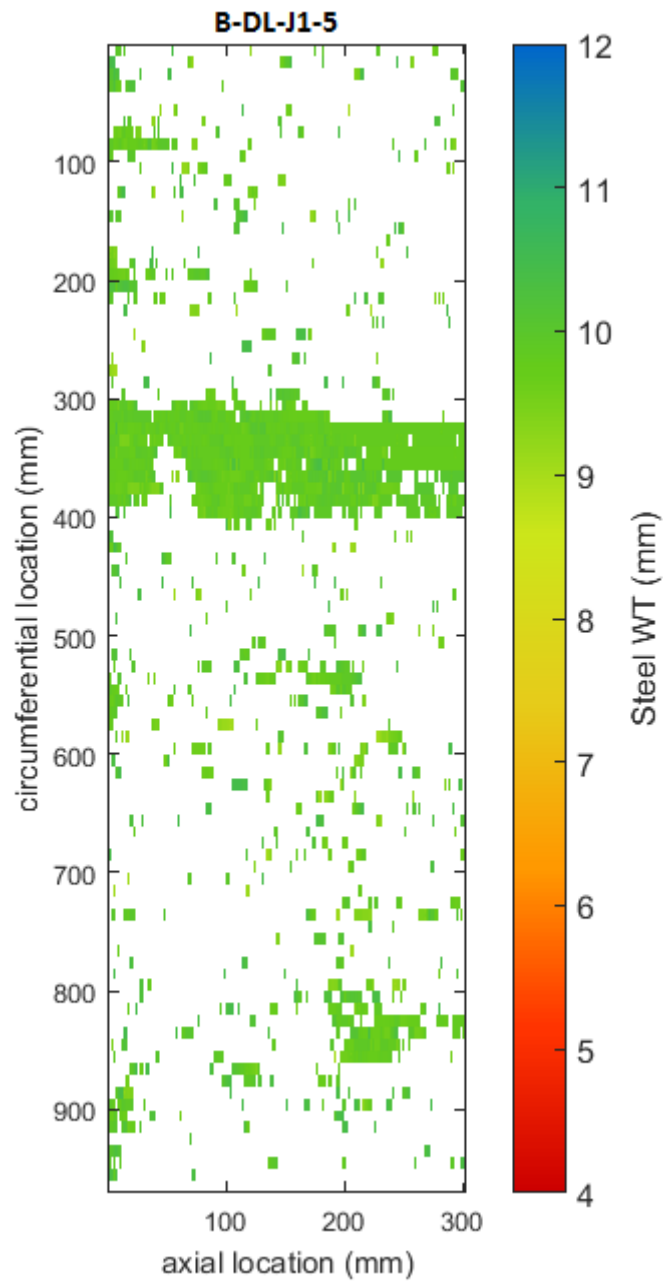
Figure 4. DRS map showing the steel WT where signals penetrated the composite. Although measurements were possible in some locations, the large areas of signal loss demonstrate that DRS is not a suitable inspection technique for this particular design.

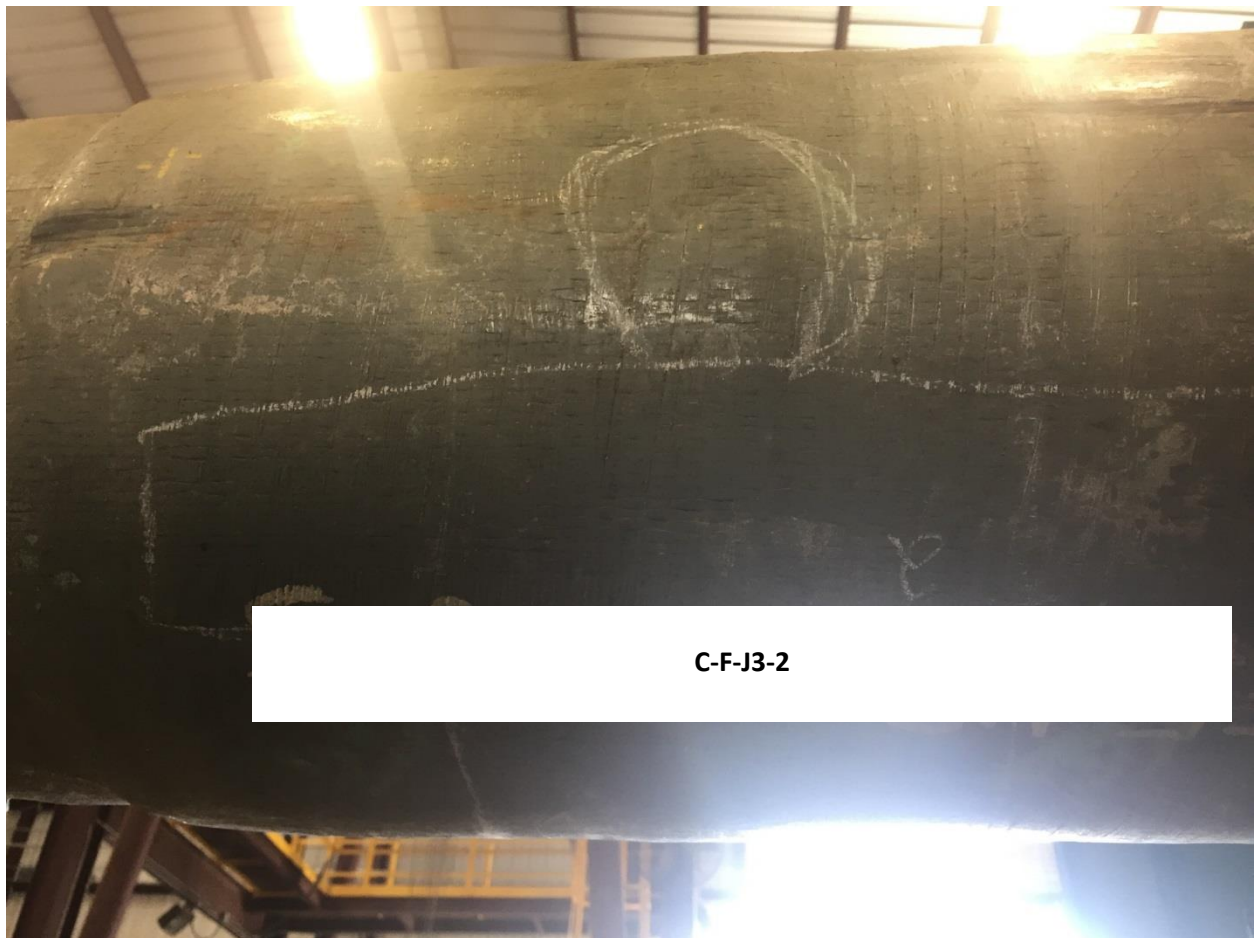
Indication # 1 Starting about 2" from nozzle end running around the circumference of the wrap inconstantly

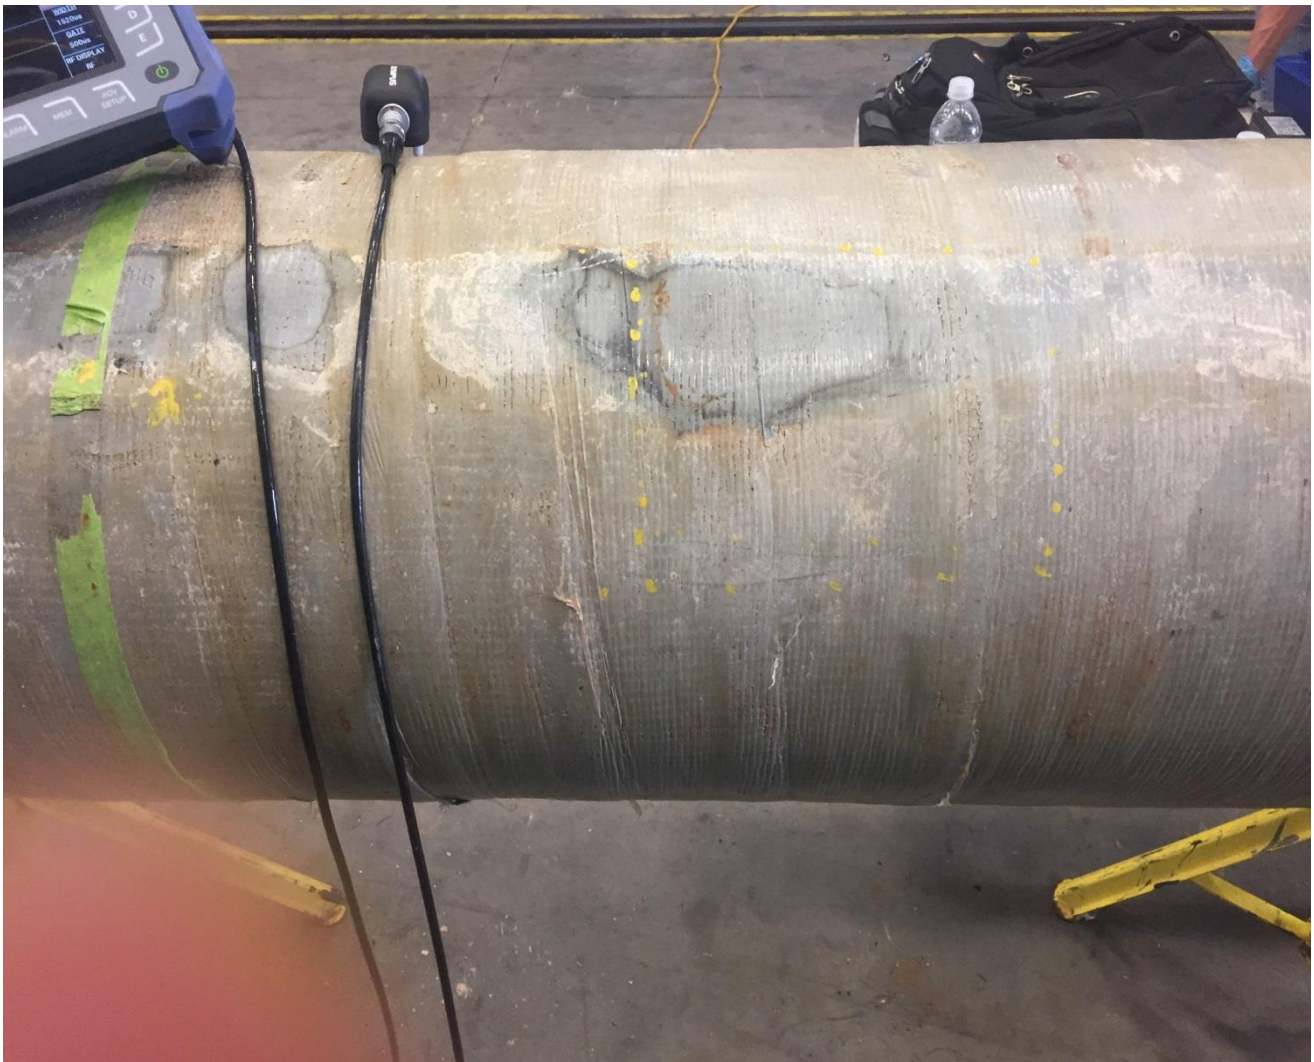
Indication # 2 (Between the 3 marker & the 0 marker). Middle of wrap closer to nozzle
