Safety Alert No. 461

May 1, 2023

Recent Tagline Entanglements Result in Several High Potential Near Misses

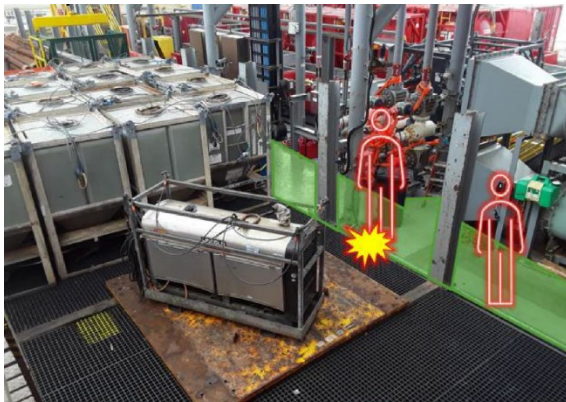
Figure 1: Worker entangled while moving toward the Step Back Area.

- **January 2023:** While lifting a welding machine from the deck, a crew member moved into the Step Back Area (Figure 1) and stepped into the coiled tagline and became entangled. The crew member was able to grab the tagline while entangled and was lifted up and swung with the load approximately 20 feet off the deck (Figure 2). The Signalman relayed the crane operator to stop the lift, and the rigger and load were lowered to the deck.
- **December 2022:** After backloading a bundle of pipe onto a motor vessel, a deckhand attached the taglines to the crane hook to send up to the platform. When the taglines were lifted, he became entangled in the lines and was lifted

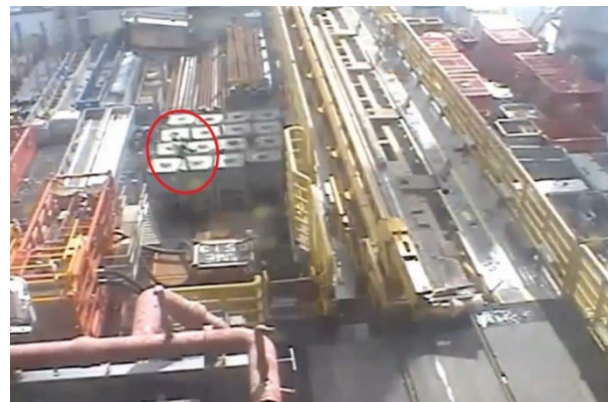
Figure 2: Worker lifted with load after becoming entangled.
