BSEE PANEL REPORT 2023-003

**Investigation of January 24, 2021, Seadrill West Neptune
Drillship Fatality**

Lease OCS-G24102

July 24, 2023

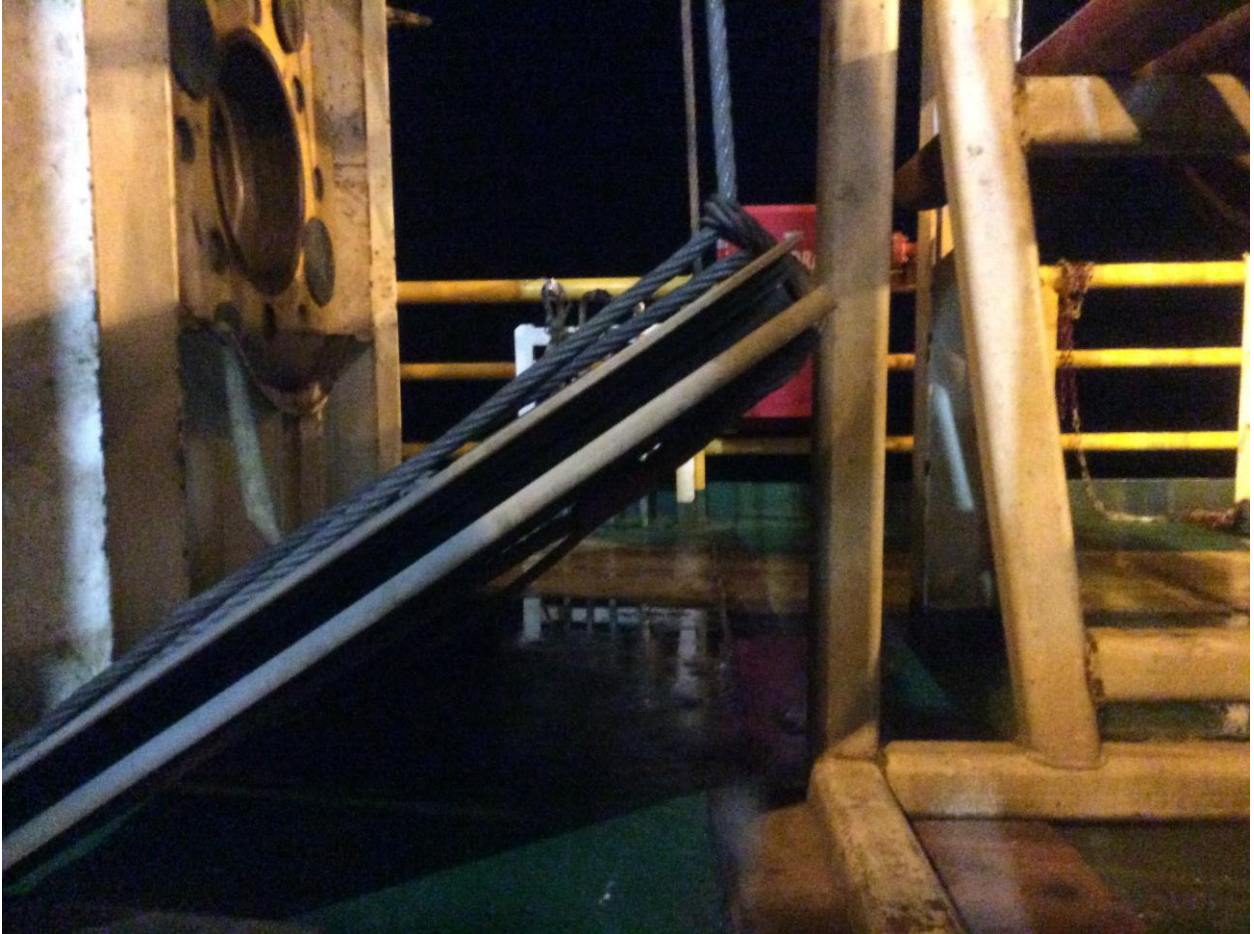
Figure 1 - Incident scene

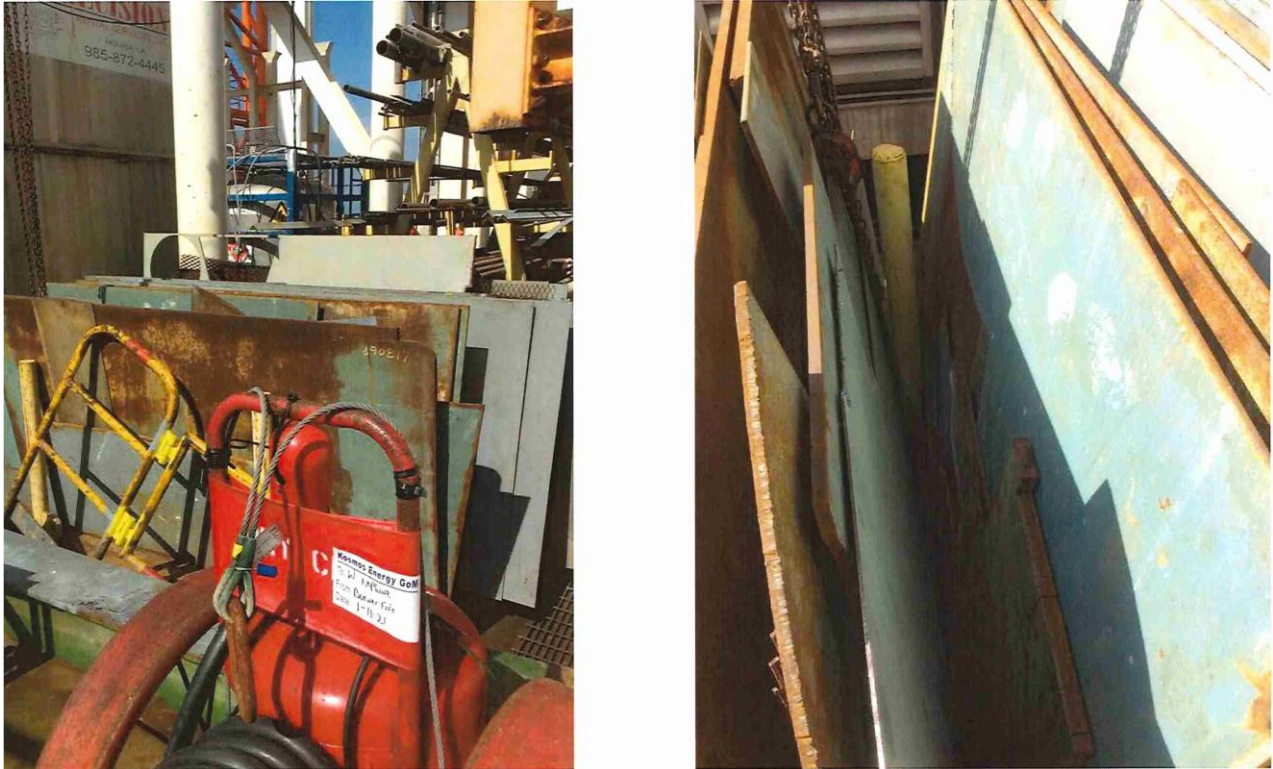
The five steel plates were initially on a supply boat and were transferred in a basket that was loaded onto the West Neptune. Later, Seadrill removed the steel plates from the basket and laid them flat with dunnage underneath on the deck to free up the basket for other uses. Seadrill again moved the steel plates and rested them in an upright position on their long edges on dunnage (two pieces of wood), then secured the plates to stanchion beams using a ratchet strap. Seadrill normally would have used the storage rack onboard West Neptune to store the steel plates, but it was full and unable to fit the steel plates purchased by Kosmos Energy. (Figure 5)

Figure 5 – Steel storage rack onboard West Neptune

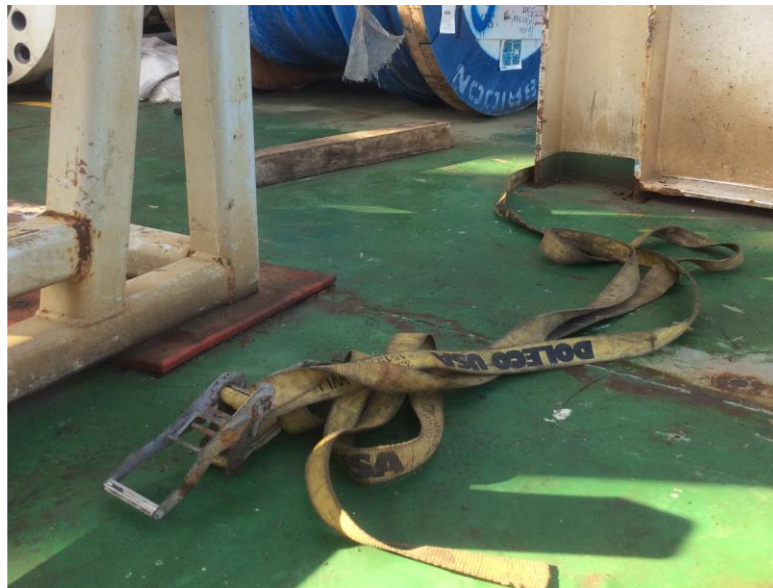
Figure 6 - Ratchet Strap that held the steel plates up against the stanchion beams

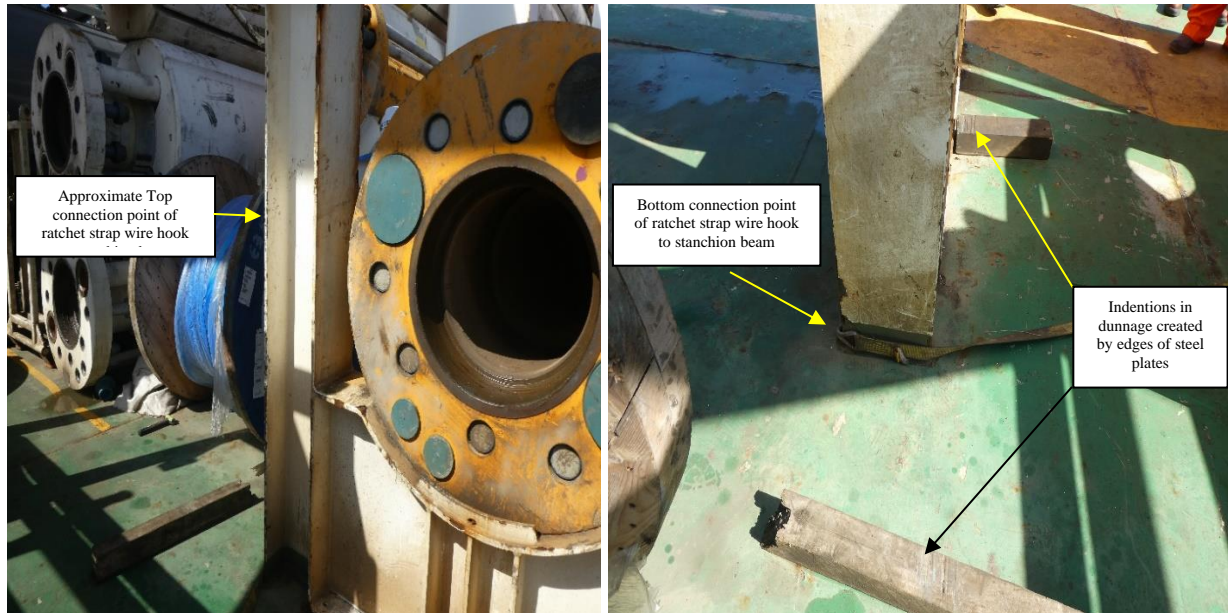
Figure 7 – Dunnage used to support plates on edge and approximate top and bottom connection points of ratchet strap wire hooks.

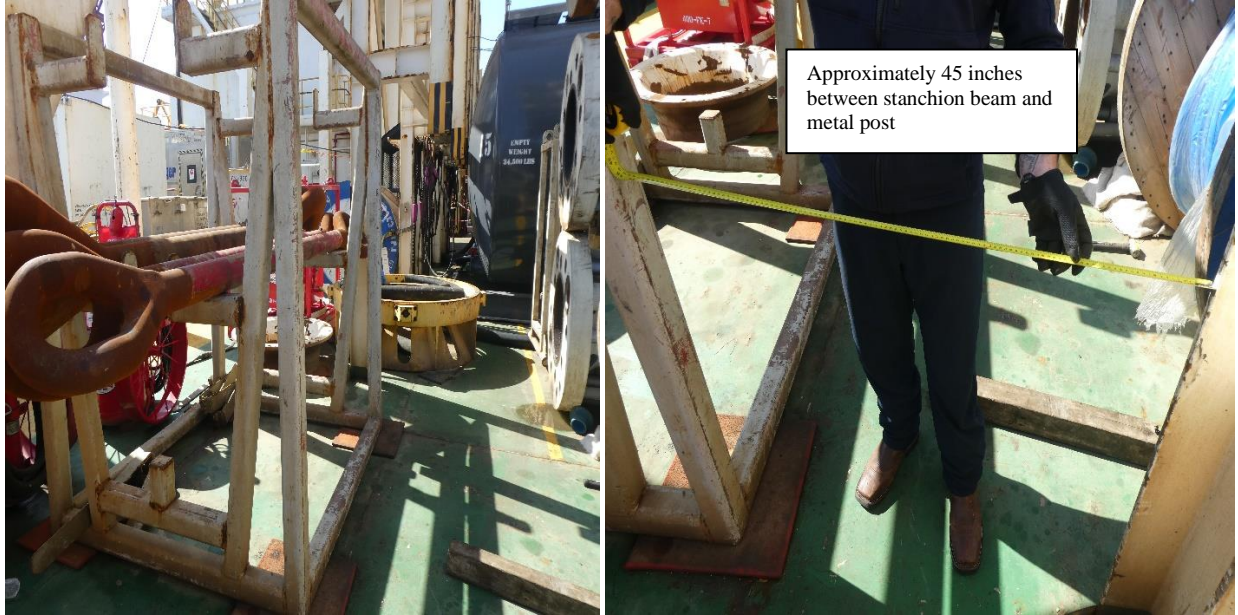
Figure 8- Area where the plates were stored

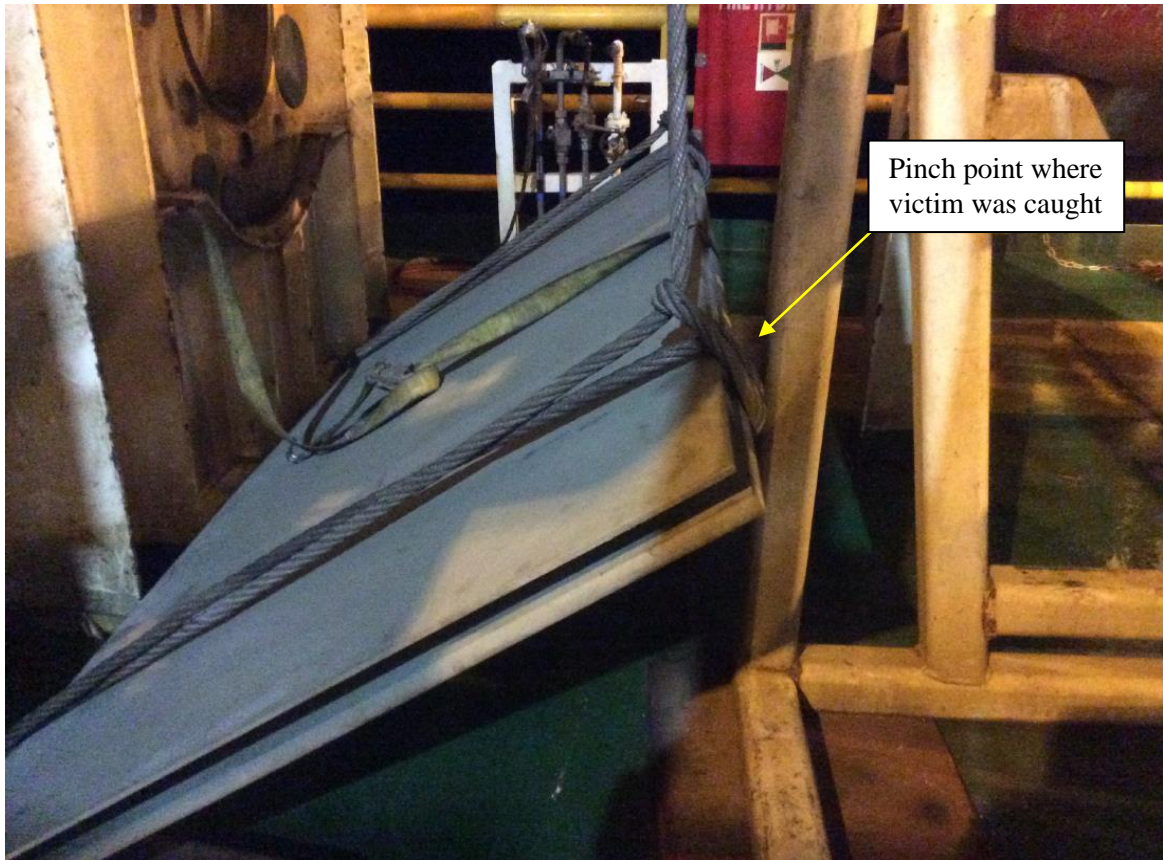
Figure 9 - Position of steel plates against vertical steel post

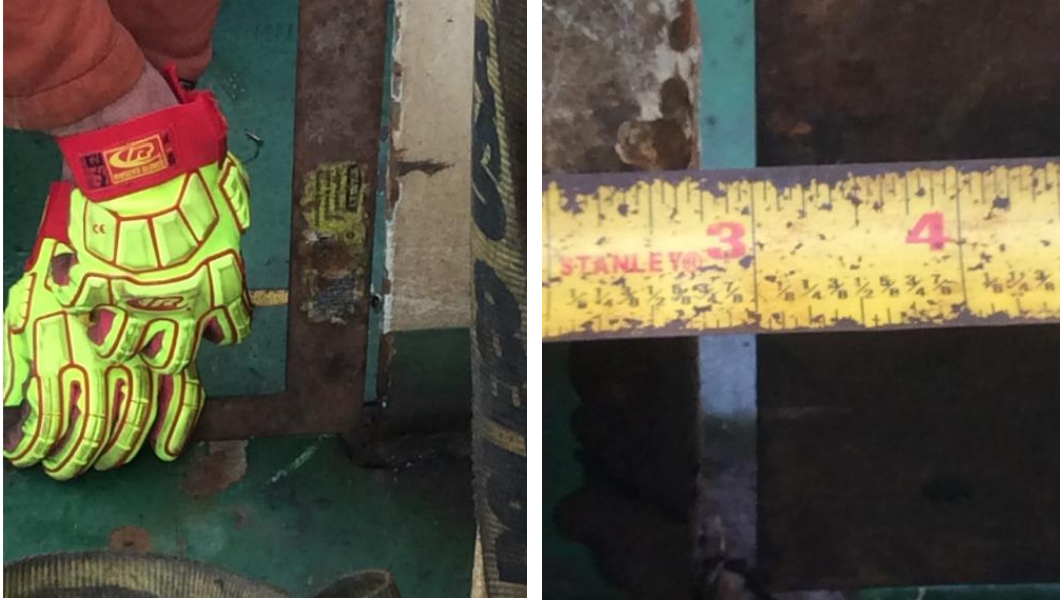
Pictures provided by Seadrill showed the stanchion beams were $\frac{1}{4}$ inch out of square to the deck, leaning towards the aft of the ship, which put the plates at an estimated 0.60 degree angle while ratchet strapped in position. (Figure 12)

According to the Seadrill incident investigation report, the stanchion that the plates were secured to was not perpendicular to the deck. This means that when the plates were secured in place by a ratchet strap (and immediately before the ratchet strap was loosened), they were slightly tilted to the aft of the drillship (towards the victim).

Figure 12 - Out of square measurement

The photos above from the Seadrill report show a 2 foot square positioned flush against the deck. Because the stanchion is slightly tilted, the square does not lie flush against the stanchion. The gap between the stanchion and the square is 1/4 inches. This is shown in the diagram below (not to scale).

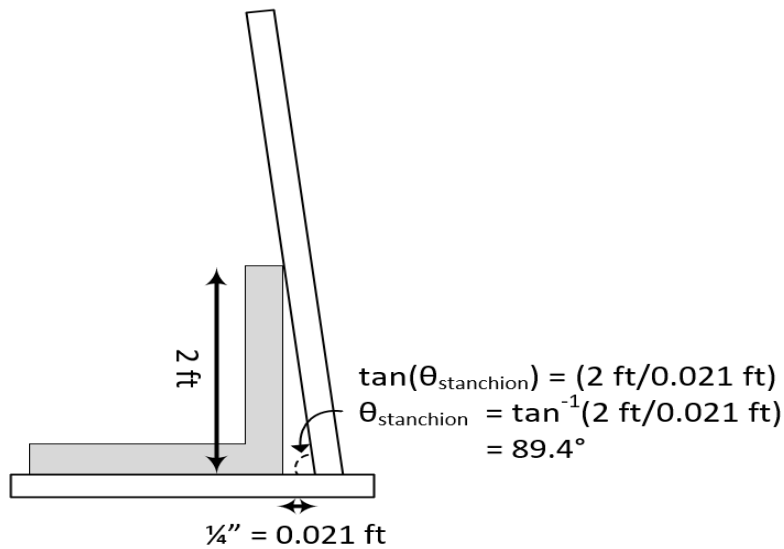
Figure 13 – Illustration of steel plates angle calculation based on out of square measurement.

If the stanchion had been perpendicular to the deck, this angle would have been 90 degrees. According to the calculations, the stanchion is tilted by an angle of $90 - 89.4 = \mathbf{0.60 \text{ degrees}}$ towards the aft of the drillship. This means that even when the plates were attached to the stanchion with the ratchet strap, they were tilted towards the victim by an angle of no less than 0.60 degrees relative to the surface of the deck. Although this angle is small, it will be shown in later calculations that even a small angle can have a significant effect.

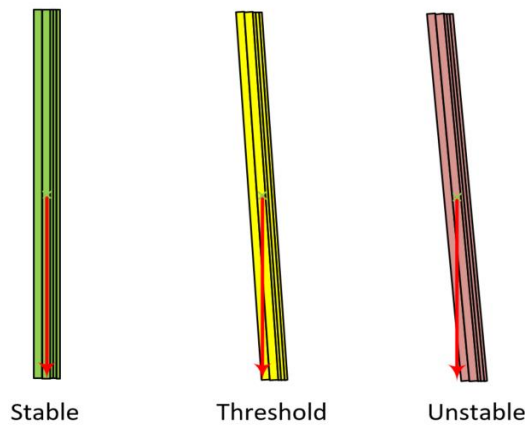
The following calculations will show the conditions when the plates would have been stable and would not have tipped over, and when they would have become unstable and would have begun to fall. Because the plates immediately began to fall towards the victim after the ratchet strap was loosened, the Panel concluded the plates were in an unstable condition.

Figure 14 - Illustration of steel plates stable and unstable positions

After the ratchet strap was loosened, the plates would only remain upright and stable if their center of gravity was above and within the footprint of the base of the plates. If the center of gravity was directly above the bottom edge of the base of the plates (as shown in the middle stack of plates in the drawing above), any further tilting would cause the plates to become unstable and fall over. This threshold tilt angle is calculated below:

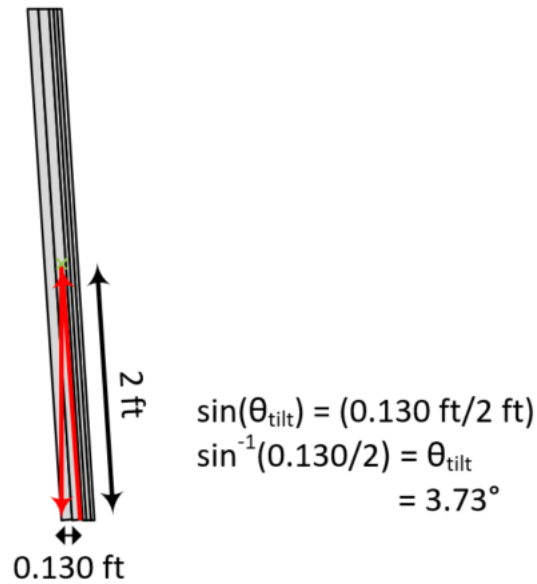
Figure 15- Illustration of weight calculations based on angles of the plates

If the steel plates were tilted by more than 3.73° when the ratchet strap was loosened, gravity would act on the plates causing them to tilt further and fall towards the victim. As the tilt angle (θ_{tilt}) increases further, the force pushing the plates over (F_{fall}) would increase, and the victim would have to apply more force to prevent the plates from tilting further. The victim used his body to counteract this force by pushing horizontally against the plates in the opposite direction. However, he was not able to apply sufficient force to prevent the plates from falling.

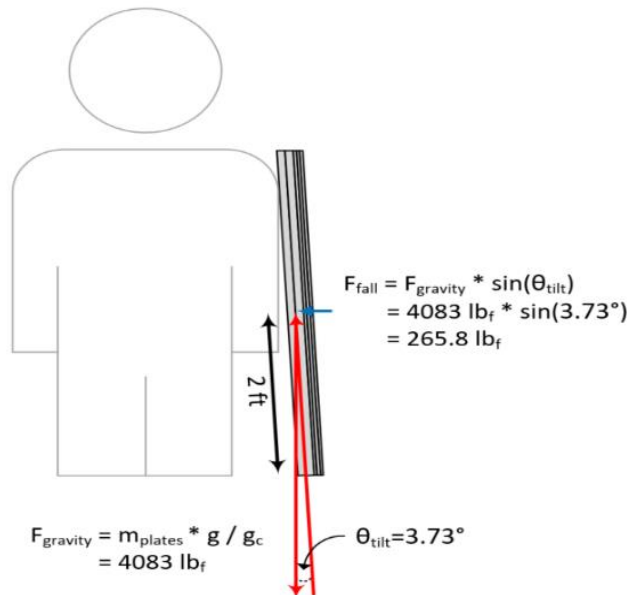
Figure 16 - Illustration of the victim's body position to plates with angle and weight calculations. The amount of force required to keep the plates upright shortly after the plates become unstable is shown on the right.

The force pushing the steel plates over (F_{fall}), calculated in the previous section, is applied at the center of gravity, which is located 2 feet above the bottom edge of the steel plates. However, the victim applied force (F_{IP}) to the steel plates with his shoulder, which was above the center of gravity. We will assume that he applied force horizontally to the top edge of the steel plate. Applying force above the center of gravity of the plates creates a second-class lever, resulting in a mechanical advantage and the effect of a greater force applied to the center of gravity (F_{lever}). This reduced the amount of force that the victim would have had to apply to hold the steel plates upright, but this was not enough to prevent the plates from falling.

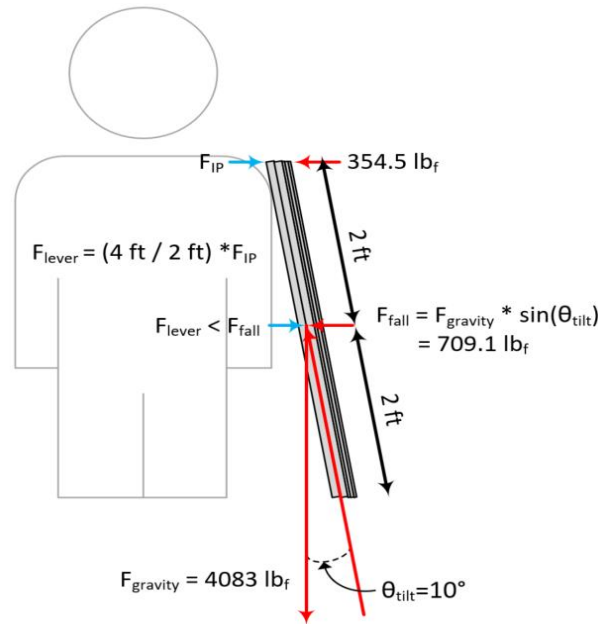
The following diagram uses a different angle (10°) from the previous calculations to show how the forces increased significantly with only a small increase in tilt angle.

Figure 17 - Illustration of the victim's body position to steel plates with angle and weight calculation as the angle of the steel plates decreased

As shown in the diagram above, due to the mechanical advantage, applying force to the top of the plate has the same effect as applying double the force to the center of the plate. Therefore, only half as much force is required to counteract the force pushing the plates over (F_{fall}). The relationships between tilt angle and these forces is shown in the table below. However, even with this mechanical advantage, the victim could not apply sufficient force to stop the plates from falling.
