Safety Alert No. 480

## Fingerboard Locking Bolt Failure Leads to Near Miss Incident

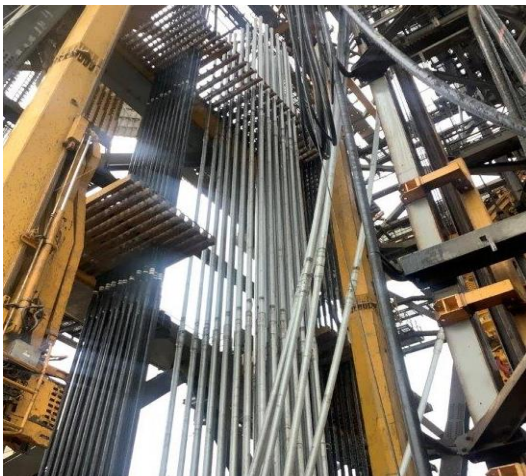
The Bureau of Safety and Environmental Enforcement (BSEE) recently investigated a high potential near miss incident that took place on a drilling rig during cement line pressure testing. Six stands of 6 5/8-inch pipe fell from the finger row and landed on the starboard side deck of the derrick (pictures below). Weather conditions at the time of the incident were 40 knot winds, heavy rain, and 8-10-foot seas. There were no personnel on the rig floor at the time of the incident.

Frontal view of stands of 6 5/8-inch pipe dislodged from finger row.

- Inspecting the condition of all casing fingerboard beam locking bolts.
- Reviewing fingerboard design and ensuring the best available locking mechanism is implemented. Contact vendor and/or manufacturer to confirm.
- Inspecting and checking the pressure applied by air cylinders to ensure proper pressure is being applied to the flip over beam.
- Ensuring all racked casing and pipe are properly secured and cannot fall out of the fingerboard during adverse weather.

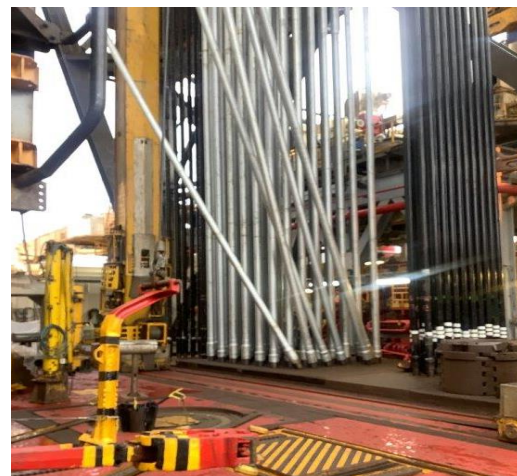
Side view of dislodged stands of 6 5/8-inch pipe.

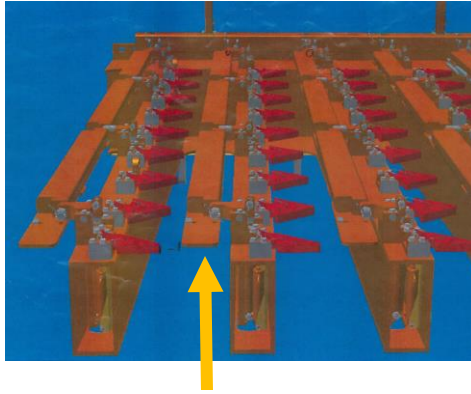
BSEE investigators determined the adverse weather conditions and the poor design of the casing fingerboard system to be main causes of the incident. The flip over beam locking bolt was not secure, and loosened during the adverse weather (see Figure 1 below). With new locking bolt arrangements with improved functionality, operators can adjust the width of the row by flip-over beams that consist of a hinged square hollow steel profile, or a steel plate. The adjustments can be made remotely or manually.

Figure 1 – Typical adjustable fingerboard with flip over locking bolt.

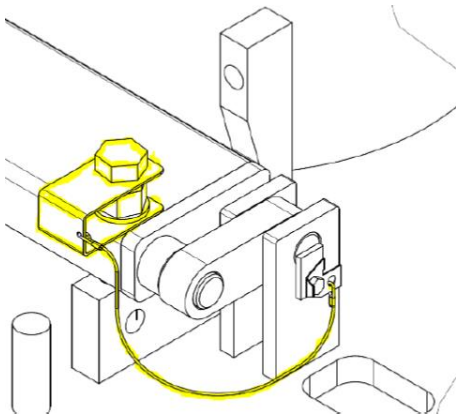
In October 2023, a manufacturer product improvement notification was distributed to inform offshore personnel about the availability of new locking bolt arrangements with improved functionality. The previous locking bolt design shown in Figure 2 underwent a redesign and enhancement to ensure improved and effective bolt locking. The enhanced locking bolt arrangement displayed in Figure 3 consists of a bolt, locking clip, and safety pin, which, when installed, prevents the bolt from unscrewing.

Figure 2 – Current locking bolt design.

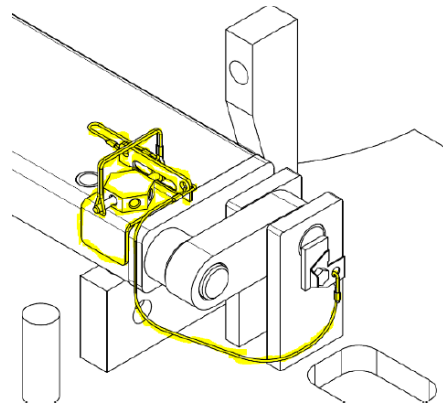
Figure 3 – Enhanced locking bolt design.
