## Bureau of Safety and Environmental Enforcement

# SAFETY ALERT

Safety Alert No. 506  
Date: Sept. 30, 2025

### Arc Flash Incident Highlights Critical Need for Voltage Verification During Offshore Electrical Maintenance

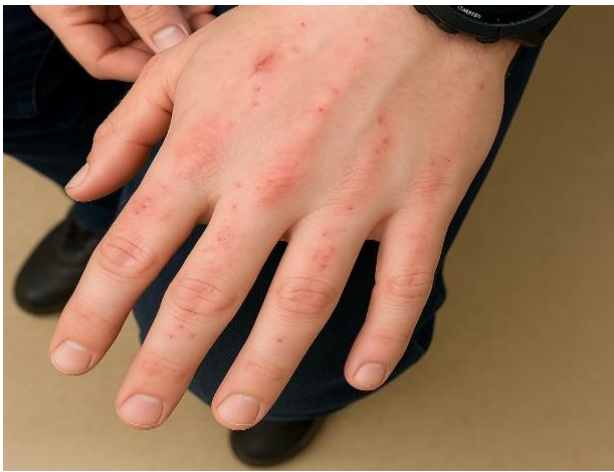
*Fig 1. Second-degree burn to technician's hand*

An electrician inside the MCC tried to reposition the cable using non-insulated pliers. That action caused an arc flash between the exposed ground wire and the energized bus bar. The electrician received a minor thermal burn (Figure 1), and the MCC panel showed charring and damage (Figure 2).

- Perform electrical work on de-energized equipment whenever technically feasible. Only perform energized work with documented risk justification and management approval.
- Require JSEAs to identify electrical hazards, arc-flash categories, required PPE, and the use of insulated tools. JSEAs should explicitly cover multi-location tasks and communication protocols.
- Require arc-rated PPE suited to the calculated incident energy. Prohibit non-insulated tools near live parts.
- Mandate verbal confirmation, read-back, and “ready/clear” signals before advancing cables or components into energized spaces. Provide radio backup when line of sight is not possible.

- Provide refresher training on electrical hazards, arc-flash awareness, and Safety and Environmental Management Systems (SEMS). Verify contractor qualifications and set competency standards for energized work.
- Audit permits, JSEAs, and field work to confirm compliance with API RP 14F or API 14FZ, SEMS, and company electrical safety procedures.
- Reinforce Stop Work Authority when conditions deviate from approved procedures or when hazards are not fully controlled.

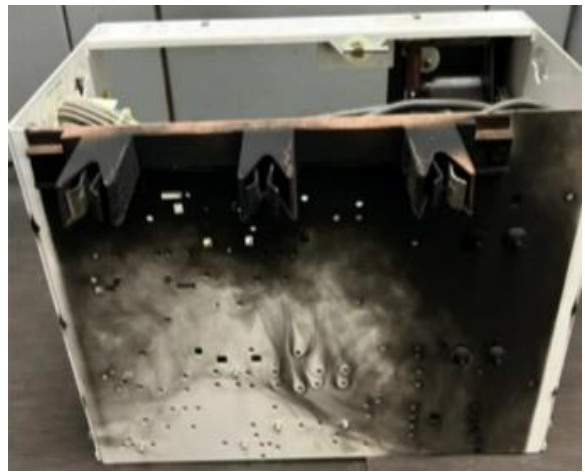
*Fig 2. Charred MCC Panel*

**Findings:** An investigation found that a procedural gap and communication failures were the primary causes. The Job Safety and Environmental Analysis (JSEA) did not recognize, or control energized electrical hazards. It did not call for electrically rated personal protective equipment (PPE) or insulated tools. Work proceeded on energized equipment without effective, documented communication between the separated work locations.

- The JSEA described routing the cable into the panel but did not identify arc flash hazards, required PPE, or the need for insulated hand tools.
- Personnel below the MCC pushed the cable before those inside the MCC were ready to receive it — there was no enforced readback “ready/clear” confirmation or reliable radio backup.
- The electrician inside the MCC was not wearing arc-rated PPE appropriate to the task and used non-insulated pliers; the tool in use was not electrically rated for exposure to energized conductors.
- The cable was pushed too far into the penetration and migrated behind the protective barrier, bringing exposed conductor(s) into proximity with the live bus bar.
- Limited visibility/line-of-sight between operators, premature action by the cable-puller, and insufficient situational awareness during cable manipulation.
