Falling Corroded Crane Component Results in Near Miss

CATEGORY: Cranes, Personnel Safety

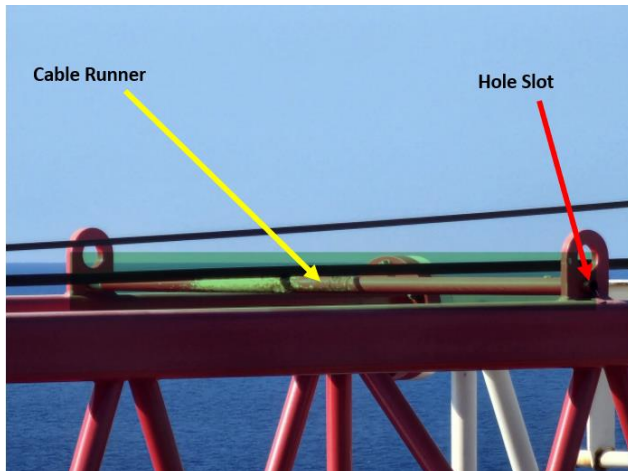
Figure 1: Corroded crane boom cable runner / roller on crane boom.

- The most recent annual inspection of the crane, conducted in 2022, identified significant corrosion on the crane's boom, including the cable rollers/runners. Before the incident, the operator failed to carry out the recommended repairs noted in the inspection.

- The threat of serious injury or fatality occurring was present due to the size and weight of the cable roller that fell 50 feet to the deck below.

- Follow maintenance recommendations and promptly perform repairs recommended by certified maintenance technicians.
- Emphasize increased awareness of aging and neglected equipment during maintenance, inspections or decommissioning activities.

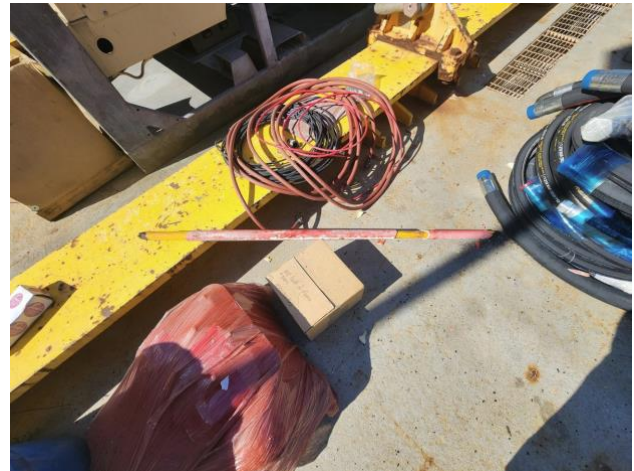
Figure 2: Area where cable roller / runner landed.

A near-miss incident involving a dropped object occurred on an offshore platform in the Gulf of America during the maintenance and inspection of a platform crane. While the crane was undergoing maintenance, a corroded cable runner on the crane's boom separated and fell approximately 50 feet to the deck below. The cable runner was approximately 66 inches long, 1 inch in diameter, and weighed approximately 15 pounds. During inspection of the cable runner, corrosion was found to have compromised its integrity, causing it to separate from the crane's boom and fall to the deck below. Following the incident, an inspection of the separated cable runner found significant corrosion that had compromised its integrity, leading to failure and subsequent drop. The crane had been out of service for approximately three years and three months before the incident. When the cable runner separated and fell, it landed on the platform's top deck approximately 20 feet from nearby personnel.

- The technicians failed to barricade the area underneath the crane before starting operations, and to prevent personnel from entering the area, given the possibility of dropped objects identified in the JSA.

- Include equipment in poor condition that is being serviced as a possible source of dropped objects when conducting dropped object hazard identification.
- If a dropped object hazard is identified, establish barriers and other controls to minimize the risk to personnel and equipment below the work area.
- Conduct an inclusive, detailed JSA meeting for all personnel involved to provide input on identifying any potential hazards present during the work being performed and the best way to mitigate them.
- Supervisors should be proactive with their personnel and discuss any concerns before and during the work.
- Develop and discuss the JSA being performed and ensure that mitigation techniques are identified for any hazards identified during the JSA meeting.
