Bureau of Safety and Environmental Enforcement  
**SAFETY ALERT**

**Safety Alert No. 513**

**Date: Feb. 5, 2026**

## Exterior Walkway Separates from Temporary Living Quarters, Putting Workers at Risk

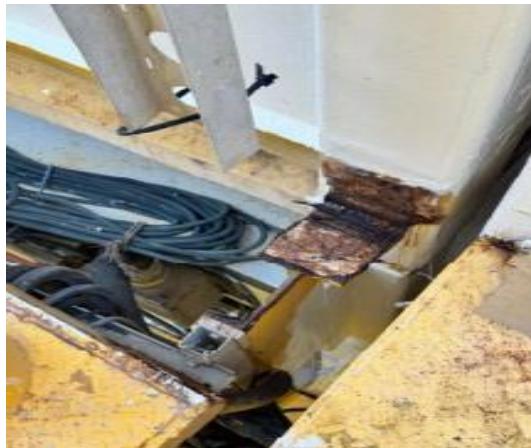
*Walkway separated outward from temporary living quarters, exposing a significant gap.*

**Findings:** The operator installed the living quarters as a temporary structure designed for removal or dismantling. (The quarters remained in service for 23 years.) As such, the operator's inspections did not account for the structure's age or the offshore environment. Inspection criteria did not address corrosion, fatigue or age-related deterioration of welds.

- **Inspections were not adequate:** The operator relied on visual inspections only. Those inspections did not verify the condition of the tab welds connecting the walkway to the living quarters.

- **Insufficient structural support:** The welded tabs at the walkway connection points did not provide enough welded surface for support. The stairway's south side lacked support, which may have increased stress and contributed to the failure.

- **Marine environment and aging:** Corrosion and age-related fatigue affected the tab welds over time.
- **Inspection management weaknesses:** The operator used inspection criteria based on the structure's original "temporary" intent. Visual inspections did not identify hazards related to structural support of the living quarters and walkways.

- Design and build temporary structures with potential long-term use in mind.
- Update inspection programs for temporary living quarters and similar installations to address marine corrosion, fatigue, weld condition and structural integrity.
- Use non-destructive testing with visual inspections, such as ultrasonic testing, to evaluate weld thickness and detect structural degradation.

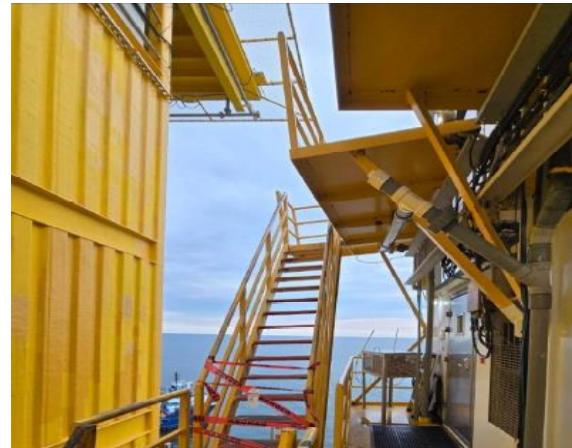
*View from below of walkway shifted outward from temporary living quarters, revealing a significant gap.*
