Safety Alert No. 514

Date: Feb. 6, 2026

## Verify Megger Testing and Termination Prep to Prevent Seawater Pump Motor Fires

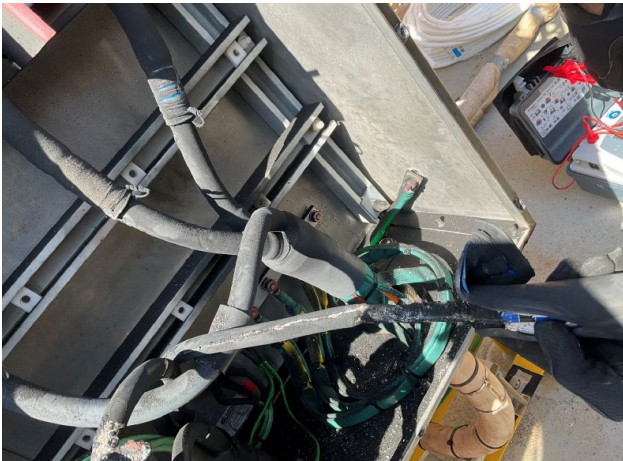
*Figure 1: Evidence of arcing and burned wiring inside the motor termination box.*

After electricians replaced stress cones and crimped lugs during a motor termination repair, the motor was placed back in service to test the work. The motor tripped offline, and multiple overload alarms were recorded. While troubleshooting, electricians found burned wiring and signs of arcing inside the motor termination box (see Figure 1). The damaged wiring was found below the stress cones, between the line and load conductors (see Figure 2).

The terminations were megger-tested<sup>1</sup> with a 1,000-volt tester, but the work pack required a 5,000-volt tester.

- The recorded insulation resistance to ground was **200,000 ohms**, which did not meet the work pack requirement of **100,000,000 ohms (100 megaohms)**.
- The semiconductor layer was not prepared as specified in the maintenance work pack.

The operator's corrective action was to create slack in the load cables, cut out damaged phase conductors, and reterminate the conductors in accordance with engineering guidance.

- Follow the manufacturer's instructions and the approved work pack for repairs.
- Verify test setup and results before restoring equipment to service.
- Use test equipment with the correct voltage rating for the job.
- Ensure workers understand unit prefixes (ohms, kilo-ohms, megaohms) and the magnitude differences.

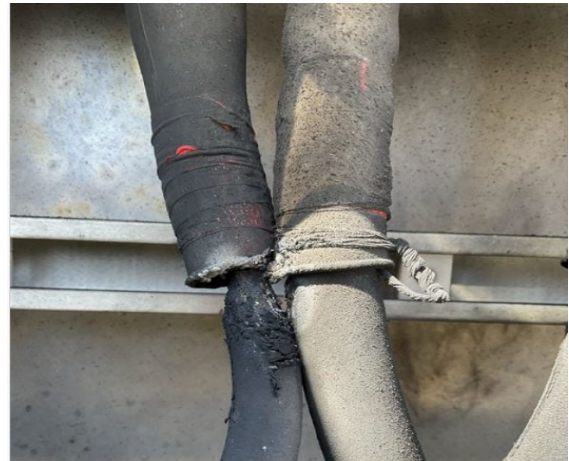
*Figure 2: Burned wiring located below the stress cones between the line and load conductors.*
