Safety Alert No. 518

Mechanical Failure of LACT Pump Caused Fire

Verify Pump Alignment After Motor Replacement to Prevent Fires

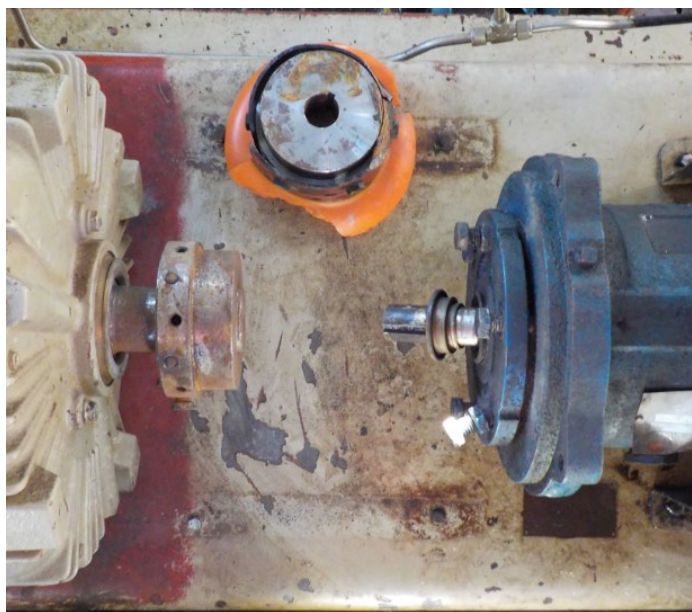
Figure 1: Damaged Lease Automatic Custody Transfer charge pump, electric motor and coupling.

The Bureau of Safety and Environmental Enforcement recently investigated a fire at an offshore production facility in the Gulf of America. The fire occurred after motor-to-pump misalignment on a Lease Automatic Custody Transfer, or LACT, charge pump caused the pump to fail mechanically (Figure 1).

The misalignment loosened the pump casing fasteners and allowed oil to leak onto the skid.

The investigation found that proper installation procedures were not followed when the electric motor and coupling were installed. A straightedge was used to align the motor horizontally and vertically, but angular alignment was not performed. The coupling bolts were not installed to the proper torque, the motor was installed without shims, and the motor mounting bolts were not torqued to proper specifications.

Disassembly and inspection of the motor confirmed the following sequence of failure: During normal operations, the motor operated at approximately 3,600 rpm. The motor-to-pump coupling misalignment, combined with the high operating speed, caused excessive vibration. The vibration loosened the pump casing fasteners, which allowed oil to leak from the pump casing. The coupling eventually failed, causing additional damage to the pump and the electric motor. These failures and the associated leak led to ignition of oil on the skid.

- Install equipment according to original equipment manufacturer specifications and approved maintenance procedures.
- Ensure that proper installation procedures and all required tools are available before work begins.
- Ensure that all personnel are properly trained on installation procedures, proper tool use, and post-installation function checks for equipment prior to performing work.
- Evaluate maintenance procedures to determine if post-installation surveillance of equipment needs improvement, such as increased frequency of operator rounds and/or multiple-day monitoring of equipment.
- Investigate vibration alarms, equipment faults, and other signs of abnormal operation. Vibration alarms may be triggered by nearby equipment if that equipment is mechanically connected or coupled.
