Safety Alert No. 519  
Date: July 1, 2026

## Verify Riser Fin Retention Systems Before Prompts Riser-Handling Operations

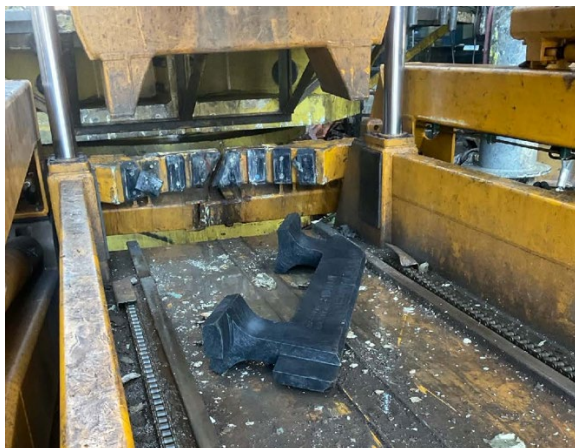
*Resting spot of one fallen fin.*

The Bureau of Safety and Environmental Enforcement recently investigated a near miss incident during riser-handling operations. While rig personnel were pulling a slick riser joint and lowering it toward the riser skate, a thermoplastic riser fin detached and fell approximately 70 feet, striking the spider platform on the drill floor.

- The fin retention system was not tensioned to Original Equipment Manufacturer, or OEM, specifications, and required torque verification steps were not completed or documented before use.

- Post-installation verification, including the required 48-hour re-torque, was not performed, leaving the retention system vulnerable during riser handling operations.

- Verify and document torque values for all riser-fin securing systems according to Original Equipment Manufacturer specifications, and ensure all required verification steps, including the 48-hour post-installation re-torque, are completed before deployment or handling.
- Implement manufacturer-recommended design improvements when performance concerns or upgrade advisories are issued.
- Reinforce procedural discipline by consistently applying established work practices and verification requirements.

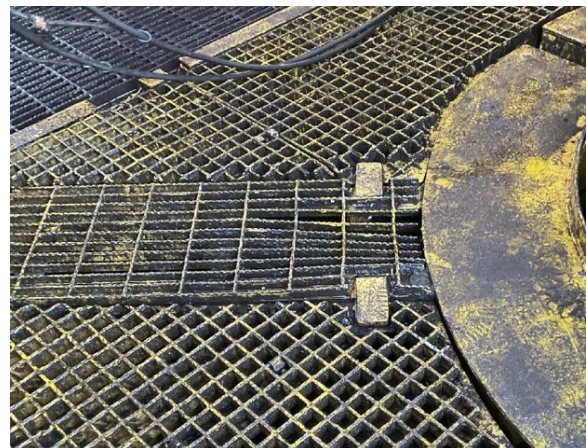
*Impact location on drill floor.*

The crew stopped riser movement and conducted an immediate safety assessment. During the assessment, the crew found that the impact had displaced the hole cover. A drill crew member re-entered the area and repositioned the hole cover to restore open hole protection.

No personnel were in the drop zone during either event; however, crew members had been in the area less than one minute before the second fin detached. Each fin weighed approximately 61 pounds, and each fall involved an estimated 4,276 foot-pounds, or 5,798 joules, of kinetic energy. This amount of force could have caused a fatal injury if personnel had been in the impact area.
