Safety Alert No. 520
Date: July 1, 2026

Inspect A2B Systems and Wire Rope Terminations to Prevent Crane Hazards

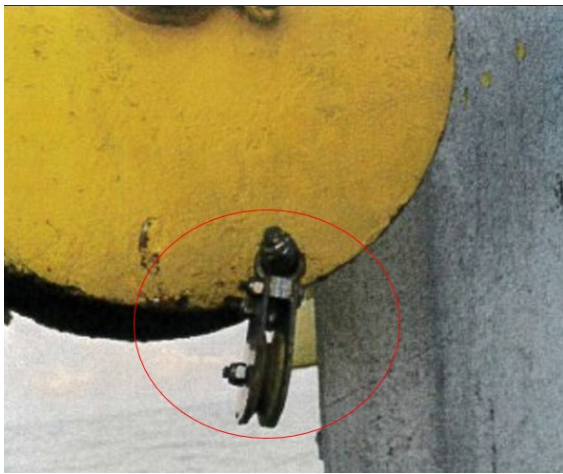
Figure 1-Damaged A2B pulley with bent bolt caused the cable to ride on the frame instead of the pulley wheel.

The bureau's investigation determined that the fast line wire rope failed because of internal corrosion at the wedge socket. The corrosion developed after the annually required cut and-slip maintenance was not performed in accordance with company policy. Investigators also found that a bent bolt caused the A2B cable to run off track and abrade, allowing the A2B weight to detach and fall.

The impact of the falling weight on the wedge socket generated a sudden, high intensity- force that exceeded the remaining strength of the weakened wire rope, causing it to part. Inadequate inspections contributed to the incident because they did not identify the bent pulley bolt, misaligned pulley, abnormal cable wear, or the deteriorated A2B wire rope before the incident.

- Conduct pre-use and periodic crane inspections to verify proper A2B pulley alignment, bolt integrity, and unrestricted sheave rotation. Remove cranes from service when inspections identify chafing, binding, or misalignment or other unsafe conditions.

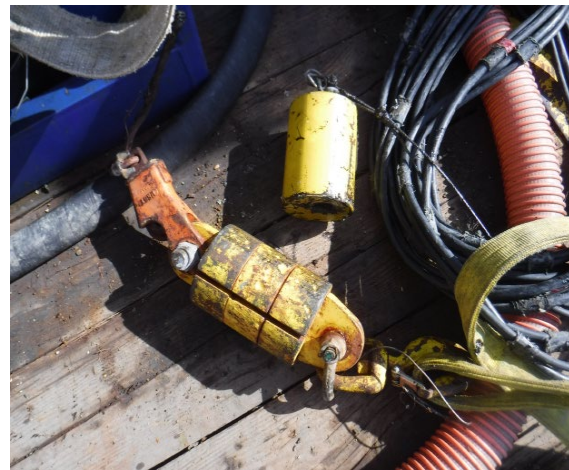
Figure 2-A2B cable failure resulted in the weight falling directly onto the deck.

During lifting operations, the lift boat crane's anti-two-block, or A2B, weight detached from its anchor point at the boom tip. The weight slid down the fast line cable and struck the fast line ball's wedge socket, causing the fast line wire rope to fail at the socket entry. The fast line ball and detached weight fell approximately 12 feet to the vessel deck.

- Ensure personnel follow API RP 2D required “cut, slip, and inspect” procedure for all wire rope terminations, especially those exposed to saltwater intrusion, so that internal corrosion and strand deterioration may be detected and corrected before rope failure.

- Consider increasing inspection frequency and shortening wire rope replacement intervals for cranes operating in corrosive marine environments, consistent with API RP 2D guidance on corrosion, abrasion, and wire rope retirement criteria.
