## MARINE MINERALS ADMINISTRATION SAFETY ALERT

Safety Alert No. 522  
Date: August 12, 2026

### Crane Failures Highlight Crane Inspection Gaps

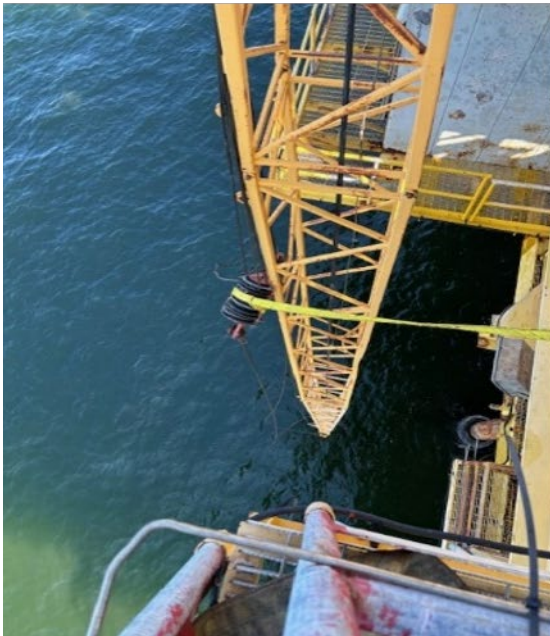
**Incident 1:** Platform crane fallen boom after boom cable separation caused by sheave bearing failure during an 8,000-pound dynamic lift.

A platform crane was making an 8,000-pound dynamic lift from a contracted motor vessel to the platform when the crane failed. During the incident, the crane's boom cable separated, causing the boom to fall uncontrollably. The boom struck platform handrails

and the motor vessel below. No injuries were reported, but the incident damaged the platform handrails, crane, and motor vessel.

- The crane suffered extensive damage after a boom cable bridle sheave bearing failed.
- Evidence indicated the bearing seized and could not spin freely as designed. Once seized, the bearing's inner race began to spin on the sheave pin, ultimately wearing through approximately 1/2 inch of the pin.
- The sheaves and bearing eventually locked up while the boom cable was still moving back and forth on the sheave. Because the sheave was made of silicon material, and softer than the crane cable, the cable cut into the sheave and wore over time until it parted.
- The third-party crane service company's training and inspection documentation did not require personnel to remove sheave pins to inspect sheave bearings or identify sheave pin wear.
- The operator's crane safe work practices and inspection guidance did not require sheave pin removal as part of crane inspections.

- Update third-party crane inspection criteria to require removal of sheave pins when needed to verify sheave pin condition, bearing integrity and signs of wear.

- Establish scheduled inspection intervals for sheaves, pins, bearings, load blocks and related components
- Train crane operators and other personnel to recognize and respond to early signs of mechanical distress, including unusual sounds, block movement, reduced cable tension, binding or other abnormal conditions.

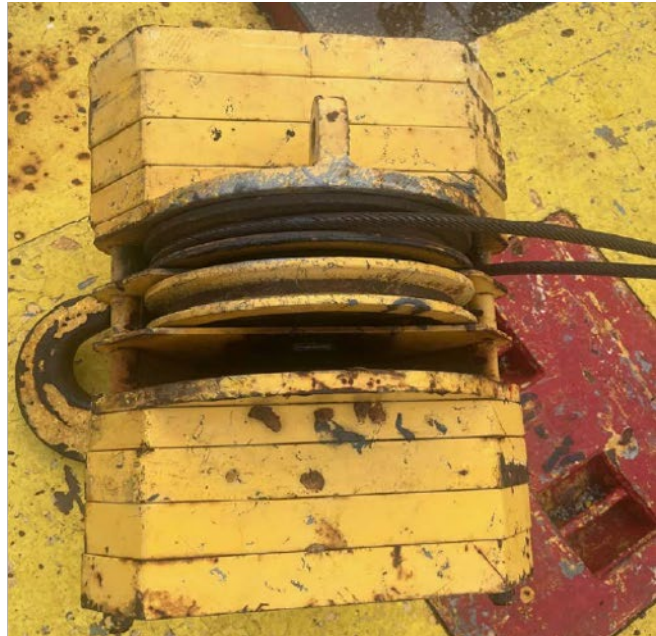
**Incident 2:** Crane load block showing corroded sheave assemblies and wire rope — result of inadequate lubrication and bearing inspection, leading to cable tension loss and sheave ejection.

In a separate incident, platform personnel were using a crane's load hoist line to lower a Job Safety Analysis (JSA), attached to a stinger, to a motor vessel crew before platform offloading operations. As the crane operator lowered the load block to the vessel, the crane cable suddenly lost tension. The crane cable and load block fell approximately 135 feet to the vessel deck.

During the incident, the dead-end sheave ejected upward from the load block and landed on the motor vessel deck. A deckhand strained his back while moving away from the falling cable and load block.

- The crane's load block sheave pin bearing failed, creating excessive rotational force that sheared the dowel pin.
- The failed bearing allowed the sheave pin and retainers to rotate freely and dislodge from the block. The sheave pin backed out of the block, the sheave ejected, and the cable and block fell to the vessel deck below.
- The bearing failure was attributed to unchecked corrosion caused by an internal

debris restriction in the sheave pin's lubrication passage.

- The operator's crane inspection and maintenance documentation did not clearly require verification of adequate load block bearing lubrication or detailed retainer condition checks.
- Personnel were not adequately trained to identify or respond to signs of crane and load block mechanical distress, including block rocking, grinding or popping sounds, and reduced wire-rope tension.
- The load block remained suspended above the motor vessel deck. The injury could have been prevented if the crane operator had identified and mitigated the hazard by keeping the load block away from the vessel deck until necessary.

- Follow safe lifting procedures, including minimizing the height of a load suspended over a motor vessel.
- Review mechanical integrity programs to verify crane maintenance and inspections are performed in accordance with the operator's SEMS plan, MMA/BSEE regulations, API RP 2D and manufacturer recommendation.
