# SAFECOM\* SUMMARY

Apr - Oct 2016

# Case Study – Doors and Windows

# Case Study – Helideck Hazards

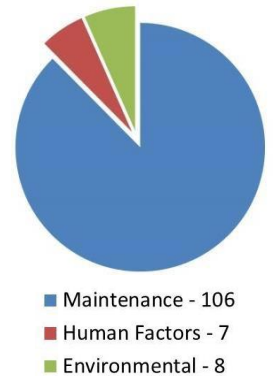
Figure 1

Many SAFECOMs that reported problems with an aircraft's engine, transmission, fuel, or hydraulic systems actually were electrical issues such as faulty transducers, broken or chaffed wires, or moisture affecting connectors. Due in part to improved hazard reporting and BSEE's frequent follow up on SAFECOMs, our aviation service providers are increasing their maintenance oversight and focusing on actions to prevent these electrical issues from interrupting our missions.

For example, BSEE's Aviation Service Provider in the Gulf of Mexico recognized that moisture is affecting canon plugs and chip detector wiring and has since published Engineering Orders for the A119 and A109 aircraft models to minimize the false indications due to the salty/humid environment.

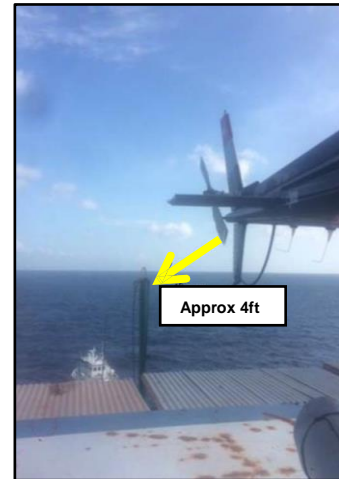
Figure 5

**July 6.** After landing near the edge of a helideck (rather than in the aiming circle), the pilot found a vent pipe four feet from the tail rotor (fig 1). ([16-0503](#))

For a full description of each event see the links to the individual SAFECOMs or go to [www.safecom.gov](http://www.safecom.gov). In August, BSEE published [BSEE Safety Alert 322](#) which summarizes these events and provides recommended actions for facility operators and pilots. BSEE also shared these lessons learned with industry via briefings for the Oil and Gas Industry and the Helicopter Safety Advisory Conference.

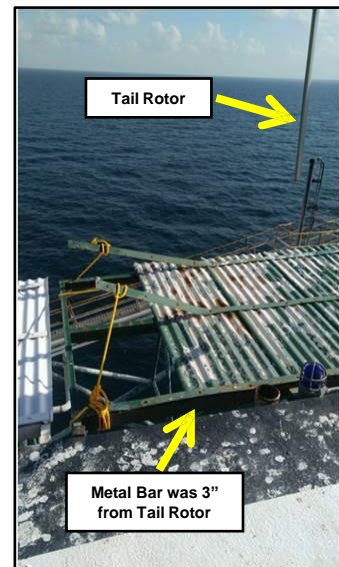
Figure 6

**August 6.** After landing on an unmanned facility, the pilot noticed a section of helideck skirting was missing and the three metal retaining bars bent upward with the closest metal bar only eight inches from the tail rotor ([16-0734](#))
