**Investigation of March 10, 2016, Fatality
Lease OCS-04940, Green Canyon Area- Block 18**

**Gulf of Mexico Region, Houma District
Off Louisiana Coast**

March 8, 2017

**U.S. Department of the Interior
Bureau of Safety and Environmental Enforcement**

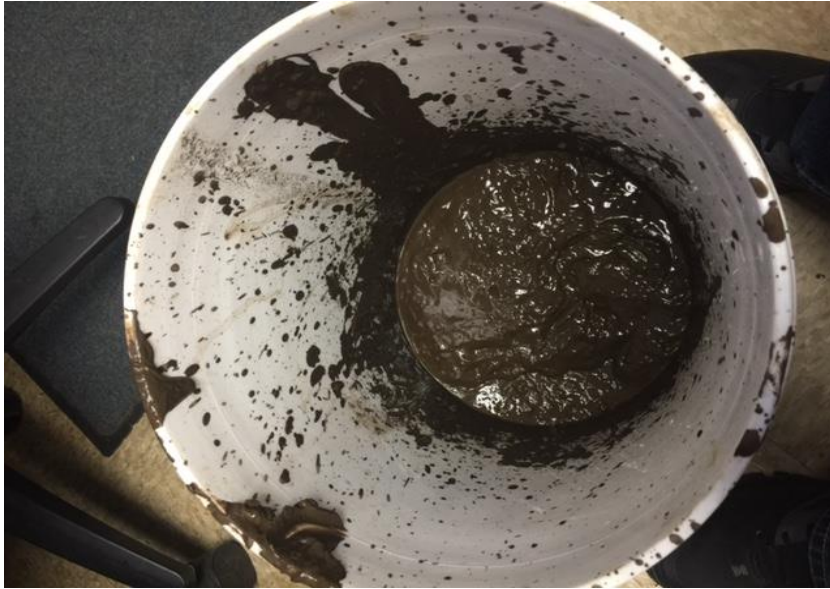
Figure 8: Image Attached to a March 6, 2016, Email Depicting the "CMT" from the Casing Valve.

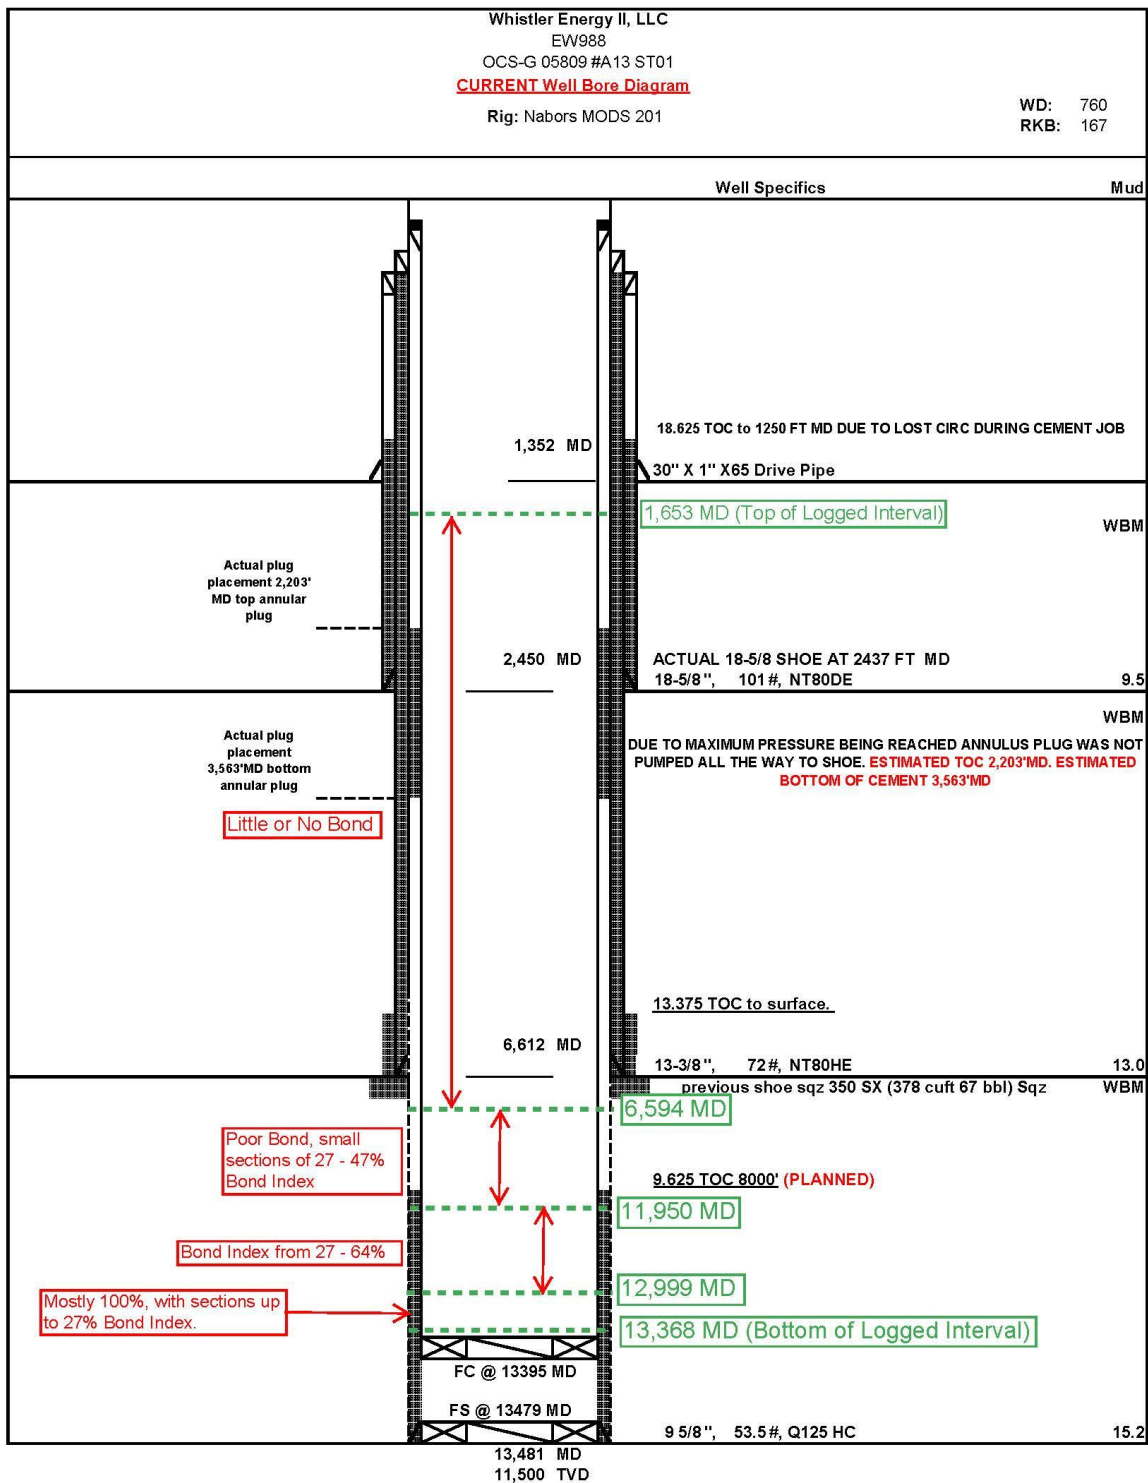
- 1. There appears to be little or no bond from the top logged interval to MD 6,594'.*
- 2. From MD 6,594' to MD 11,950', poor bond was mostly found with small sections of 27-47% bond.*
- 3. From MD 11,950' to MD 12,999', the bond index ranges from 27-64%.*
- 4. From MD 12,999' to the bottom of the logged interval, the bond is mostly 100% with sections up to 27% bond. Channeling was not observed, and the Variable Bond Log indicated good bond to formation in this region.*

Figure 9: Wellbore Schematic Depicting CBL Results.

The CBL evaluation indicated that cement was not present in or near the area where the annulus squeeze plug cement was estimated to be. In that event, the plausible flow path and resultant location of the annulus squeeze plug cement, was if it flowed upward to the BOP, where it would have likely remained until it was flushed out of the BOP into the choke manifold and MGS.

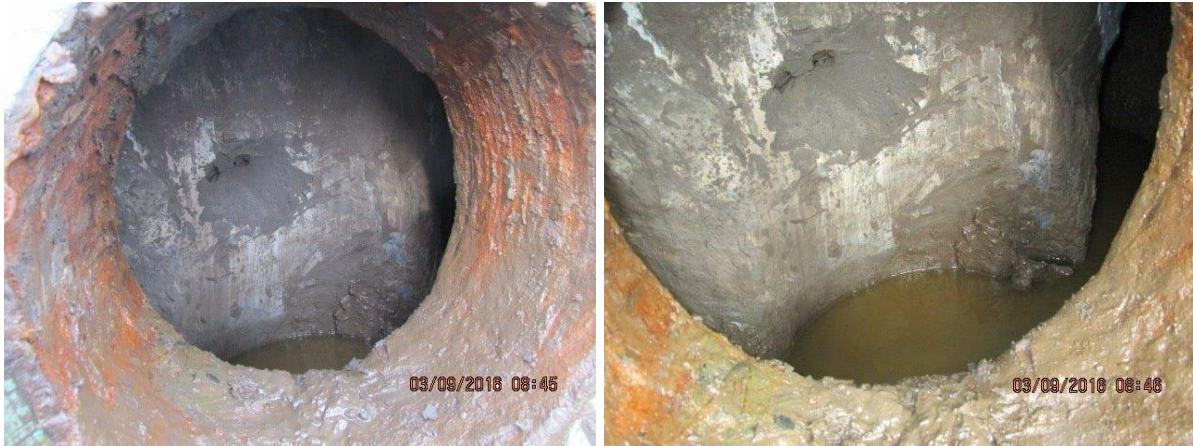
At the beginning of the day shift, Nabors Derrick Hand (DH) was troubleshooting difficulties encountered during draining and flushing of the MGS and BOP system pressure test the previous day. When the DH opened the MGS's inspection hatch, the material build up was discovered inside. The DH then summoned the RM⁵ to assess the abnormal findings. The condition of the material found inside the MGS appeared to range from a fluid and slurry like state to a hardened state (*see Figure 11*). After the RM assessed the conditions inside the MGS, the work to remove the material was approved and began.

Figure 11: Photographs of the Viewpoint through the MGS Inspection Hatch Opening after the Inspection Hatch Cover was Removed (Taken by the RM).

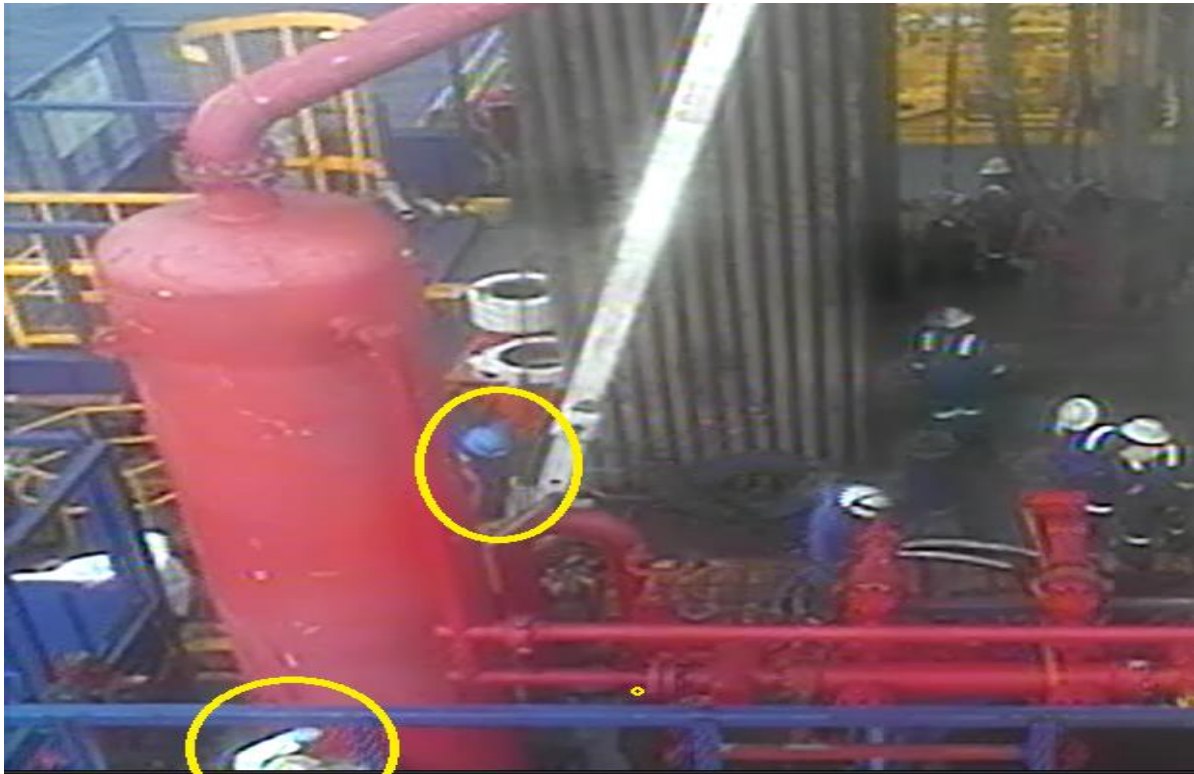
Figure 13: At approximately 07:07, the DH's Body Position and Movements Appeared Consistent with that of a Person who might be Reaching into the MGS with their Right Arm (still image from rig video).

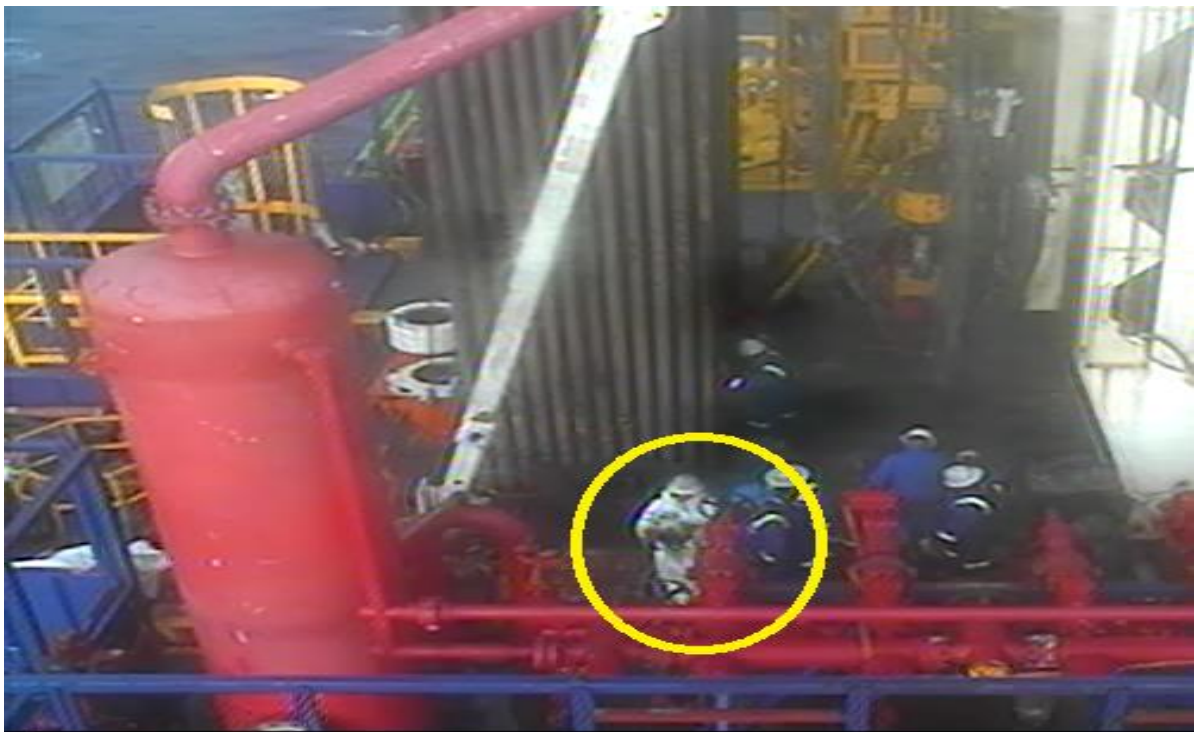
Figure 14: At approximately 07:10, The DH Approached and Engaged with the RM with Readily Apparent Discoloration (soiling) up the Right Arm and Right Side of the PPE (still image from rig video).

The DH approached and engaged with the RM with the distinct and readily apparent discoloration of the light colored protective over-garment in plain view. The RM made multiple visits to the MGS area throughout the day shift. During one of those visits, from approximately 12:32 to 12:43, the RM appeared to reach into the MGS, tap on the exterior of the MGS and engage with multiple personnel while evaluating the working conditions. The video documentation of the rig floor area indicates that both the DH and the RM had placed their head and/or arm(s) into the MGS by this point, on this first day of the task.

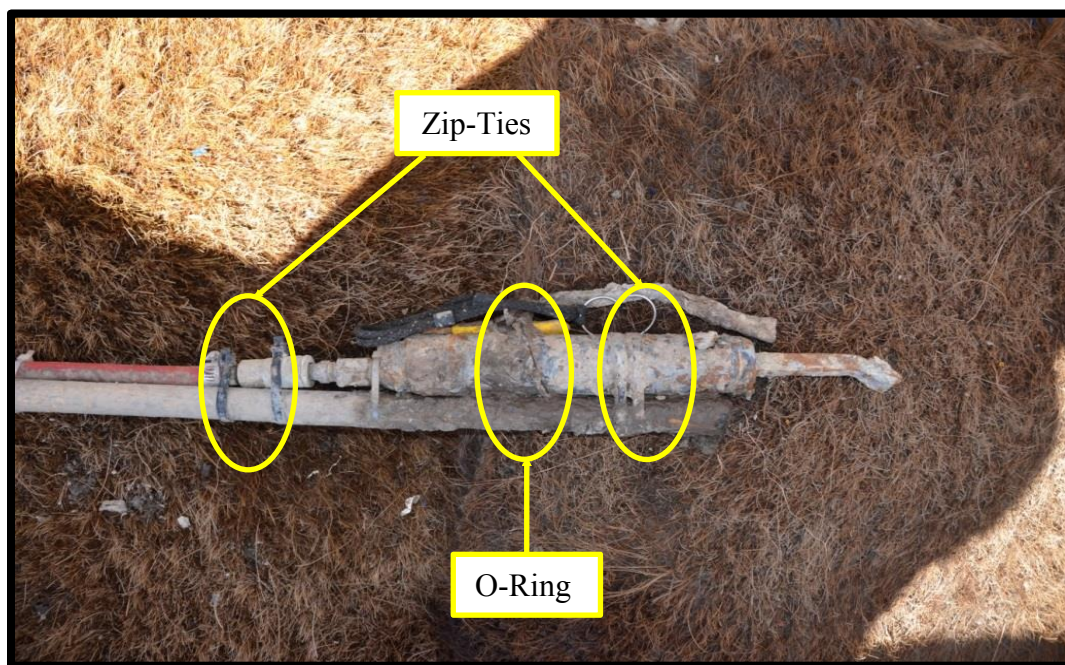
By mid-day shift, the hammer and chisel had been replaced by a pneumatic air-powered chisel. The DH explained that the mechanic provided the chipping tool. The DH described the chipping tool as a pneumatic chipping head that was attached by zip ties to a wooden stick. A flexible O-ring had been placed around the activation lever of the chipping tool, allowing for continuous activation of the pneumatic mechanism (to prevent the chipping tool operator from having to constantly hold the activation lever when chipping (*see Figure 17*)).

Figure 17: Post-Incident Photograph of the chipping tool.

The JSA document was not updated or revised to account for the transition to the pneumatic chipping tool and the unique hazards presented with its use. Furthermore, use of chipping tools could create a spark during the task and therefore the task (being outside of an approved safe welding area) required a HWP.

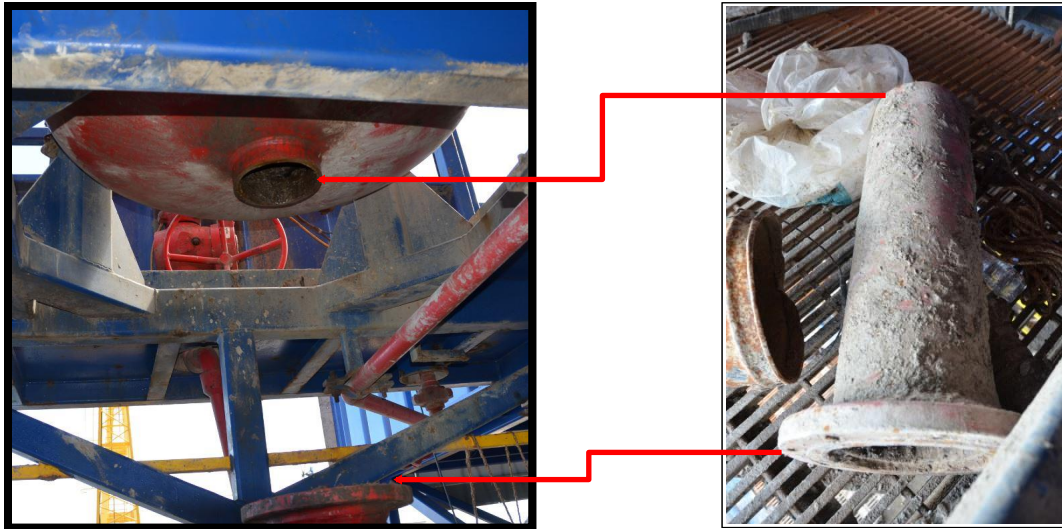
The night shift completed the removal of a section of 8 inch drain pipe using a band saw, creating an opening at the bottom of the MGS (*see Figure 18*). Buckets could now be placed below the newly created opening to collect the material debris as it fell out of the MGS drain line opening. Once filled with the material, the buckets were also used to transport the material collected, to nearby compactor bags for later disposal.

Figure 18: Post-Incident Photographs of the MGS Section of 8” Drain Outlet Piping after Cutting and Removal.

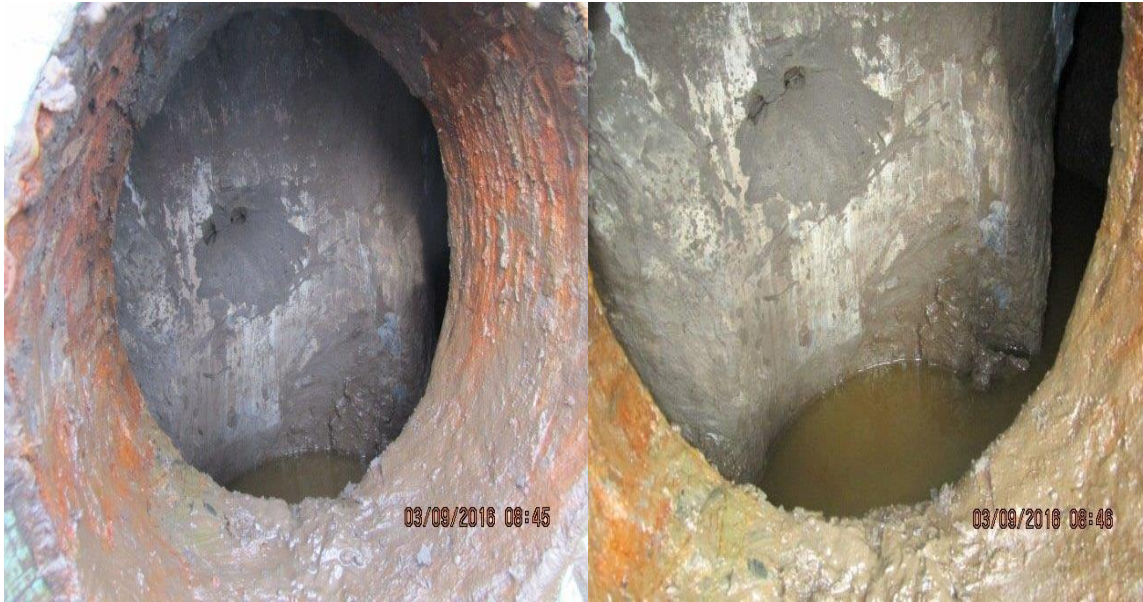
The DH explained to the panel that he kept telling the TS and AD that once they chipped all the way through, and if the overhead material didn’t fall, it was up in the baffles and therefore, cement was 12 feet overhead and would not fall. In the DH’s opinion there was no way they were going to chip it all out. The DH said he never got word to stop chipping so they kept chipping.

Figure 24: Pre-Incident Photographs of Viewpoint through the Inspection Hatch into the MGS (taken by the RM).

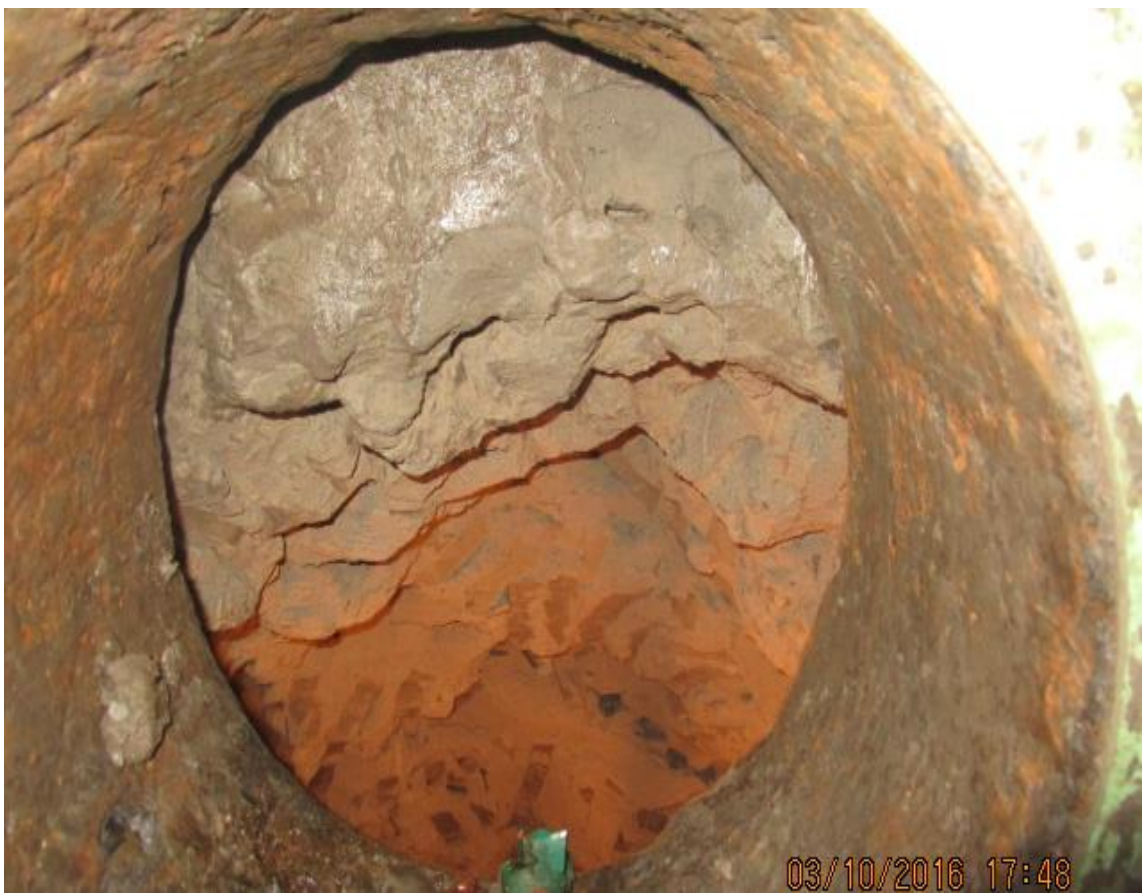
Figure 25: Post-Incident Photograph of Viewpoint through the Inspection Hatch into the MGS (taken by the RM).
