HPHT 17TR8 Test Articles: Post-Test Characterization Following Pressure Burst Testing (Final)

*Examination of F22 Materials Following Plastic Deformation from Controlled
Pressure Testing*

April 30, 2018

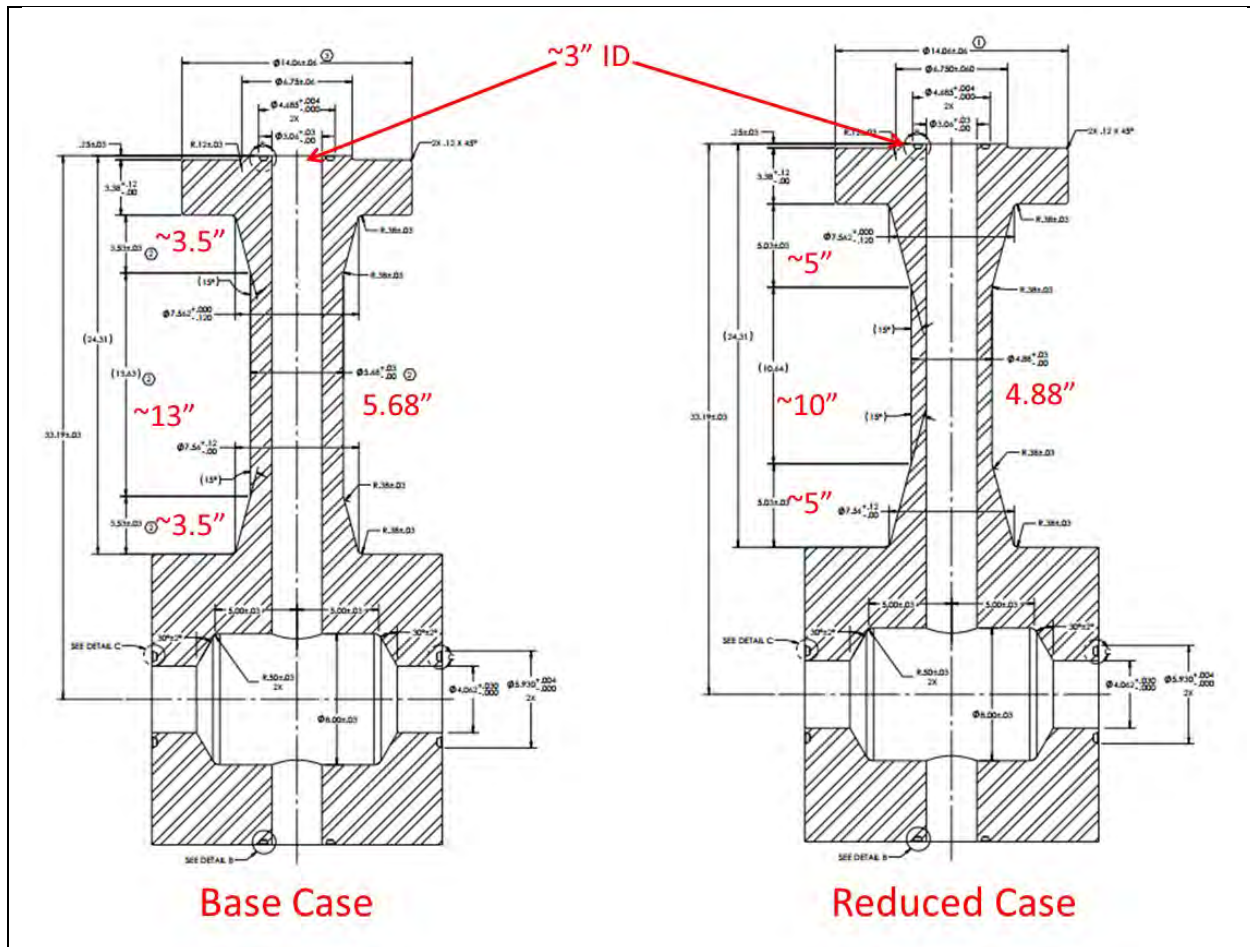
FIGURE 1 SCHEMATIC DIAGRAMS OF THE TWO F22 TEST PIECES

Figure 1 shows a schematic diagram of the two test pieces³. Note that the difference between the pieces is the throat region. The thicker throat sample is per ASME Boiler and Pressure Vessel Code Section VIII Division 2 (from API 17TR8) has a wall thickness of 1.34 inches and is designated the “base case.” The throat region of the other sample is per Section VIII Division 3, the “reduced case,” has a wall thickness of 0.94 inches. When these samples experienced burst failure, failure occurred as an inside diameter (ID)-initiated longitudinal “fish mouth” crack in the throat portions the two specimens.

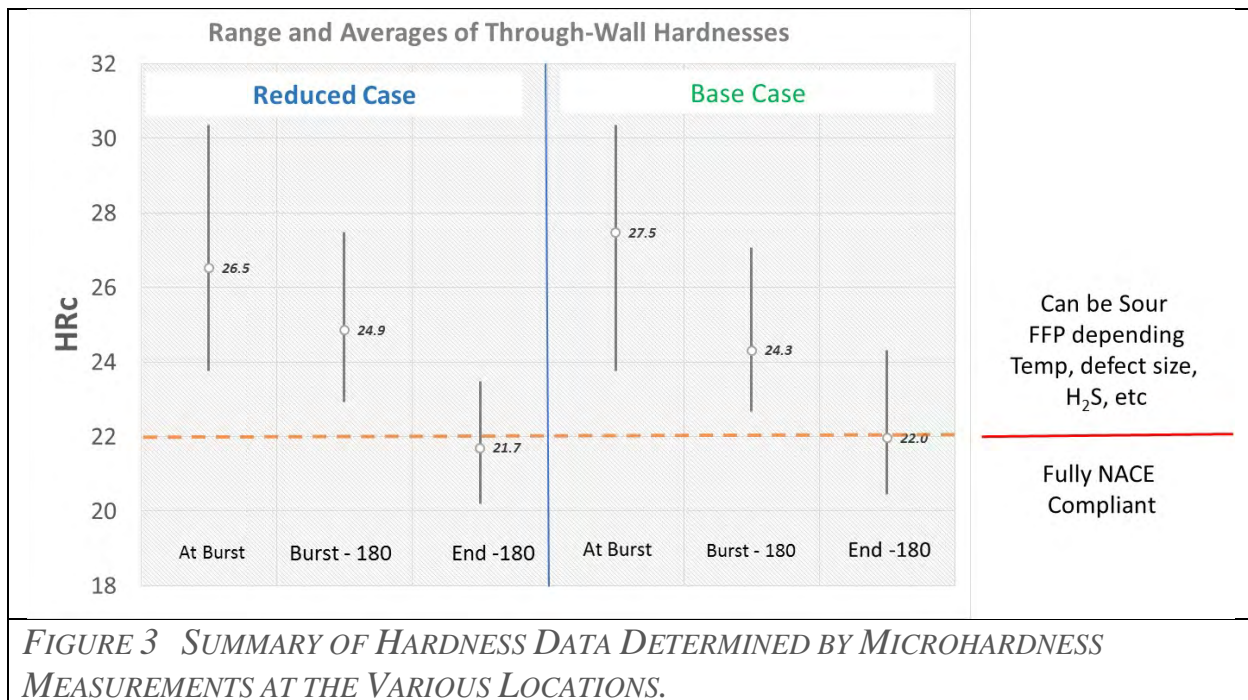
Figure 3 shows the range and average hardness at the three chosen locations for both samples. The bar represents the range of measurements made at a location; the number associated with each bar is the average value at that location. Note the horizontal, dashed line at HRc = 22.0. Below this hardness level, material is considered fully NACE compliant, as defined by ISO 15156/NACE MR0175. Materials above the line can be used if it can be demonstrated that they are fit-for-purpose (FFP) for specific temperatures, pressures, pH, and H₂S concentrations. As shown in Figure 3, the thick material away from the burst location has hardness values showing complete compliance with ISO 15156/NACE MR0175. Near the burst location, where plastic deformation occurred, hardness can be as high as HRc 30.0.

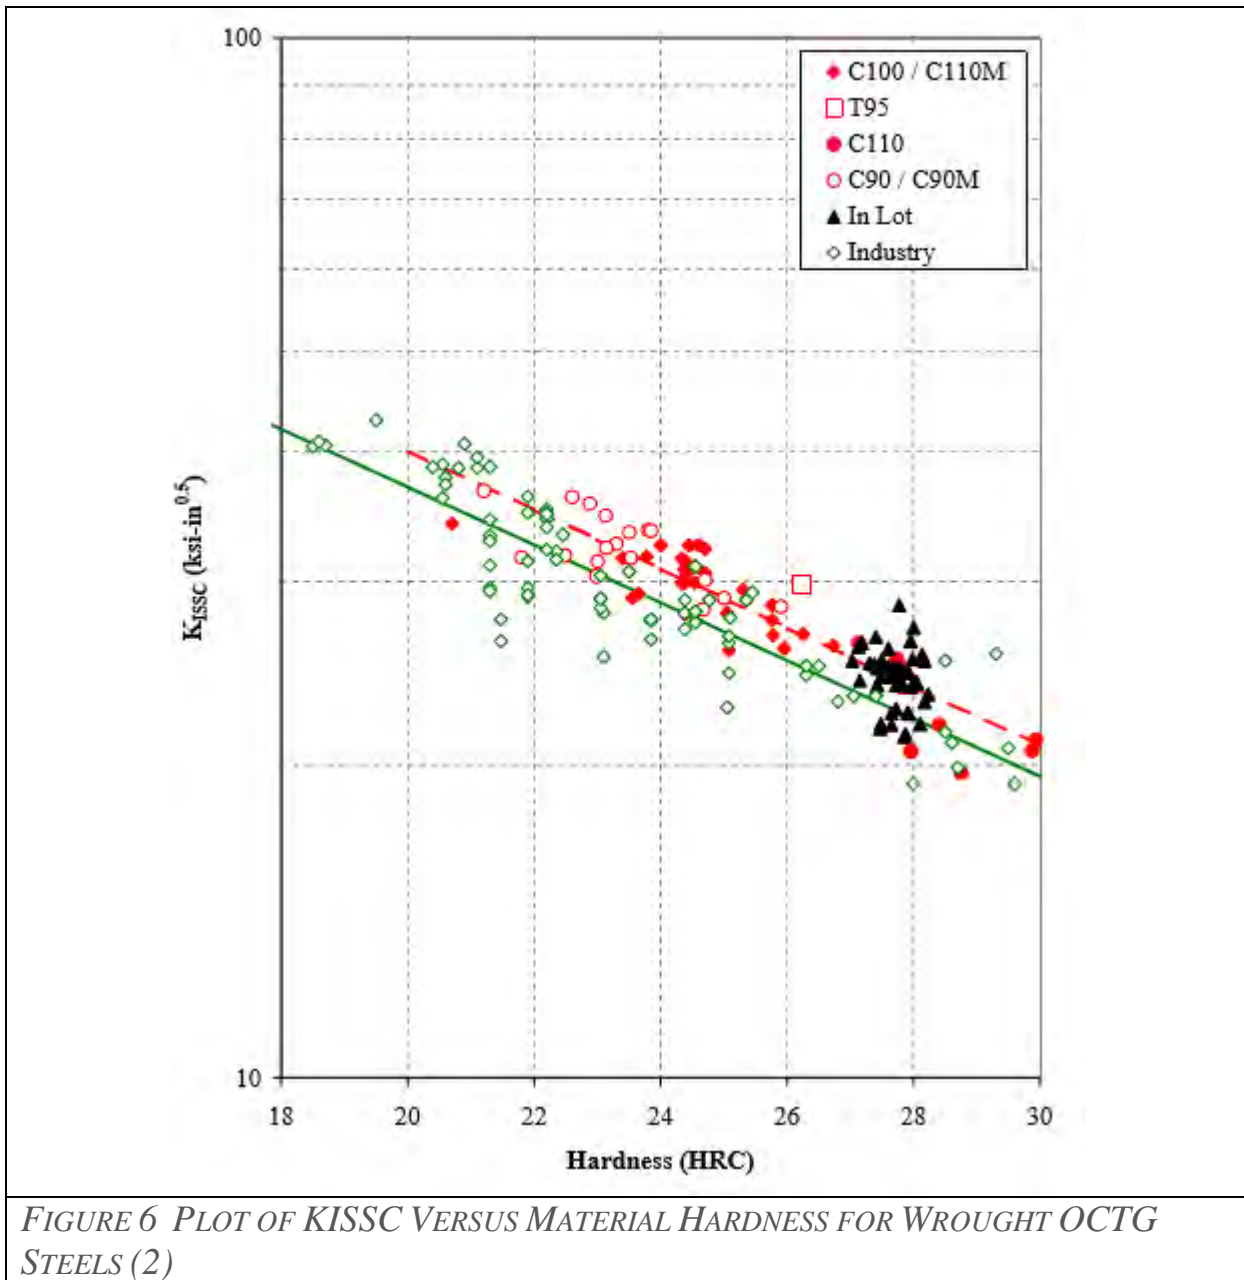
FIGURE 6 PLOT OF KISSC VERSUS MATERIAL HARDNESS FOR WROUGHT OCTG STEELS (2)

One requirement for a fracture mechanics assessment of the component would be material property data. Figure 6, for example, shows material property data for steels that are in the wrought condition and that are used for oil country tubular goods (OCTG).

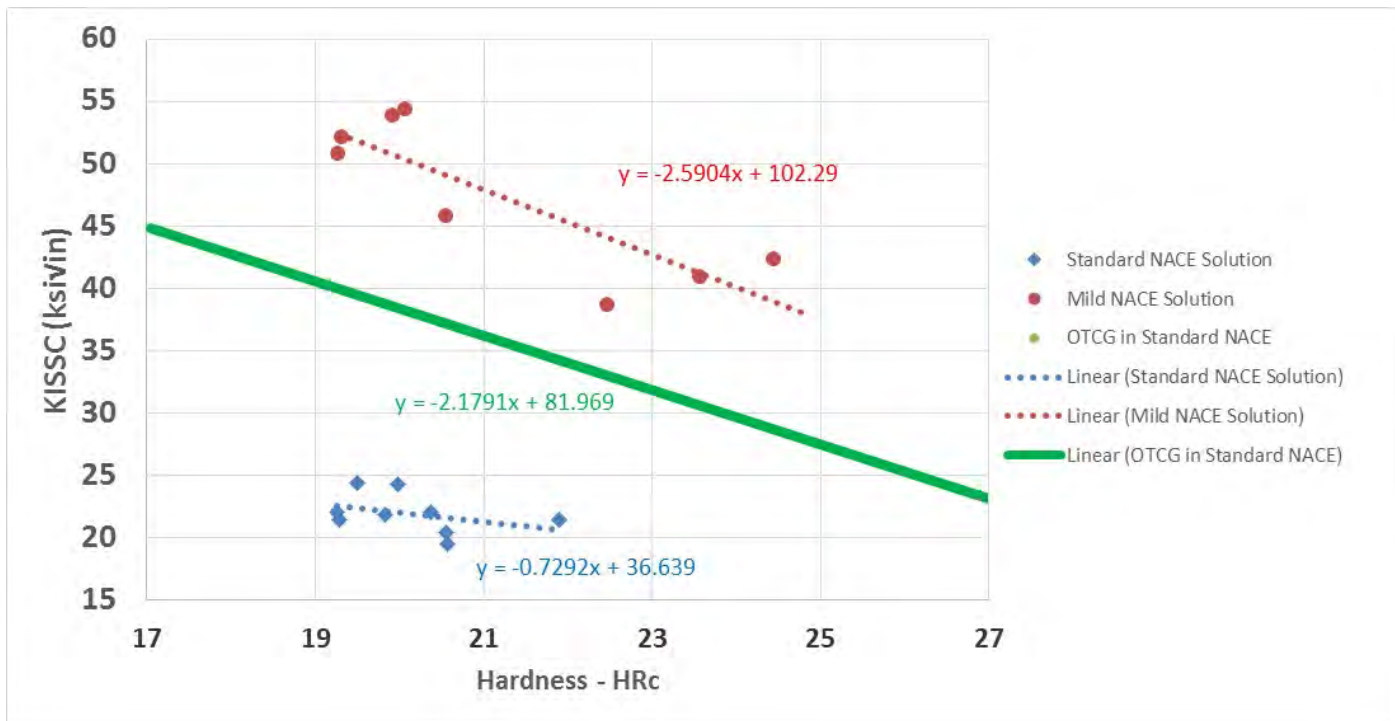
FIGURE 8 PLOT OF NACE METHOD D RESULTS FOR F22 FORGING MATERIAL AND COMPARED TO WROUGHT OCTG STEEL

The heavy, solid green line in Figure 8 is the same as the line labelled “industry” in Figure 6. This heavy, solid line shows a lower bound in SSC performance for sour grades of OCTG. As noted in the legend of Figure 8, environmental conditions were the same for the OCTG materials and for the F22 materials in the standard test solution. Also plotted in Figure 8 are the data for the F22 forging material tested under mild conditions. Two observations from Figure 8 are quite apparent:

1. The SSC performance of F22 material is greatly improved if the standard environment (i.e., 100% H₂S with initial pH of 2.7) is substituted with the mild environment (i.e., 7% H₂S with initial pH of 4.0).
2. The forged F22 material performed poorly (i.e., lower KISSC values- range of 20-25 ksi√in) in the standard environment compared to the OCTG materials (OCTG standard NACE minimum range is 33-40 ksi√in). The forged F22 and wrought OCTG materials had the same general microstructure (i.e., quenched and tempered martensite) and were tested at some of the same hardnesses (i.e., HRC values > 22.0).

The first of these observations is not surprising. One would expect a material to have better cracking resistance in less severe conditions. The second observation requires a little more explanation.

Containing less carbon than a typical C90, the F22 is processed at a lower tempering temperature. The F22 also has higher amounts of Cr, S, and Ni. Since OCTG chemistries are optimized for enhanced SSC resistance, chemistry and processing variations for the F22 result in poorer SSC resistance in the same environment and under the same loading conditions.

This report recommends that standard NACE tests should be performed to determine the sulfide stress cracking performance of the forging material and test results compared to published data on wrought steel products used for casing in sour wells.

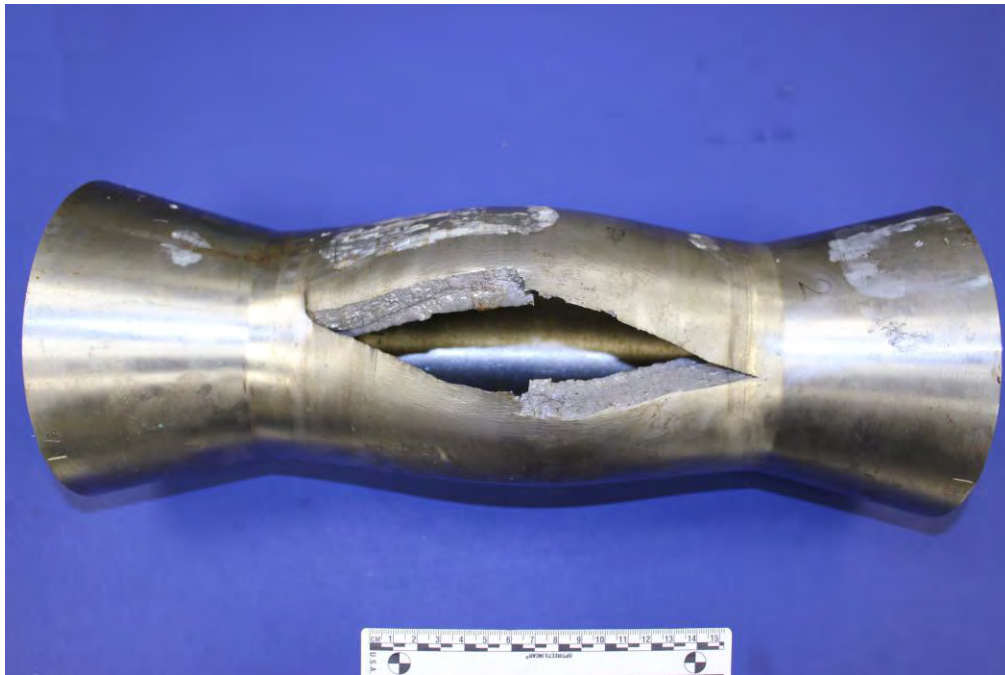
Figure 1: As Received Photograph – Sample 1 - Top View of Reduced Case at Burst (scale in mm)

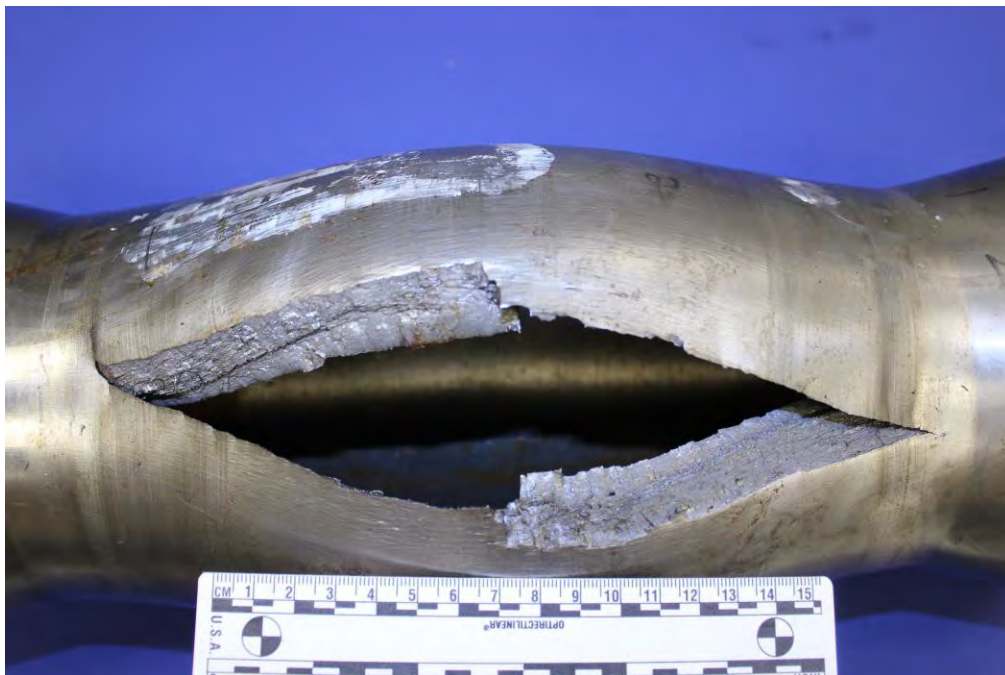
Figure 2: As Received Photograph – Sample 1 – Close-up View at Burst (scale in mm)

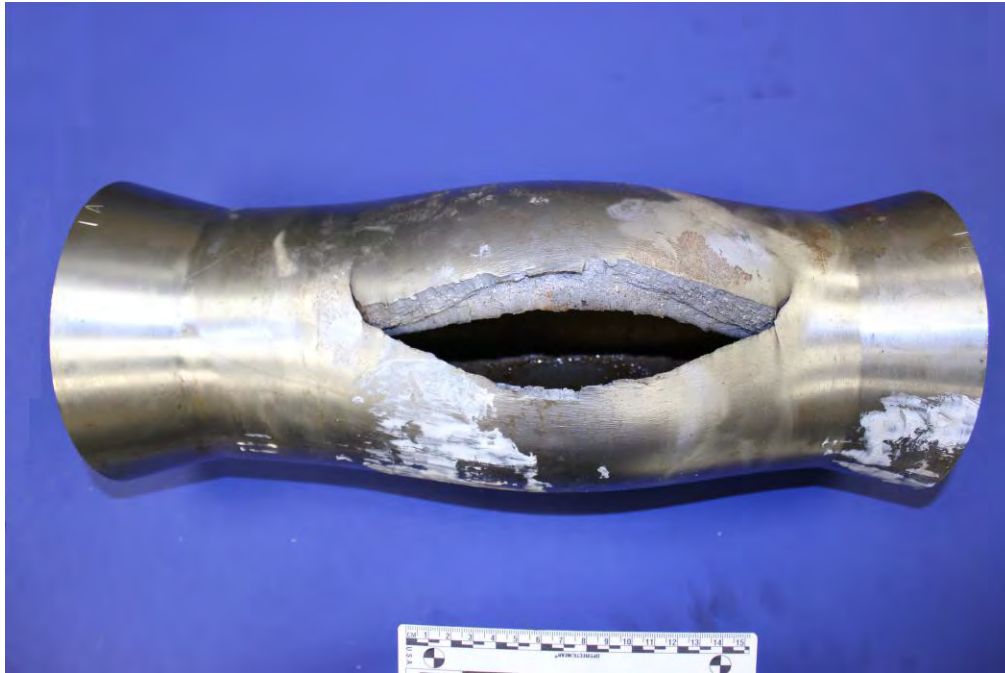
Figure 3: As Received Photograph – Sample 2 – Top View of Base Case at Burst (scale in mm)

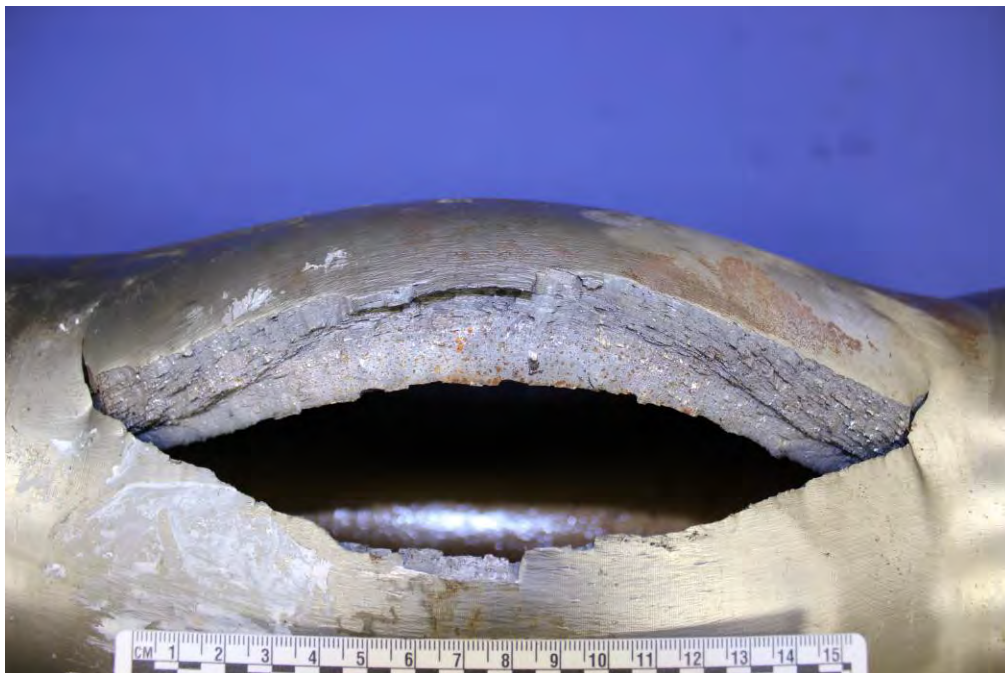
Figure 4: As Received Photograph – Sample 2 – Close-up View at Burst (scale in mm)

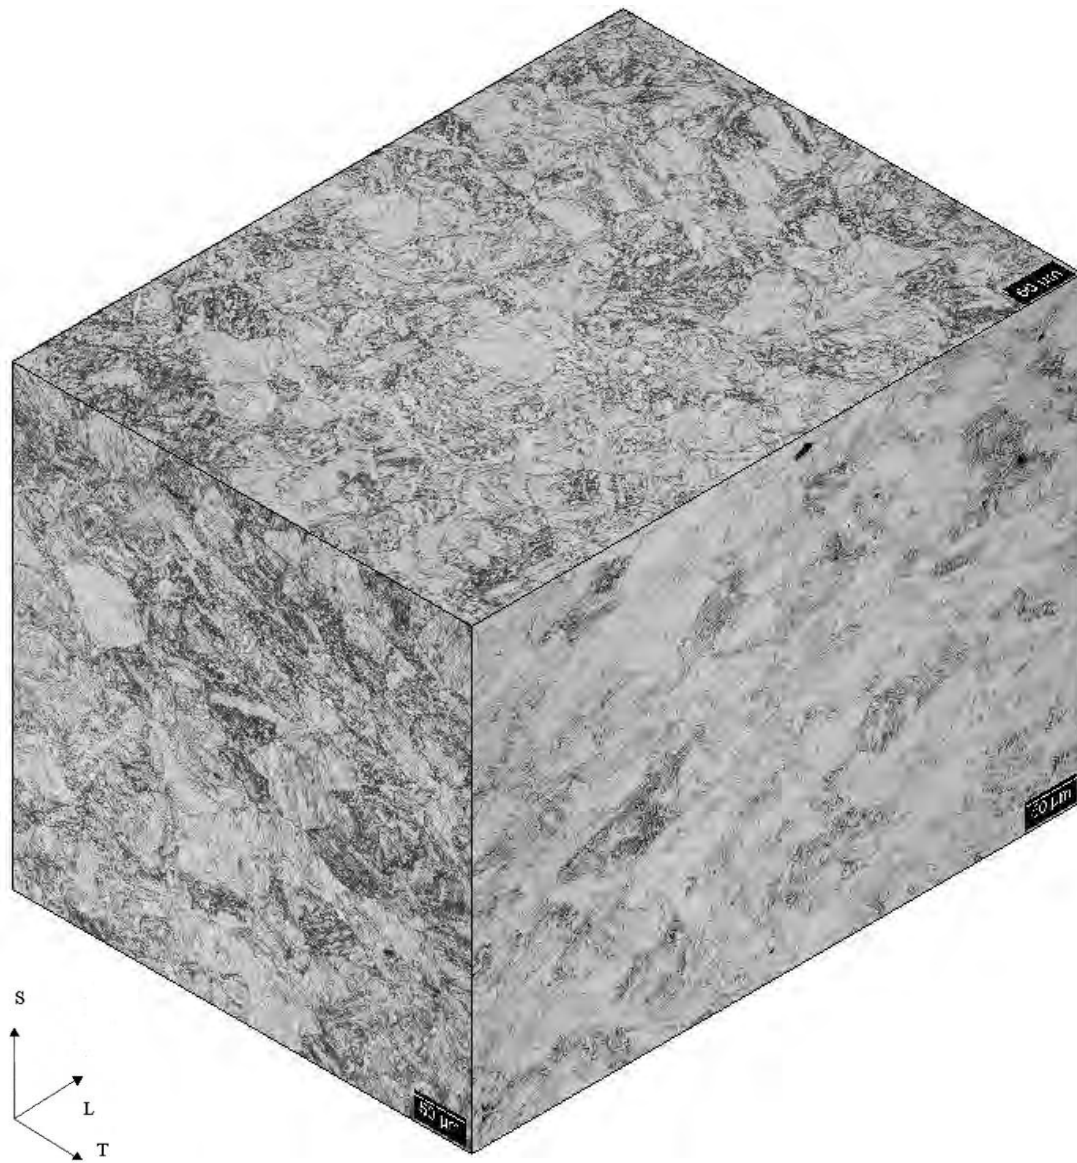
Figure 15: Sample 1 – Summary Composite Photo – At Burst

Base Case					
Exova ID	Location	Orientation	Grain Size Result	Comments	Figures
37	At Burst	Transverse	No. 7	Tempered Martensite, elongated grain structures	39, 40
38	At Burst	Longitudinal	No. 7	Tempered Martensite	41, 42
39	At Burst	OD Surface	No. 6	Tempered Martensite	43, 44
40	180° from Burst	Transverse	No. 6	Tempered Martensite	45, 46
41	180° from Burst	Longitudinal	No. 7	Tempered Martensite	47, 48
42	180° from Burst	OD Surface	No. 7	Tempered Martensite	49, 50
43	180° from Burst At End	Transverse	No. 7	Tempered Martensite, noticeably smaller grain structures, more compact	51, 52
44	180° from Burst At End	Longitudinal	No. 7	Tempered Martensite, noticeably smaller grain structures, more compact	53, 54
45	180° from Burst At End	OD Surface	No. 7	Tempered Martensite, noticeably smaller grain structures, more compact	55, 56

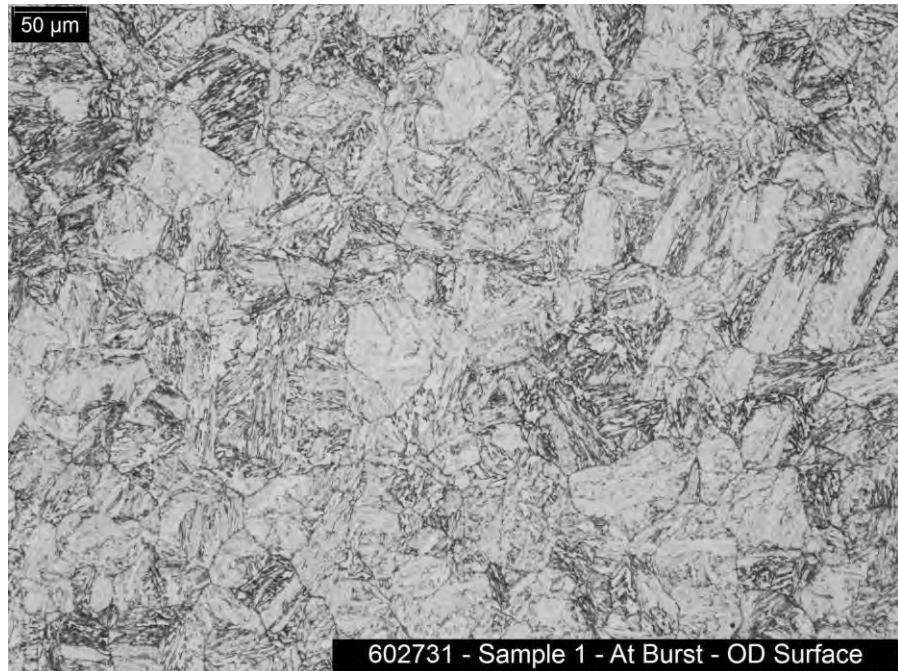
Figure 26: Sample 1 – Micro photograph of OD Surface cross-section at Burst, Grain Size No. 6

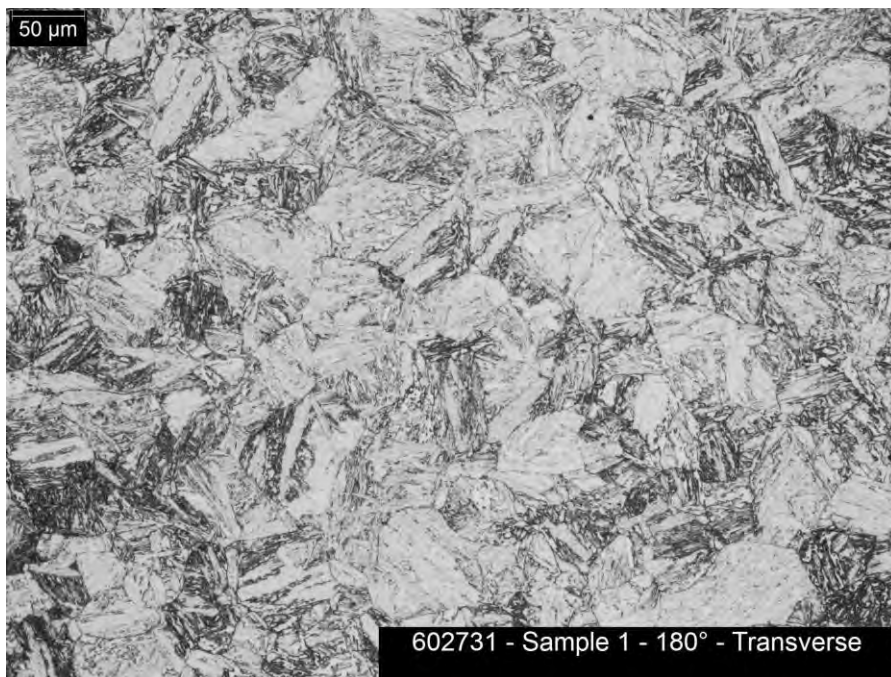
Figure 28: Sample 1 – Micro photograph of Transverse cross-section at 180° from Burst, Grain Size No. 6

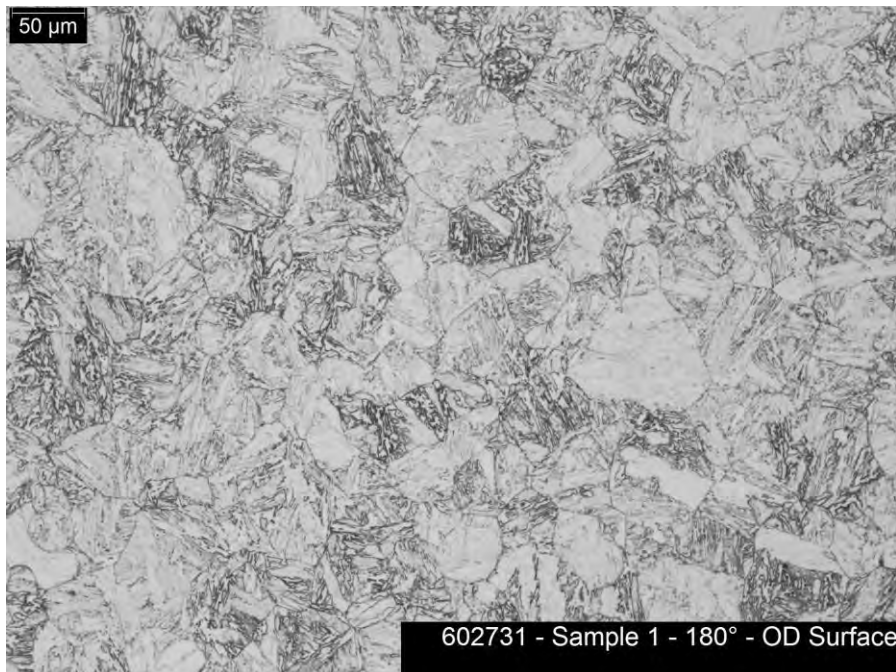
Figure 32: Sample 1 – Micro photograph of OD Surface cross-section at 180° from Burst, Grain Size No. 6

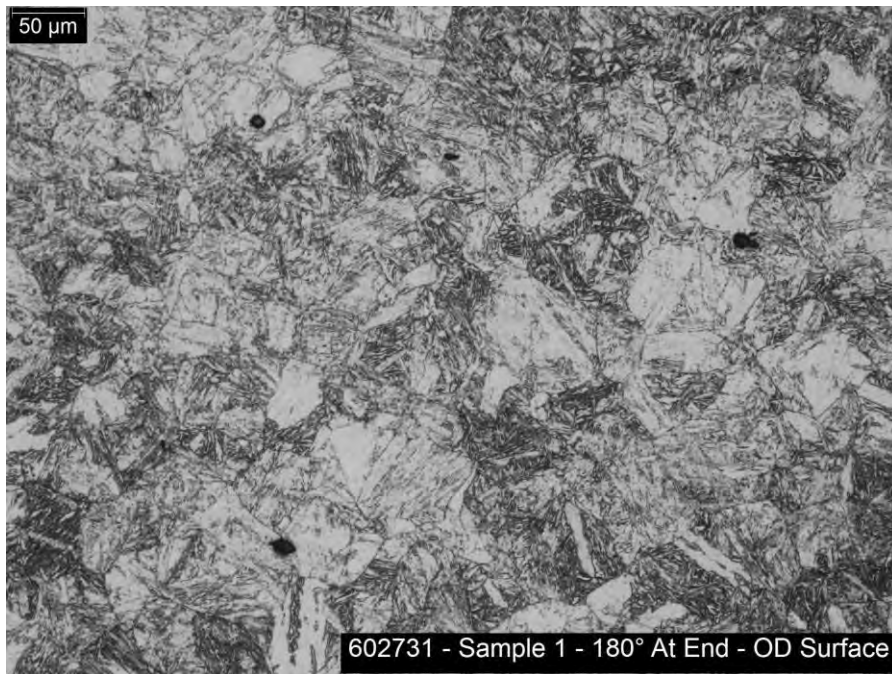
Figure 38: Sample 1 – Micro photograph of OD Surface cross-section at 180° from Burst at End, Grain Size No. 7

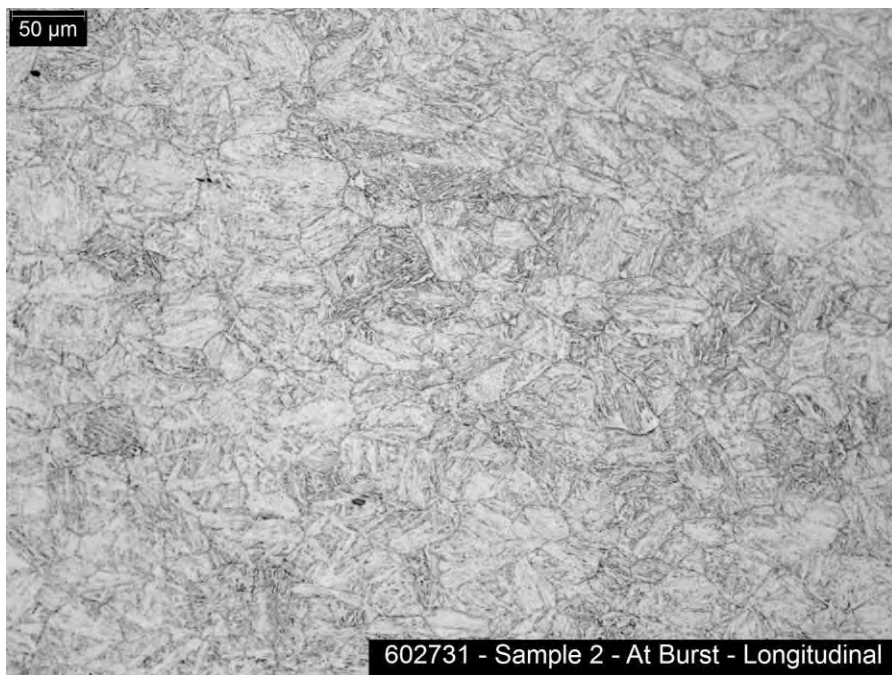
Figure 42: Sample 2 – Micro photograph of Longitudinal cross-section at Burst, Grain Size No. 7

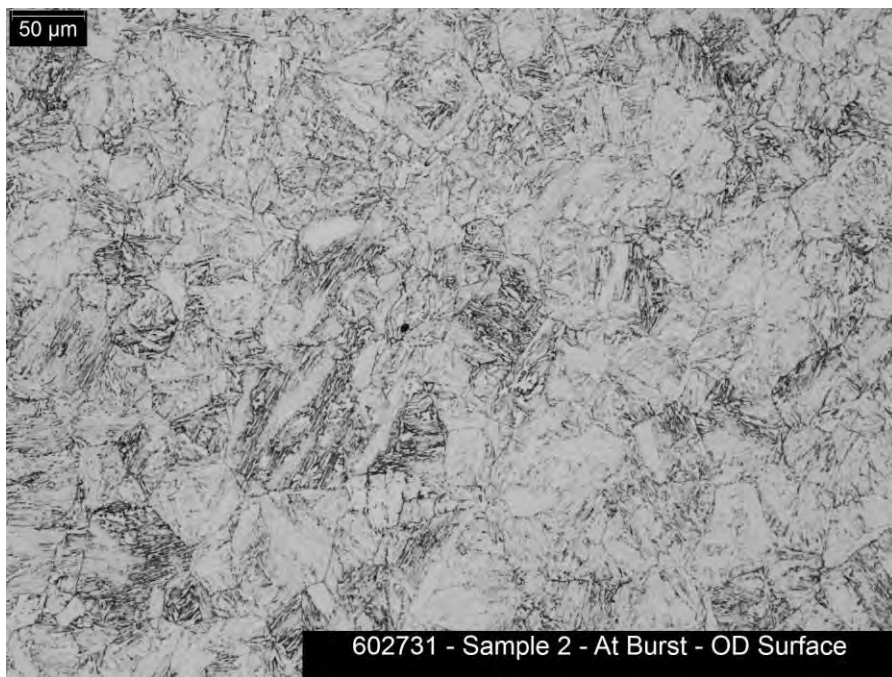
Figure 44: Sample 2 – Micro photograph of OD Surface cross-section at Burst, Grain Size No. 6

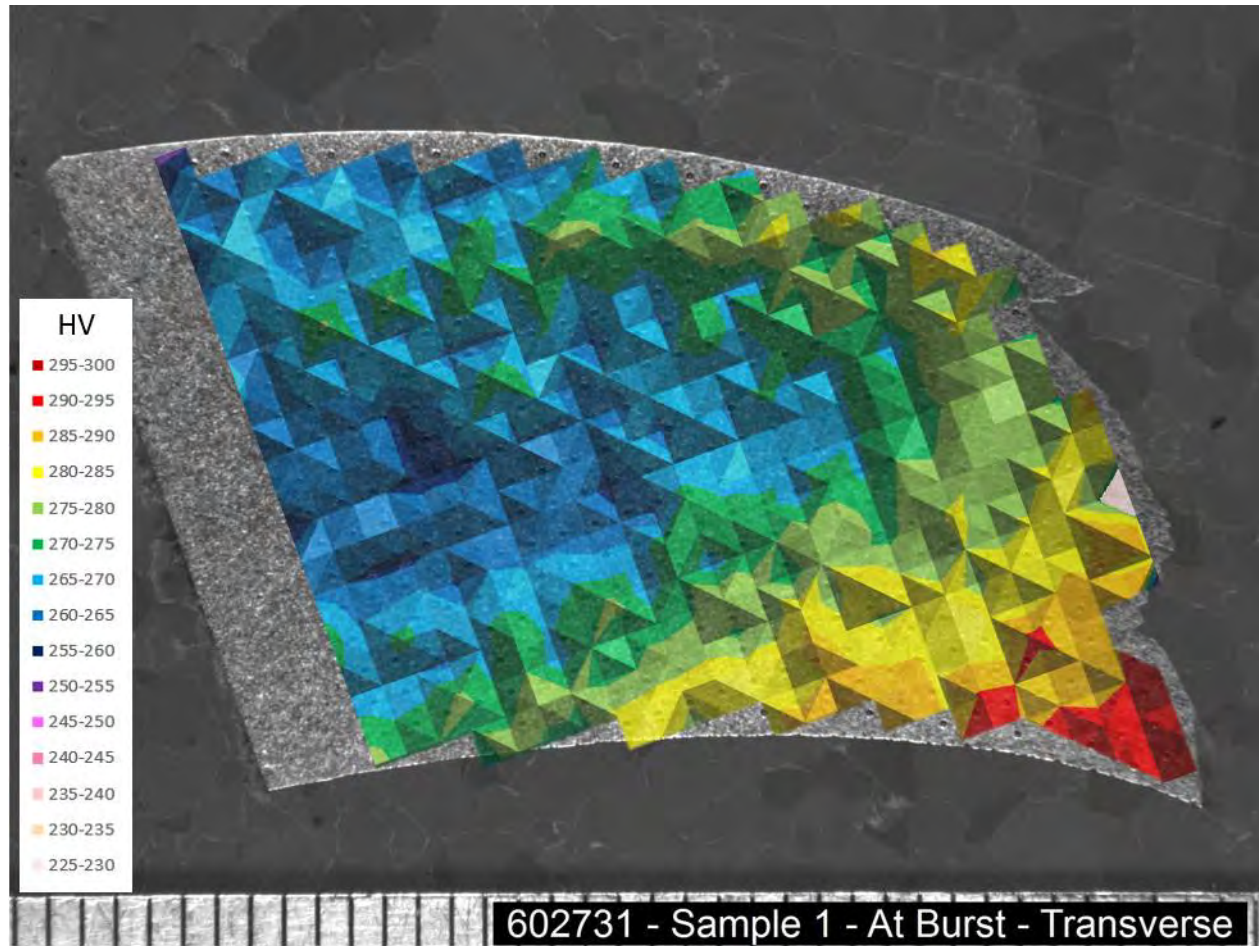
Figure 57: Sample 1 – Hardness Map of At Burst - Transverse Area (scale in mm)

Vickers Hardness Comparison - Sample 1					
Location	Minimum	Maximum	Range	Average	Comments
At Burst	*252	300	48	272	*Hardness value of 229 resulted as an invalid indent, excluded from data; next lowest is 252. High hardness near ID and fracture. High hardness at fracture is due to strain hardening.
180° from Burst	246	279	33	260	Higher hardness values near ID
180° from Burst at End	226	250	24	237	Hardness values more homogenous across sample. Lower hardness values compared to At Burst and 180° from Burst Locations.

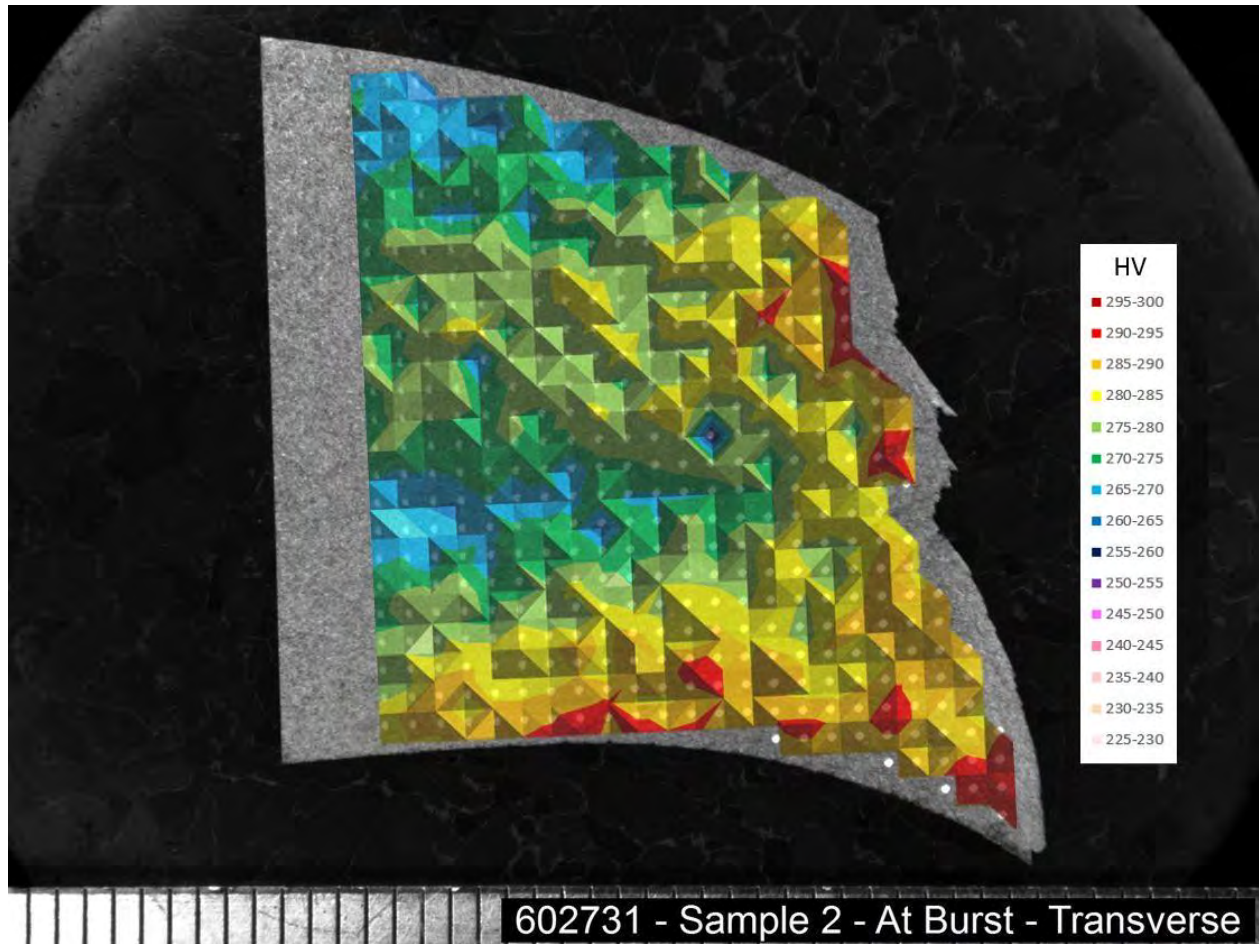
Figure 60: Sample 2 – Hardness Map of At Burst - Transverse Area (scale in mm)

Vickers Hardness Comparison - Sample 2					
Location	Minimum	Maximum	Range	Average	Comments
At Burst	252	300	48	279	High hardness near ID and at fracture. High hardness at fracture is due to strain hardening.
180° from Burst	244	276	32	256	Higher hardness values near ID.
180° from Burst at End	228	256	28	239	Higher hardness values near ID. Lower hardness values compared to At Burst and 180° from Burst Locations.

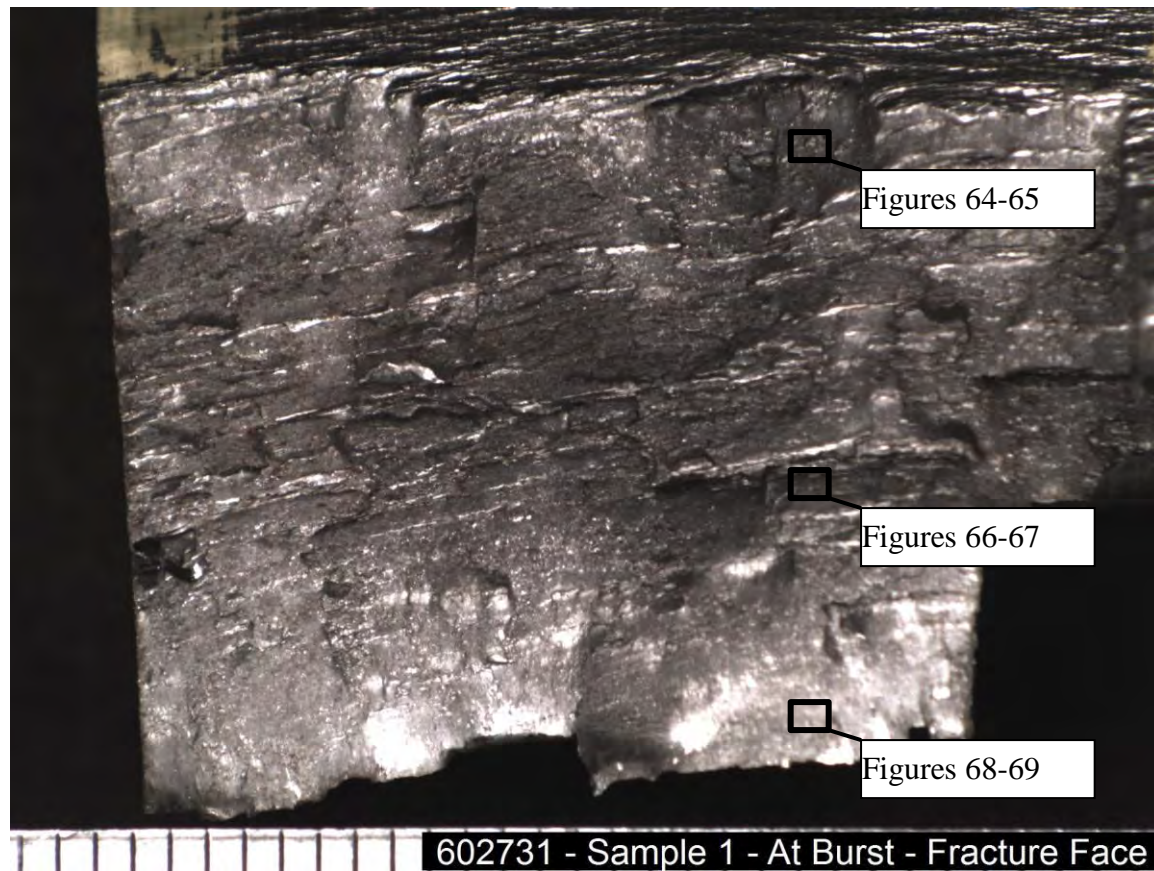
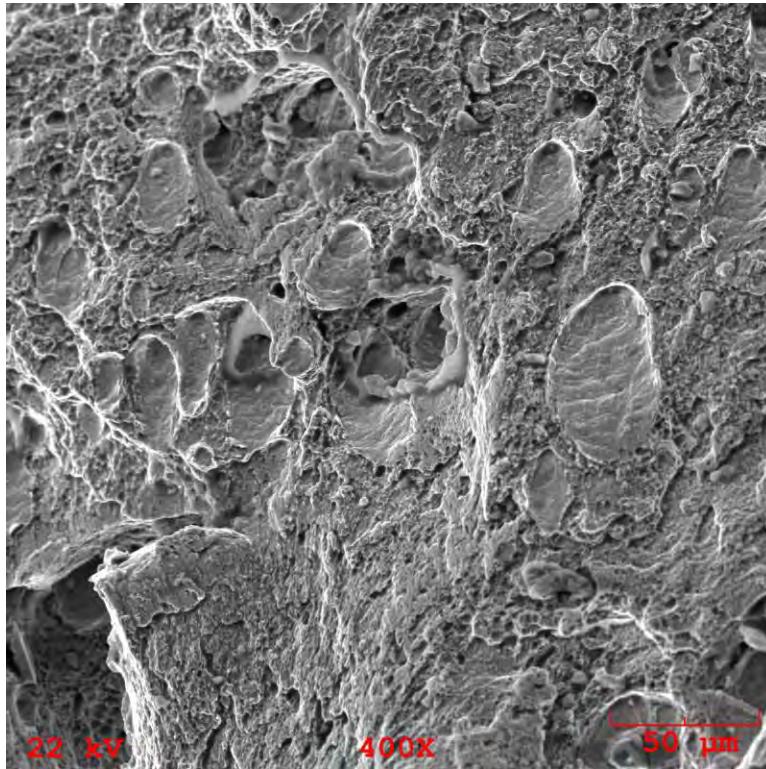
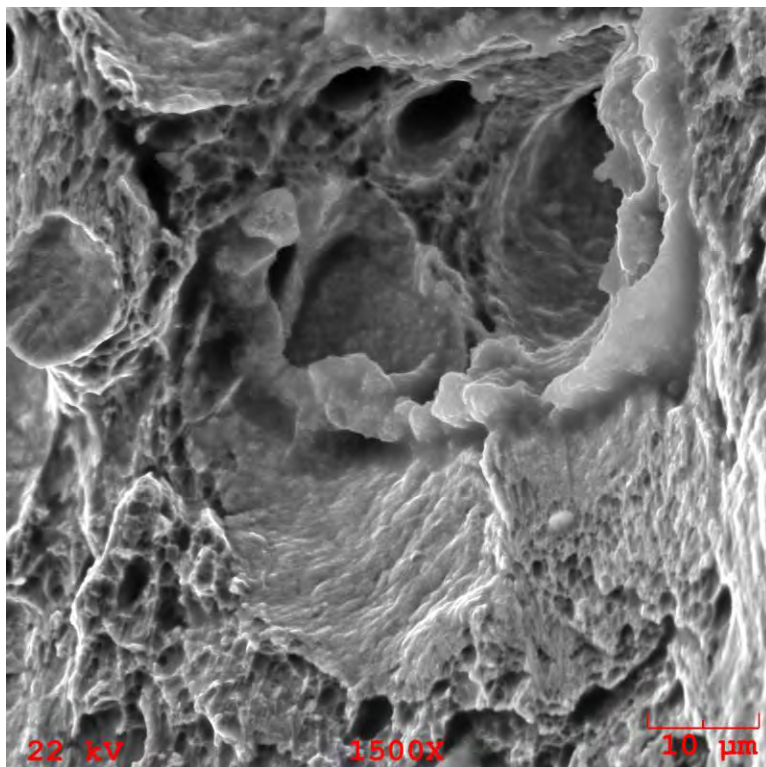
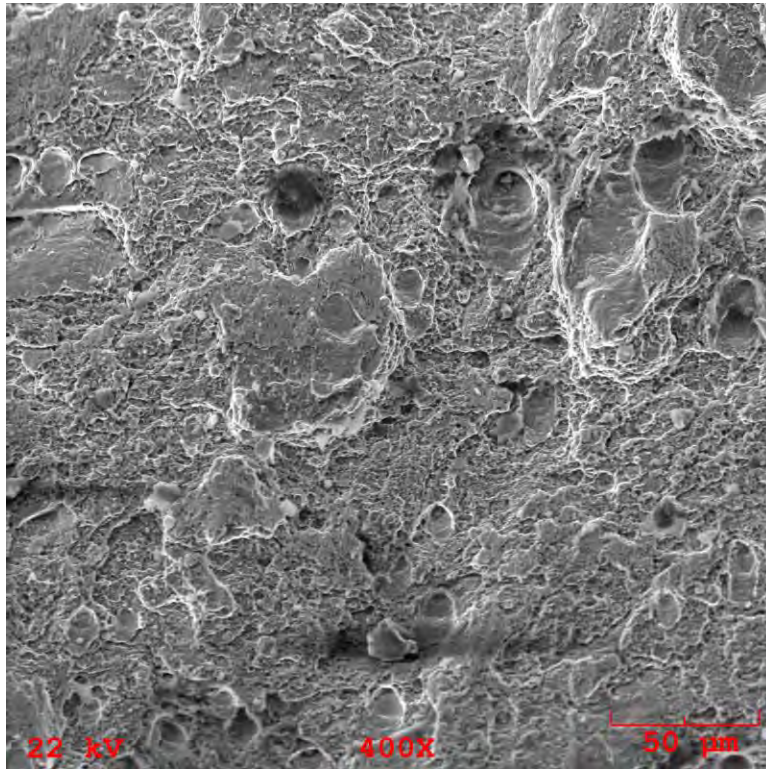
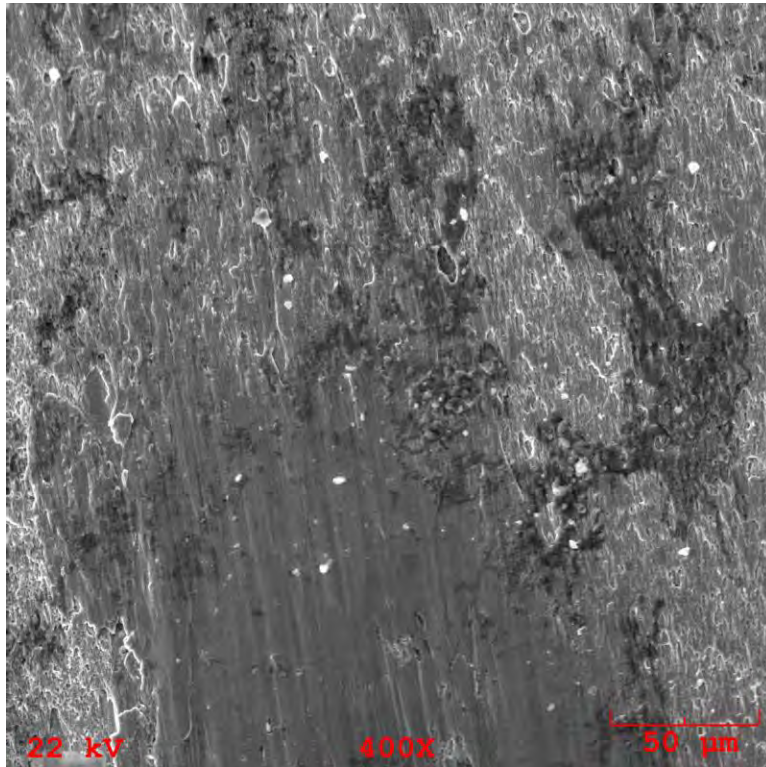
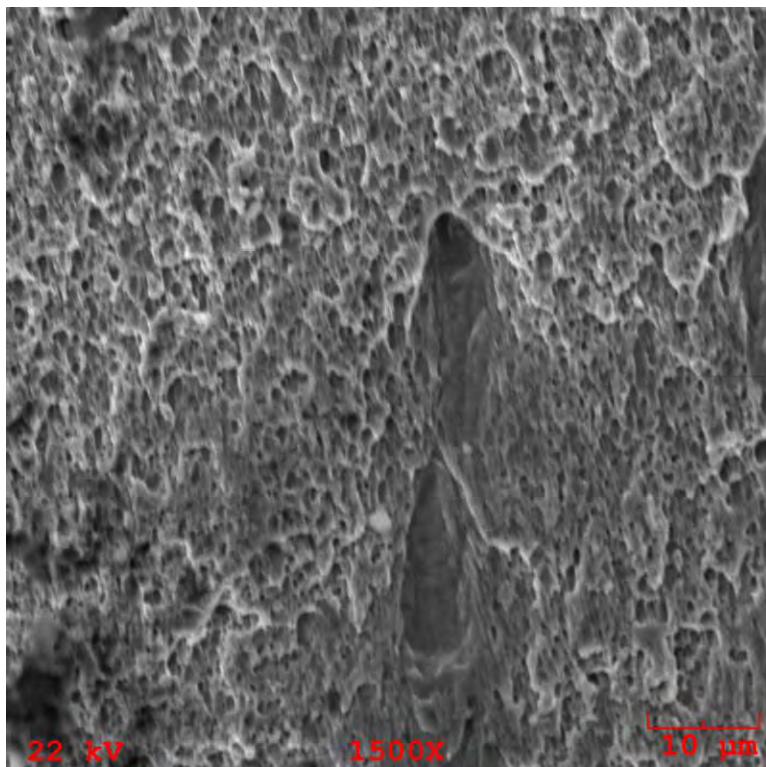
The SEM examination for both samples revealed numerous cuplike depressions consistent with dimple rupture. Elongated dimples were observed near the OD and ID. No evidence of machining or material defects were found during the SEM examination.
