HPHT 17TR8 Test Articles: Post-Test Characterization Following Pressure Burst Testing (Final)

*Examination of F22 Materials Following Plastic Deformation from Controlled
Pressure Testing*

April 30, 2018

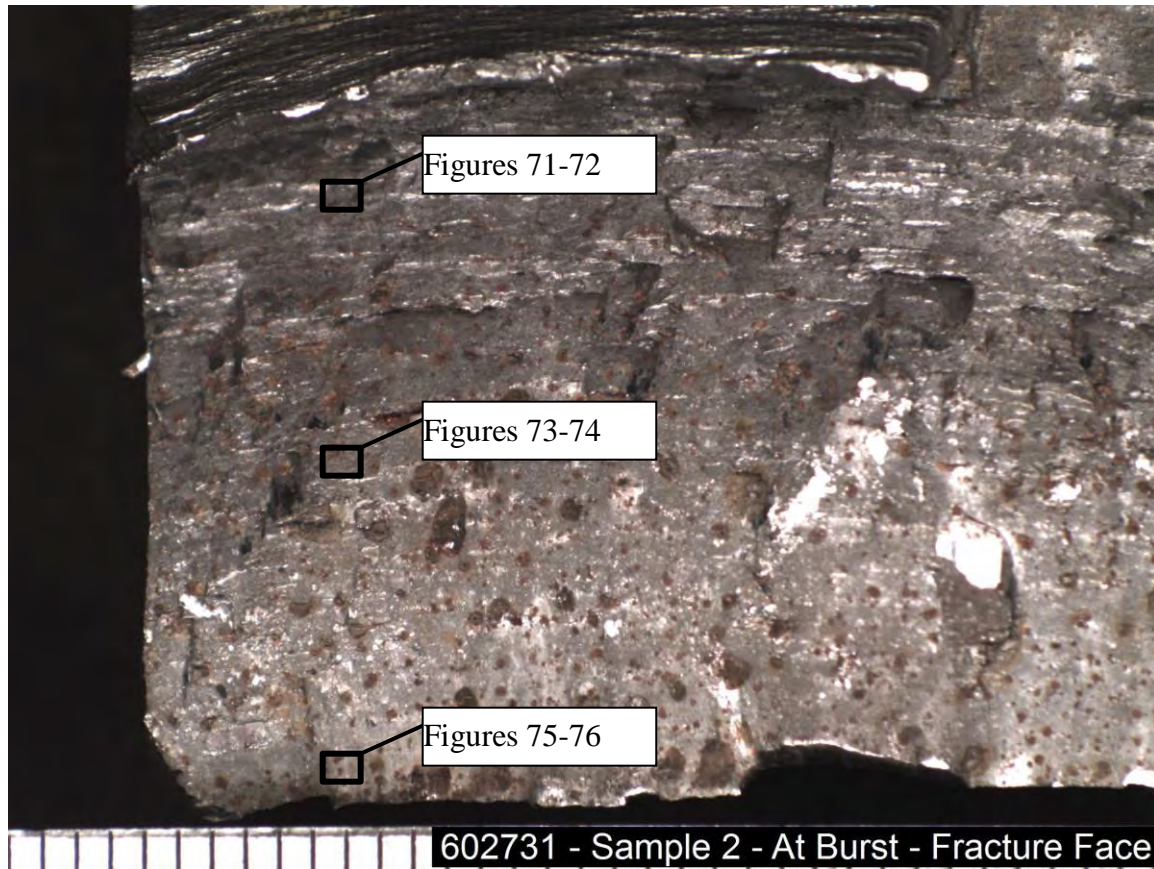
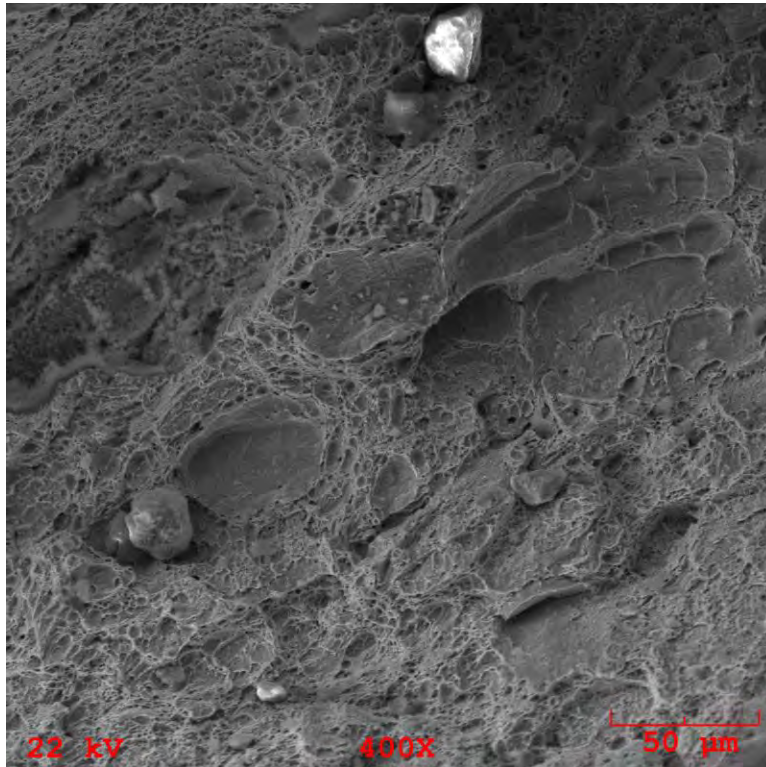
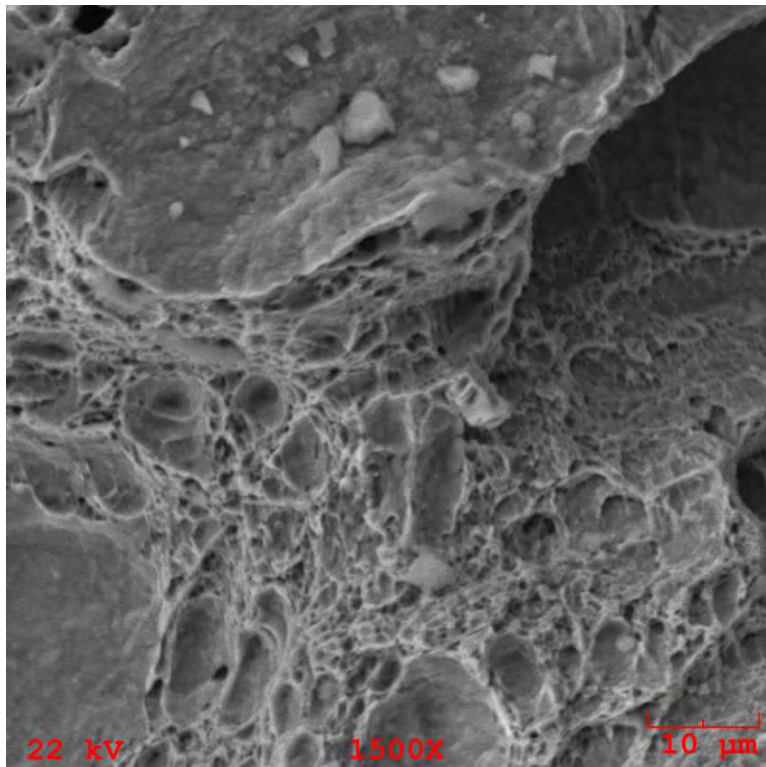
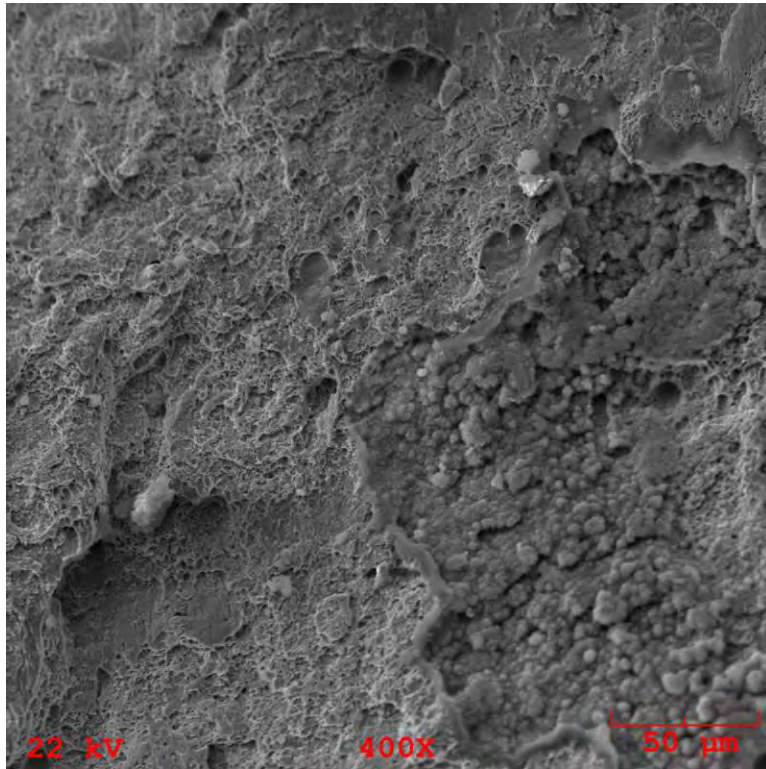
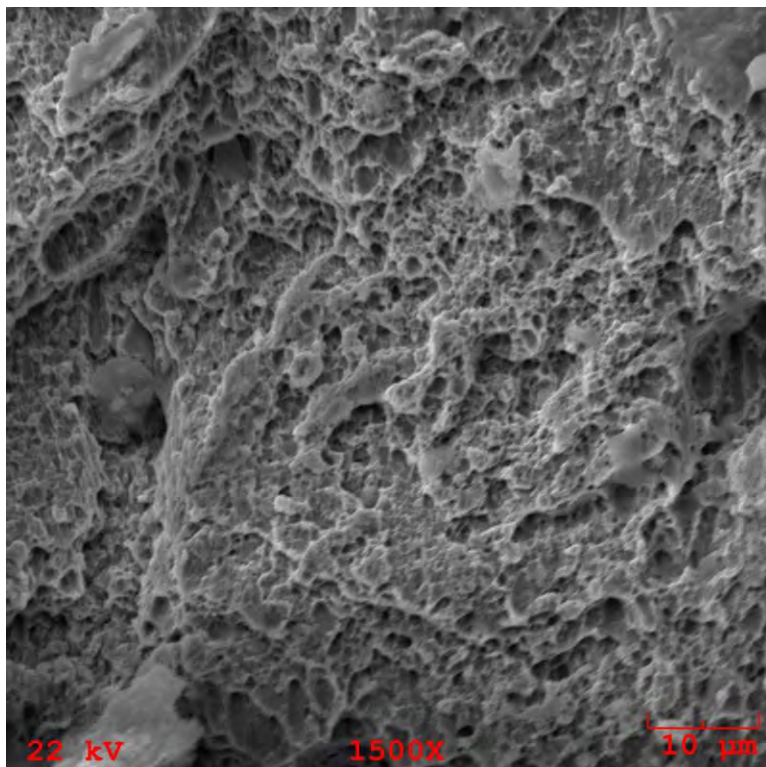
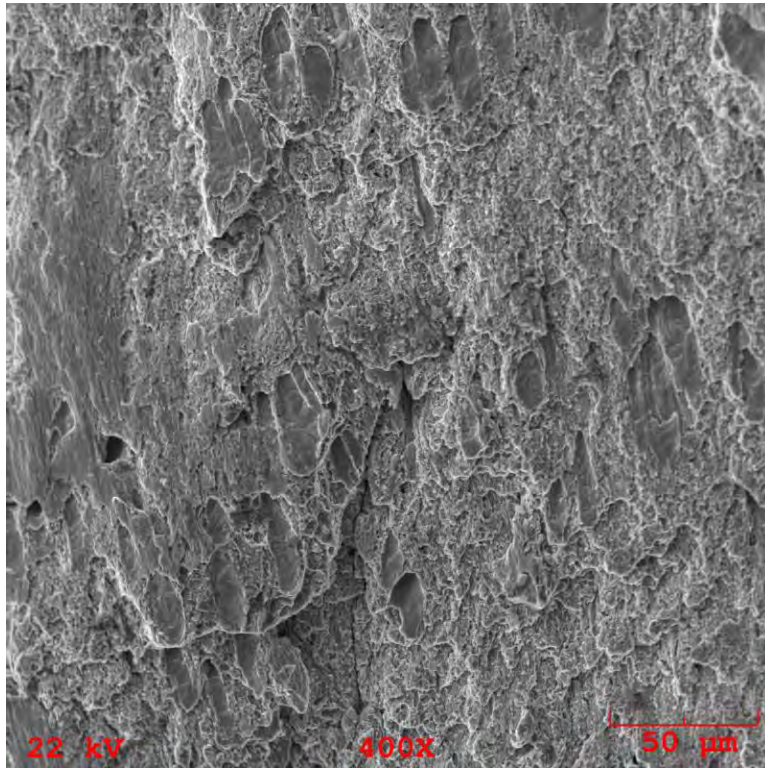
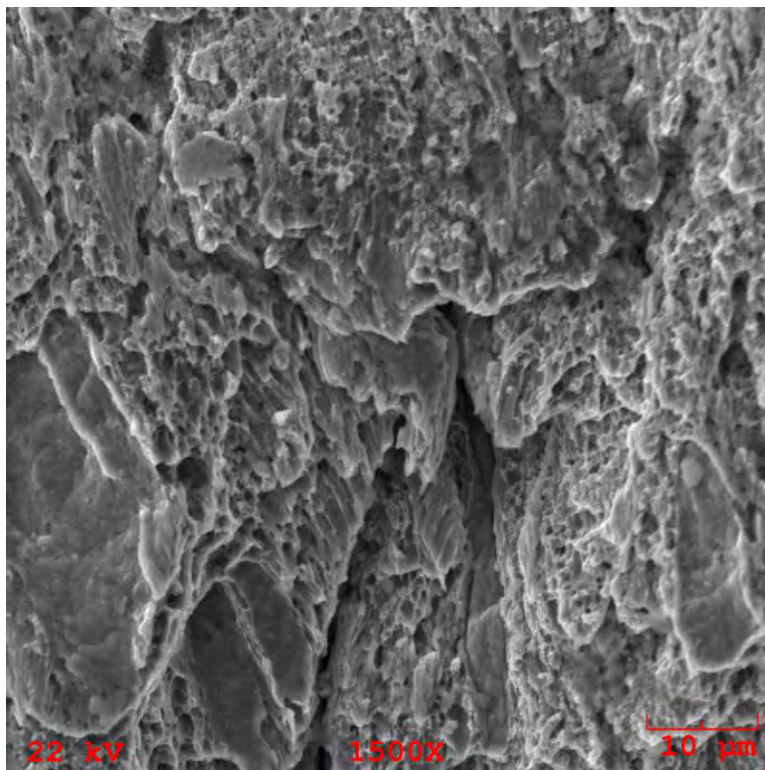
The SEM examination for both samples revealed numerous cuplike depressions consistent with dimple rupture. Elongated dimples were observed near the OD and ID. No evidence of machining or material defects were found during the SEM examination.
