OCS REPORT
86-0101

**Investigation of September 1984 Blowout and Fire
Lease OCS-G 5893, Green Canyon Block 69
Gulf of Mexico,
Off the Louisiana Coast**

October 1986

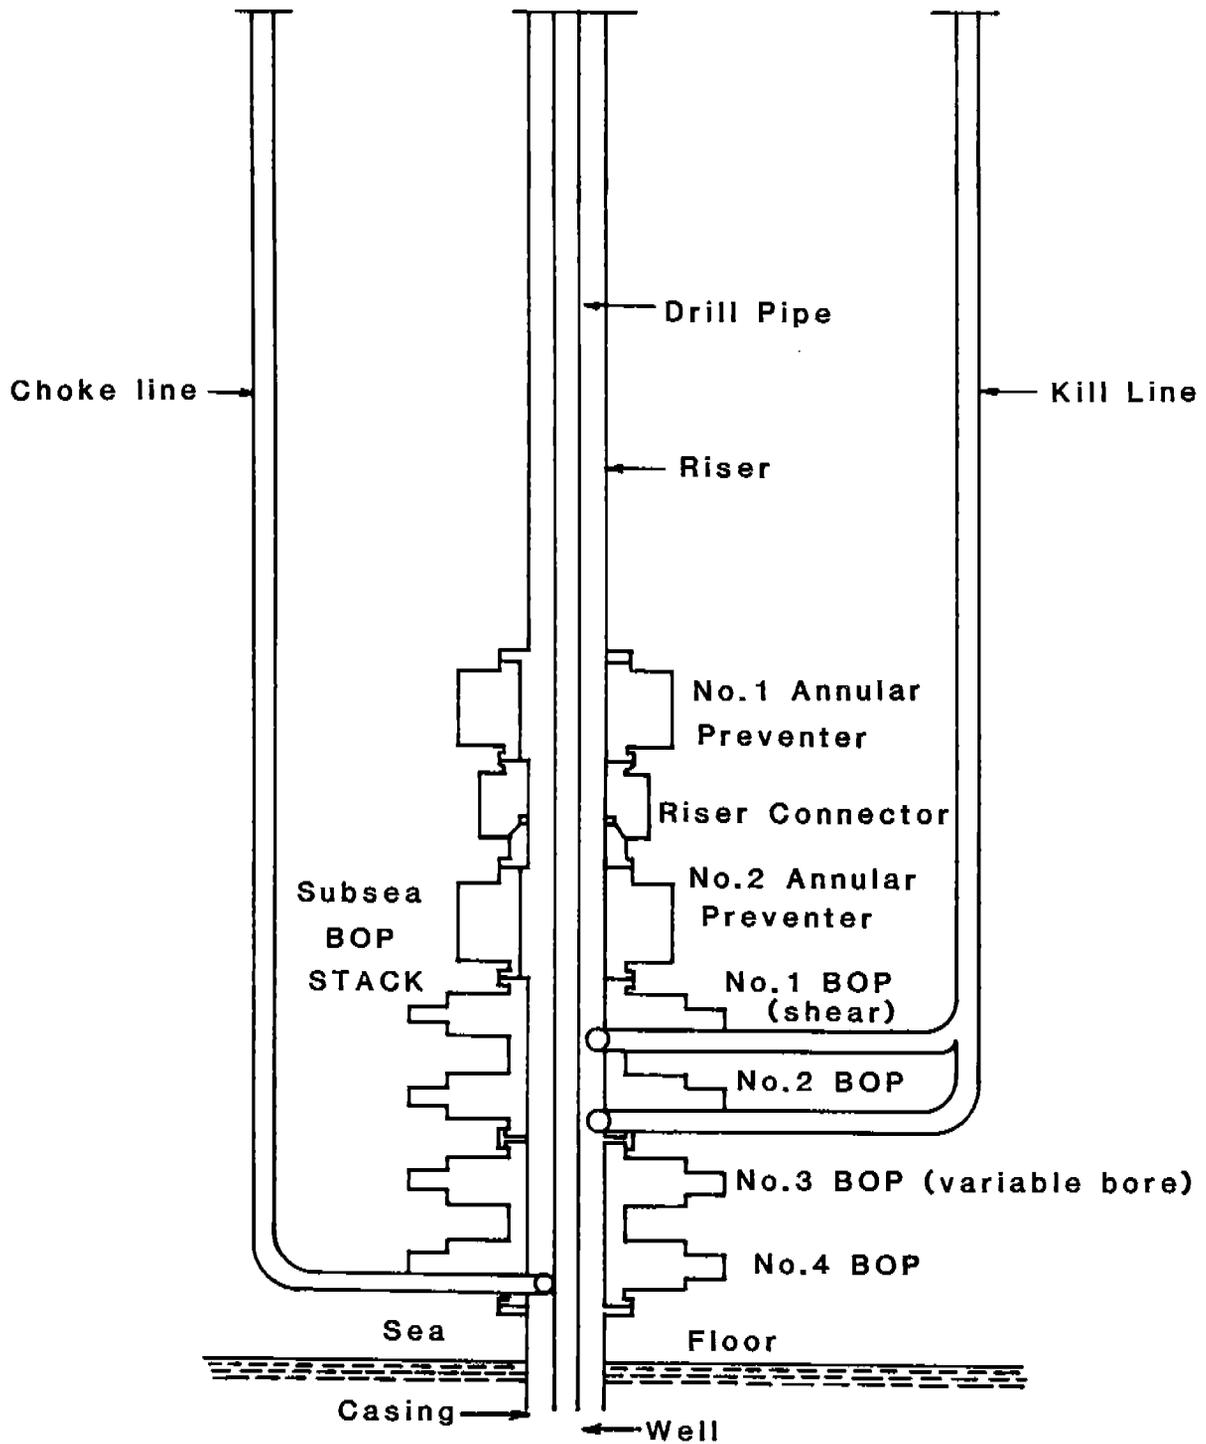
SCHEMATIC OF SUBSEA BOP STACK ZAPATA LEXINGTON

1. Circulation of the 30-bbls kick that was taken at 9,535 feet MD out of the well.
2. The locating of outlets for the choke and kill lines on the subsea BOP stack in such a manner that circulation of the stack while isolated from the well could not be accomplished.
3. Lack of experience on the part of the drilling personnel in the method used to reduce the pressure of and remove the gas trapped in the BOP stack, as evidenced by the failure of the personnel to:
 - a. Closely monitor the amount, type, and pressure of the returns that were taken at the Halliburton unit.
 - b. Allow time for the pressure of the trapped gas to be sufficiently reduced to a point where the hydrostatic pressure of the 12.5 ppg mud in the riser could U-tube the gas out the kill line.

1. Lessees and contractors should determine that the configuration of the choke and kill lines on the subsea BOP stack allows for circulation of the BOP stack when one of the annular preventers and one of the BOP's (pipe rams) are closed.
2. Lessees and contractors should review drilling operation manuals to determine if a method for removal of gas in a subsea BOP stack is included. If not, consideration should be given to adding a section that addresses this operation.
3. Lessees and contractors should determine if the riser can withstand the external hydrostatic pressure of seawater at the water depth it will be used in if it is voided of fluid. If it cannot withstand the pressure, consideration should be given to using riser-fill valves instead of pumping mud to prevent riser collapse when the riser is unloading.

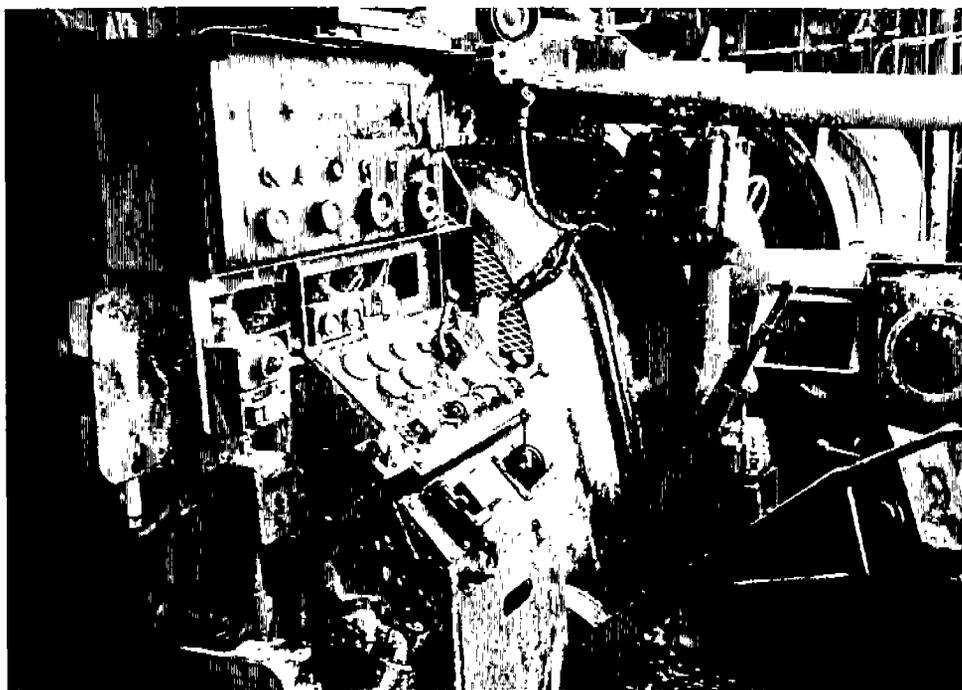
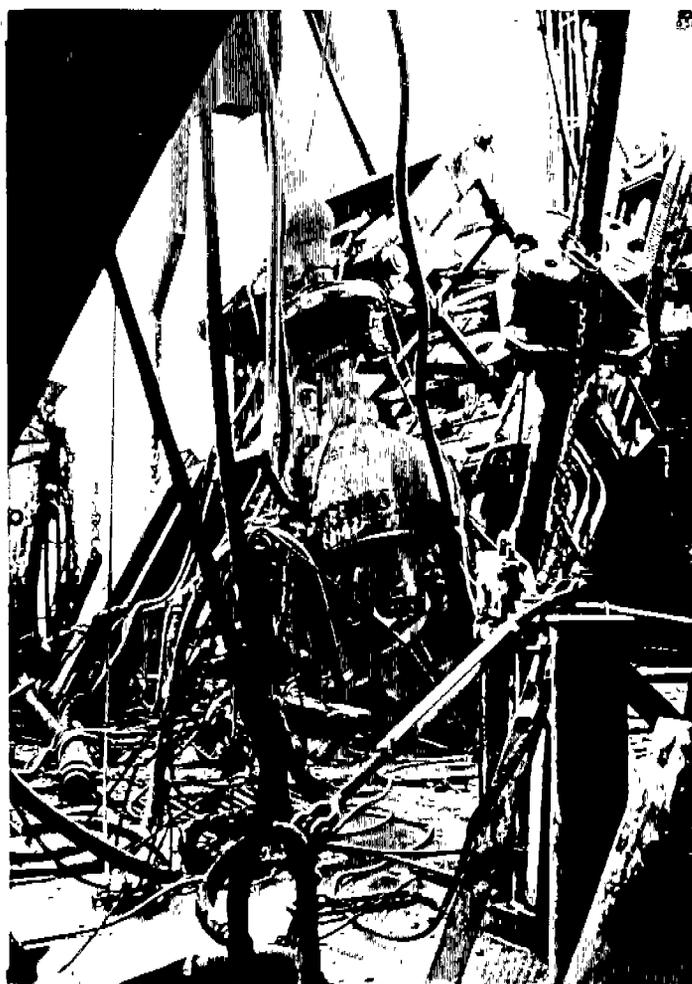
PHOTOGRAPHS OF DAMAGE

The rig was surveyed and four bodies were found. Damage to the drill floor and equipment on the starboard side of the rig near the shale shaker room was extensive (for photographs of the damage, see appendix, attachment 5).

The rig sustained severe fire damage in the vicinity of the drill floor. The entire drill floor and associated equipment, including the derrick, had to be replaced. Costs to repair the damages to the *Zapata Lexington* are estimated at \$15 million.

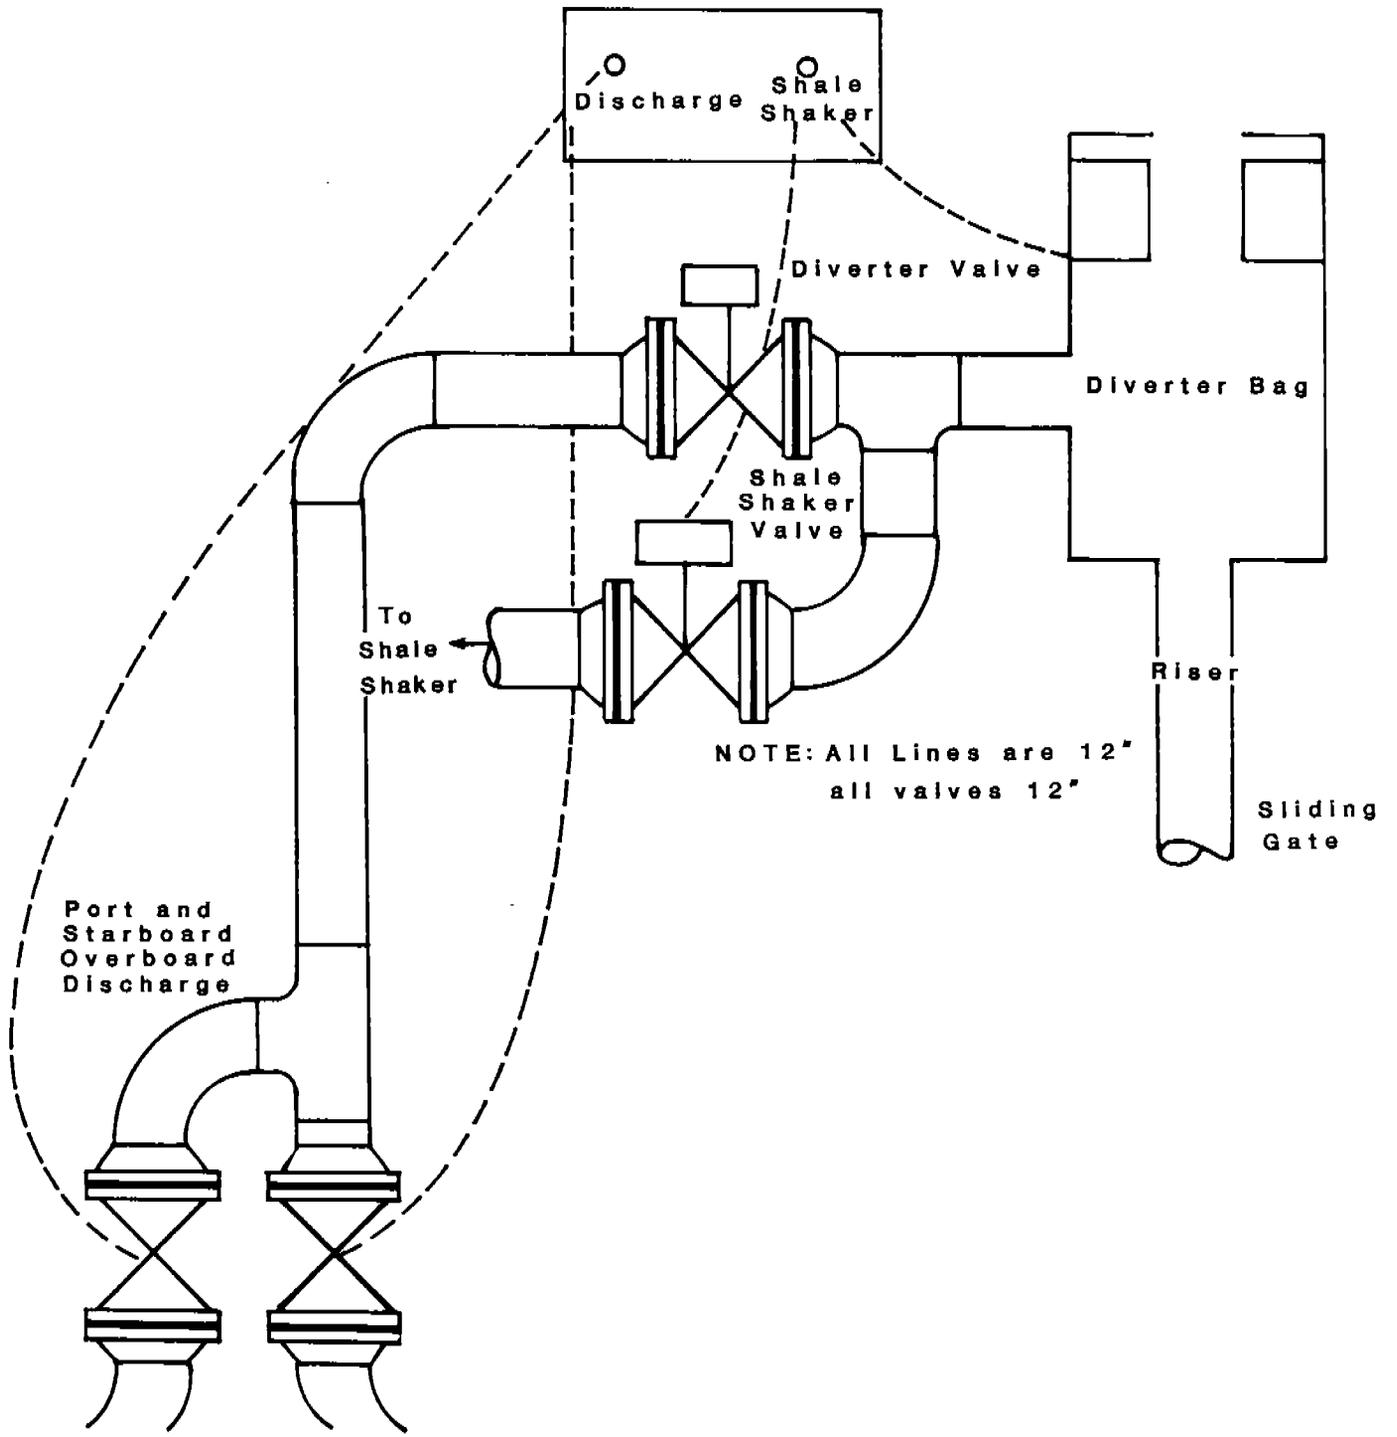
SCHEMATIC OF FLOW PATHS ZAPATA LEXINGTON

Below the diverter bag there were a number of possible flow paths for the mud and gas being circulated out of the riser (for schematic of flow paths, see appendix, attachment 7). The mud and gas could be diverted overboard on either the port or starboard side of the

rig, or both, or could flow through the gumbo box, shale shakers, and degasser into the mud pits. The latter flow path was selected. One consideration used in this decision was that the 12.5 ppg mud in the riser contained 6 percent mineral oil, and pollution would have occurred if the mud and gas had been diverted overboard.
