Gulf of Mexico OCS Region

Investigation of March 19, 1989, Fire South Pass Block 60 Platform B Lease OCS-G 1608

E. P. Danenberger
S. T. Dessauer
C. J. Schoennagel
W. D. Terrebonne
F. J. Torres

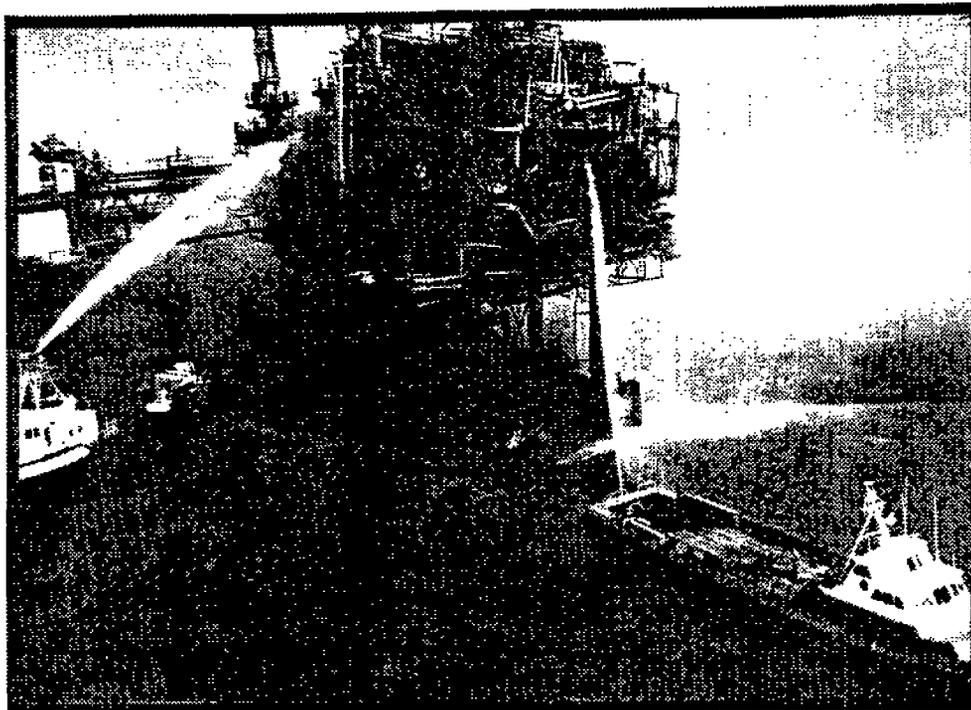
Scene of accident

Minerals Management Service personnel flew to South Pass Block 60, Platform B, on March 20, 1989, and photographed the scene from a helicopter. They then proceeded to Venice, Louisiana, to obtain preliminary information from personnel familiar with the accident. (For photograph of scene, see attachment 1.)

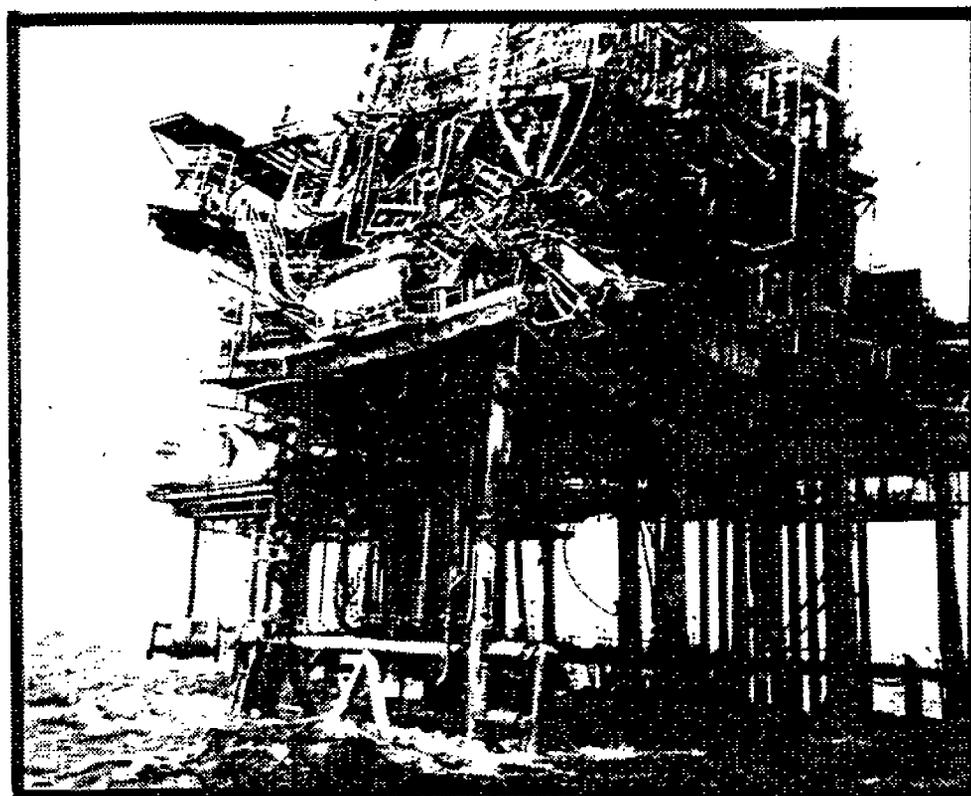
Investigative Panel members flew to the accident location on March 28, 1989, and landed at South Pass Block 60 Platform A. They obtained additional preliminary information from personnel familiar with the accident. They then proceeded by workboat to Platform B to peruse and photograph the structure from the vessel. (For photograph of Platform B, see attachment 1.)

The production and drilling decks of Platform B were completely destroyed. (However, only one production vessel appears to have ruptured during the fire.) These decks and associated equipment have been removed. The platform jacket and wellheads remain, and ARCO is evaluating plans for remedial action. The 18-inch pipeline has been temporarily abandoned, and SONAT is also evaluating future activities.

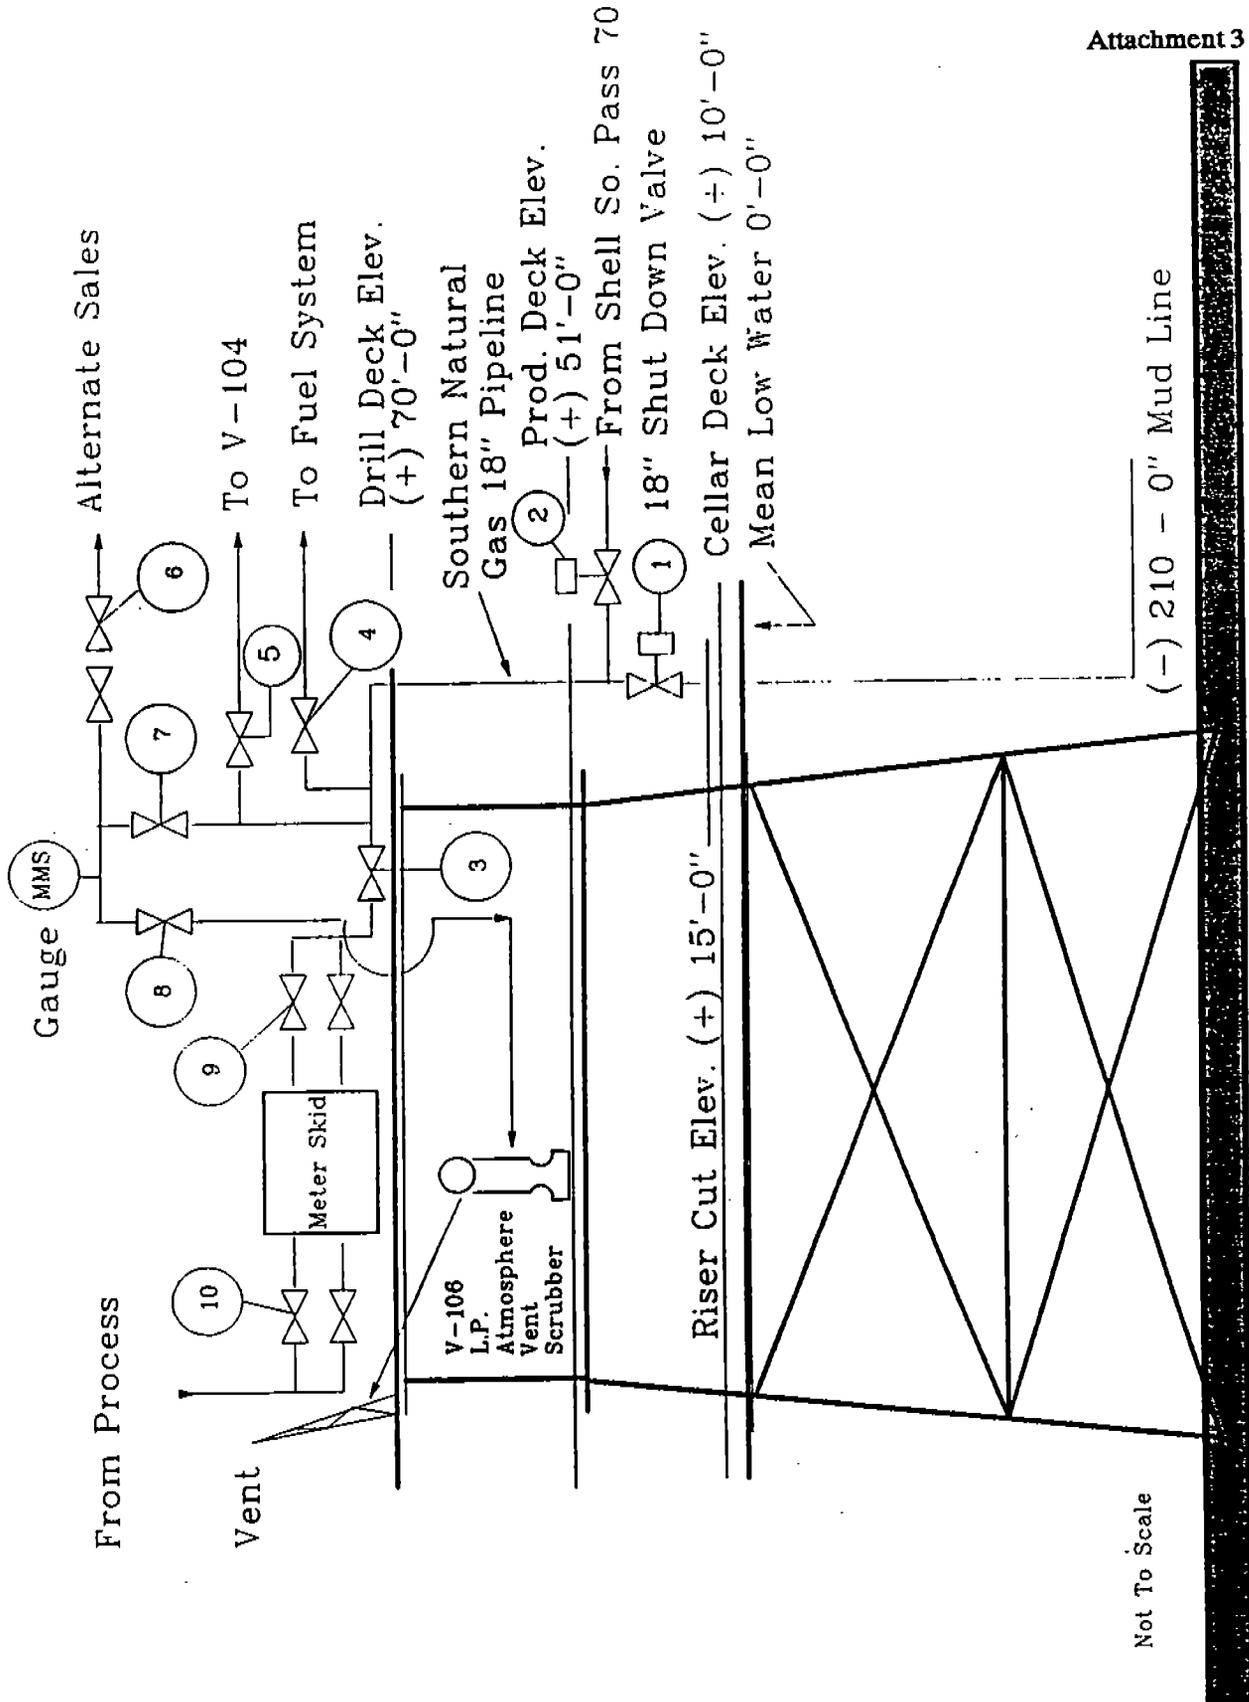
Schematic of riser piping including valve identification

At approximately 11:30 a.m. on March 19, 1989, personnel from ARCO and SONAT closed Valve No. 8 and pumped open the 18-inch shutdown valve. The gauge read approximately 6 psig with Valves Nos. 1 and 7 opened and Valves Nos. 2, 3, 4, 5, 6, 8, 9, and 10 closed. Valve No. 8 was cracked open and, over the next 30 minutes, the line was bled to 0 psig. The 18-inch shutdown valve was then closed at 12 p.m. on March 19, 1989.

Subsequent investigation has revealed two important aspects about the bleed-down of the 18-inch riser. Liquid hydrocarbons have been found in the ball cavity of the 18-inch shutdown valve, indicating that this fluid was trapped there when the valve was closed around 12 p.m. on March 19, 1989. A plugged port on the bottom side of the 18-inch shutdown valve body was found to be in communication with the annulus of the 18-inch riser, thereby allowing access to determine the contents of the riser before cutting operations began. (For photograph of plugged port, see attachment 4.)

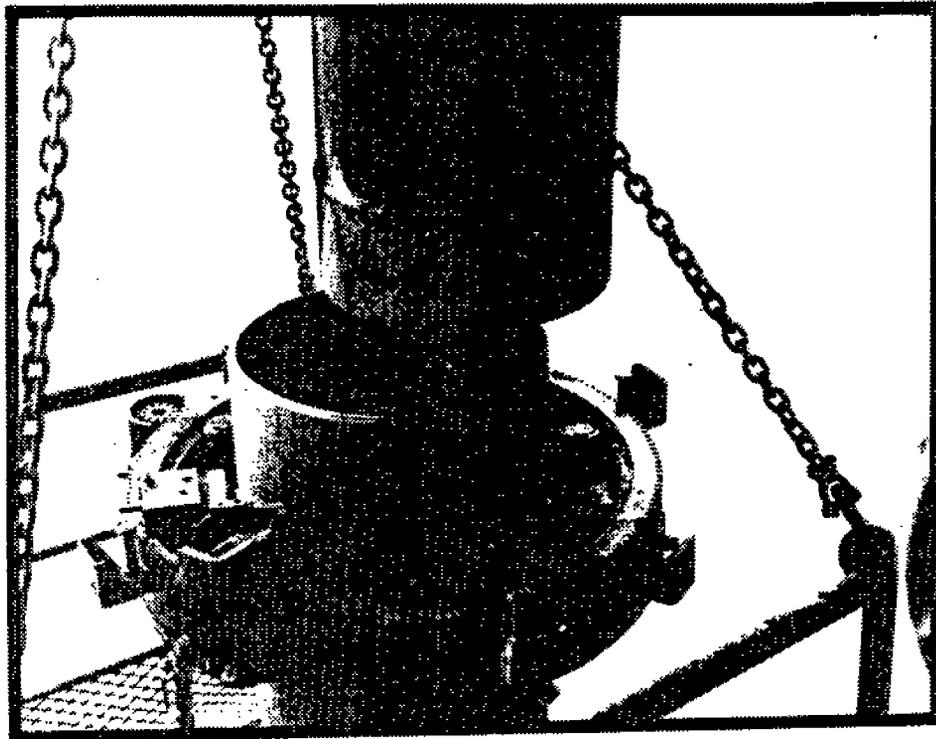
Cold-cut machine

At approximately 5 p.m. on March 19, 1989, a Pipeline Supply and Service Company employee responsible for operating the cold-cut machine (machine operator) arrived via crew boat at the South Pass Block 60 Platform B. (For photograph of cold-cut machine, see attachment 4.) This machine has a cutting head that is driven by compressed air and makes a beveled cut around the pipe without producing sparks. The cutting head continues to make a deeper groove as it rotates until it eventually severs the pipe.

The machine operator stopped the cold-cutting operation at least once to make adjustments to the machine. At approximately 7:20 p.m., the cold-cut machine initially penetrated the 18-inch pipe. A fluid immediately started to flow from the penetrated area, and almost simultaneously the machine operator closed the air valve shutting down the machine.

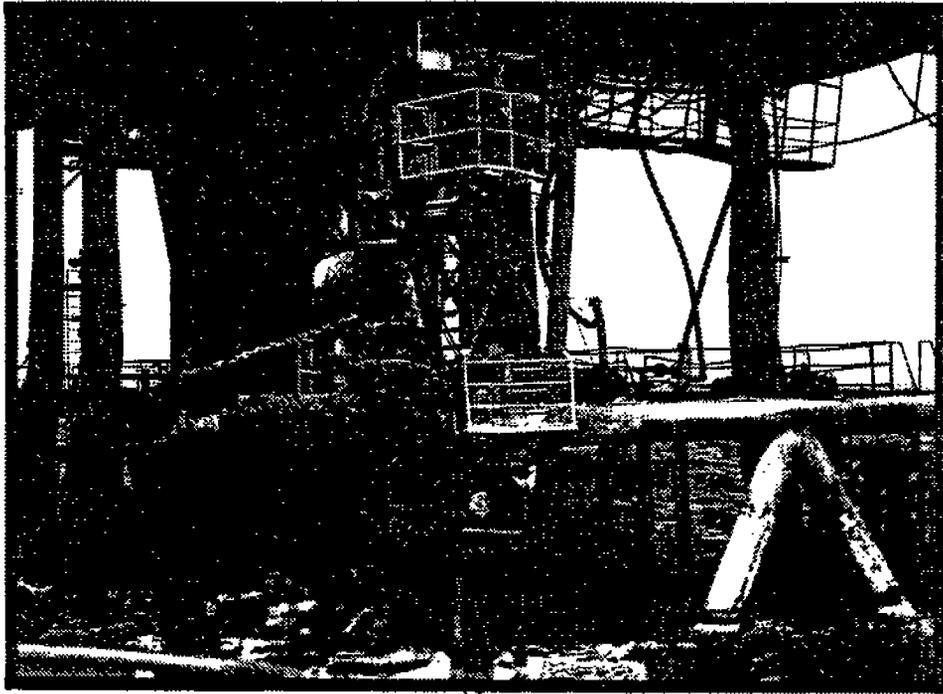
Area of cut

The machine was clamped onto the riser, and the initial cut of the 18-inch pipe began at approximately 6:30 p.m. at the 15+ foot level of the platform. A compressor located on the *M/V Bo-Truc 20* supplied the air to run the machine. The machine operator, who was in a workbasket located adjacent to the 18-inch riser, controlled the air with a valve on the machine. (For photograph of cut area, see attachment 5).

Probable Cause of Incident The probable cause of the incident was the cold-cutting of the 18-inch riser. After the pipeline was flooded, liquid hydrocarbons, which have a specific gravity less than water, migrated up the riser, above the water line. The penetration of the riser from the cold cut allowed a mixture of gas, liquid hydrocarbons, and water to escape to the atmosphere. This escape reduced the hydrostatic pressure, creating a pressure differential that allowed additional flow into the riser. The presence of gas, which would expand over six times its volume up the riser, provided the driving force to expel the liquids.

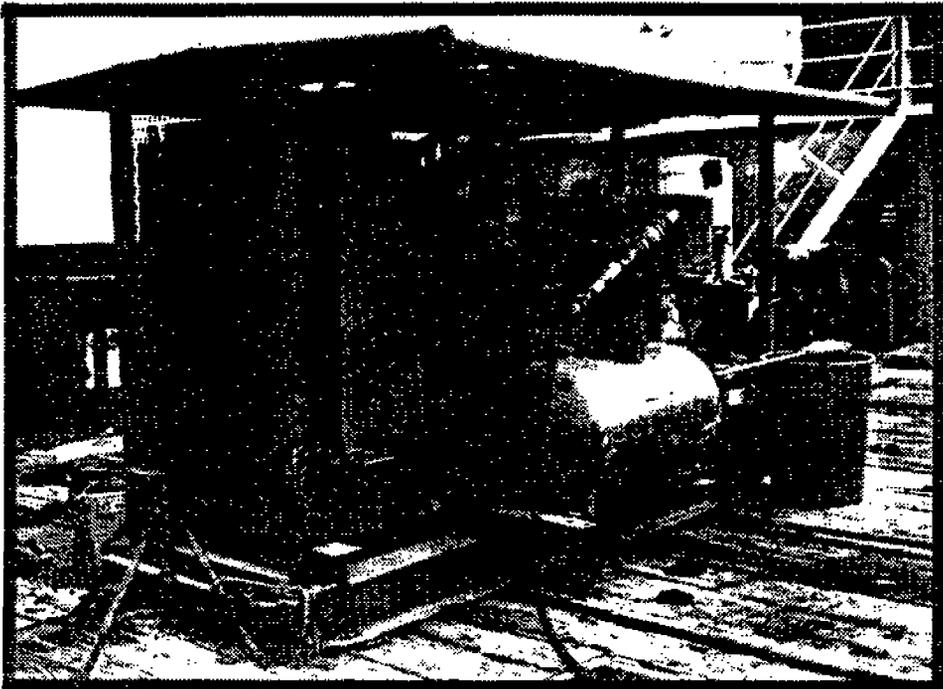
Compressor on M/V *Bo-Truc 20*

given by the machine operator, a valve located at the compressor was used to restart the machine. (For photograph of compressor, see attachment 5.) After the initial flow, but prior to the restarting of the machine, there appears to have been little discussion among the PLUS foreman, machine operator, and SONAT representative as to what should be the next course of action.

Conflicting testimony was obtained as to the initial source of ignition. One witness has indicated that the fluid ignited at the air compressor skid on the deck of the M/V *Bo-Truc 20* due to the overspeeding of the diesel engine. Another witness has stated that hot exhaust pipes located above the riser area on the production deck caused the fluid to ignite.

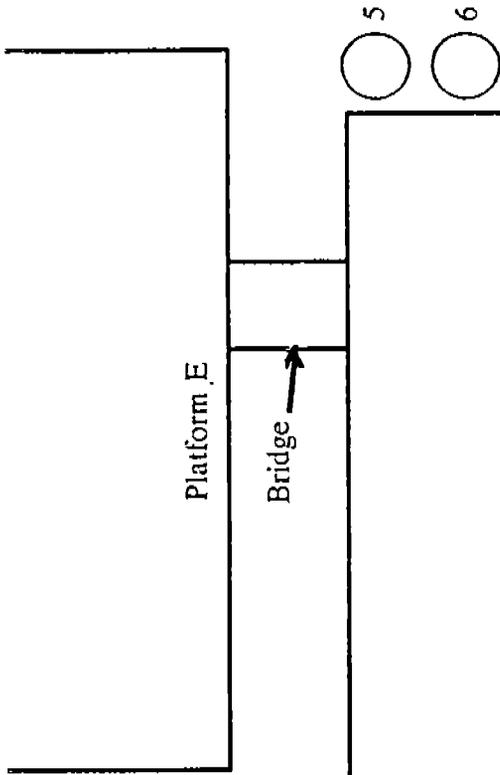
Platform B

Pipeline No.	Size	Flow Direction	Contents	Operating Pressure (psig)	Rupture Point
1	18-inch	Departing	Gas	1,000	Riser Cut
2	8-inch	Incoming	Gas	1,000	No Rupture
3	6-inch	Departing	Gas	1,000	Under Production Deck
4	12-inch	Incoming	Gas	80-90	Under Production Deck
5	12-inch	Incoming	Gas	80-90	No Rupture
6	12-inch	Incoming	Gas	80-90	No Rupture
7	12-inch	Departing	Gas	1,000	Under Production Deck
8	4-inch	Bi-directional	Gas	3,000-3,200	Under Production Deck
9	6-inch	Bi-directional	Gas	1,000	Cellar Deck
10	6-inch	Departing	Oil	300-400	Cellar Deck
11	6-inch	Departing	NGL*	500-550	No Rupture
