**THE BUREAU OF OCEAN ENERGY MANAGEMENT,
REGULATION AND ENFORCEMENT**

**VERMILION BLOCK, PRODUCTION PLATFORM A:
AN INVESTIGATION OF THE SEPTEMBER 2, 2010 INCIDENT
IN THE GULF OF MEXICO**

May 23, 2011

**Vermilion Block, Production Platform A:
An Investigation of the September 2, 2010 Incident
In the Gulf of Mexico**

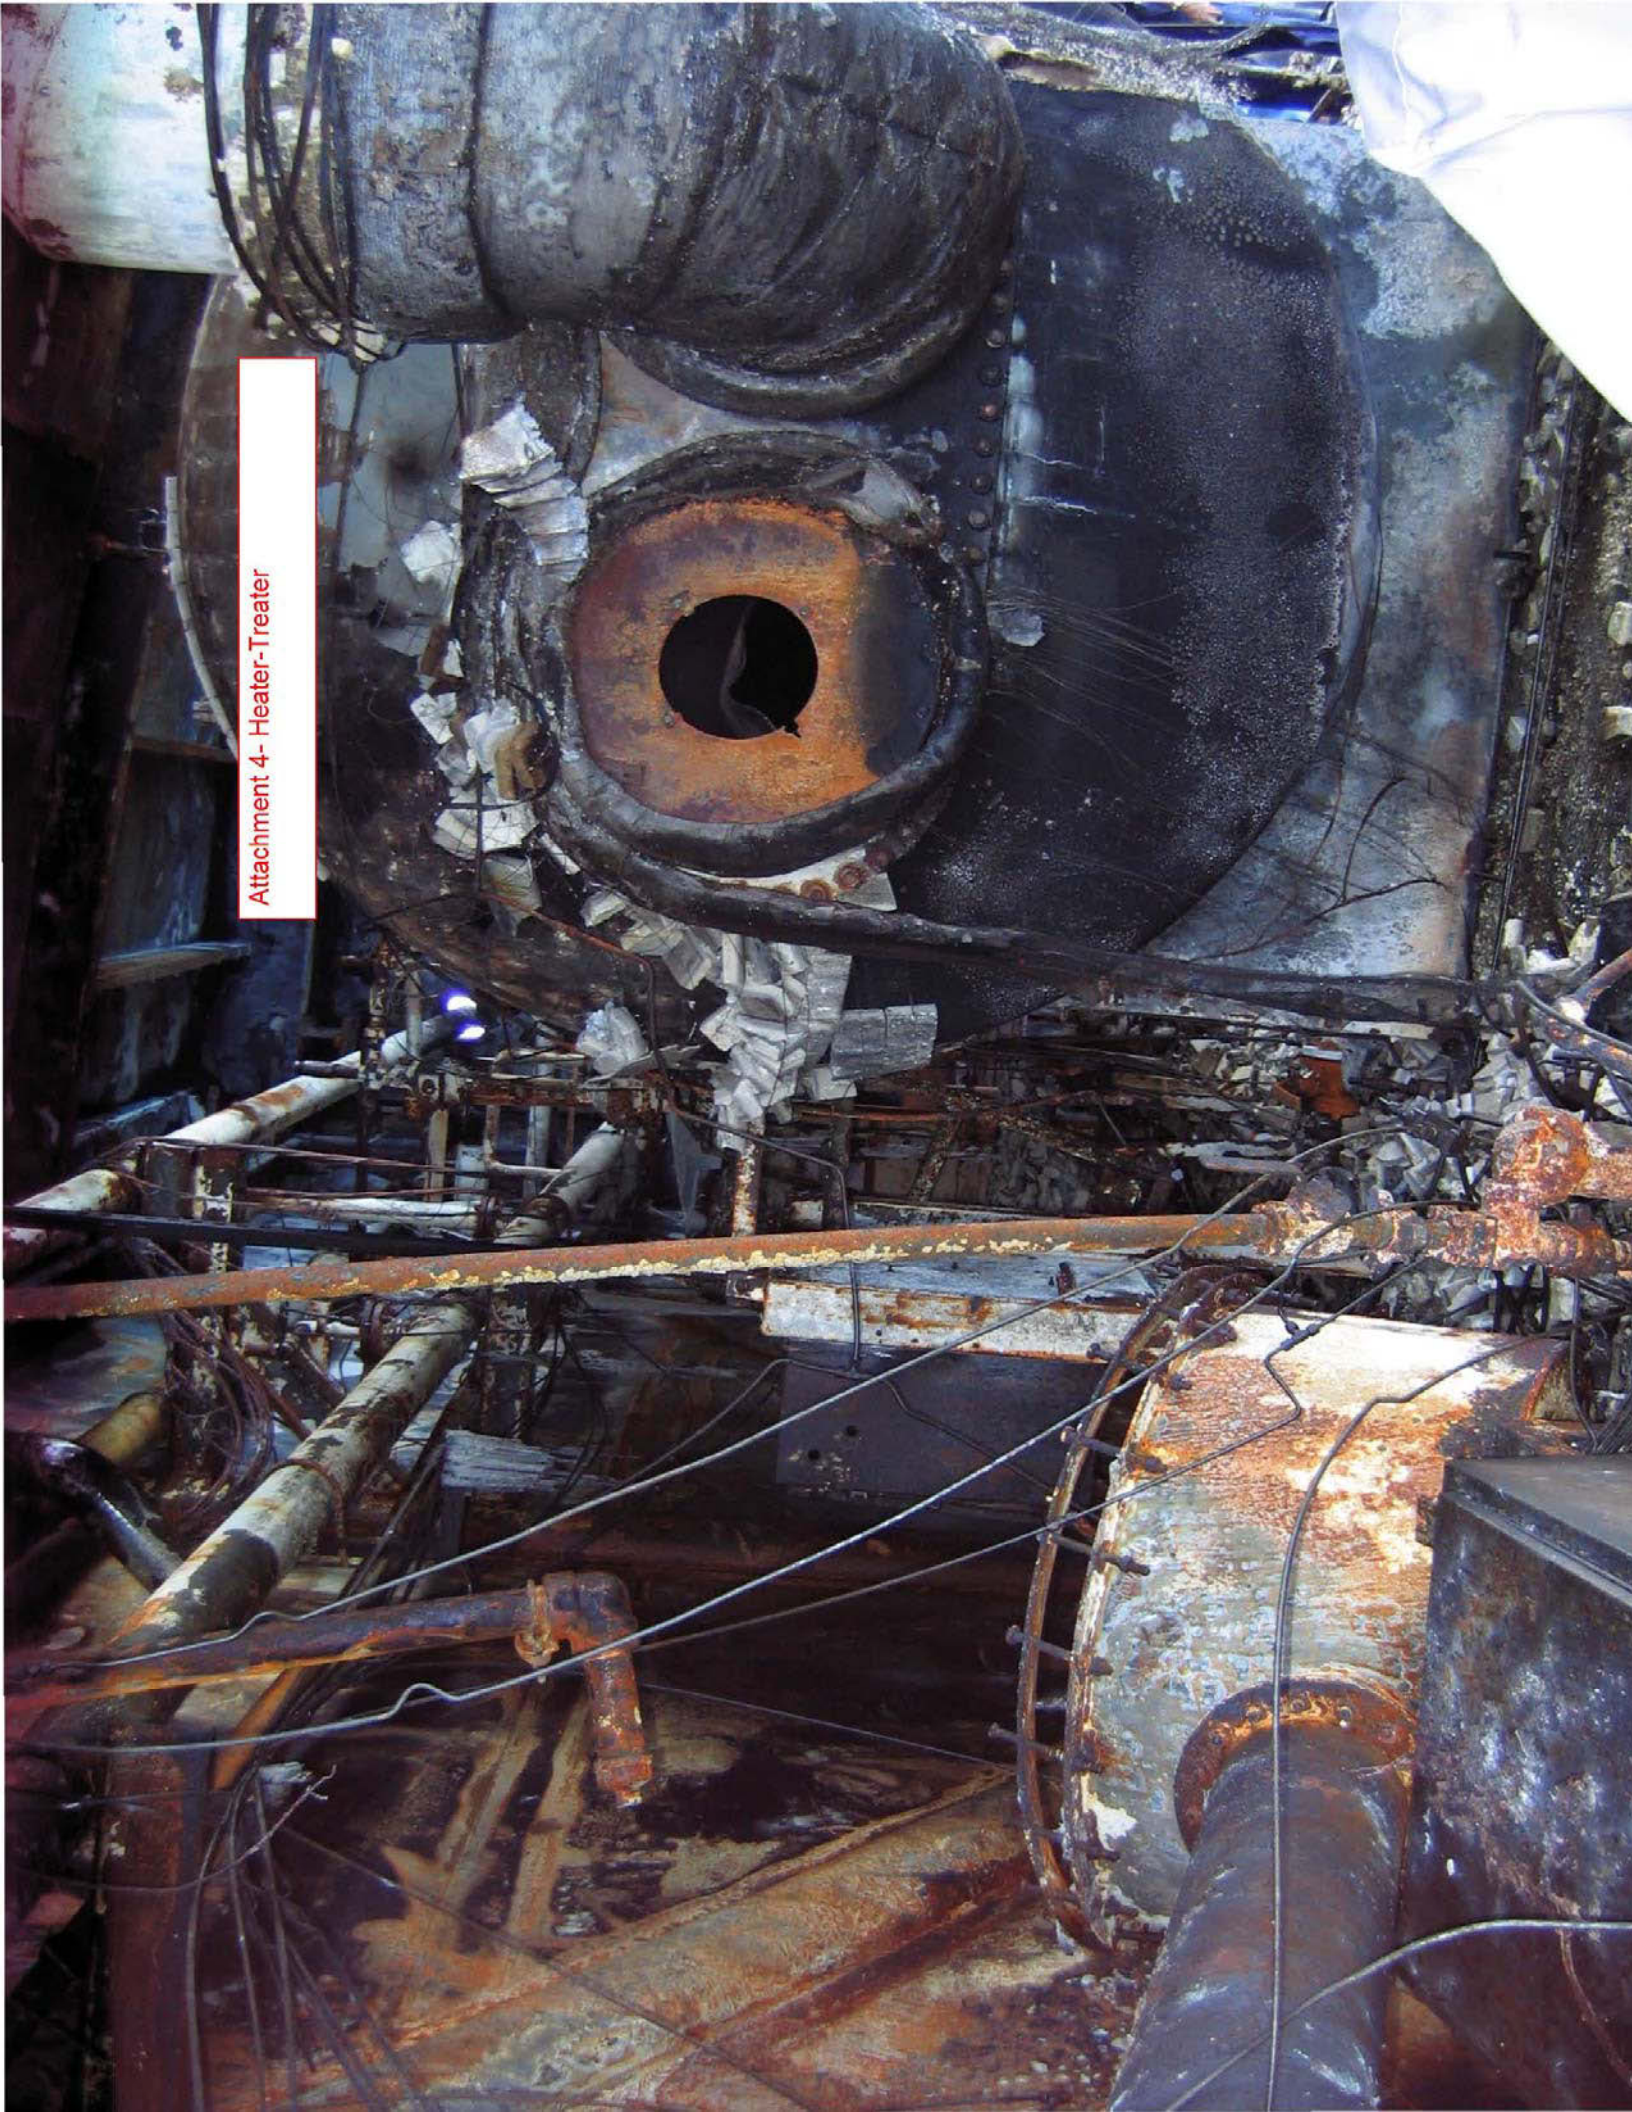
Attachment 4- Heater-Treater

BOEMRE personnel also observed substantial damage to the Heater-Treater and its immediate surroundings. The Heater-Treater's exterior sustained significant fire damage, and was blackened in various parts. The forced-draft fired component assembly section was found at least eight feet away from its original position on the front of the vessel. The round opening on the front of the Heater-Treater, which was exposed when the fired component assembly was ejected, had three of four bolts still in place with one bolt missing and the corresponding area split, which was consistent with the assembly forcibly being blown off. Viewing through the front of the opening, the BOEMRE inspectors could see that part of the fire tube had buckled or bent in a wavy configuration.

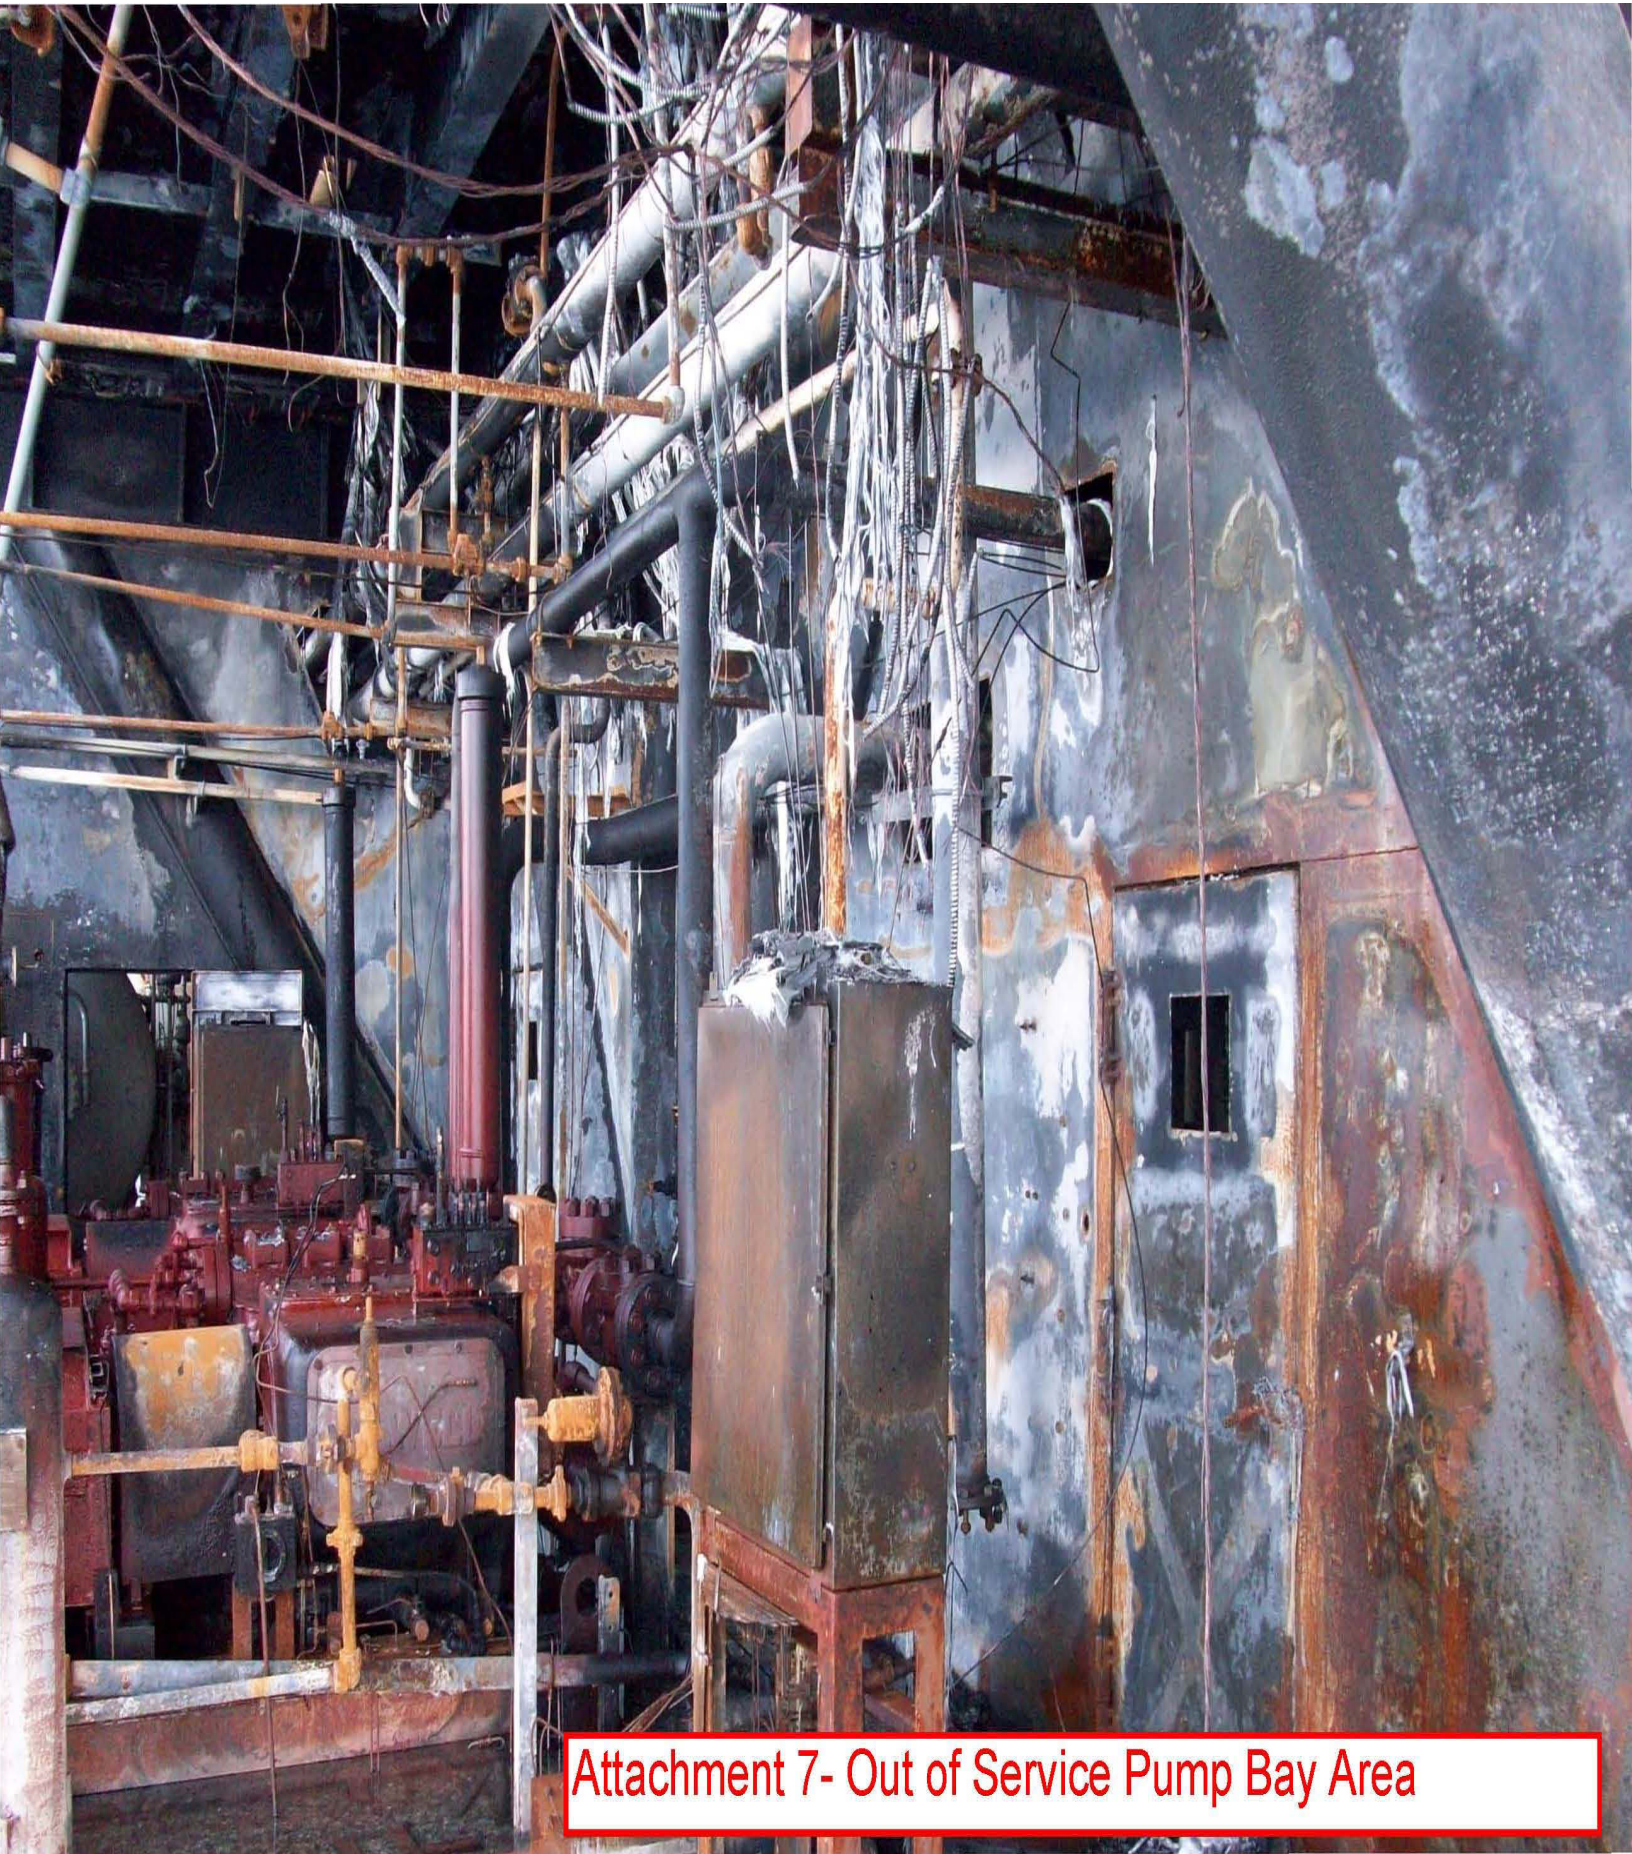
Attachment 6- Deck Plating Above Heater-Treater

BOEMRE personnel also noticed that the fire walls and deck plating near and above the Heater-Treater were affected by the fire. These barriers appeared to function as intended by helping minimize damage to the Platform. They also observed that ignited liquids appeared to have burned the floor in the area near the Heater-Treater, and that the fire spread on the floor from the Heater-Treater to the area where the "out of service" pipeline pumps and good and bad oil storage tanks were located. Furthermore, the Heater-Treater's electronic control panel, pneumatic slave panel and flame signal panel sustained significant fire damage or were destroyed.¹⁰ The Heater-Treater's slave panel was seriously damaged and bent away from the front end of the Heater-Treater. The damage to these panels impaired the Panel's ability to conduct testing on them, and to reach conclusions regarding possible malfunctions or warning signals in the panels.¹¹

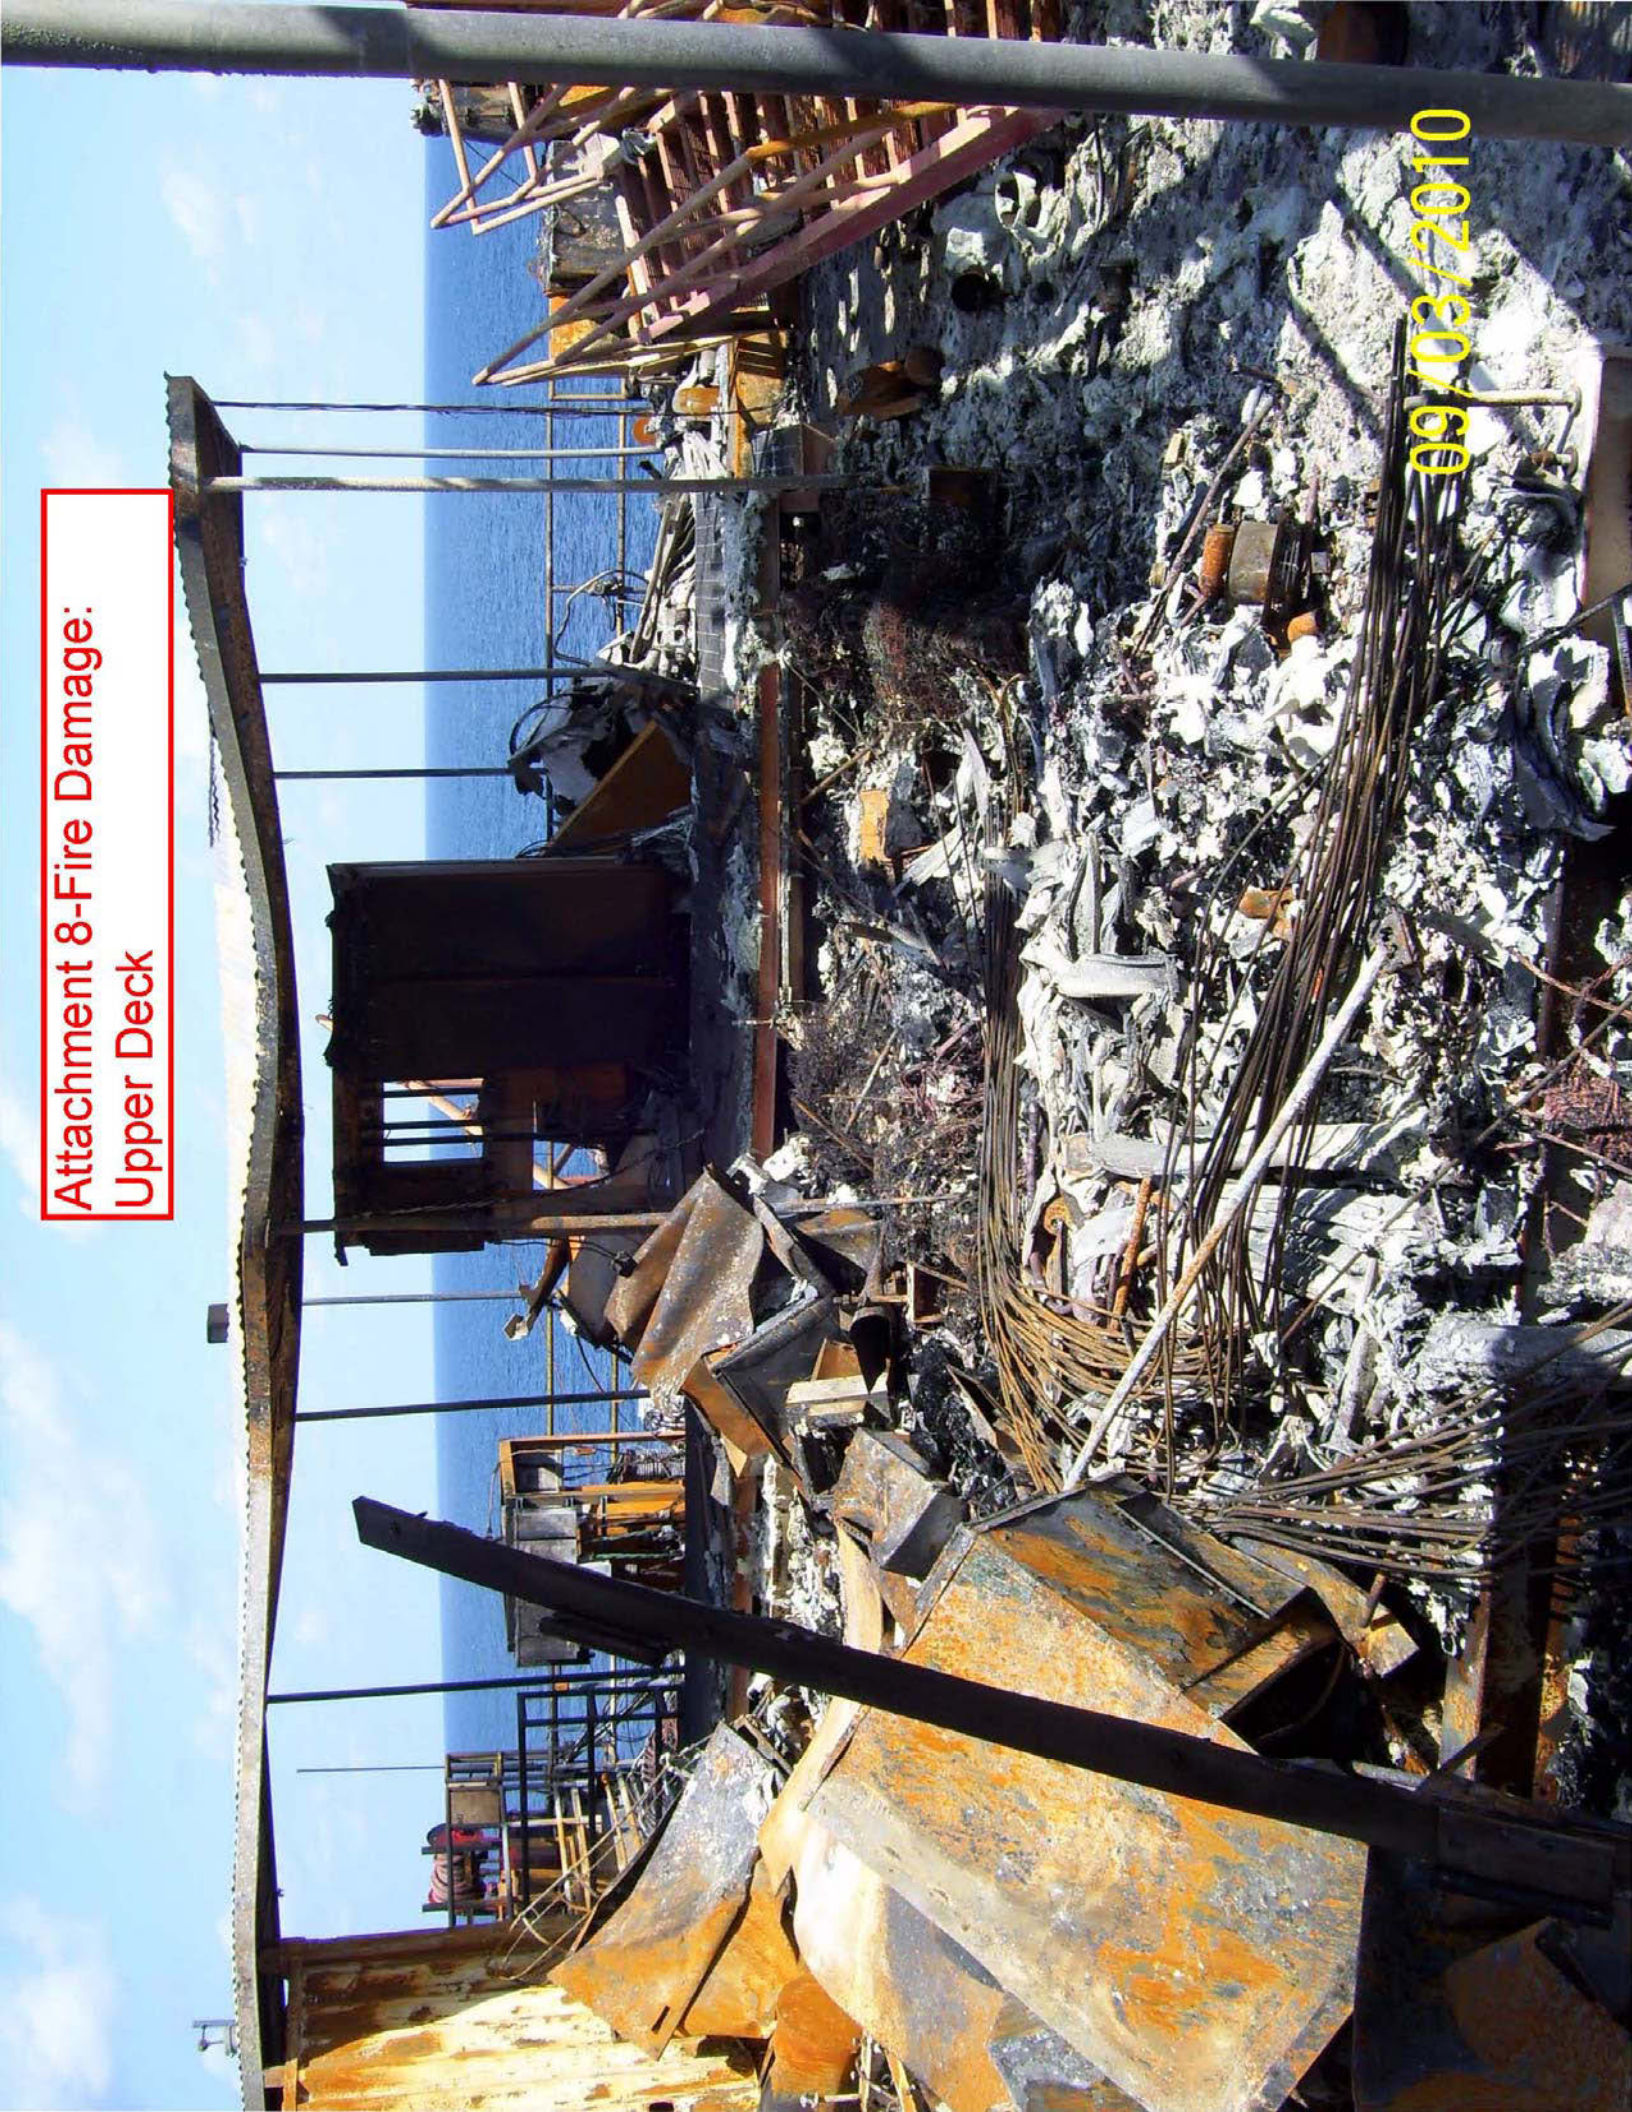
Attachment 8-Fire Damage:
Upper Deck

BOEMRE personnel concluded that the fire affected both the cellar and main decks of the Platform. For instance, on the main deck, the effects of the fire were visible in the center and the western areas of the platform -- the sleeping quarters, galley, MCC building, gas generator, several storage tanks, and storage buildings all sustained major damage or were totally destroyed. The switchgear building also was damaged. The fire on the cellar deck appeared mainly confined to the north, center, and western bay areas, which contained two out-of-service gas-driven pipeline pumps, the LACT charge pumps, "good" and "bad" oil tanks, and the Heater-Treater and Vent Scrubber, respectively. The components located in the north and center bays⁹ sustained varying levels of damage, which ranged from minimal to severe.

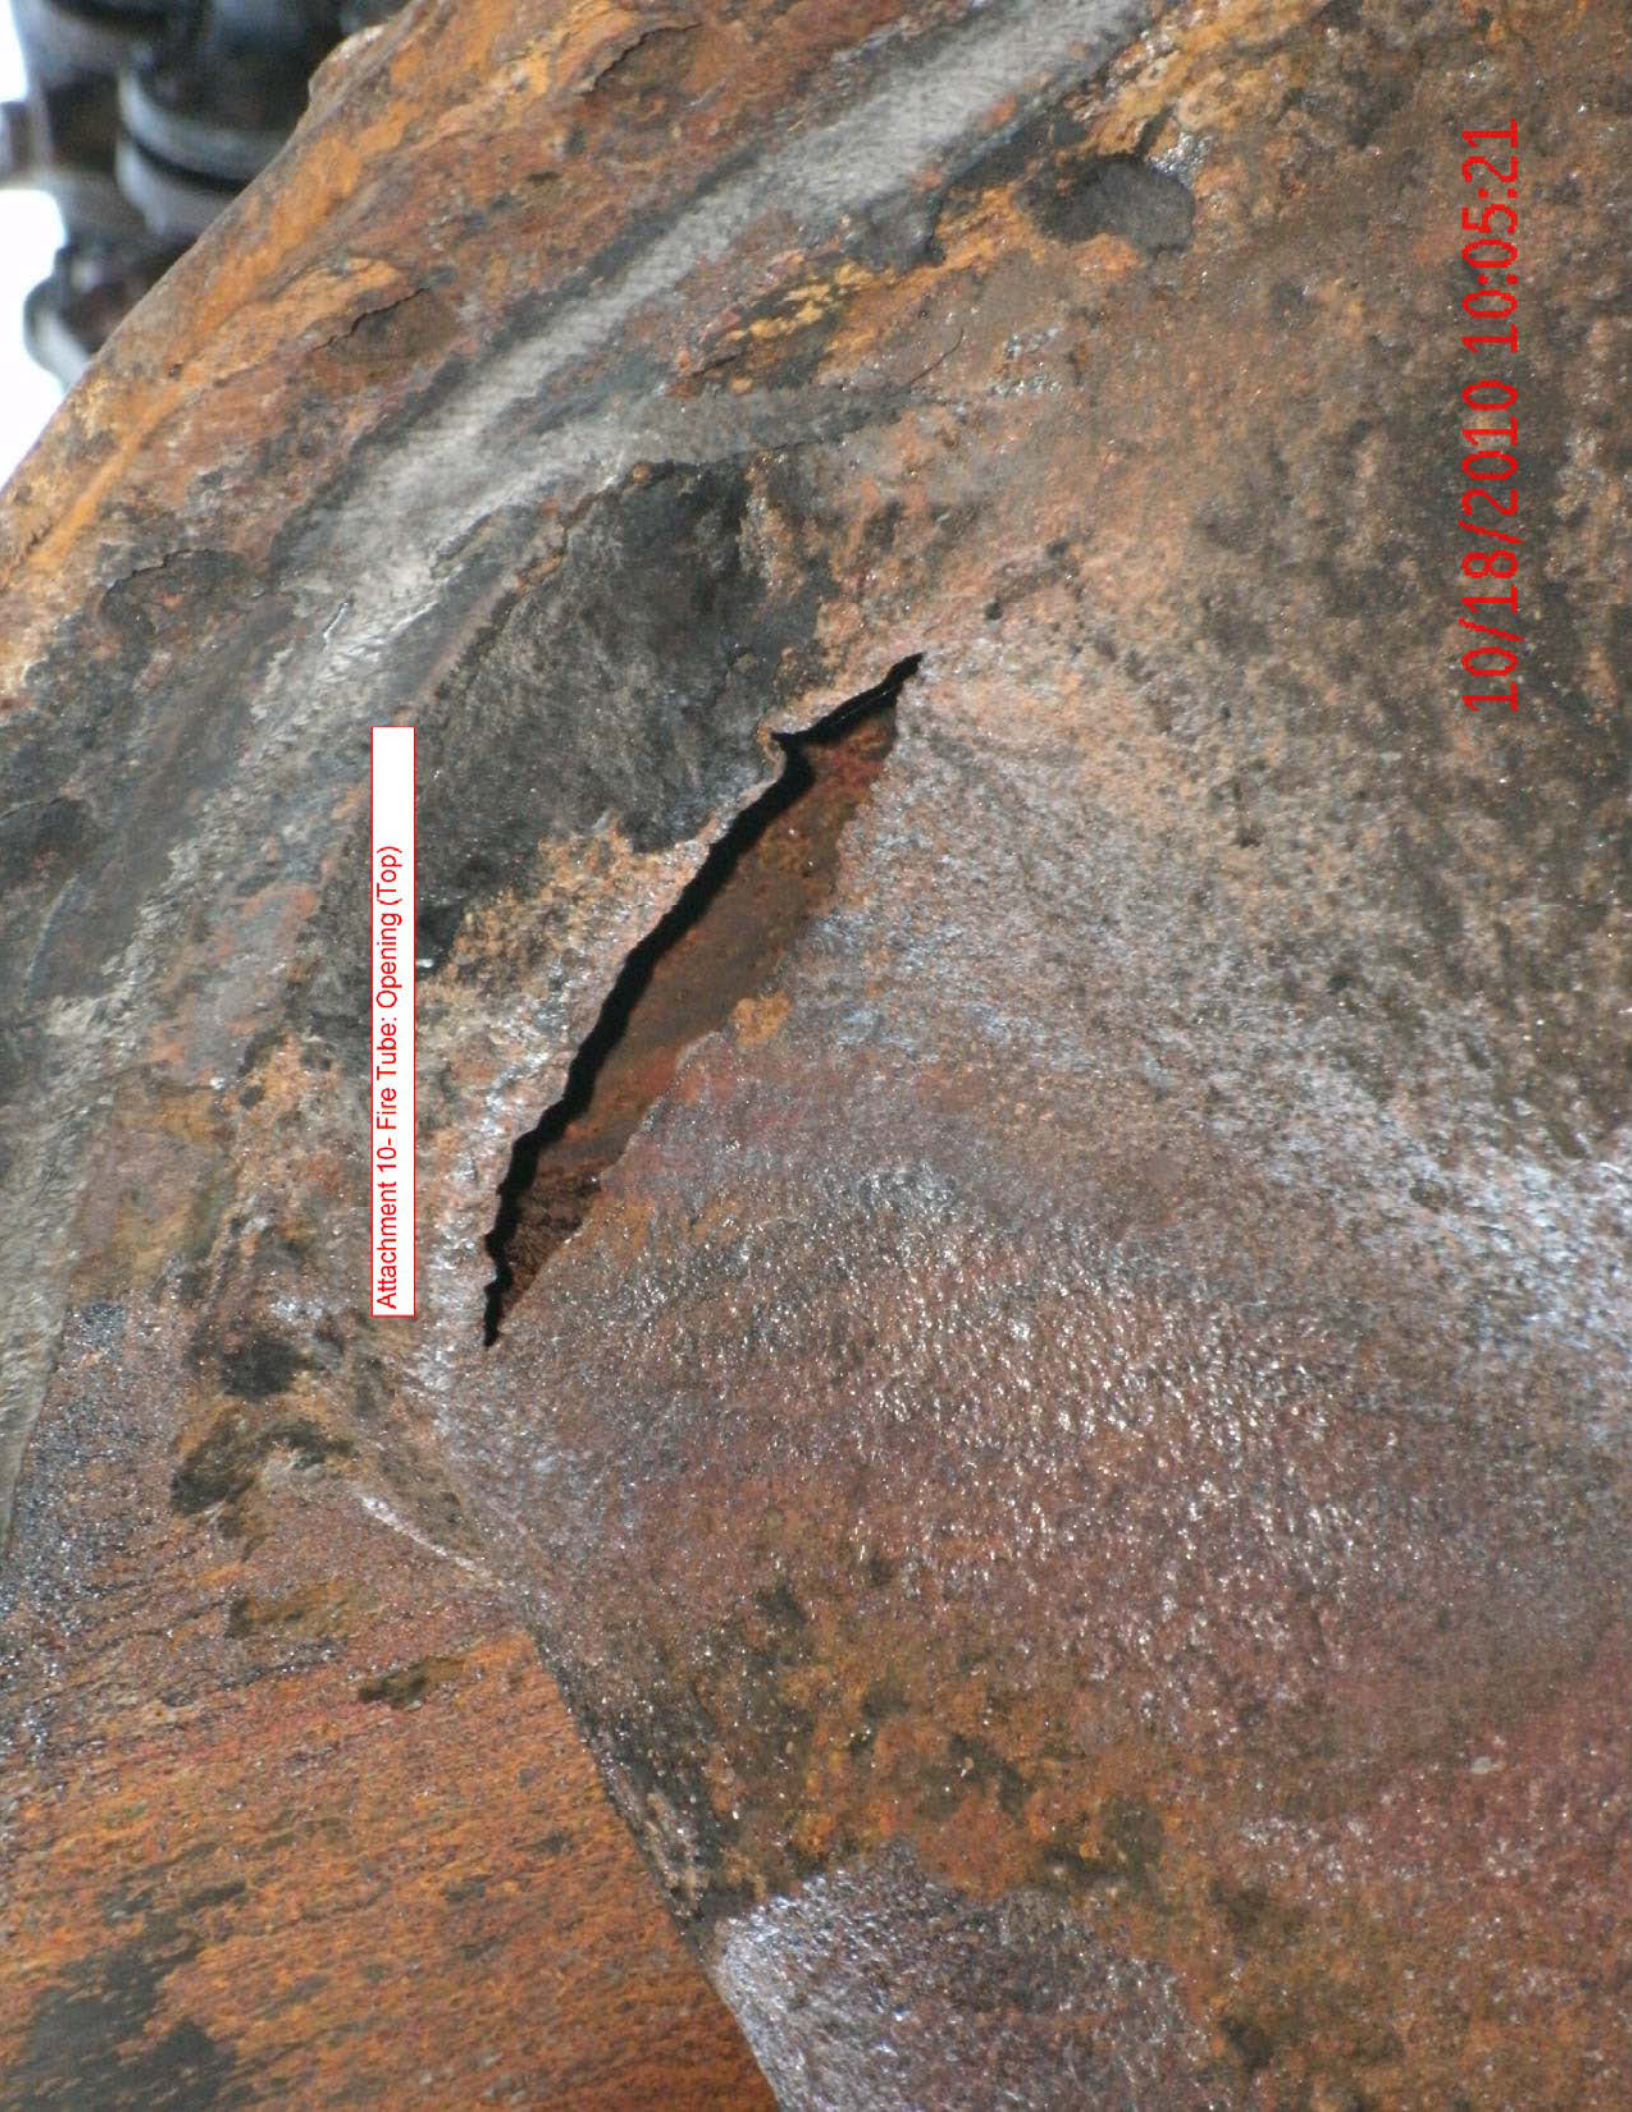
Attachment 10- Fire Tube: Opening (Top)

Members of the investigative team witnessed the removal of the fire tube from the Heater-Treater. As the fire tube was being removed, they observed that the fire tube was collapsed in a “canoeing” configuration—in other words, it was caved upward and inward from the top and the bottom. When members of the investigative team examined the Heater-Treater where the fire tube was originally located, they concluded that two openings were created, both of which were located on the fired side of the fire tube near the mounting flange. The underside or bottom of the fire tube caved upward and inward, separated from the mounting flange, thus creating one large opening. The top of the fire tube collapsed downward and inward, creating a smaller opening. The “canoeing” extended from the point at which the fire tube separated from the mounting flange through the middle section of the tube turn.

Upon careful examination of the fire tube, members of the investigative team found that it was blackened in color and there was evidence of a darker spot or “hot spot” on the top of the tube at a point near where the main burner’s flame was located when the tube was inside of the vessel. There was a crack in the first weld of the tube turn on the fired side, which was also located at a point close to where the main burner’s flame was located. Evidence of heavy corrosion and pitting (dimpling) were found along various parts of the fire tube, mainly on the fired side.

All of these factors suggested that the fire tube was affected by heat that, in turn, contributed to the deterioration of the steel comprising the tube. *See Attachments 10-15, Photographs of the Heater-Treater.*

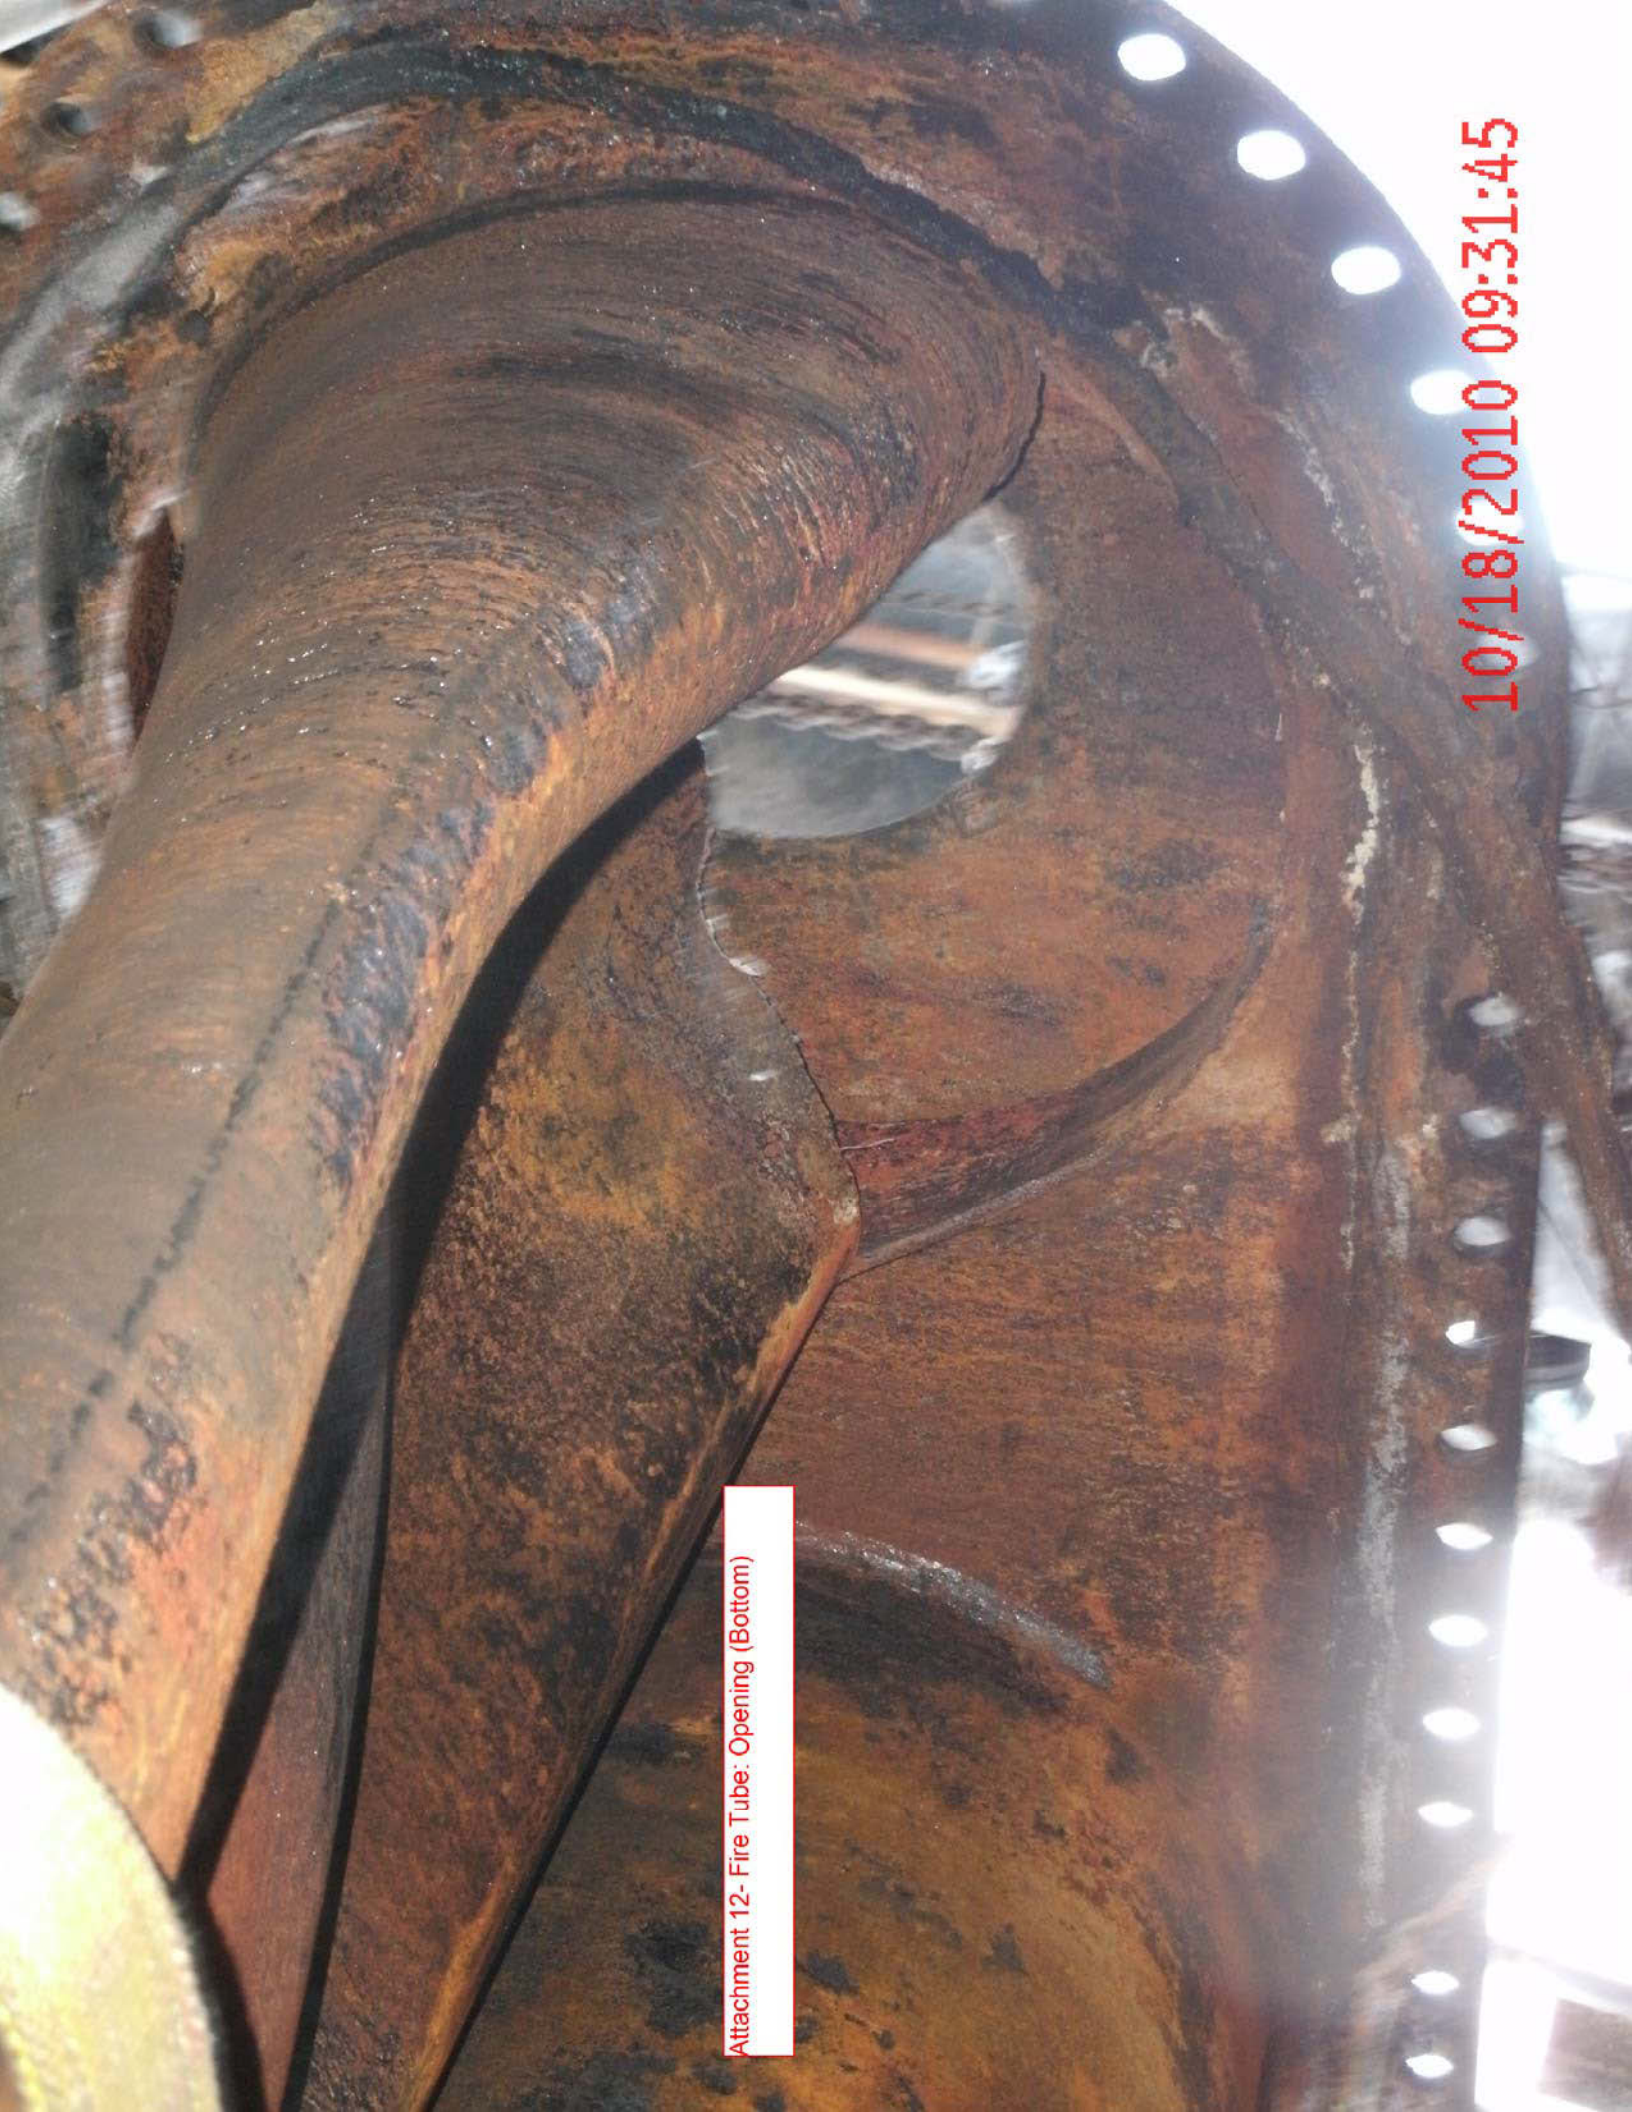
Attachment 11 - Tube Turn Crack

Significantly, the lead operator corroborated Contractor #2’s account that there was a crack in the fire tube in 2006, and that Heater-Treater experienced temperature spikes in 2006 and 2009. In particular, he stated that when the temperature inside of the Heater-Treater got too high, the crew would have to “cut it off.”²⁴ In addition, the lead operator acknowledged that as recently as January 2009 Contractor #2 warned the company that there was too little oil production for the Heater-Treater, and that this caused the Heater-Treater to experience frequent temperature spikes. The lead operator claimed, however, that when the A-20 well was brought online in January 2009, the temperature-related malfunctions ceased. The lead operator claimed that there were no other temperature-related issues with the Heater-Treater after 2009.
