Bureau of
Safety and
Environmental
Enforcement

QC-FIT EVALUATION OF FASTENER FAILURES- ADDENDUM

QC-FIT Report # 2016-04
February 2016

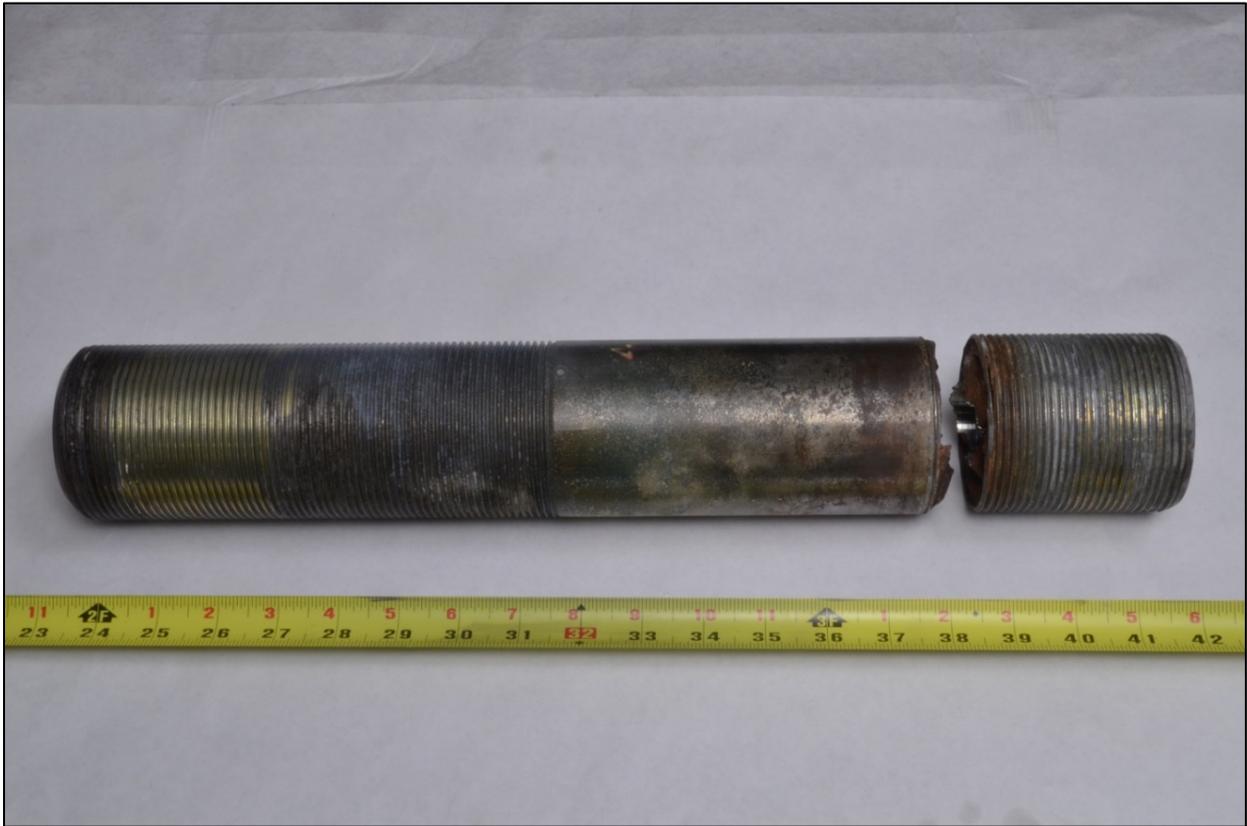
The hydraulic connector (HC), which is located in between the lower marine riser package (LMRP) and lower blowout preventer (LBOP), secures the LMRP to the LBOP (Figure 1). The twenty fasteners on top of the HC (see Figure 2) secure the HC to the bottom of the upper annular in the LMRP, and nine of those the twenty fasteners on the HC failed (Figure 3). Eight of the failed fasteners fractured at the first engaged thread, located below the upper annular flange (see Figure 4). One fastener failed below the nut on the top of the upper annular flange.

Figure 3: Hydraulic connector sheared fastener

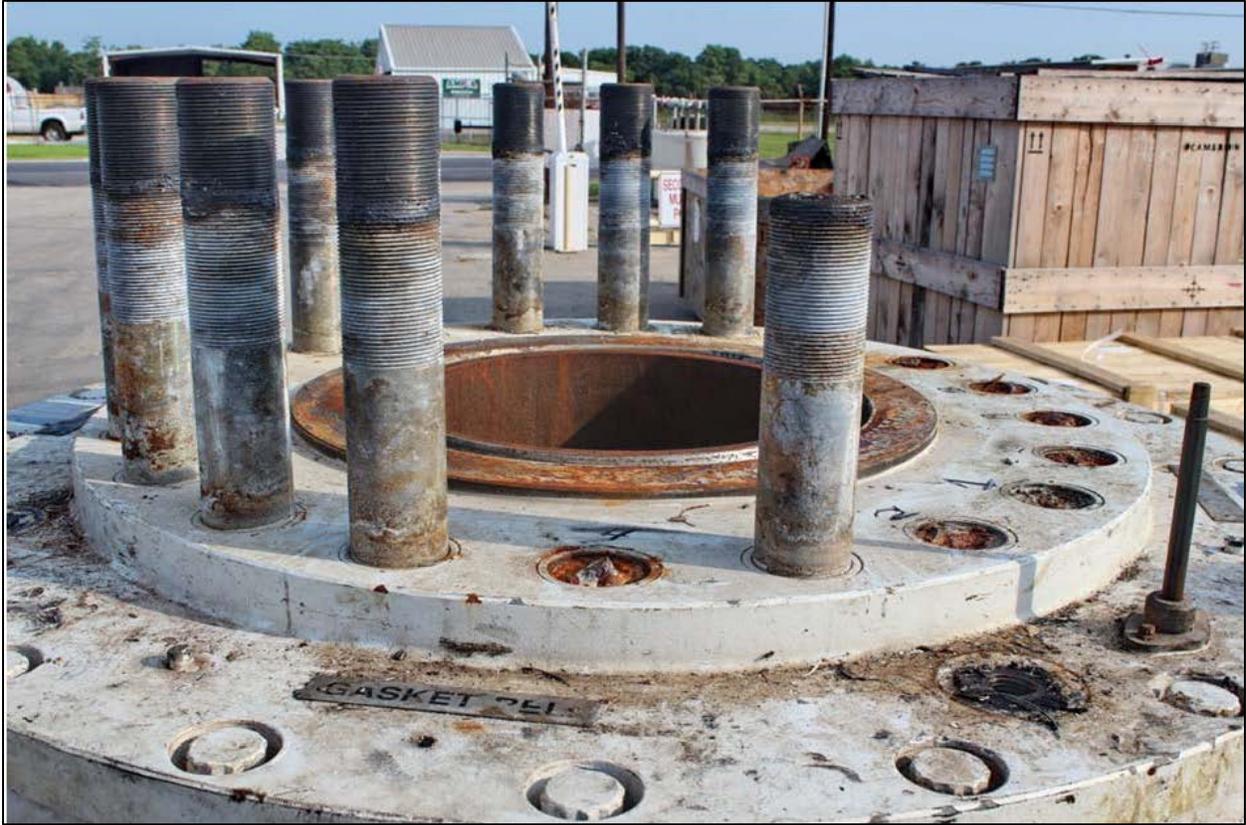
Figure 4: Hydraulic connector flange/fasteners showing failures and first engaged threads

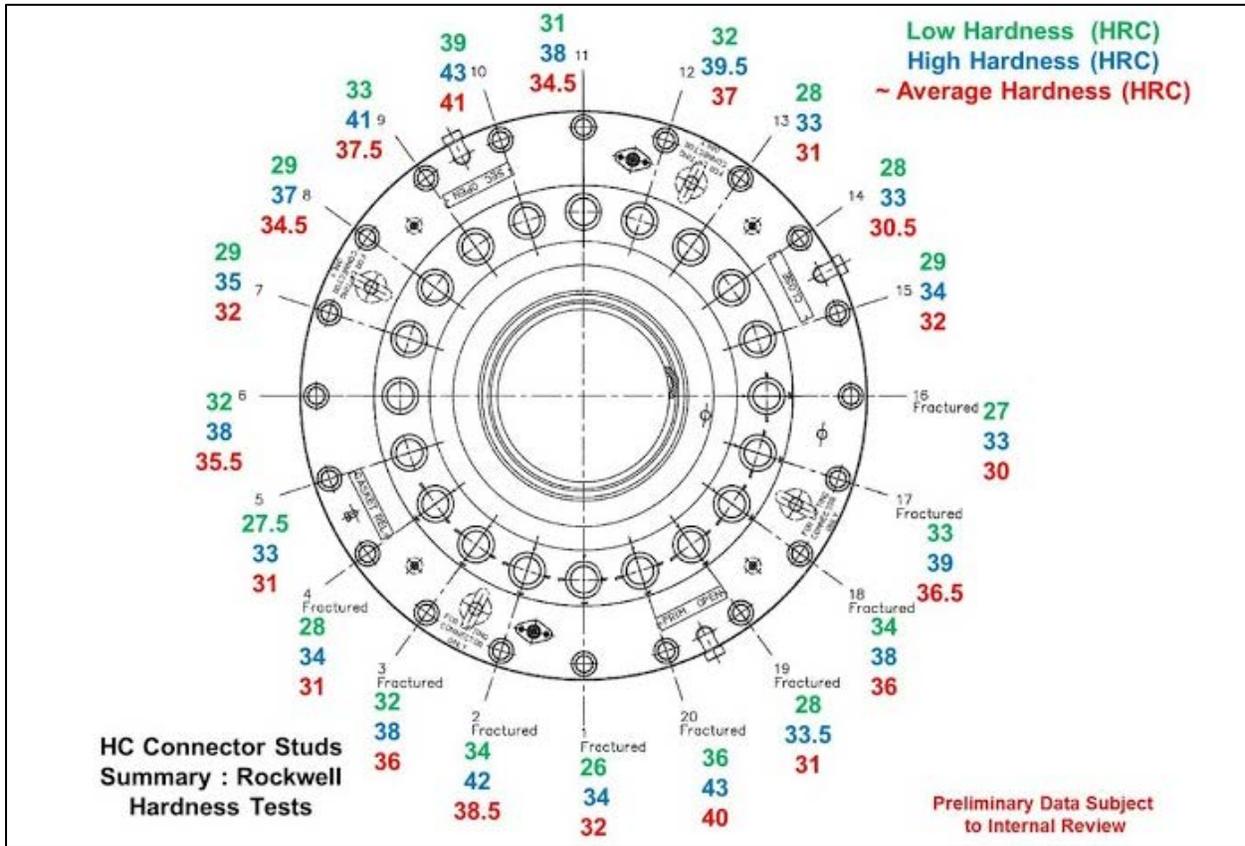
The OEM's material specification had specified HRC values with a range of 31-35 for these fasteners. Testing showed HRC values ranging from a minimum of 27 to a maximum of 41 (see Table 1). Four of the nine failed fasteners had average hardness values below 35 HRC and five of the nine failed fasteners had average hardness values above 35 HRC. Seven of the eleven intact fasteners had average hardness values below 35 HRC and four of the eleven intact fasteners had average hardness values above 35 HRC. The fastener flange location and correlating hardness values can be seen in Figure 5.

Note: BSEE has concerns with the use of fasteners with hardness values exceeding 34 HRC in subsea applications as it increases their susceptibility to EAC.

Figure 5: Fracture location and corresponding Rockwell Hardness Values
