**Investigation of Pig Launcher Explosion,
Main Pass Block 41,
Gulf of Mexico,
Off the Louisiana Coast**

Frank Pausina
Leslie Monahan
Tom Perry
Carl Anderson

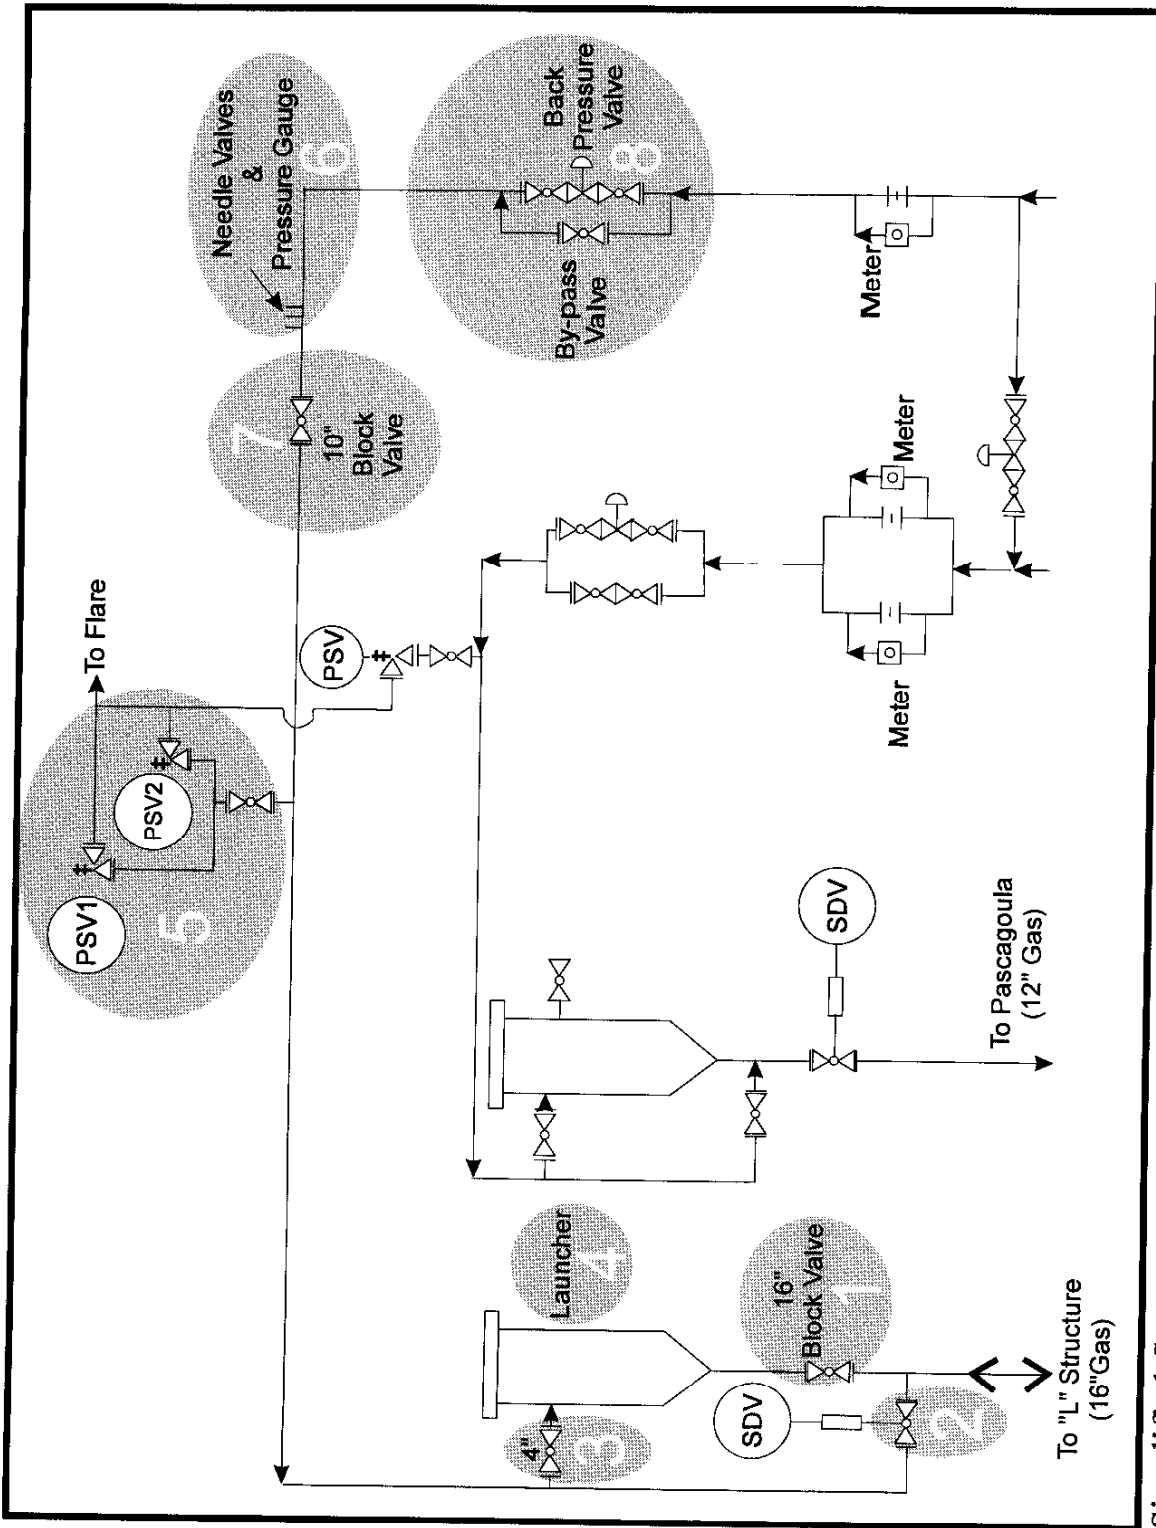
Simplified flow schematic for Main Pass Block 41 Platform B, 12- and 16-inch pipelines.

The flow schematic for Platform B at the time of the accident incorrectly showed a nonexisting pressure relief valve on the launcher barrel and also incorrectly showed the location of the SDV. Furthermore, the manufacturer's literature with respect to launcher closures that was available on the platform was for Peco closures. The literature states that a safety feature of the closure is that it cannot be opened under pressure. As previously stated, the launcher closure was a TUBE-TURN closure that clearly could be opened under pressure. However, there is no evidence that either Operator 1 or Operator 2 referenced any literature prior to the accident.

One method is through the ½-inch needle valves (See Attachment 2, shaded area 6). This is not a very practical method in that it would require a needlessly excessive amount of time to accomplish the task.

Another method is through the pressure safety valves (PSV) (See Attachment 2, shaded area 5). The PSV's allow the gas to flow to an underwater flare, thereby venting the gas to the atmosphere at a safe distance from the platform. This method can reasonably be expected to require approximately four to five hours to blow down the pipeline. A potential problem associated with this method is the cutting of the PSV seats, resulting in their inability to reseal properly. This can, however, be avoided by using a spool piece. In 1993, the launcher was isolated and blown down successfully, and the 16-inch pipeline was blown down through the PSV's using a spool piece.

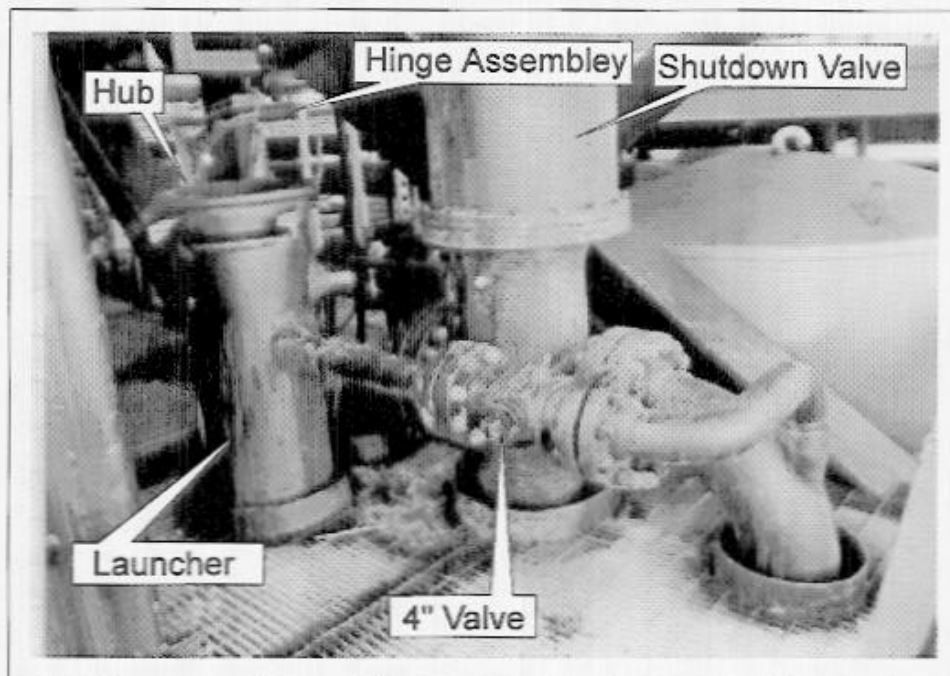
Pig launcher after the accident.

Launcher and Piping The 16-inch gas pipeline from Platform B to Platform L is connected to a vertically oriented pig launcher on Platform B. (For a simplified schematic of the launcher and the associated platform piping and relevant devices, see Attachment 2.) Just below the launcher (Attachment 2, shaded area 4) is a 16-inch block valve (Attachment 2, shaded area 1). Gas from the platform flows through 10-inch piping into the pipeline at a point below the block valve. Connecting the piping to the launcher is a 4-inch kicker valve (Attachment 2, shaded area 3). The 10-inch piping is fitted with an automatically actuated shut-down valve (SDV) (Attachment 2, shaded area 2). (For a picture of the launcher after the accident, see Attachment 3.)

At the time of the accident the launcher was not equipped with either a pressure gauge or pressure relief valve. When the launcher was installed in 1969, a vent valve was installed on the barrel for pressure bleed-off purposes. However, during an upgrading operation in 1991, the valve was removed and capped. Subsequently, three operators

The subject launcher is the only launcher/receiver on Platform B that was not fitted with a pressure relief valve and pressure gauge. The absence of these devices required the tracing of the piping on Platform B in order to blow down the launcher prior to opening the launcher closure lid of the 16-inch pipeline.

The deaths of the two Chevron operators were the result of Operator 2's attempt to open the launcher closure lid while the launcher contained gas that was pressurized to 1,020 psi. The findings indicate that, as one of the yoke bolts was turned at most two full turns, the yoke containment of the lid was lessened to the degree that the lid broke free of the containment, was torn from the hinge, and then propelled through the overhead deck. The resultant sudden release of the pressurized gas, which was isolated in the launcher by the previously mentioned 4-inch and 16-inch valves, caused the injuries to the operators, which resulted in their deaths.

1. That all pig launcher/receivers be fitted with a pressure relief valve and pressure gauge, and
2. That pig launcher/receivers be used to blow down pipelines only if no other practical method exists, a safety analysis of the operation has been conducted, and resultant procedures are documented and reviewed prior to such an operation.

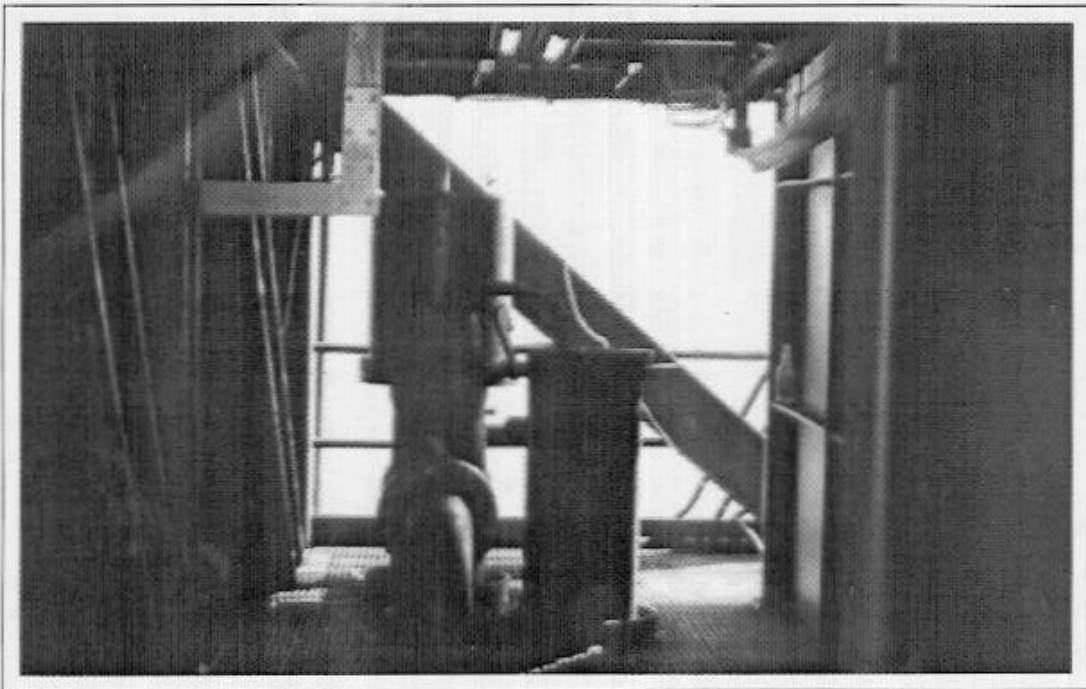
Pig launcher area.

The third method is to blow down the pipeline through the launcher. This is accomplished by first blowing down the launcher. The least hazardous way to blow down the launcher is to close the 16-inch block valve, the SDV, and either the 10-inch block valve (See Attachment 2, shaded area 7) or the back pressure valve (See Attachment 2, shaded area 8) and then open the 4-inch kicker valve and blow down the launcher through the PSV's or the needle valves. The most hazardous way to blow down the launcher is to slightly open or crack the closure lid by an amount that would allow the pressurized gas to escape in a controlled manner. After the launcher is depressurized, the 4-inch valve is closed and the launcher closure lid is completely opened. At this point the pipeline may be blown down through the launcher by cracking the 16-inch block valve or by opening the SDV and cracking the 4-inch valve. In this method the time to blow down the pipeline is reduced substantially; however, gas is released on the platform itself and in a relatively confined area. (For a picture of the confined launcher area, see Attachment 6.)

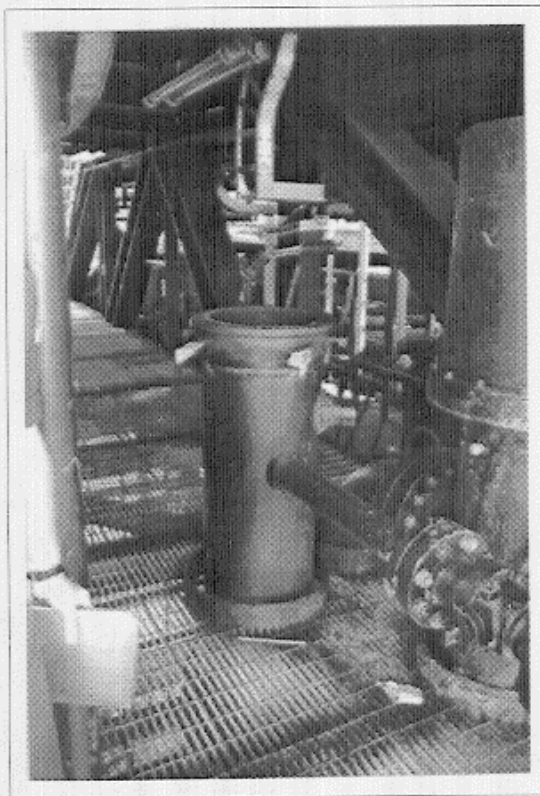
Attachment 7

The closure lid, which was torn off its hinge assembly by an explosion, penetrated the ¼-inch steel deck above the launcher area, penetrated the bottom of the well control panel, which shut in the only producing well on the platform, exited the back of the panel, and then came to rest approximately one foot from the panel. (For pictures of the lid and associated damage, see Attachments 7 and 8.)

Pig launcher and torn hinge.

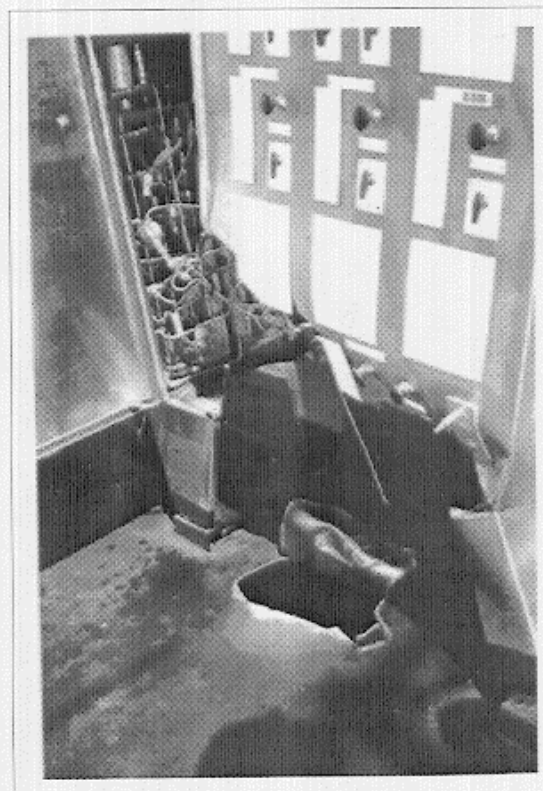
Damaged deck and well control panel above the launcher area.

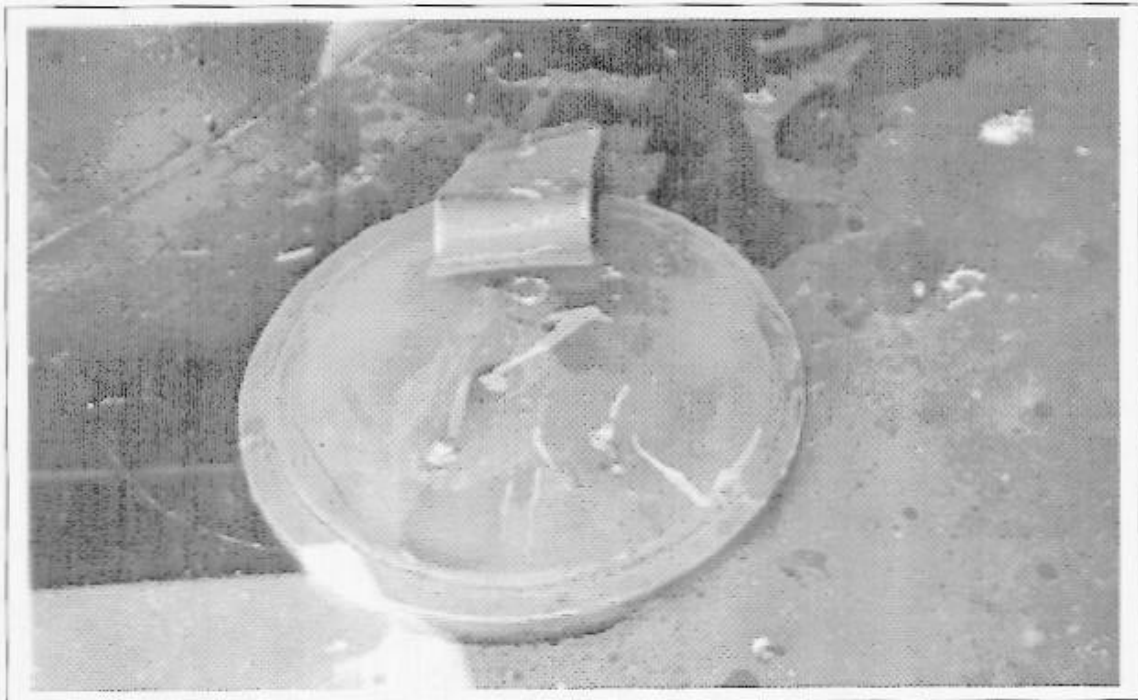
Attachment 8

Furthermore, the accident investigation panel's inspections of the launcher and conversations with the manufacturer of the launcher have resulted in no indication that the explosion was the result of any material defect in the launcher closure.

TUBE-TURN closure lid and twisted hinge arm.
