Investigation of November 12, 2016 Fire with Multiple Injuries

Lease OCS-30206, Grand Isle Area-Block 115

**Gulf of Mexico Region, New Orleans District
Off Louisiana Coast**

August 29, 2018

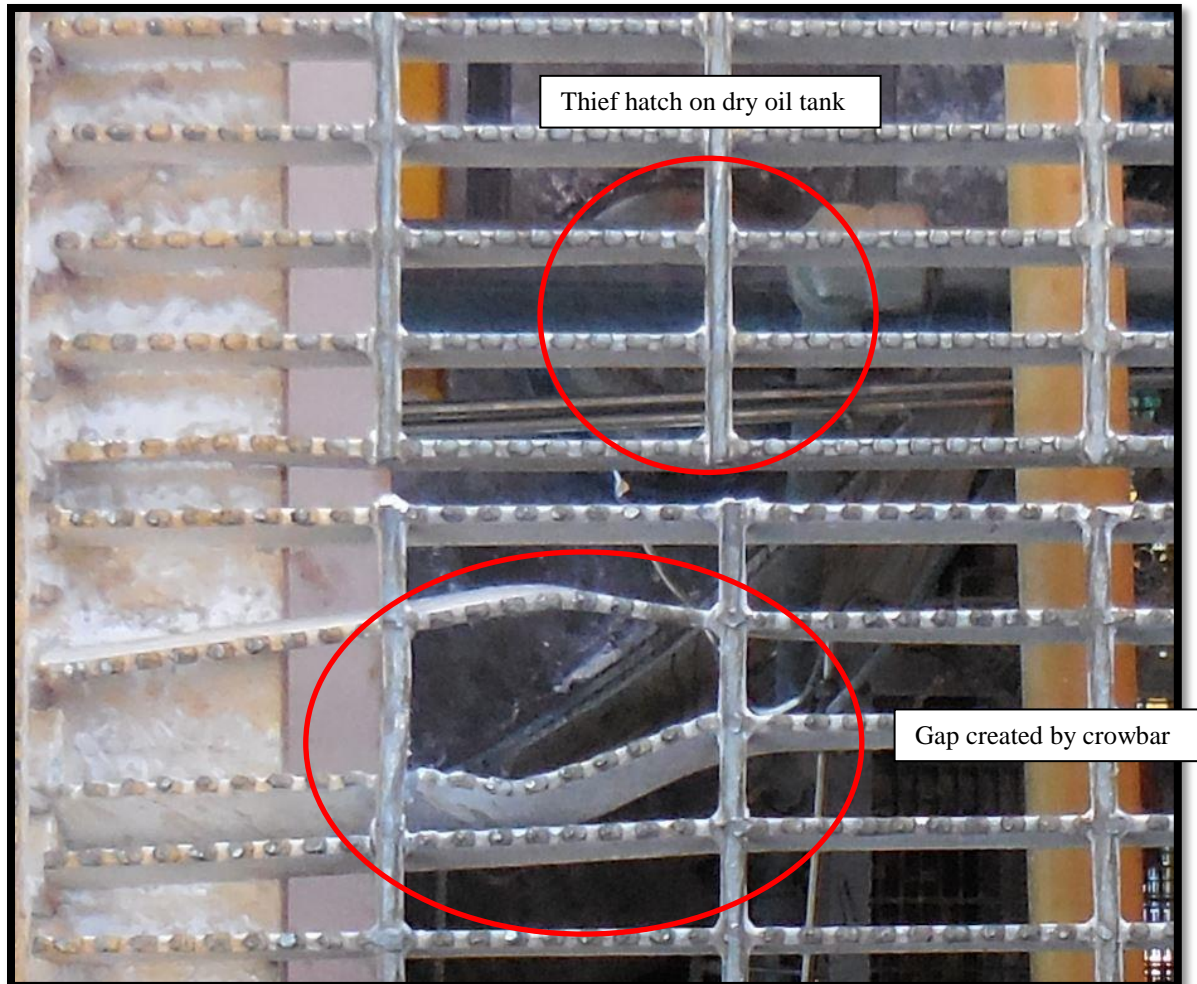
Figure 14: Gap in Grating Near Heater Treater

heater treater flame arrestors, which would eliminate the possibility of ignition due to metal-to-metal contact from the crowbar usage.

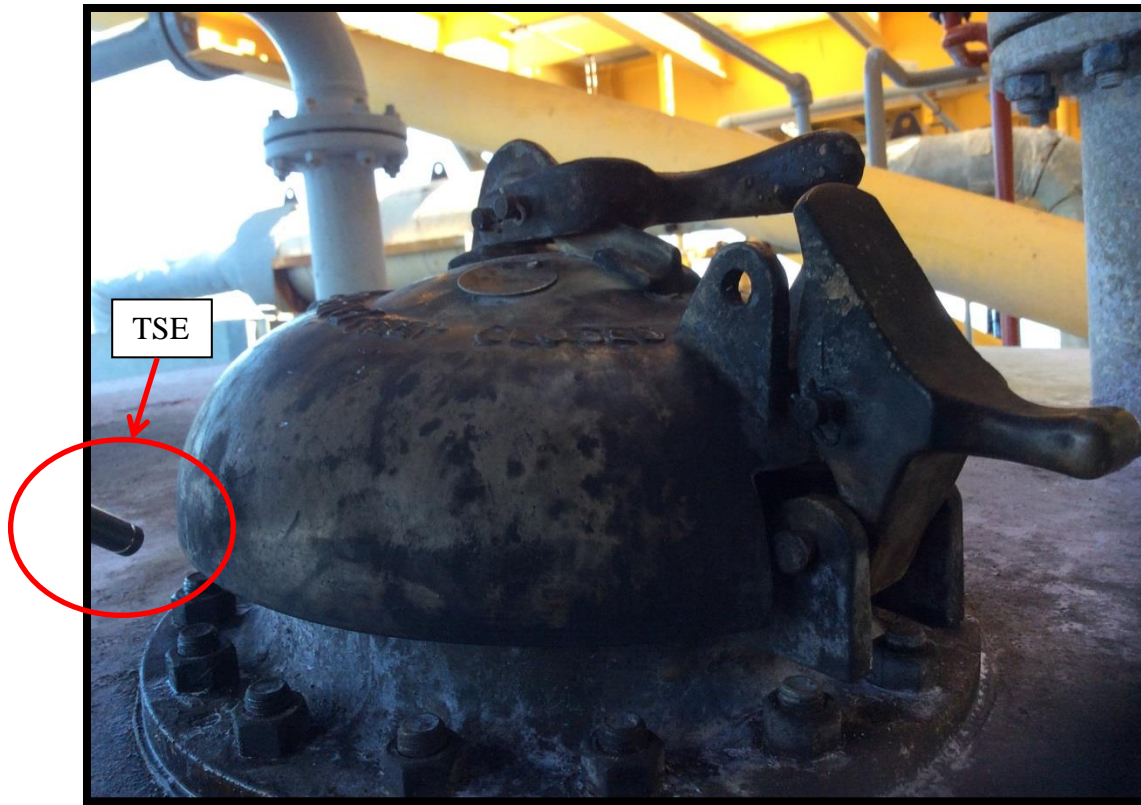
Figure 15: TSE Near Dry Oil Tank Thief Hatch

Another possibility for metal-to-metal contact was between a TSE and a thief hatch on top of the dry oil tank (*see Figure 15*), which LLOG identified as the most likely ignition source in their initial incident report. However, IP-2, stated that the thief hatch was open at the time of ignition. In that position, the hatch would not have been in contact with the TSE. This eliminates the possibility of metal-to-metal contact between the TSE and the thief hatch (#3 eliminated).

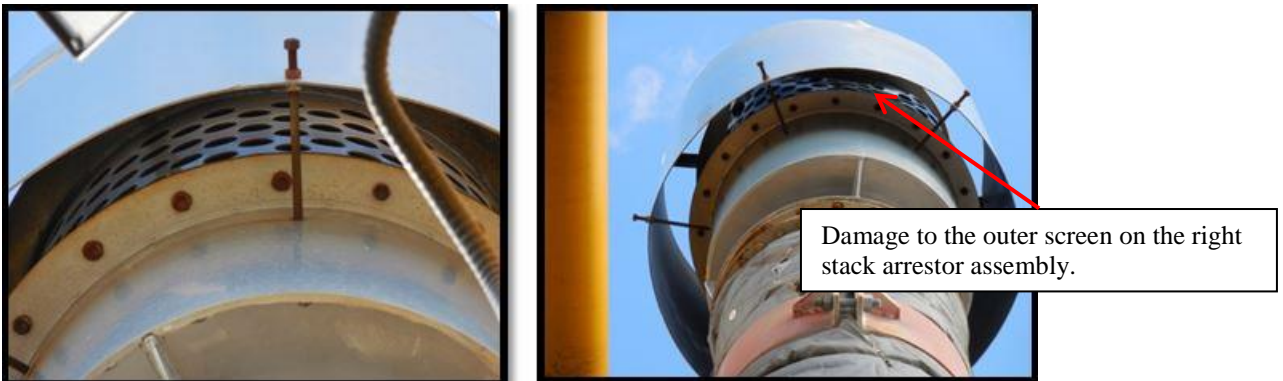
Figure 17: Comparison of Left and Right Stack Arrestor Assemblies

During the initial panel site visit to the platform on November 18, 2016, the panel members discovered damage to the right stack arrestor housing (*see Figure 17*). The external damage to the right stack arrestor housing prompted the panel to request an inspection of the flame arrestors and spark arrestors.

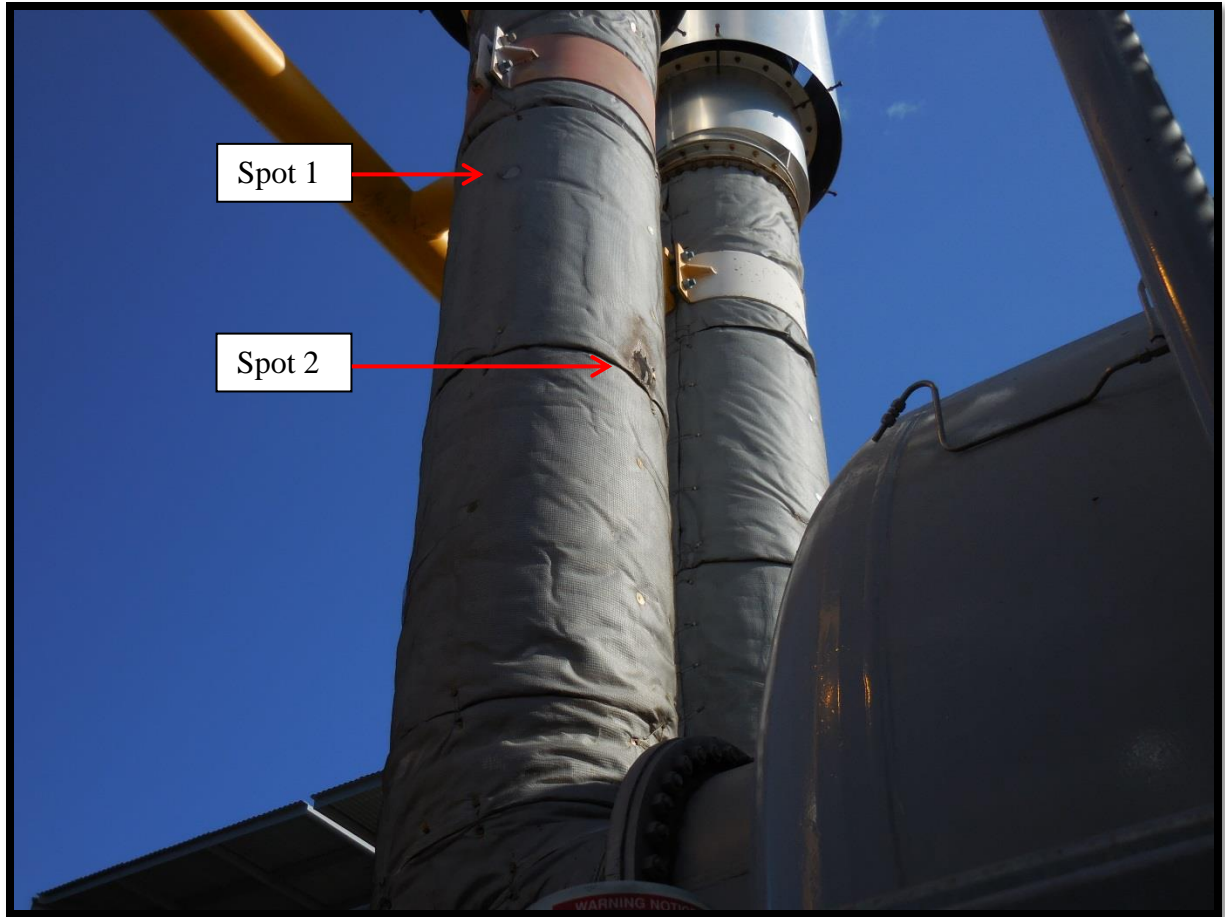
Figure 18: Heater Treater Stacks

The panel members also discovered exposed surfaces on the right stack due to insulation damage (*see Figure 18*). Spot 2 in Figure 18 shows possible heat damage to the insulation on the right stack, indicated by the appearance of charring.

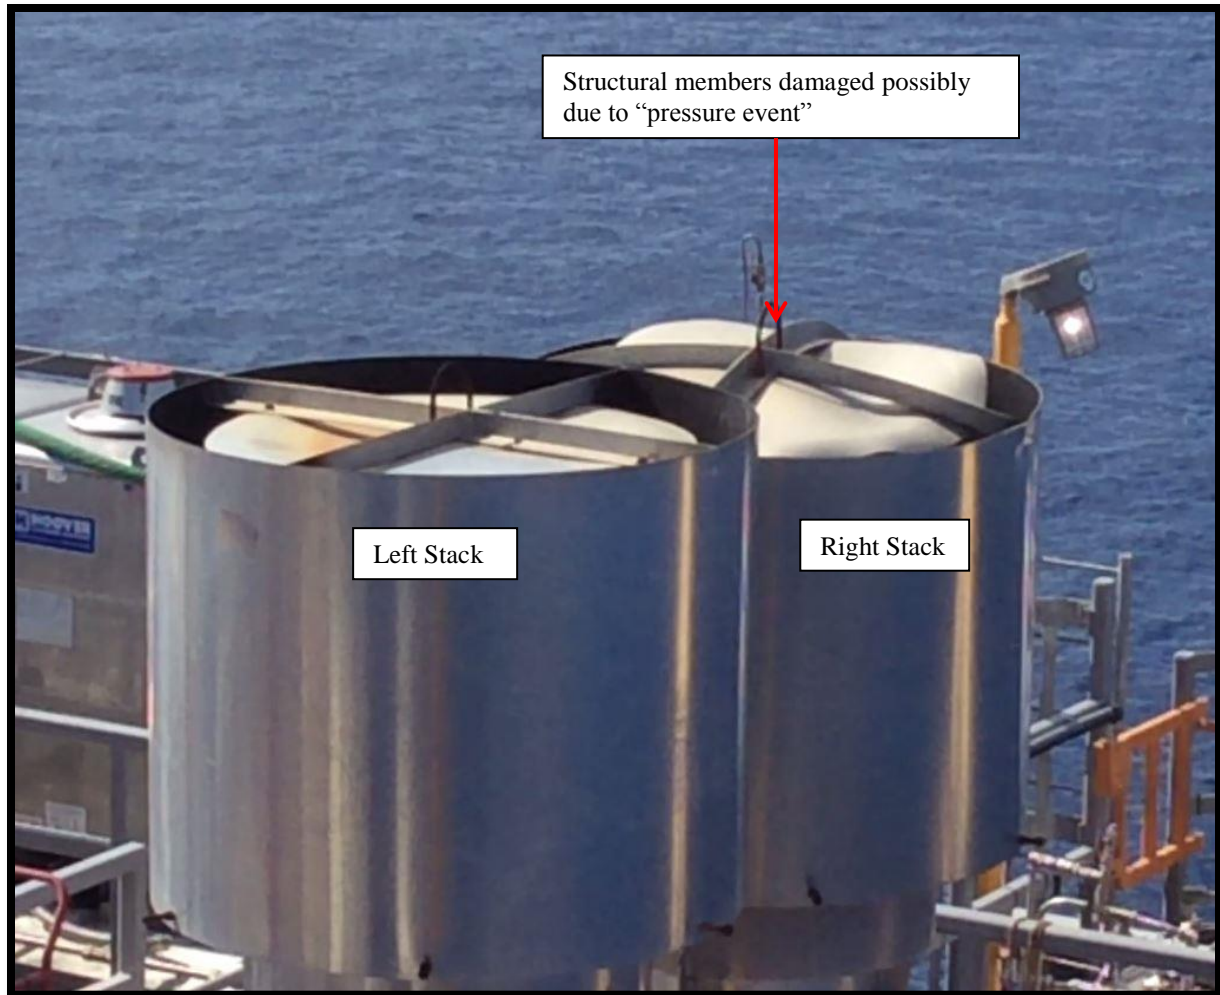
Figure 19: Stack Arrestor Housings

While conducting another site visit on November 22, 2016, panel members discovered further damage to the right stack arrestor housing (*see Figure 19*). The observed damage included an abnormal dome shape to the support braces on the top of the stack arrestor housing, deformation of the weather cap and indication that the entire housing assembly had deviated from its originally installed position. An LLOG employee stated that this may have been caused by a “pressure event” that occurred at some point prior to the incident, possibly in August 2016 but maybe as early as April or May 2016.

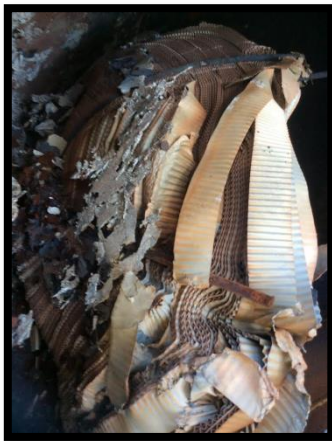
Figure 21: Right Stack Arrestor

During an inspection of the stack arrestors on December 12, 2016, the panel identified deformation of the right stack arrestor¹¹ supports and discovered that the stack arrestor was missing from the right exhaust stack (*see Figure 20*). There was visible damage to the right stack weather cap, which also serves as the stack arrestor housing. The left stack arrestor housing appeared to be undamaged. The damage to the right stack arrestor prompted the panel to request a third-party inspection of the fire tubes.

(see Figure 21). The left exhaust stack did have a spark arrestor intact, but there was significant heat damage to both the arrestor and the arrestor housing (see Figure 22). The initial survey of the damage by a BSEE engineer¹² suggests that the heater treater was exhausting at a temperature approaching or above the melting point of the aluminum that made up the housing and the arrestor. The arrestor manufacturer indicated that the stack arrestor and supports were made of the same aluminum alloy series, for which the onset of thermal deformation begins at approximately 700 degrees Fahrenheit. The published melting point of the aluminum alloy series is 1170 – 1210 degrees Fahrenheit. Both fire tubes appeared to be undamaged, with minimal deflection due to deformation.

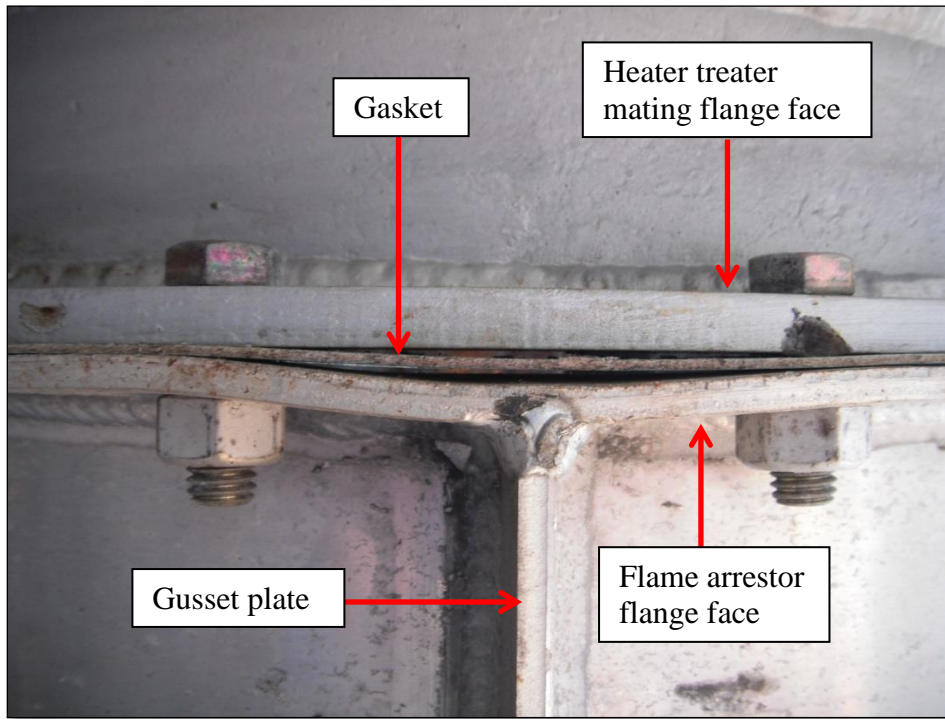
Figure 24: Gap in Heater Treater Fire Tube Flange

The gap was measured by a third-party fire investigator at approximately 4 inches in length and opened approximately 1/4 inch at the greatest opening, with daylight visible through the gap after removal of the flame arrestor. It was noted that a minimum gap of 1/16 of an inch in the gasket or within the flame arrestor could create a flame path.

Figure 24 shows the mating flange connecting the left flame arrestor to the heater treater, viewed looking up from beneath the vessel. The flange face on the side of the heater treater is flat, whereas the flange face on the side of the flame arrestor is bowed between two adjacent bolts. The point where the gap is largest corresponds roughly to the point where a gusset plate is welded to the flame arrestor flange face.

- Consider conducting visual inspections of natural draft burners, ensuring airtight integrity between flame arrestors and fire tubes.
- Consider the use of a portable gas detector when operating in the vicinity of fired vessels.
