Investigation of May 11, 2016, Shell Glider Subsea Jumper Leak, Lease OCS-G15565, Green Canyon Block 248 Subsea Well #4

Gulf of Mexico Region, Houma District
Off Louisiana Coast

March 9, 2018

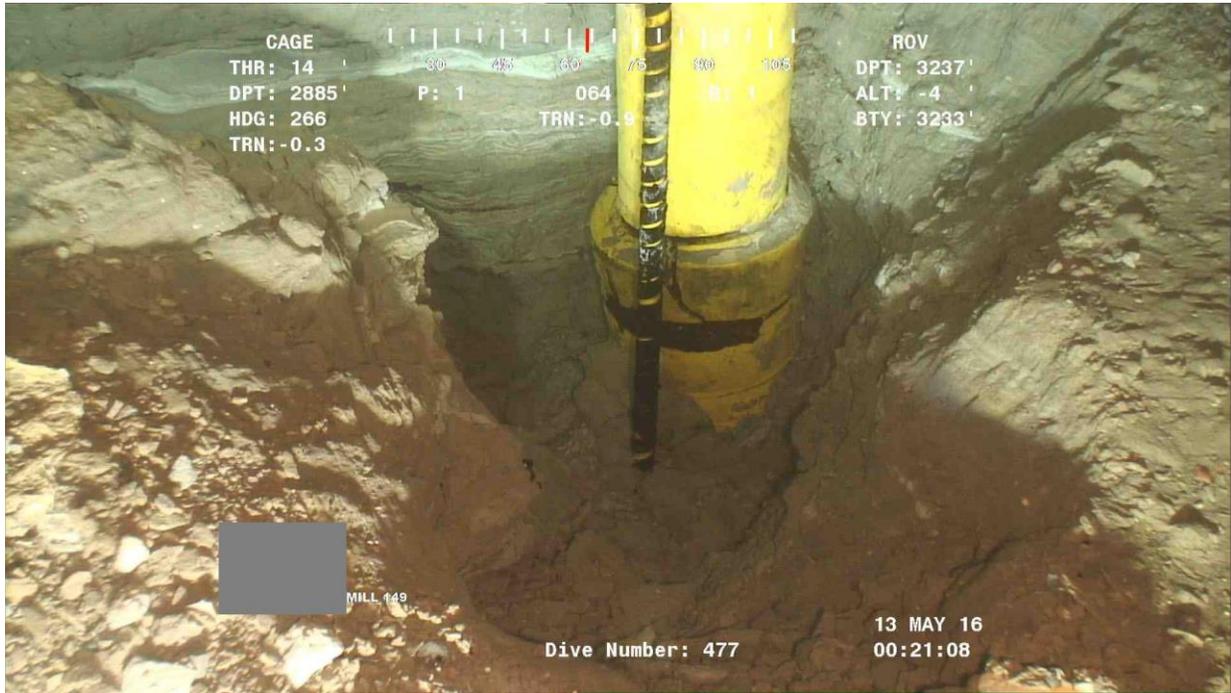
Figure 1 Glider #4 Well Side Jumper and Load Limiting Joint

On May 12, 2016 at 11:35, Shell notified BSEE of the incident. On the evening of May 12, 2016, Shell enacted their inspection procedure and a remotely operated vehicle (ROV) was called into the field to visually inspect for a leak in the Glider subsea system. Just after midnight on May 13, 2016, a crack was located on the Glider subsea well (SSW) #4 jumper below the mudline (Figure 1). The estimated volume associated with this leak was 1,926 bbls of oil.

Stress Engineering was contracted by Shell to perform evidence preservation and failure analysis of the Glider SSW #4 jumper. Stress concluded and BSEE agreed, the failure was a result of a ductile tensile overload fracture of the load limiting joint (LLJ) on the subsea jumper. After reviewing all available documentation, the BSEE investigation concluded the ductile tensile overload was caused by the burial of the subsea jumper and sled #2. This burial caused additional stress to the Glider # 4 jumper that was not accounted for in the jumpers design (Figure 2). This stress included the sled #2 settling further than anticipated and the partial burial of the Glider #4 jumper. This allowed additional stress impact the LLJ

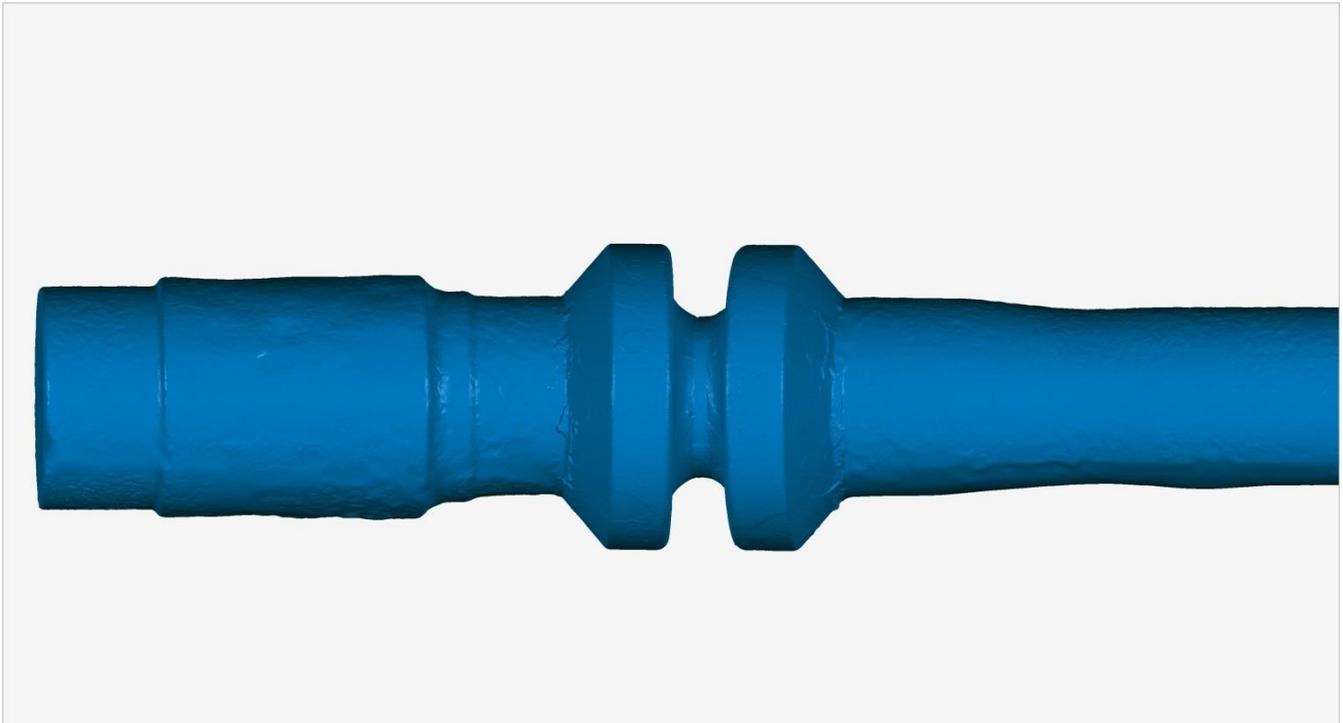
Figure 5 Load Limiting Joint

The LLJ is located on the vertical portion of the jumper nearest to the well (Figure 5). It is an engineered weak section in the jumper so that the jumper will fail in a known way if overstressed. This section prevents the possibility of transferring unwanted loads to the SSW in an overstress event such as an anchor drag from a mobile offshore drilling unit, also known as a MODU.

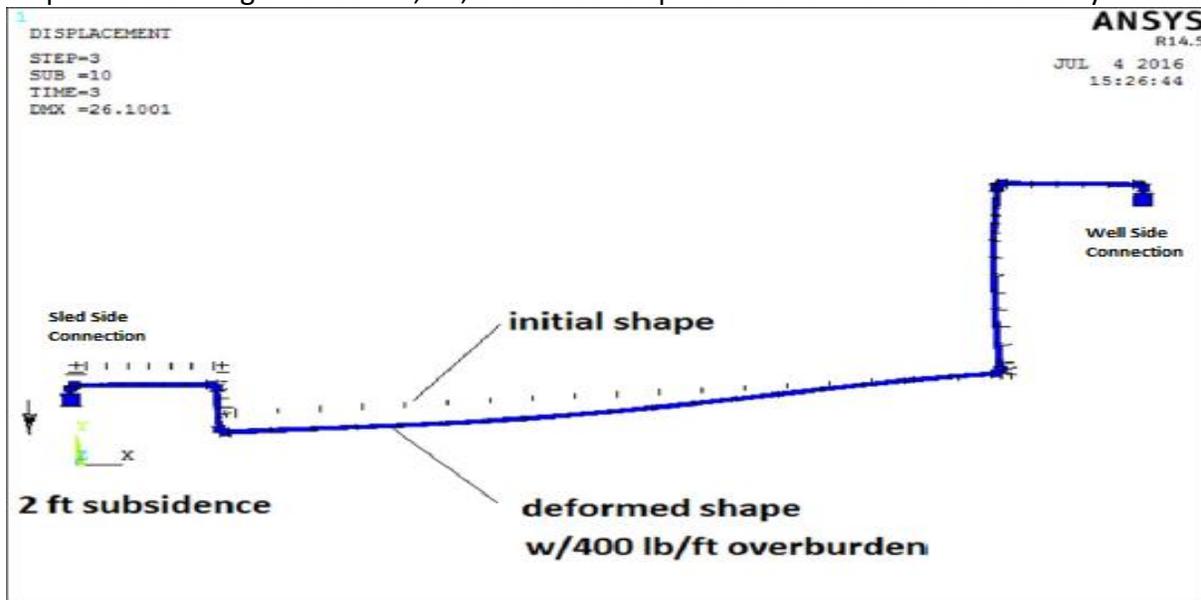
Figure 6 Deformed Shape of the Jumper

Metallurgical testing revealed no manufacturing defects or anomalies with the jumper line and LLJ. The LLJ failure was a result of a ductile tensile overload fracture from bending loads imposed on the jumper and LLJ (Figure 6). The source of these bending loads was produced by drill cuttings and excess cement which had covered the jumper line, sled #2, and LLJ. These cuttings and excess cement were deposited by the open hole drilling of Glider #6, #7, and #8 development wells in late 2013 and early 2014.

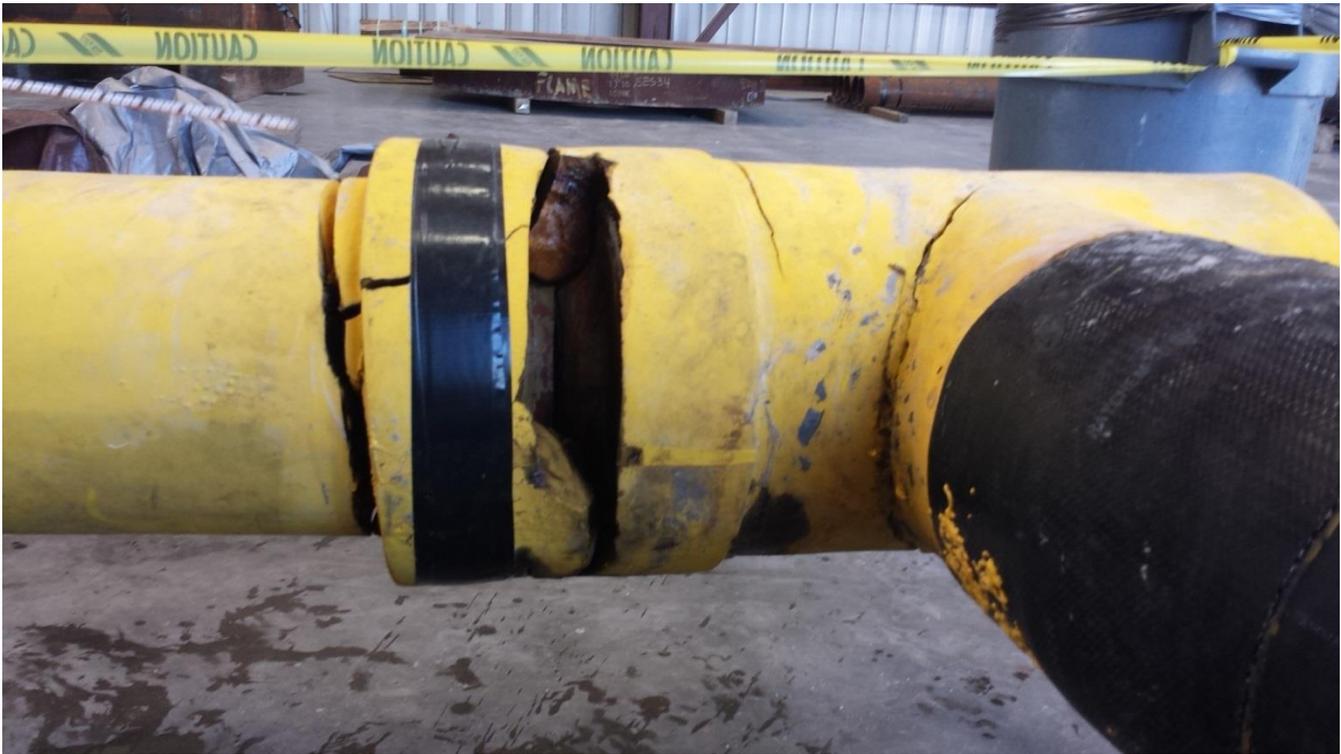
Figure 7 Load Limiting Joint Fracture

Since the only identified cracks were located at the designed "weak-link" U-Groove of the LLJ, the metallurgical failure testing and analysis focused on the LLJ fracture (Figure 7). The following metallurgical tests and analyses were performed on the LLJ:

Based on visual inspection, optical, SEM examination and metallurgical testing of the LLJ and jumpers, it appears that the fracture in the LLJ responsible for the Glider GL-4 leak was a result of bending tensile loads imposed on the jumper and LLJ system due to the deposited soil, cement, and drill cuttings. Further, BSEE and Stress concluded, the vertical tree-to horizontal jumper and 90-degree connection/elbow was subjected to a bending moment caused by the overload which resulted in an attempt to straighten the elbow (90 degree connection). The bending moment placed the inside of the elbow in tension with the outside of the elbow in compression. As a result of the overload, the tension side of the LLJ fractured in response to the applied moment. The ductile fracture LLJ occurred at the designed “weak link” U-groove joint failure location (weakest joint). The ductile fracture, most likely due to bending loads imposed on the jumper and the LLJ system.

The tension side (inside the 90-degree elbow) of the LLJ U-groove fractured in response to the applied moment due to overload likely from the drill cuttings. While the compression side of the U-groove did

not fracture. There was an increase in the wall thickness of the U-groove due to the applied moment to the jumpers. Therefore, forensic metallurgical analysis confirmed the fracture morphology was primarily due to ductile tensile overload of the LLJ.

Based on BSEE's investigation and all available data, BSEE concluded that the loss of containment in the Glider subsea system was caused by the ductile tensile overload fracture of the LLJ of the Glider #4 jumper. The ductile tensile overload fracture was caused by the bending loads imposed as a result of the partial burial of the Glider #4 jumper and subsequent subsidence of the subsea sled #2 (ref figure 7).

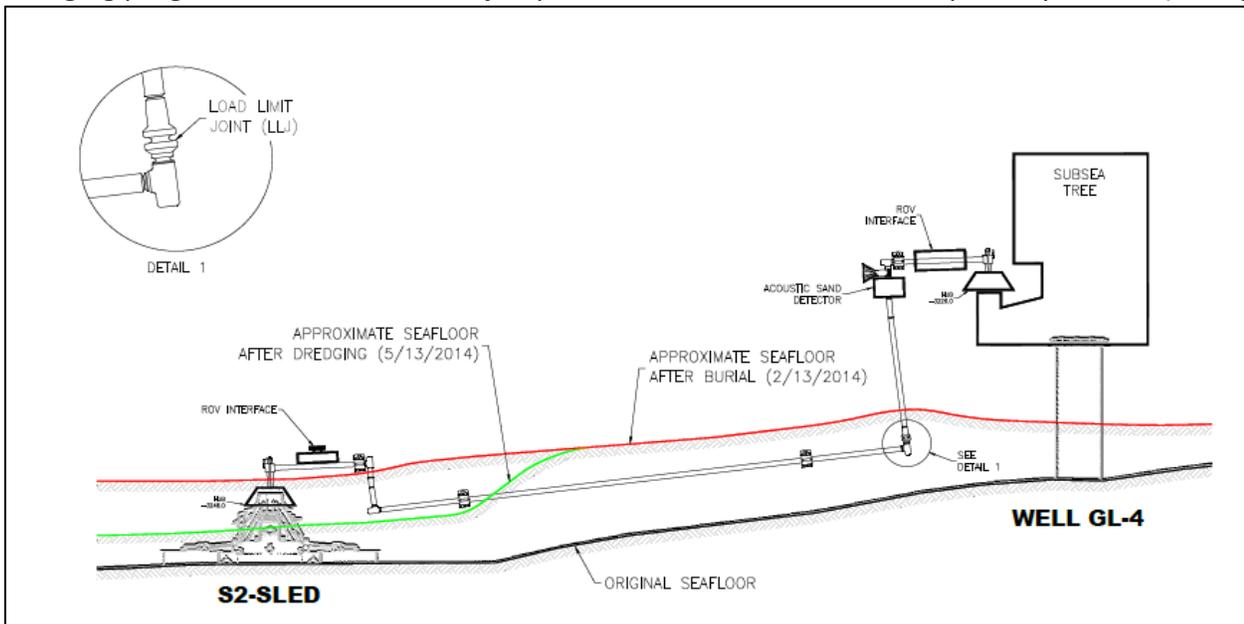
Figure 8 Jumper Line Pre and Post Dredging

Shell performed a risk assessment to identify hazards associated with the burial of the Glider subsea components. Based on Shell’s risk assessment, three phases of dredging were implemented that spanned across 19 months. Dredging was performed to allow for access to all controls and valves, visual inspection of equipment, and monitoring of cathodic protection. At the conclusion of the dredging program, the Glider well #4 jumper to include the LLJ remained partially buried. (Ref figure 8)

BSEE’s investigation revealed that the drawings of the Glider #4 jumper used in Shell’s risk assessment did not show the LLJ. The LLJ was shown on structural drawings of the Glider #4 jumper, but not the piping instrumentation drawings Shell used for the risk assessment. This risk assessment did not consider structural integrity as a potential risk; therefore, the structural drawings were not reviewed. Post incident analysis shows that even if Shell had not used the LLJ, the additional settlement and overburden over time may have eventually caused the jumper to fail at the next weakest point.

Based on BSEE's investigation and all available data, the Panel recommends that when it is discovered by the operator that environmental factors have changed (i.e. equipment has become buried) an engineering assessment should be performed to ensure equipment is operating inside acceptable design parameters. Additionally, notifications should be made to appropriate regulatory authorities.

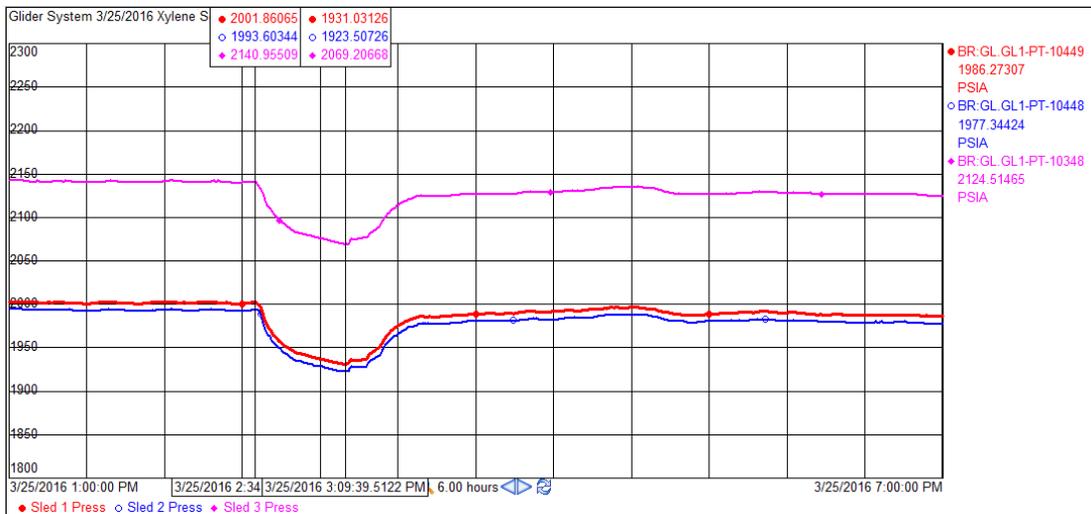
Figure 9 Glider Subsea Systems Processing a Slug

Documents provided by Shell (ref figure 9 and figure 10) show the difference between a slug working its way through the Glider subsea system and the rupture which happened May 11, 2016. In figure 9, it is noticeable when the subsea pressure for sleds #1, #2, and #3 drop between 50 and 100 psi due to a slug. It is also noticeable when the slug leaves the system and return to normal operating pressure occurs. Figure 10 shows a more dramatic pressure drop between 400 and 500 psi for sleds #1, #2, and #3. Additionally, in figure 10 there is almost no return to normal operating ranges as you see happen during a slugging issue in figure 9.
