**Investigation of December 2, 2017 Fatality
Petrobras 10000 Drillship
Lease OCS-16997, Walker Ridge Area Block 469**

**Gulf of Mexico Region, Houma District
Off Louisiana Coast**

Feb. 13, 2019

U.S. Department of the Interior Bureau of Safety and Environmental Enforcement

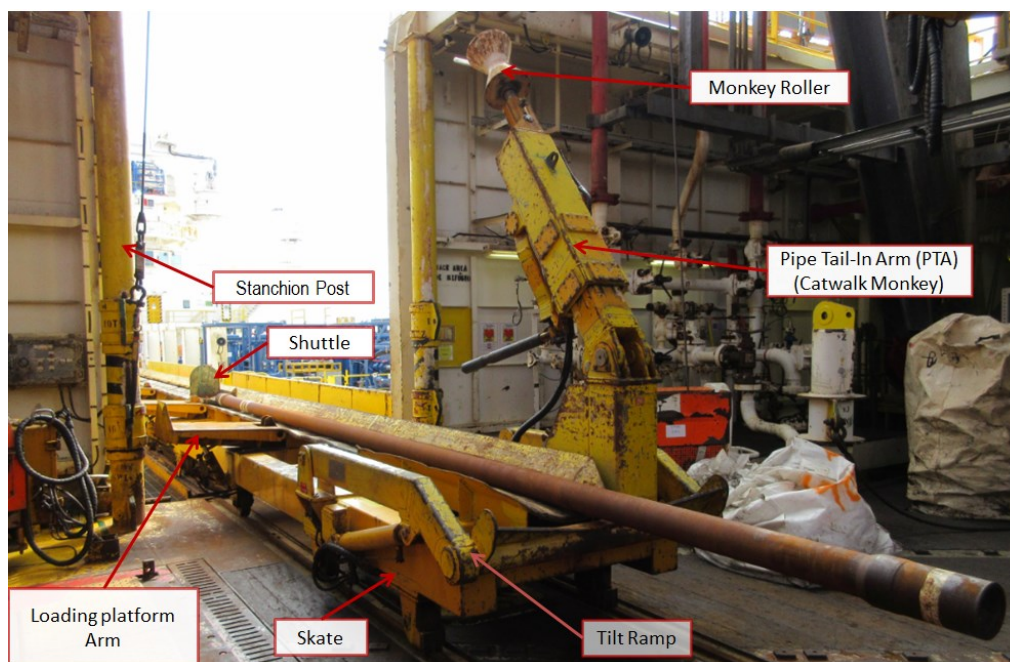
Figure 4: PBS 10K PHCM - post incident (BSEE photo)

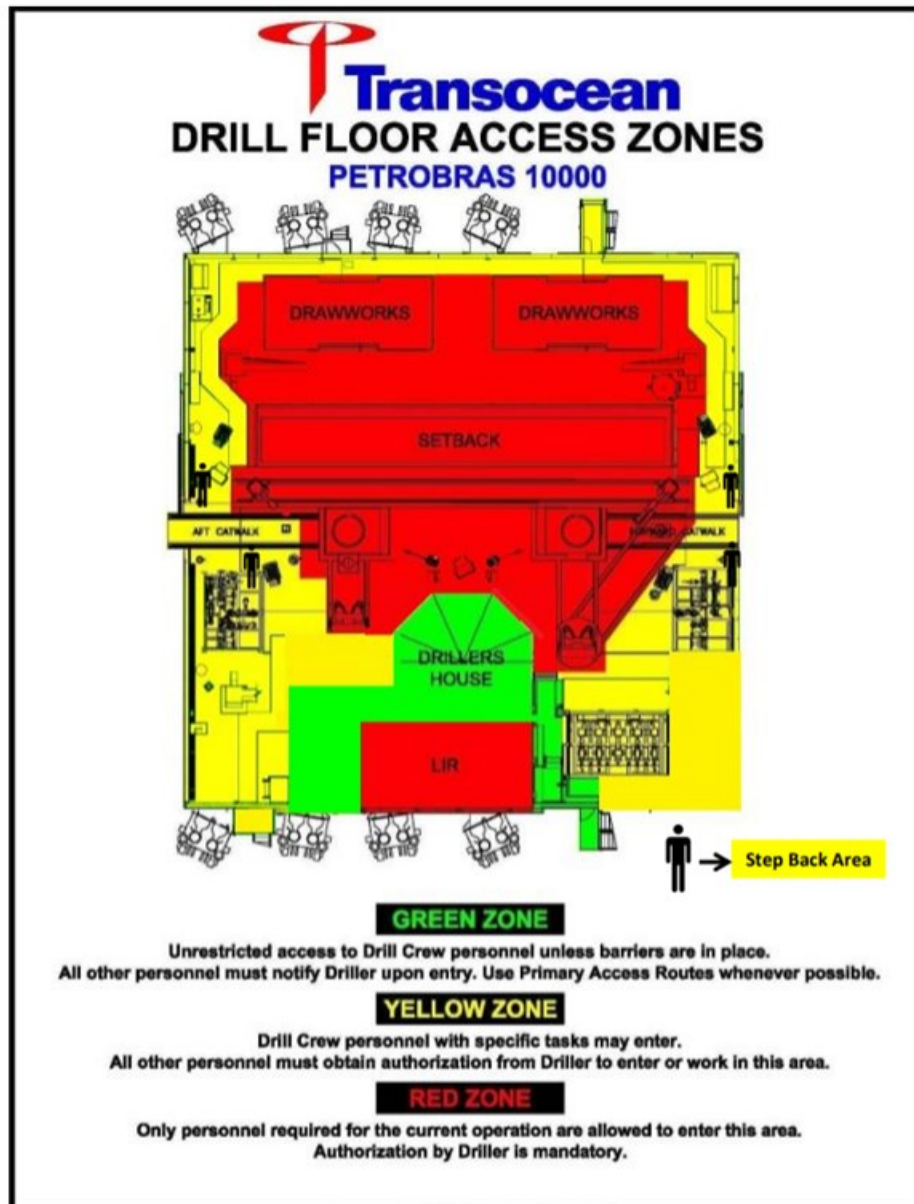
Figure 5: Drill Floor Access Zones diagram (posted on drill floor wind wall at time of incident)

The Drill Floor Access Zones diagram shown in Figure 5 was posted on the auxiliary drill floor wind wall at the time of the incident. The diagram differentiates zone areas to ensure controls are implemented to prevent incidents by restricting access to potentially hazardous zones. Personnel indicated this diagram was primarily utilized for protection from dropped objects. Figure 5 included a legend for the Step Back area, as discussed later in this report. At the time of the incident, the victim was in the yellow zone area based on this diagram.

¹ BSEE concluded the Drill Floor Access Zones diagram posted on the wind wall within 10 feet of the incident location was inadequate and misleading for routine drill floor operations such as picking up drill pipe. The subject diagram did not identify the area of convergence of the loading platform arms and the stanchion post or the entire path of the skate as a red zone. The diagram incorrectly indicated the victim was in the safe Step Back area at the time of the incident. Based on post incident interview accounts, the diagram was made primarily to protect personnel from dropped objects; yet nothing on the diagram indicated strictly dropped objects.

- Clarify the meaning and location of access zones with employees, in procedures and on diagrams.
- Ensure all personnel are trained on restricted access zones, including periodic refresher training, and know where they are supposed to be at all times during an activity.
- Incorporate a system to ensure the access zones are clearly marked on the surface of the drill floor, such as a schedule to evaluate paint wear or utilization of colored mats.

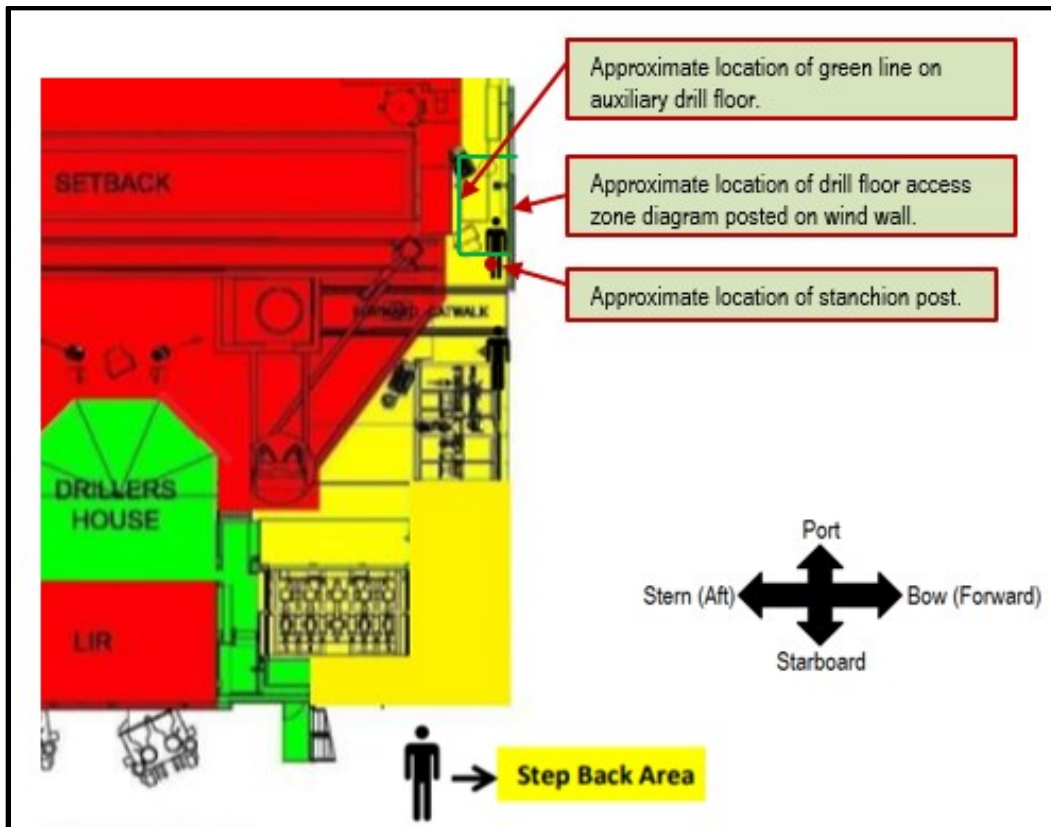
A small area within the yellow zone and located on the port side of the stanchion post was a rectangular box delineated by the wind wall and three faded green lines (see Figure 6). On the surface of the floor, inside these lines, were faded stenciled letters which read, “Step Back Area.” These words were also stenciled on the wind wall adjacent to the green box. Similar green lines and stencils were located on either side of the PHCM on both the auxiliary and main drill floors.

Figure 6: Drill Floor Access Zones diagram with approximate location of green line & stanchion post (BSEE illustration based on witness accounts and lines on actual drill floor)

As seen in figures 5 and 6, the location of the stanchion post, as well as a partial path of the skate, were both in a yellow zone and were not restricted to the requirements of the red zone. Also, the location of the

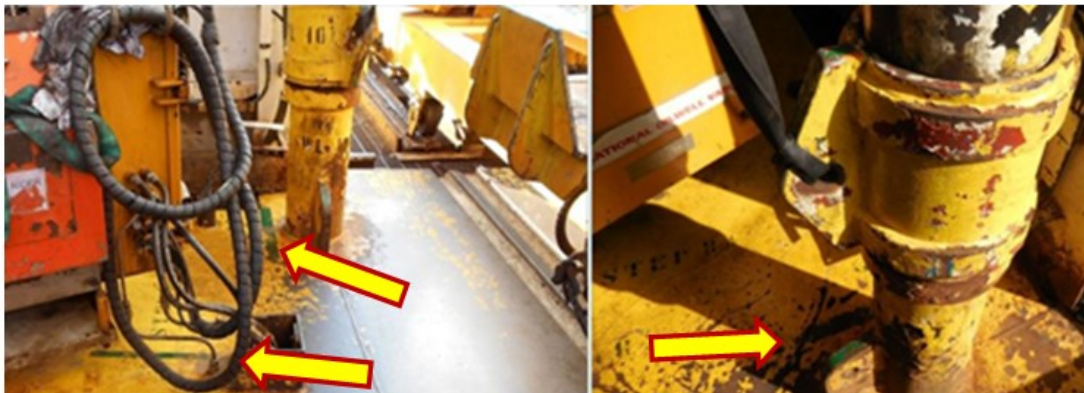
In general, interviews conducted by BSEE panel indicated that personnel on Drill Crew C had similar but not exact interpretations of where the Step Back area was located. Some said the Step Back area, or safe zone, was the area designated as yellow on the zone diagram (see Figure 5) or with yellow paint on the surface of the drill floor; including the skate operator. Others described it as the area behind the hoist and/or within the green lines on the surface of the drill floor (see Figure 6).

Figure 9: Green lines and Step Back area on drill floor (12/3/17 and 12/19/17)

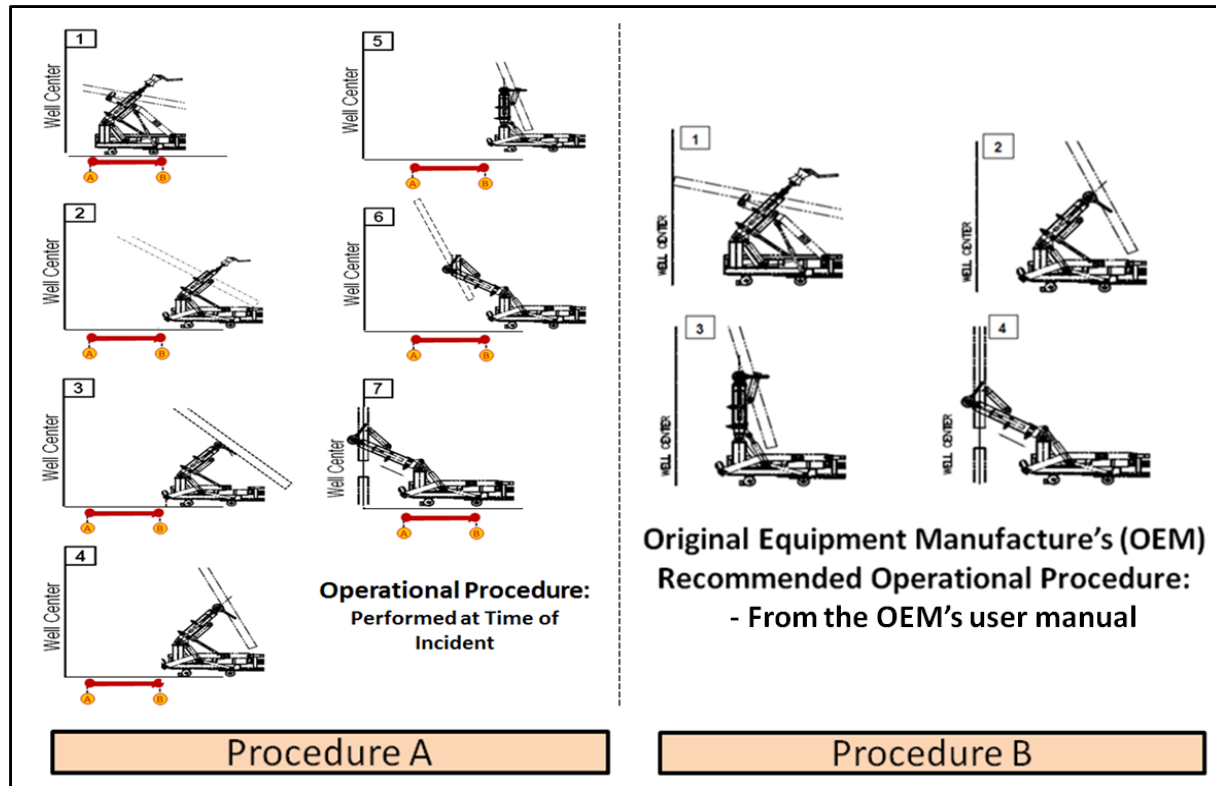
Figure 11: PHCM Operational Procedures (BSEE illustration using OEM user manual schematic)

The skate was reversed away from well center to the designated position and the TDS raised the DP vertically (See Figure 11 Procedure A step#2). The skate operator manipulated the PTA until the PTA roller was under the DP (See Figure 11 Procedure A step#3). The skate operator and driller worked together in manipulating the PTA arm and lifting the DP in order to: (1) lift up the DP pin end off the skate's shuttle and (2) guide the DP pin end in front of the skate (See Figure 11 Procedure A step#4, 5 & 6). With the DP pin end in the front of shuttle, the floorhands were then be able to remove the thread protector and dope the DP.

- Update procedures to include all steps necessary to complete the job. All steps should then be analyzed for hazards and the hazards subsequently mitigated. Deviations from procedures should be evaluated and considered for change management.
- Include safe locations to stand during the job steps in the procedures.

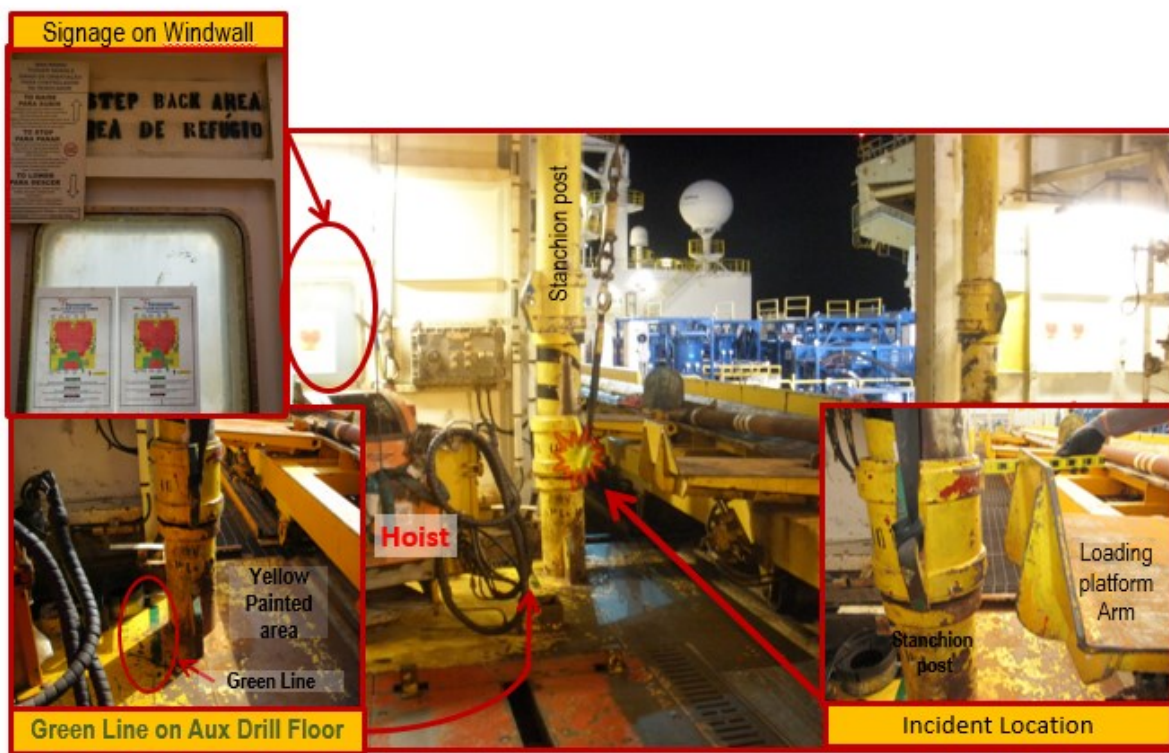
Figure 12: Auxiliary drill floor loading platform arm/ stanchion post proximity (floor hand view)

When the skate was moving, the skate's loading platform arm passed the stanchion post where the victim was located, creating a dangerous pinch point that had not been specifically identified by the drill crew. At the convergence of the loading platform arm and the stanchion post, there was approximately a three-inch clearance between the port side aux stanchion post and the skate's loading platform arm at the closest point. The skate was moved in reverse while the victim was in the strike zone of the previously unidentified pinch point (see figures 12, 13, 14, 16 & 17). No one on the drill crew proactively stopped the job. The victim, who was still facing away from the operation, was pinned between the stanchion post and the skate loading platform arm.

The panel identified a pinch point with only a three-inch clearance between the stanchion post and skate's loading platform arm, when the loading platform arm was extended and aligned with the stanchion post, also caused the incident. This pinch point hazard was unidentified by the drill crew and was without sufficient barriers to prevent entry to the pinch point. This was a hazardous location that was not adequately identified, mitigated or clearly marked as a hazardous zone. The pinch point hazard was not identified on any known official risk assessment.

- Alter the design of a skate to add more clearance to eliminate the hazard.
- Remove the pinch point (hazardous) area by relocating the stanchion posts.
- Add physical barriers (i.e. caution tape) around pinch point (hazardous) area.
- Add an audible alarm to moving equipment, especially the skate.
- Add an additional visual alarm (i.e. light) which would alert floorhands during skate movements.

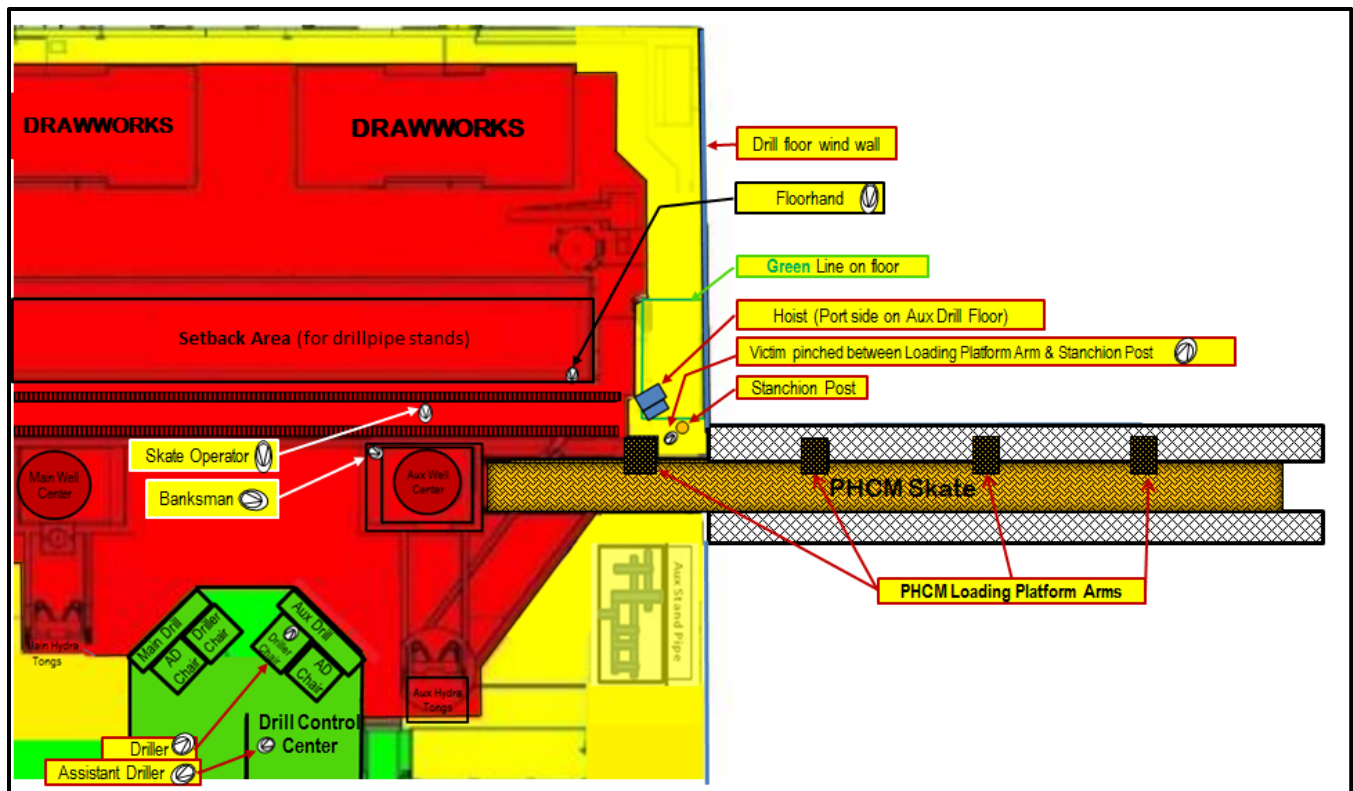
The elevators had just been latched to the box end of the DP and the TDS and PHCM were simultaneously being utilized to pick up the DP. The skate operator and banksman stood in the red zone in front of the skate as the elevators latched to the DP. The banksman used a hand signal to confirm the latch to the driller, and then began walking away from the auxiliary well center. The driller then began to raise the TDS elevators. While the elevators raised the DP vertically, the skate operator reversed the skate away from the auxiliary well center. He said he was looking up to ensure a proper elevator latch on the DP. The AD was standing behind his chair in the driller's shack.

Figure 13: Birds-eye view of approximate location of drill crew personnel at time of incident (BSEE Diagram)

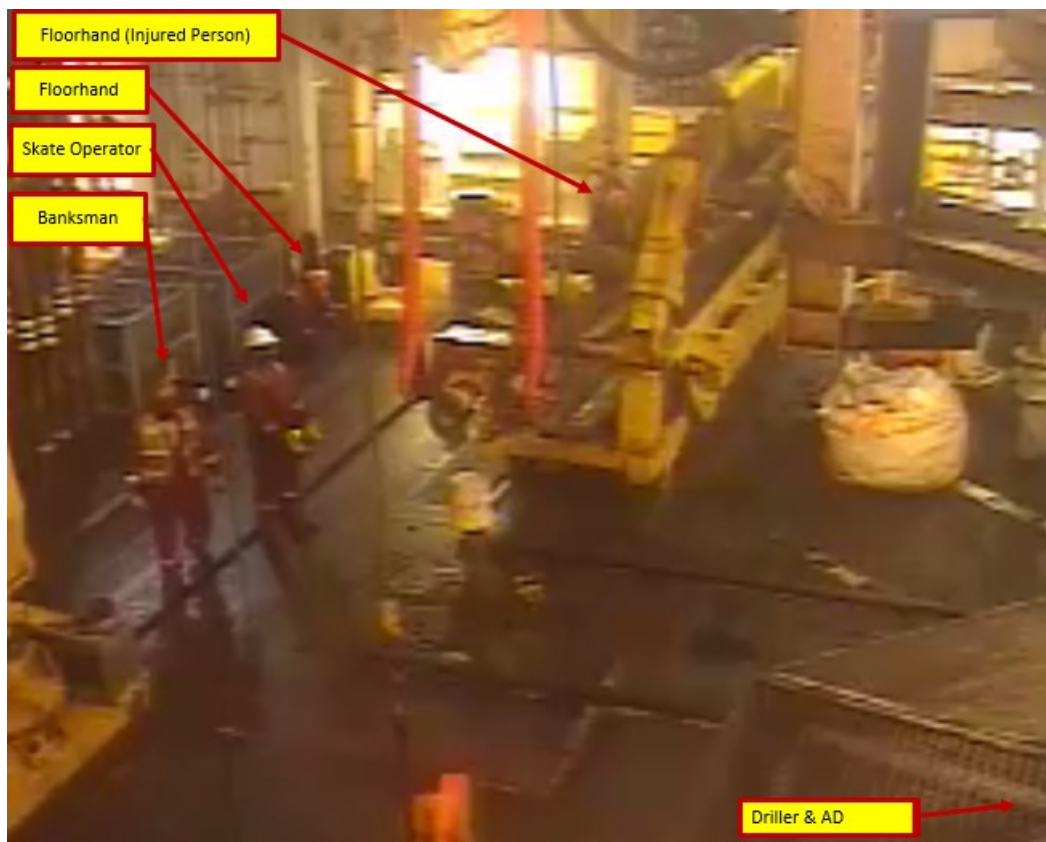
Figure 14: Image of auxiliary drill floor near the time of the incident.

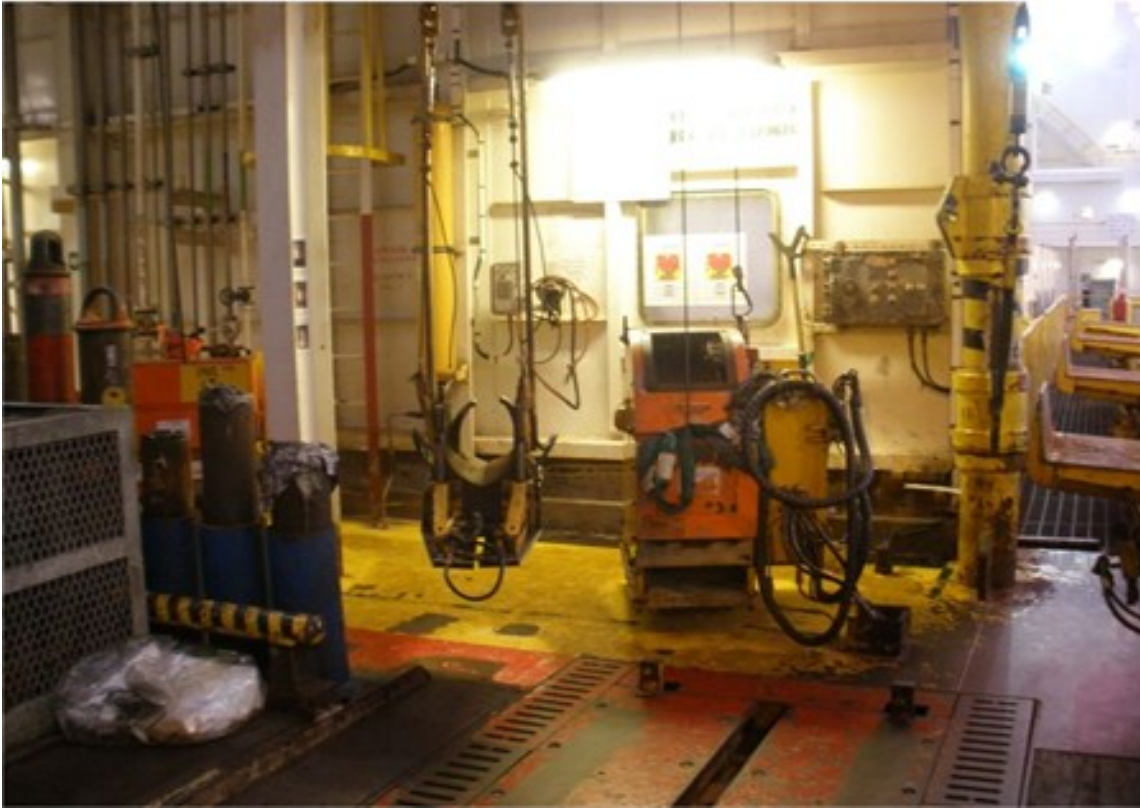
The PBS 10k is equipped with a dual activity drill floor which accommodates both the main and auxiliary well centers on the same floor. The PBS 10K has two derricks to allow for simultaneous rig operations. The drill control center, which accommodates both the auxiliary and main drill controls, is in the center of the drill floor (see Figure 13). The drill control center uses a partial hexagonal window arrangement as well as several video cameras to see all the rig activities. The aux drill floor was designed for pick up and racking back drill pipe. The PHCM skate is on a rail system and enters the aux drill floor side (bow side of the ship) and proceeds toward the auxiliary well center. On the port side of the skate is the hydra-rack pipe racking system. On the starboard side of the skate is the iron-roughneck. Other equipment, including the hoist, is also located on the port side of the skate in the vicinity of the green lines and stencils for the Step Back area (see Figure 15).

Figure 15: Depiction of access to the green box / Step Back area (provided by PAI)

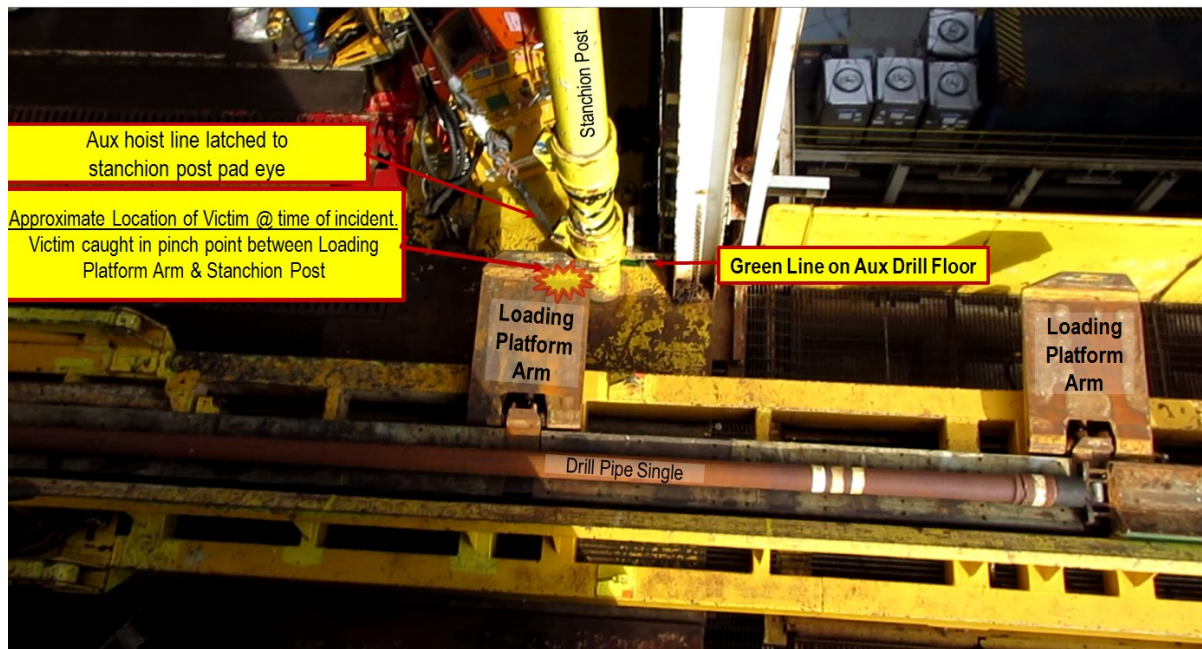
Personnel described having to turn sideways when walking along the catwalk or the skate and the video archive shows the injured person several times narrowly avoiding the skate pinching him in that area prior to the fatal incident. However, according to personnel the specific hazard of a pinch point between the loading platform arms and the stanchion post was never identified and thus never mitigated prior to the incident.

Figure 16: Auxiliary drill floor loading platform arm/ stanchion post proximity - birds-eye view #1 (BSEE photo)

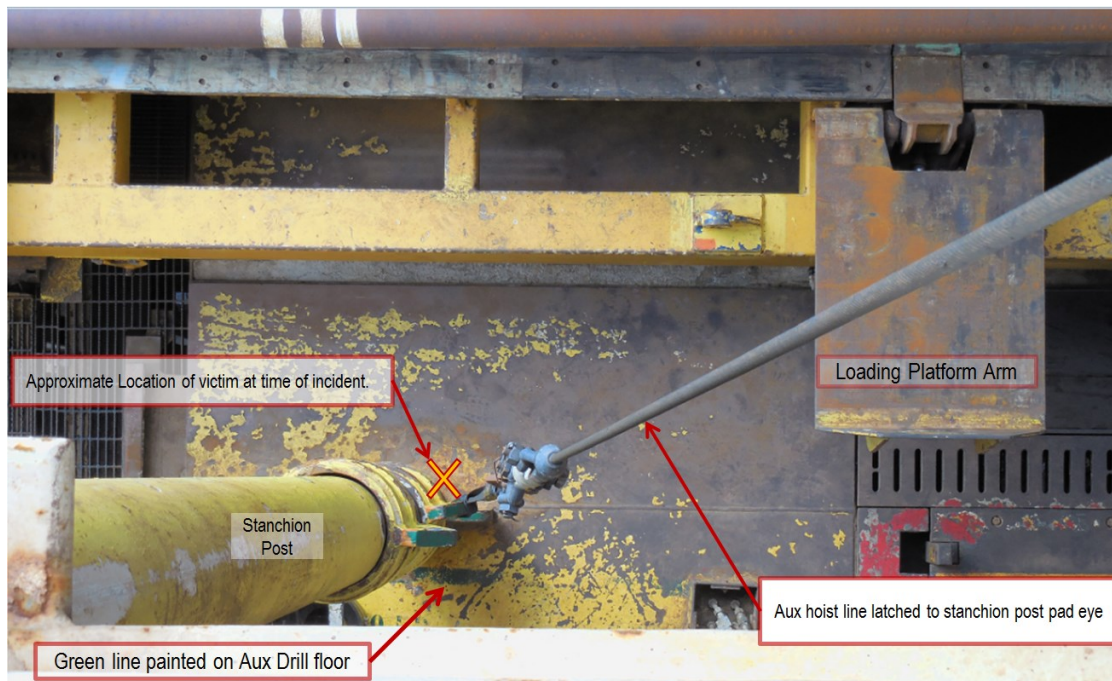
When multiple singles were placed on the loading platform arms, there was little to no space available for someone to walk between the skate and the stanchion post. However, space became available as each pipe was offloaded from the loading platform and into the PHCM's shuttle's cradle. Once the last drill pipe single was tipped into the skate's shuttle cradle, personnel had space to walk between the skate, the loading platform arms and the stanchion post (see Figure 17). In fact, in the hours preceding the incident the victim was observed stretching and also moving between the skate, the loading platform arm and the stanchion post after the last drill pipe was tipped.

Figure 17: Auxiliary drill floor loading platform arm/ stanchion post proximity - birds-eye view #2 (BSEE photo)
