Investigation of Fall and Fatality Mississippi Canyon Block 109 August 16, 2000

**Gulf of Mexico
Off the Louisiana Coast**

Frank Pausina
David Dykes
Charles Griffin

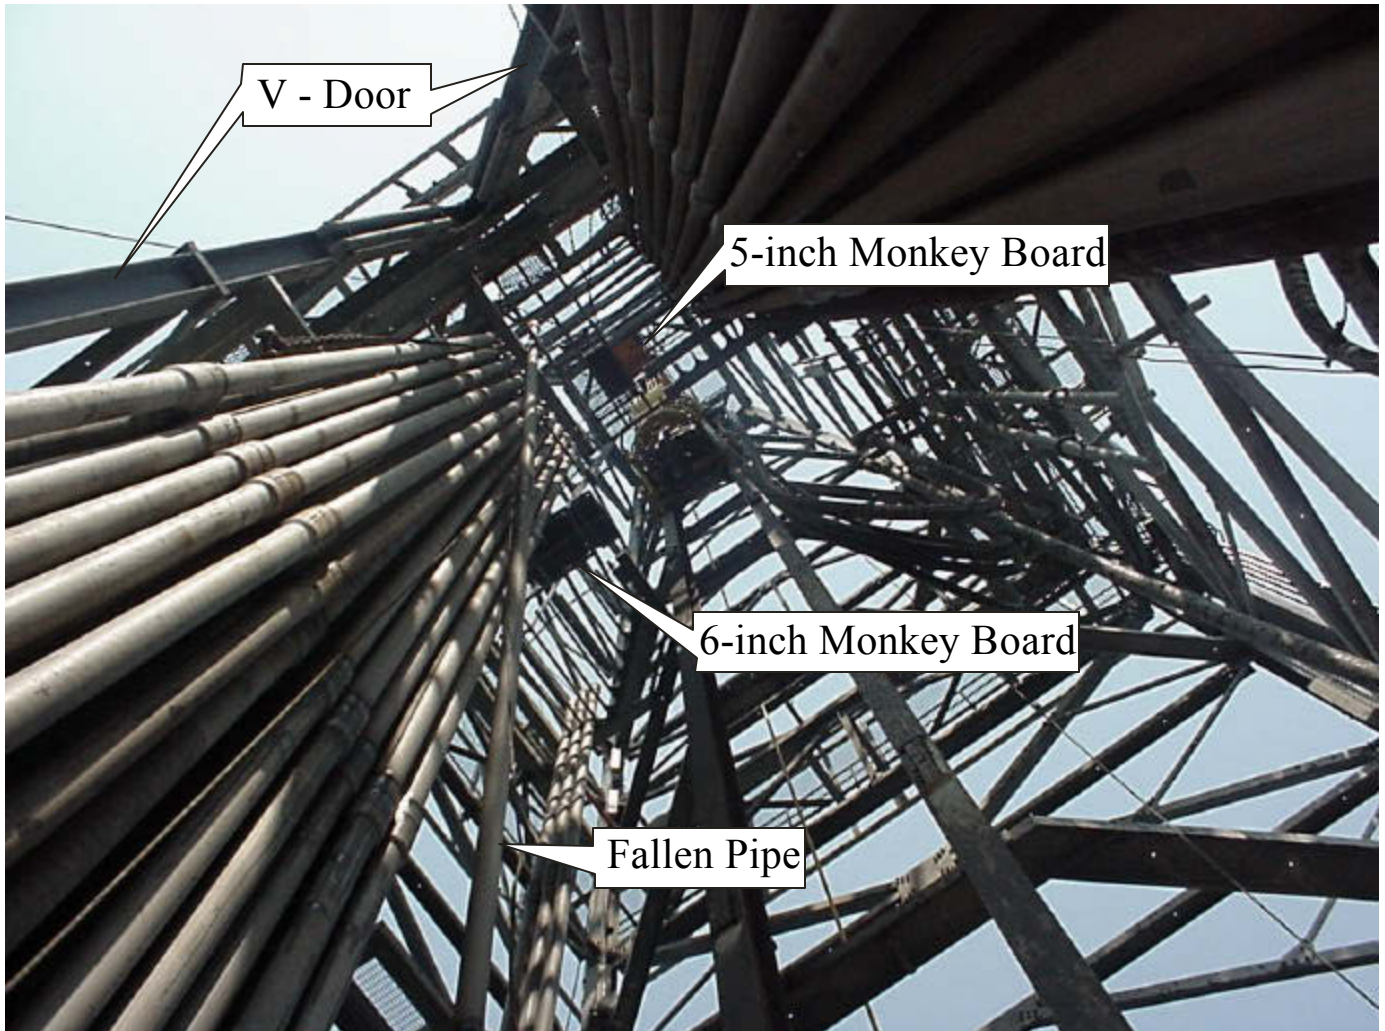
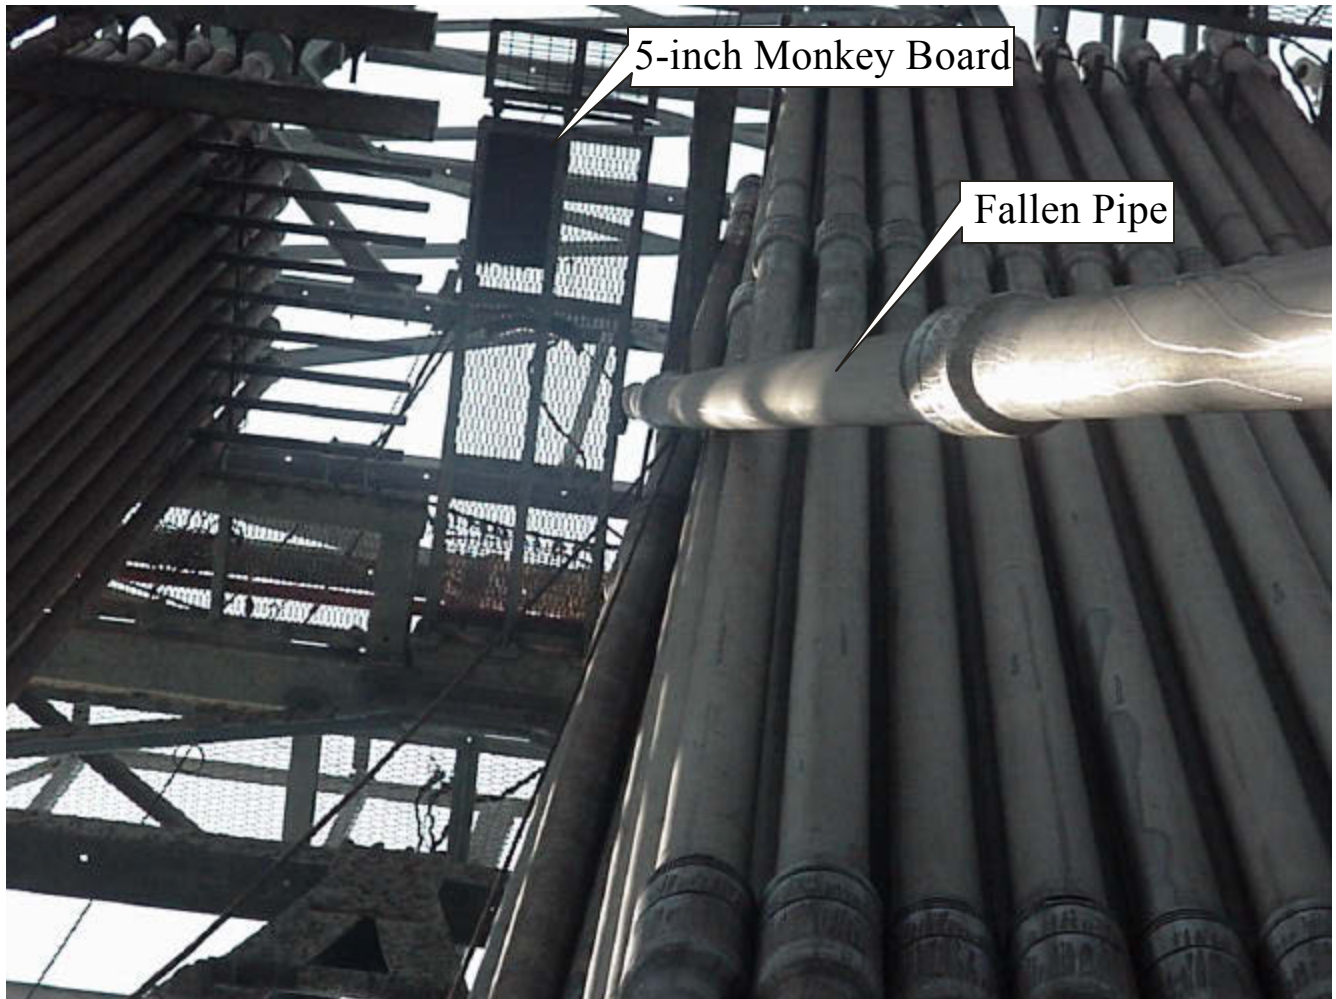
During drilling activities at approximately 2110 hours, a 6 5/8-inch stand of pipe fell across the rig and came to rest between the 5-inch monkey board and the fingers of the 6 5/8-inch pipe rack. *For photographs of the fallen pipe, see Attachments 2 and 3.* The derrickman at that time, henceforth referred to as H&P 1, was standing on the 6 5/8-inch monkey board and was not able to reach the fallen stand of pipe. In an attempt to assist H&P 1, a second H&P employee, henceforth referred to as H&P 2, strapped himself into a body harness with a built-in boatswain's chair (harness) and placed the "D" rings of the harness into the hook attached to the air hoist line. H&P 2 was then lifted, without any personal fall-protection, into the derrick by the air hoist to a stop position height of approximately 80 feet above the rig floor. This position placed H&P 2 approximately 4 to 10 feet below the monkey board level. As H&P 2 attempted to maneuver into a position to board the 5-inch monkey board, the harness "D" rings became detached from the air hoist hook, resulting in H&P 2 falling to the rig floor and sustaining fatal injuries. *For a diagram of the derrick layout, see Attachment 4.*

Photograph of Fallen Pipe

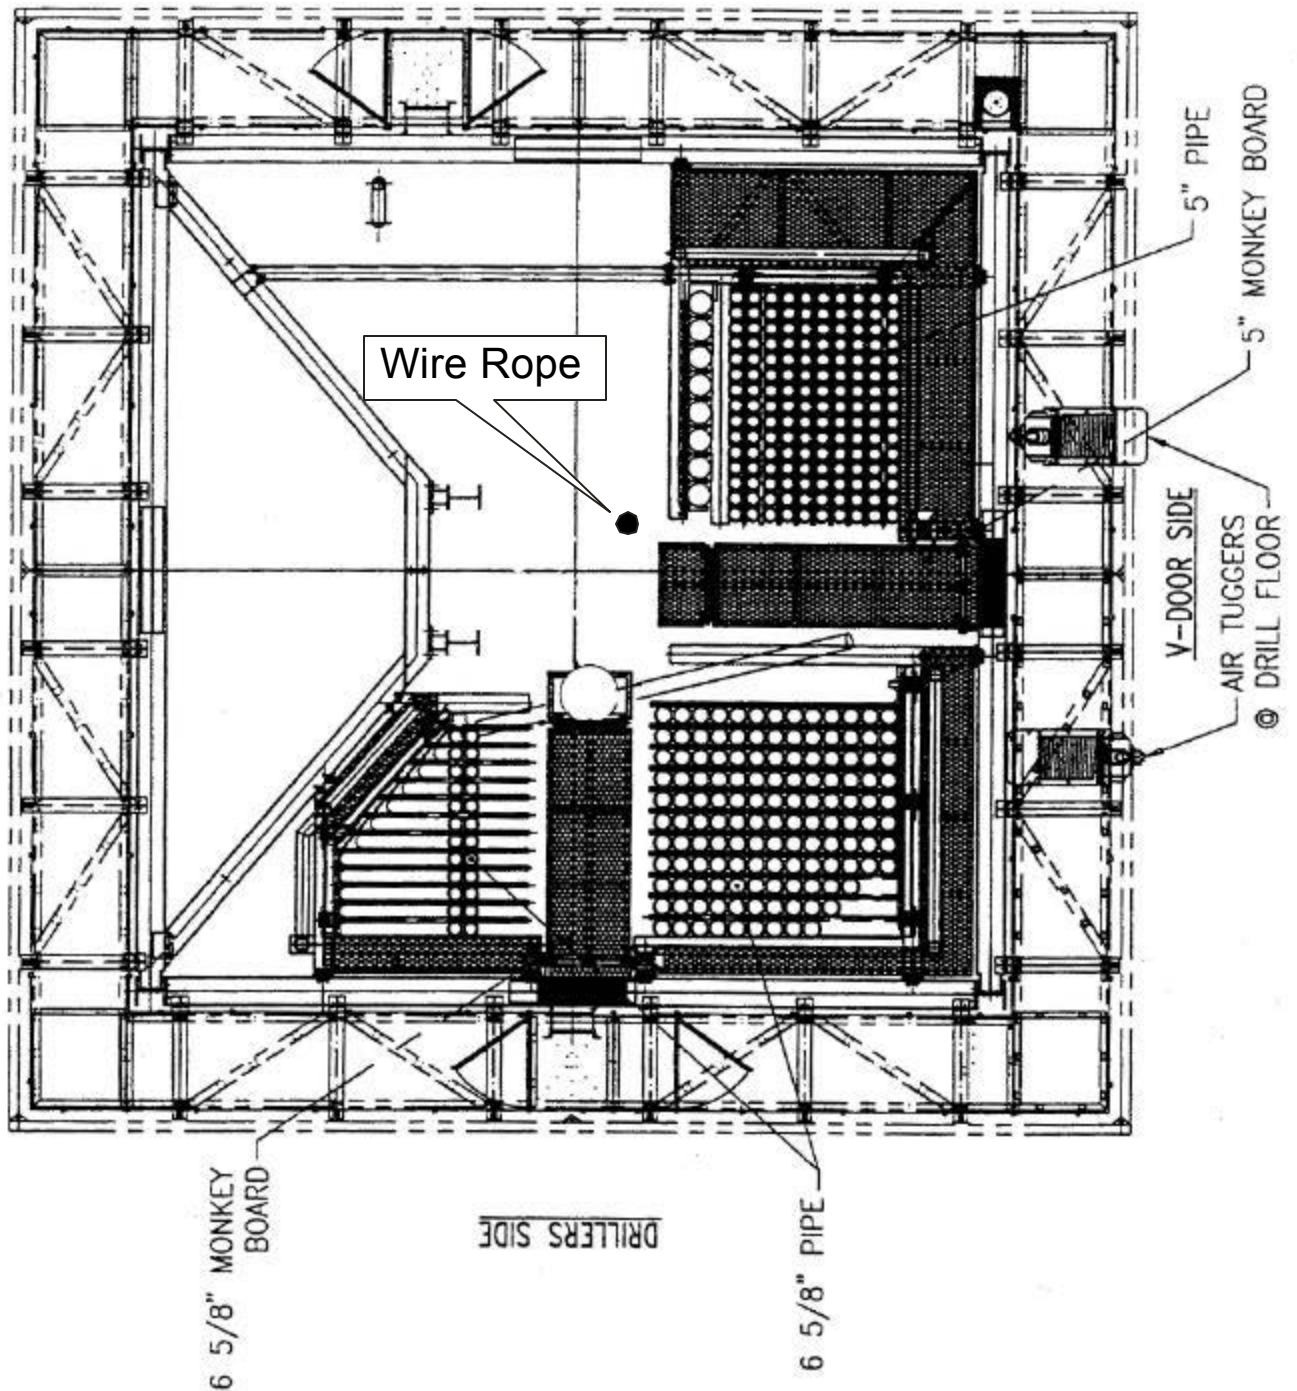
Diagram of Derrick Layout

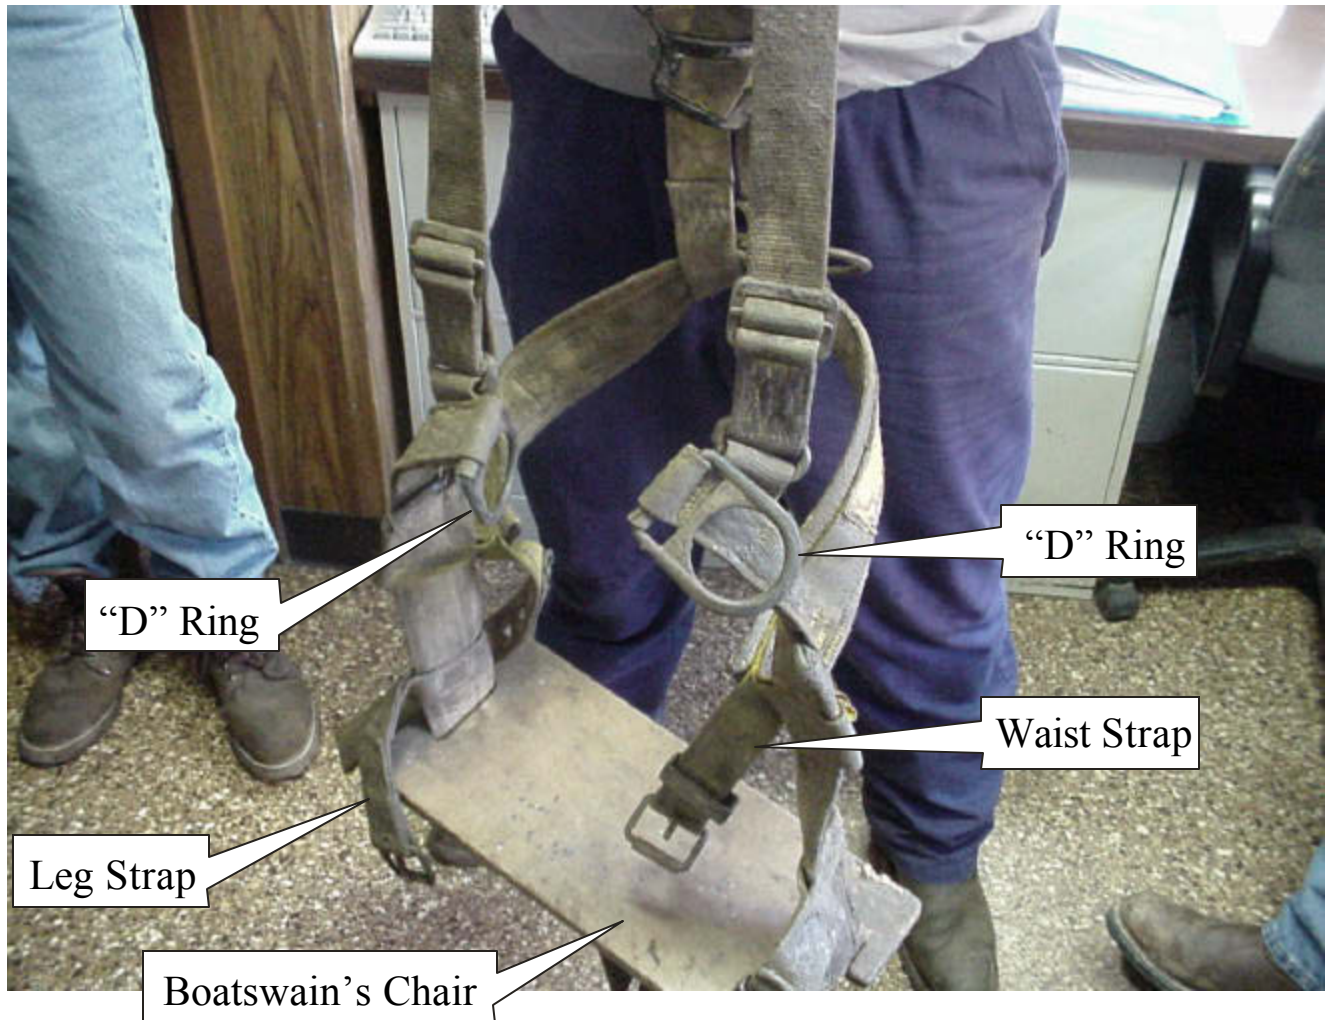
The body harness used in this incident consists of a full body harness with a built-in boatswain chair. The harness is constructed with leg straps to provide support in a seated position and to prevent the individual from falling out of the harness. The harness is equipped with two D-rings on the front on each side at the waist. The harness is also equipped with a third D-ring located on the upper back of the harness in the center. This D-ring serves the purpose for attaching a fall protection lanyard or for attaching a retrieval line. *For photographs of the harness, see Attachments 5 and 6.*

Photograph of Harness

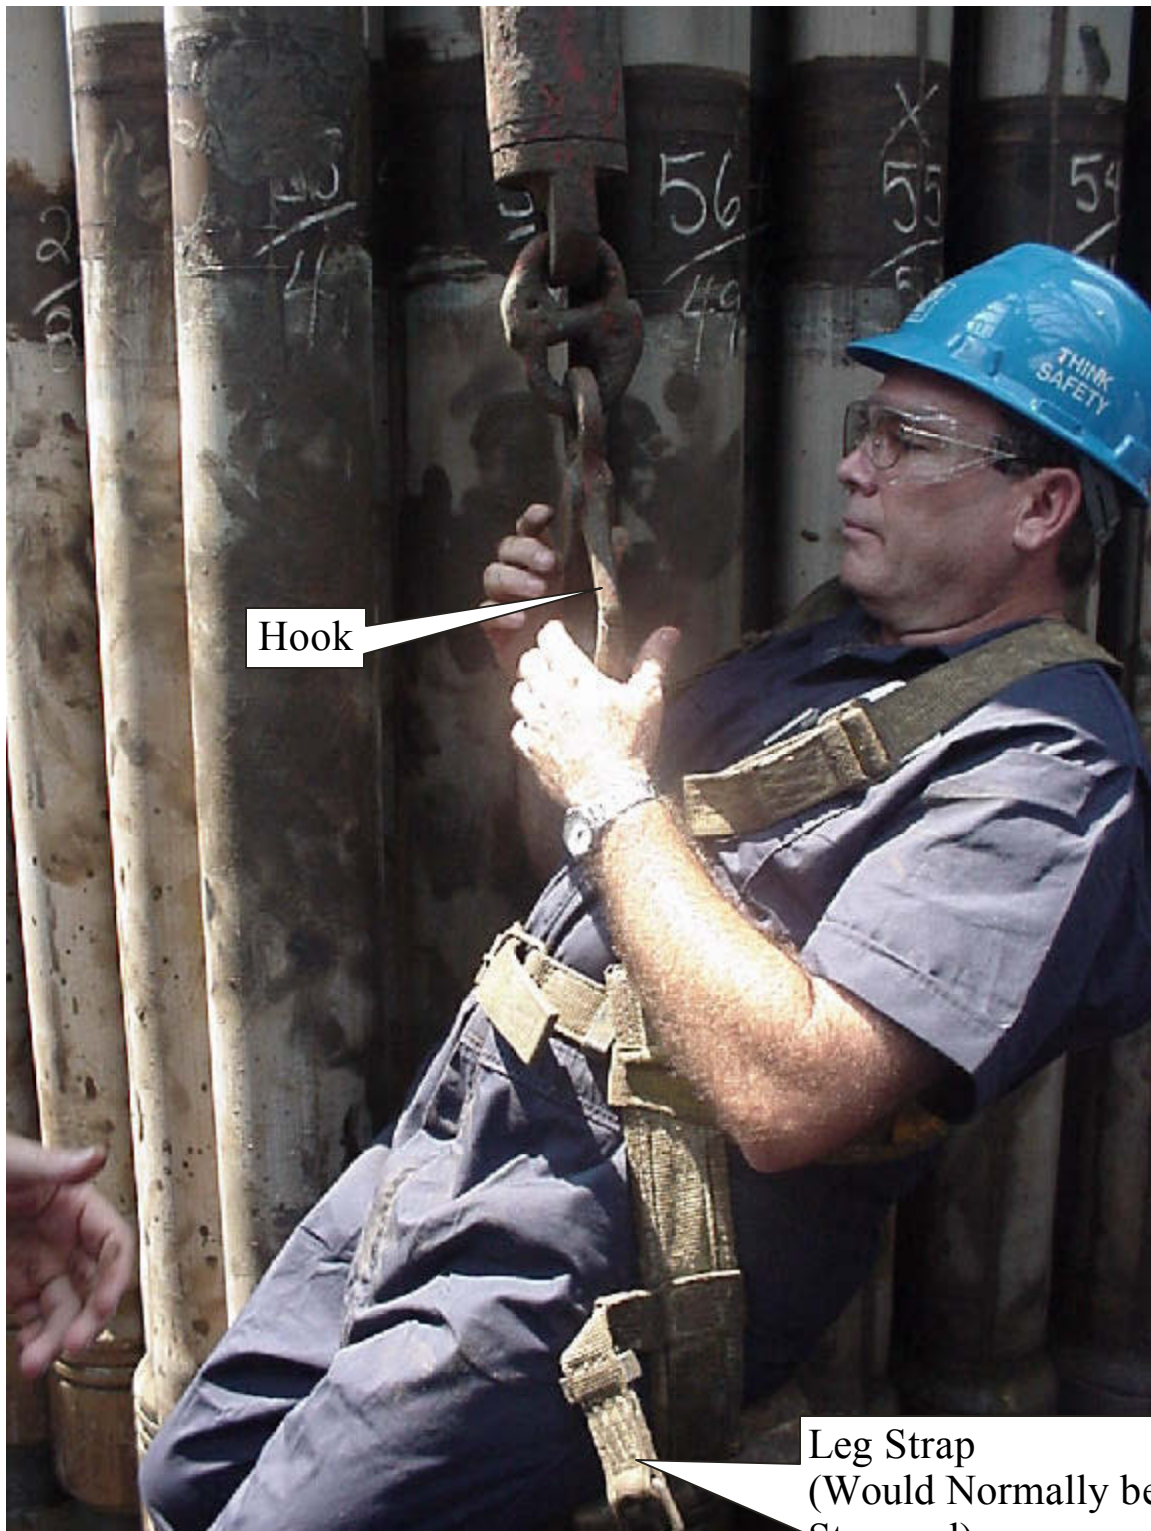
Hook

Leg Strap
(Would Normally be
Strapped)

Photograph of Man in Harness

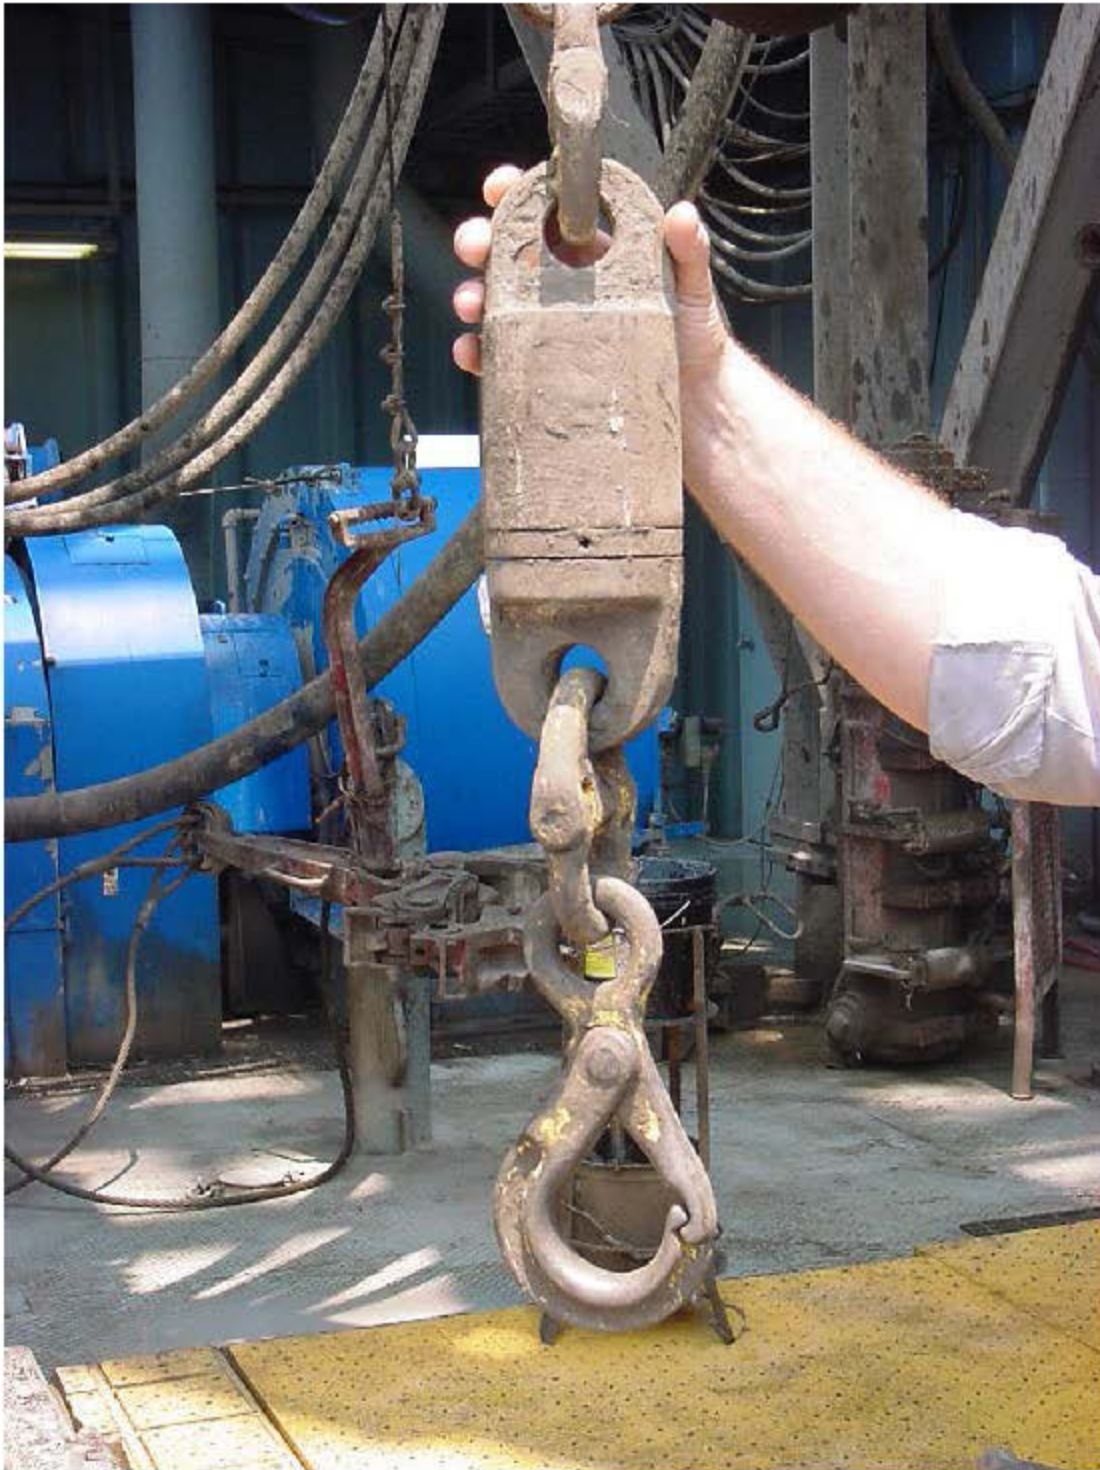
The hoisting system is a conventional air-operated “tugger.” The tugger is one of two located just to each side of the V-door on the rig floor. The tuggers are equipped with 5/8-inch, 19x7 wire rope with a breaking strength of 33,600 pounds. The lines from the tuggers run up the inside of the derrick to each side of the crown block respectively. The free end of the line is finished with a machined eye and swedge sleeve socket. The Gunnebo OBK 13-8 Hook is attached to the cable eye via a weighted swivel. *For a photograph of the hook assembly, see Attachment 7.* The tuggers are used to lift joints of pipe from the V-door up into the derrick and for lifting and moving tools and other utility equipment around the drill floor.

Photograph of Hook Assembly

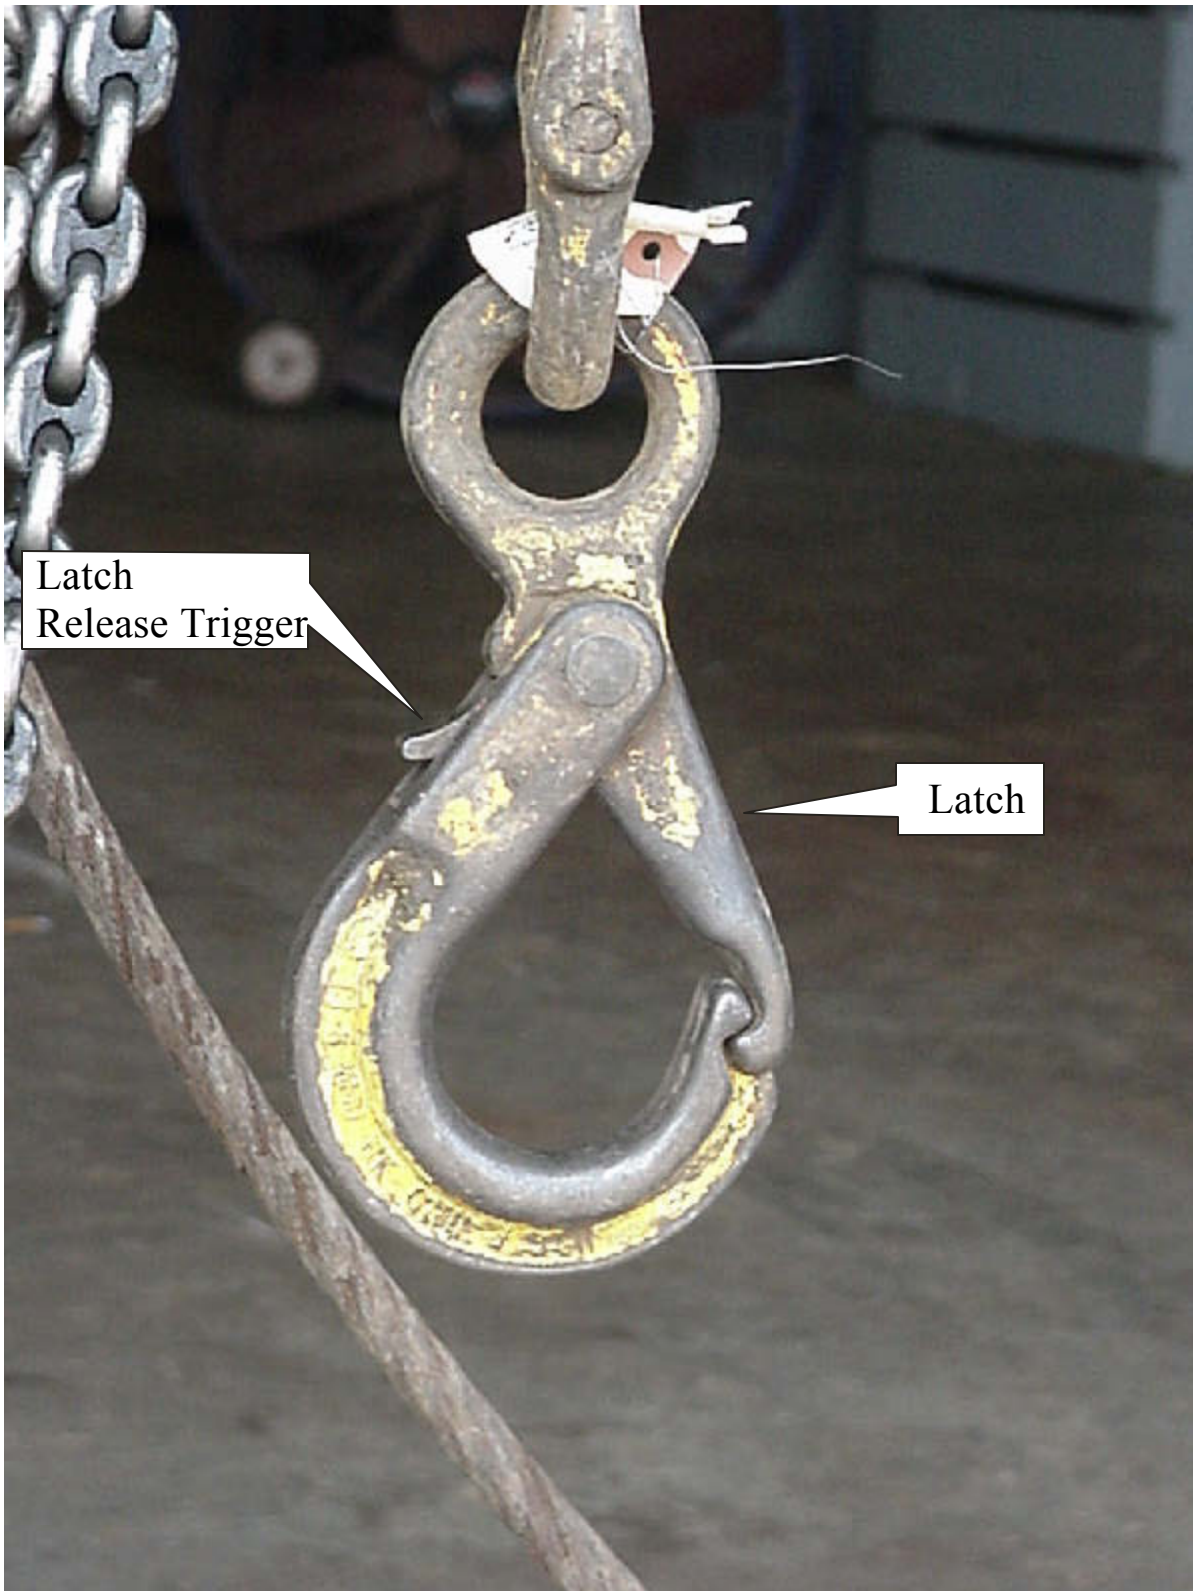
The air hoist hook consists of an outward opening, self-locking latch, and a latch release trigger. Pressing the trigger inward releases the latch and allows separation between the latch and the hook. *For a photograph of the hook, see Attachment 8.*

- ◆ Using an air hoist hook with an outward opening latch.

Photograph of Hook

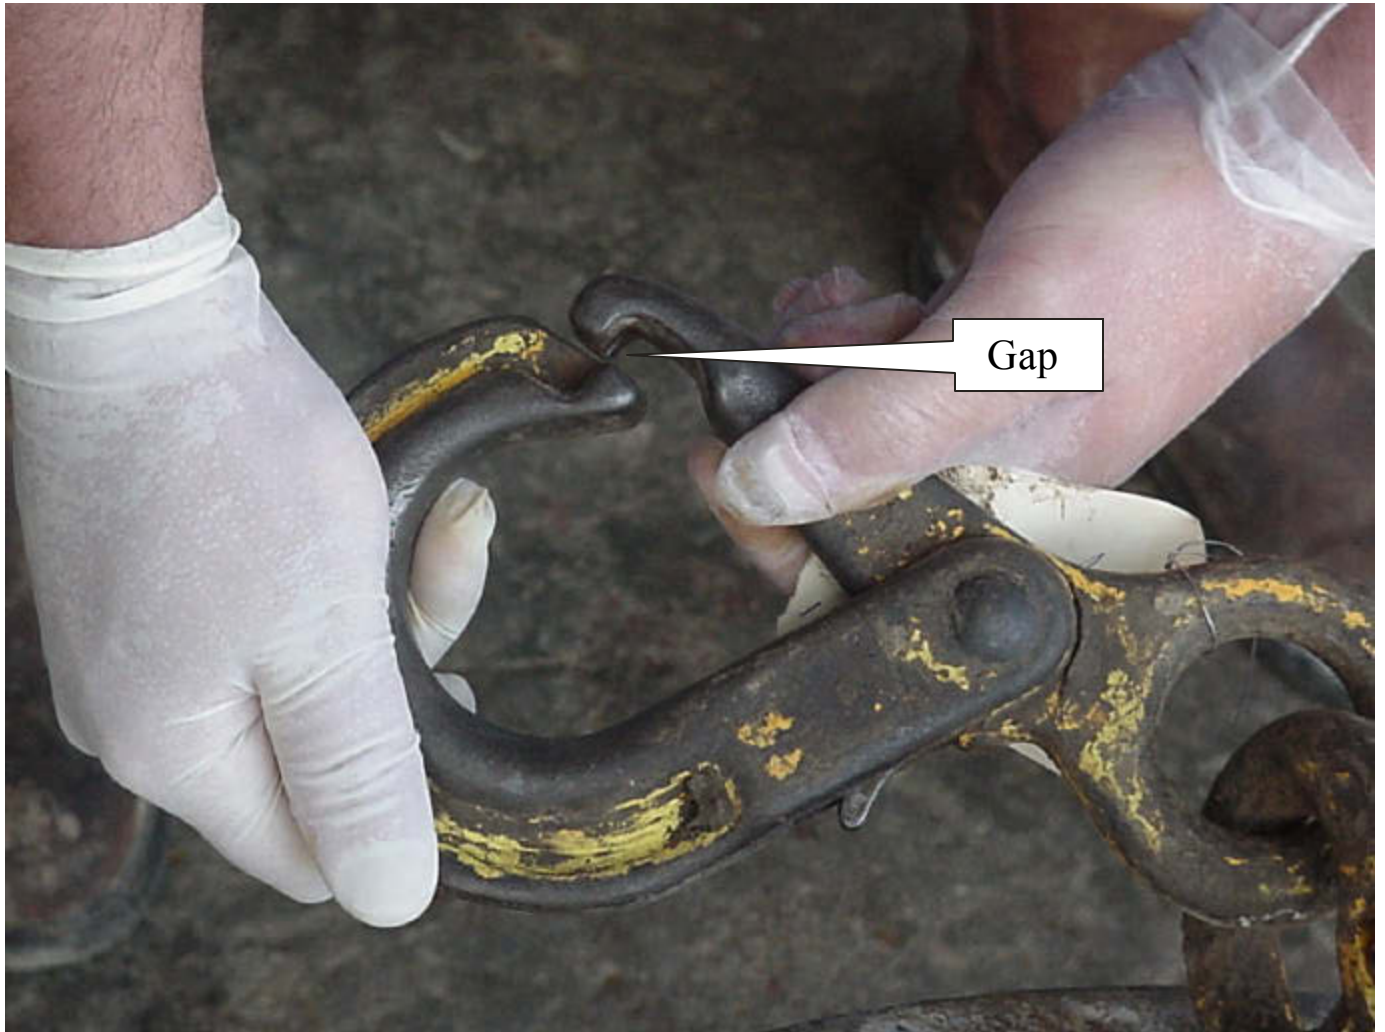
Equipment Analysis The hook was inspected by MMS district personnel at the accident site and by MMS panel members at H&P facilities in Jackson, Mississippi, where the hook and harness were secured. Both inspections revealed that a gap of approximately 4/10 inch between the latch and the hook can be produced by slightly pulling outward on the latch while the hook is in the closed position, i.e., with the latch release trigger not pressed inward. *For a photograph showing the gap, see Attachment 9.*

- ◆ Using the air hoist hook with a latch/hook gap.

- ◆ The failure of H&P's inspection/maintenance program to identify the latch/hook gap as a potential hazard by a more in-depth inspection of the hook.

Photograph of Hook/Latch Gap

The panel further recommends that MMS review their regulations and those of other agencies, which do reference personnel lifting, for the purpose of evaluating the possible need to add a specific MMS regulation(s) to 30 CFR 250 regarding the lifting of personnel. Specifically, the evaluation should consider the types of hooks used and the need for fall-arrest systems.

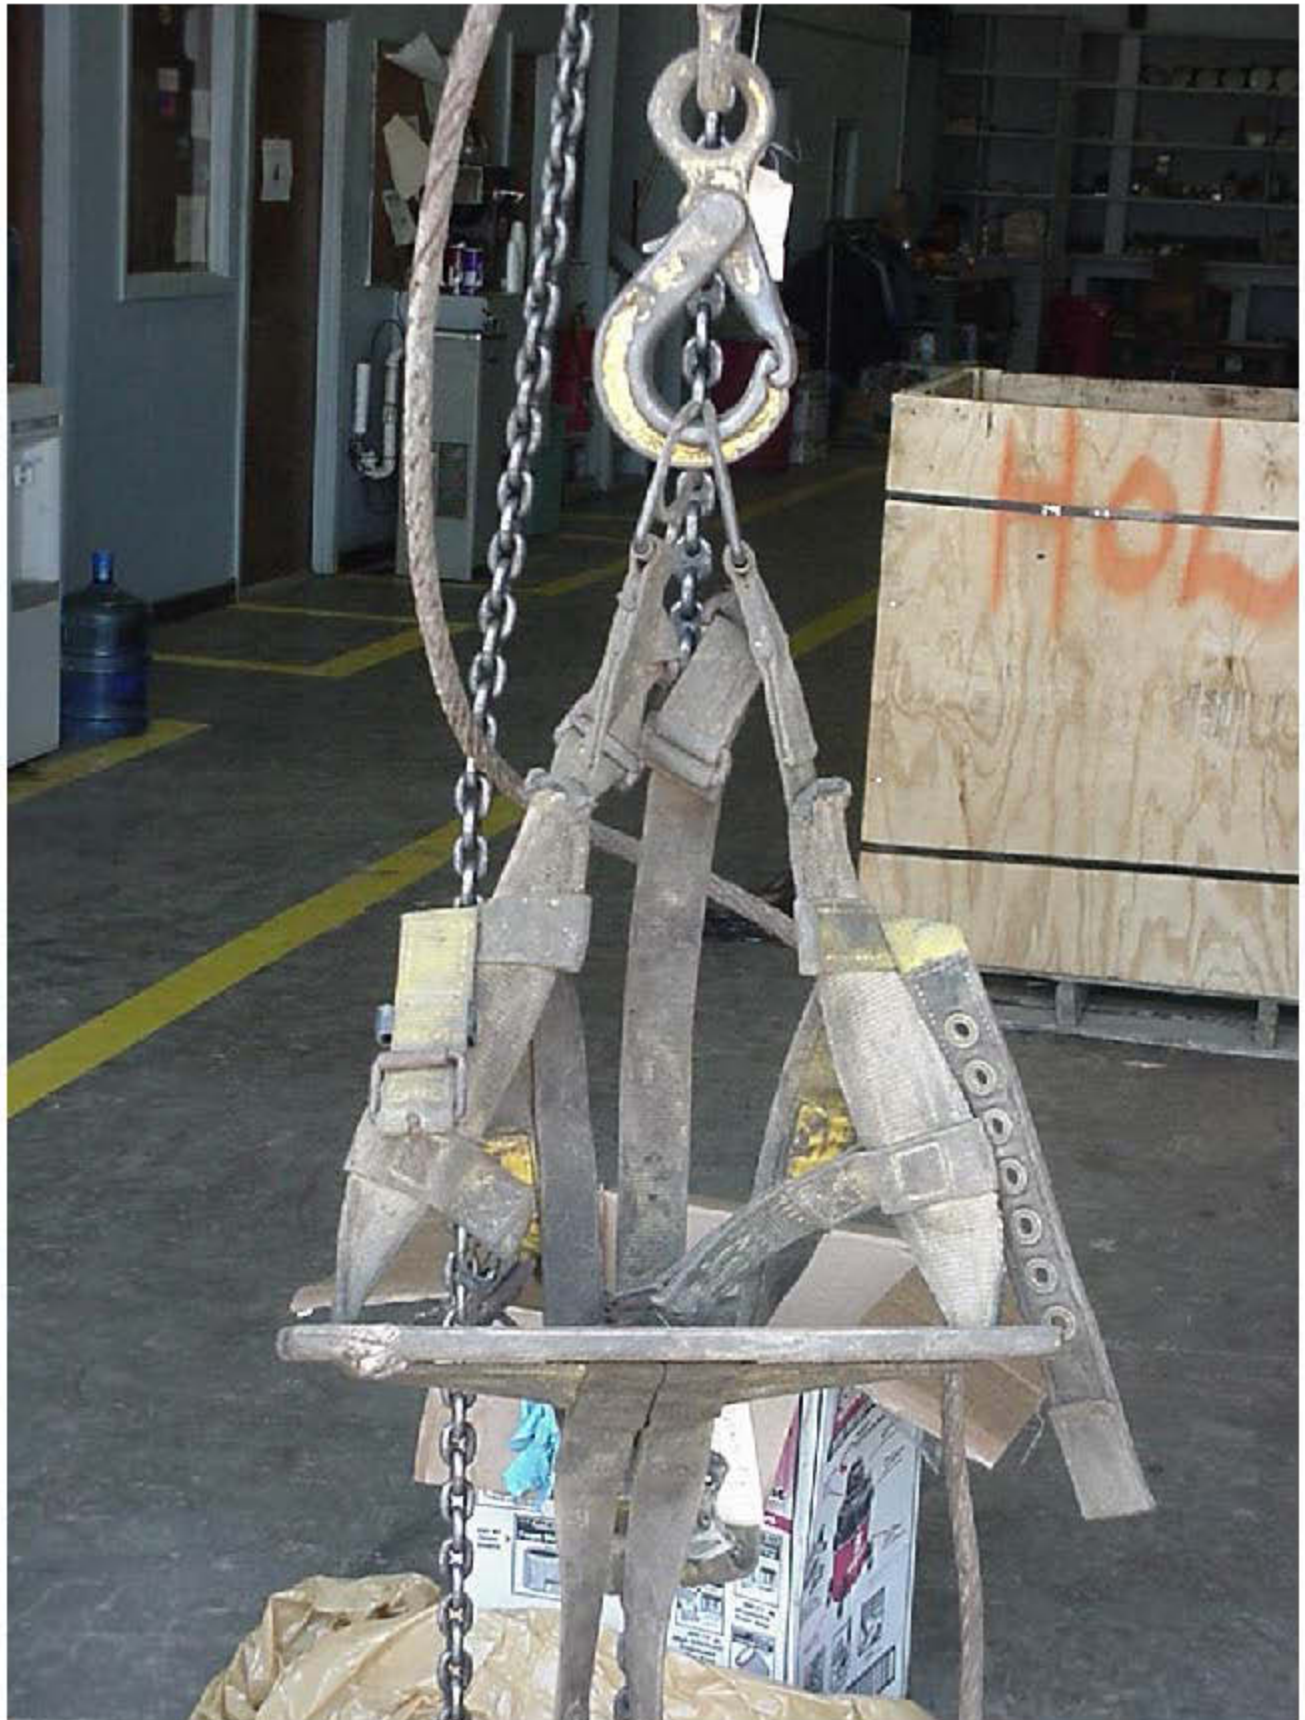
At the Jackson facilities, panel members suspended the hook from an overhead crane and hung the harness from the hook by placing the chair's "D" rings in the hook. *For a photograph of the harness suspended from the hook, see Attachment 10.* It was revealed that the "D" rings fit into the latch/hook gap. *For photographs of the "D" rings in the gap, see Attachments 11 and 12.*

Photograph of Harness Suspended from Hook

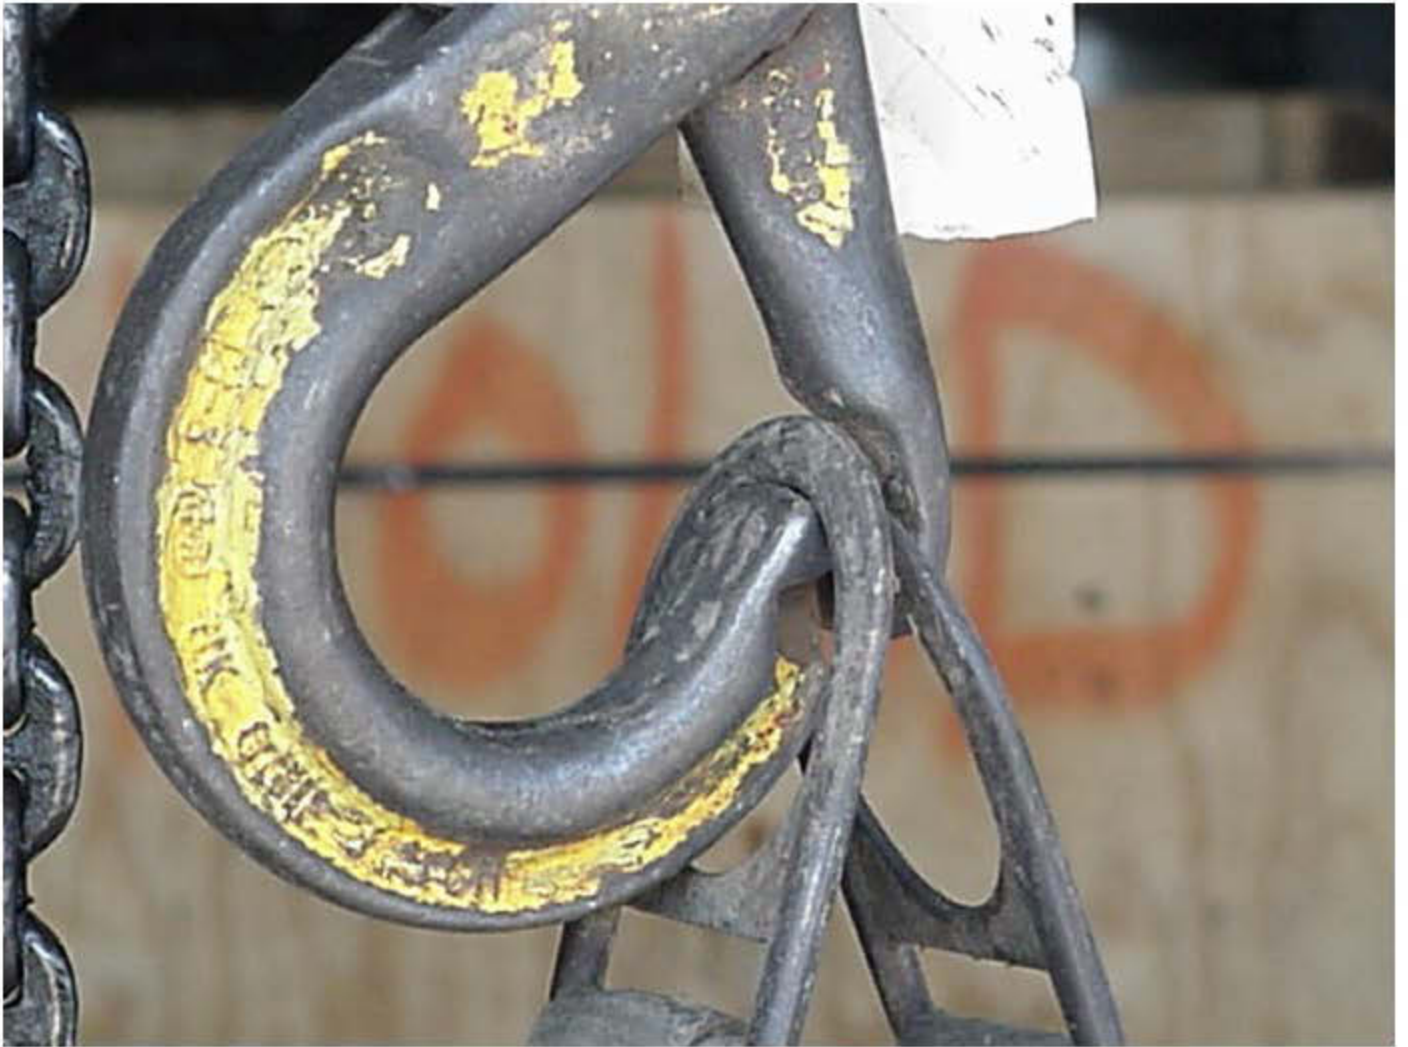
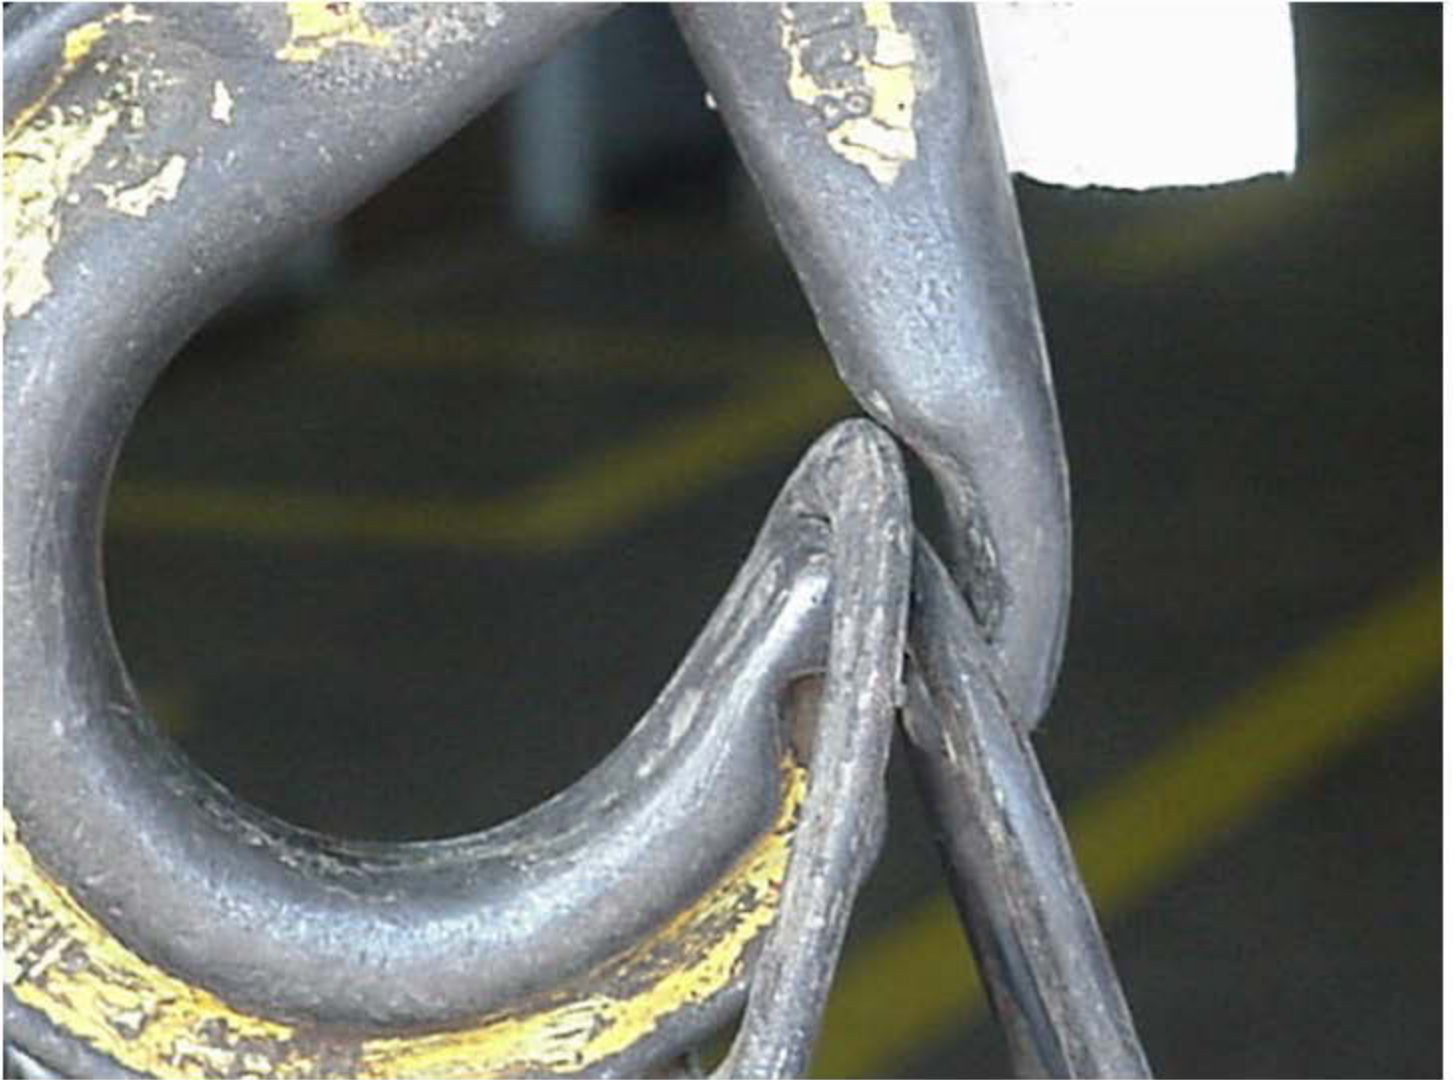
With the "D" rings in the gap, panel members were unable to physically pull the "D" rings downward from the hook. With the "D" rings in the gap and with the latch release trigger fully depressed, the panel members were still unable to pull the "D" rings downward from the hook. However, with the "D" rings in the gap and with the latch release trigger fully depressed, the "D" rings separated from the hook as soon as the panel members stopped pulling downward on the "D" rings. It should be noted that in both of the above demonstrations with the trigger fully depressed, the trigger was not easily depressed. This indicates that it is possible that the "D" rings can detach from the hook during a personnel lifting operation if the rings are in the latch/hook gap, the trigger is depressed, and the occupant of the chair

either (a) pulls his weight off the chair with his hands placed on or above the hook trigger or (b) again with his hands on or above the hook trigger, pushes his weight off the chair with his feet against a stand of pipe.

It is the conclusion of the panel that, at some point in his elevation into the derrick, H&P 2's harness "D" rings fell into the latch/hook gap. While maneuvering into position to board the 5-inch monkey board, H&P 2 accidentally depressed the latch release trigger of the air hoist hook and simultaneously either pulled or pushed his weight off the boatswain's chair. At that point, the harness "D" rings slipped out of the hook, resulting in H&P 2 fatally falling approximately 80 feet to the rig floor.

Photograph of “D”Rings in Hook/Latch Gap
