**Investigation of Crane Accident and Injury
South Timbalier Block 185
OCS-G 1569
March 21, 2000**

**Gulf of Mexico
Off the Louisiana Coast**

Jack Leezy
Freddie Mosely
David Dykes

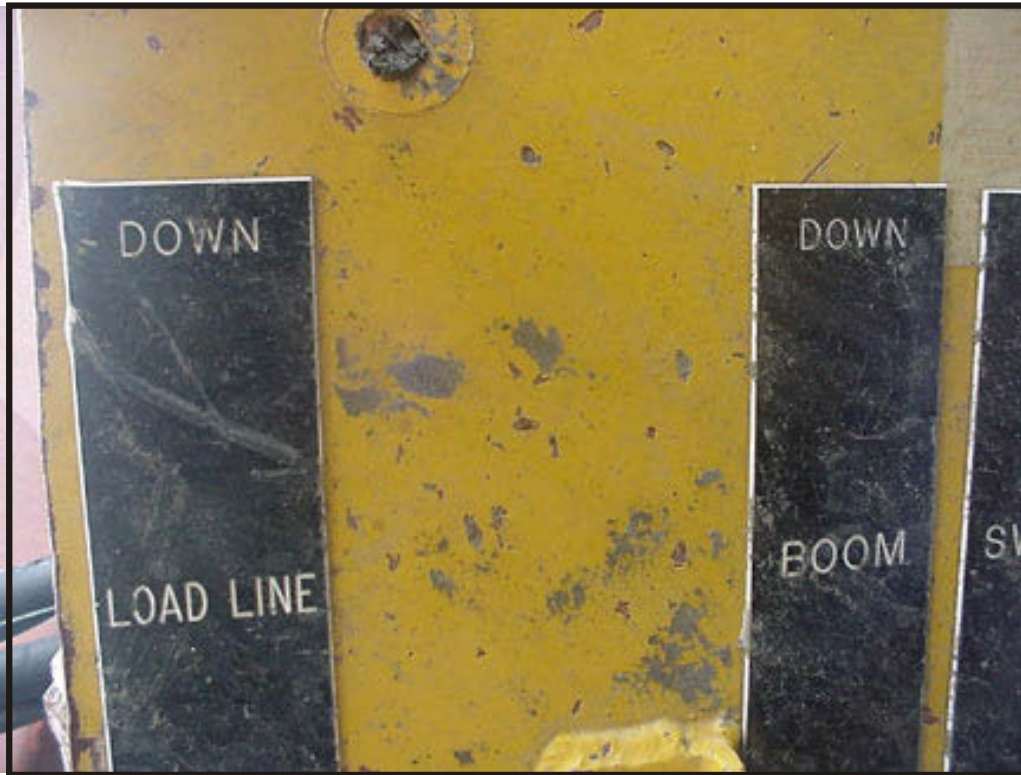
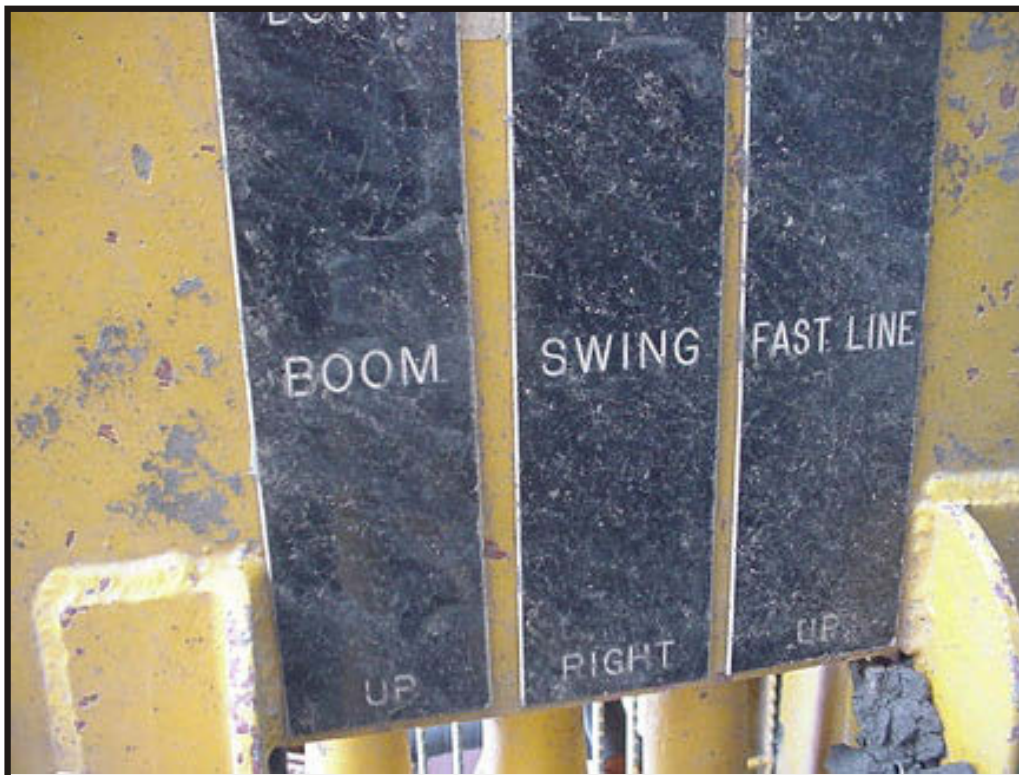
Photographs of Control Handles - ST185 Crane

- The configuration of the control handles was unique to this crane and not the typical control configuration as other cranes he had operated. *For pictures of the control handles, see Attachment 3.*
- The crane would rock on the pedestal at high boom angles.
- The operation of the crane was not smooth.

Control handle configuration

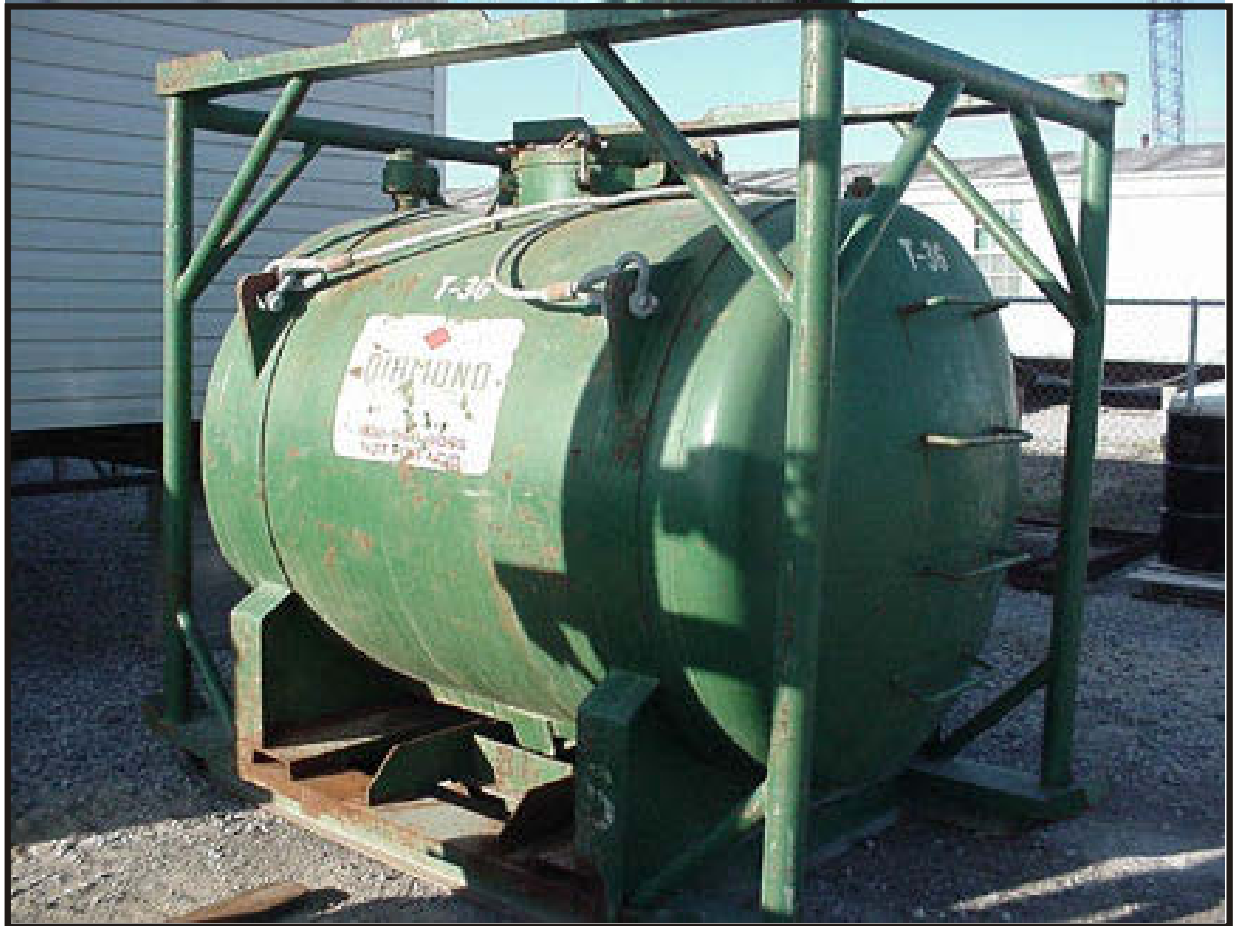
Photograph of Diamond Tank Rental 25-Barrel Tote Tank

The tank involved in this incident was a 25-barrel tote tank owned by Diamond Tank Rentals. *For picture of the tank, see Attachment 4.* The empty weight of the tank was 4,080 pounds. This weight is marked on the manufacturer's plate located on the inside support leg of the tank.

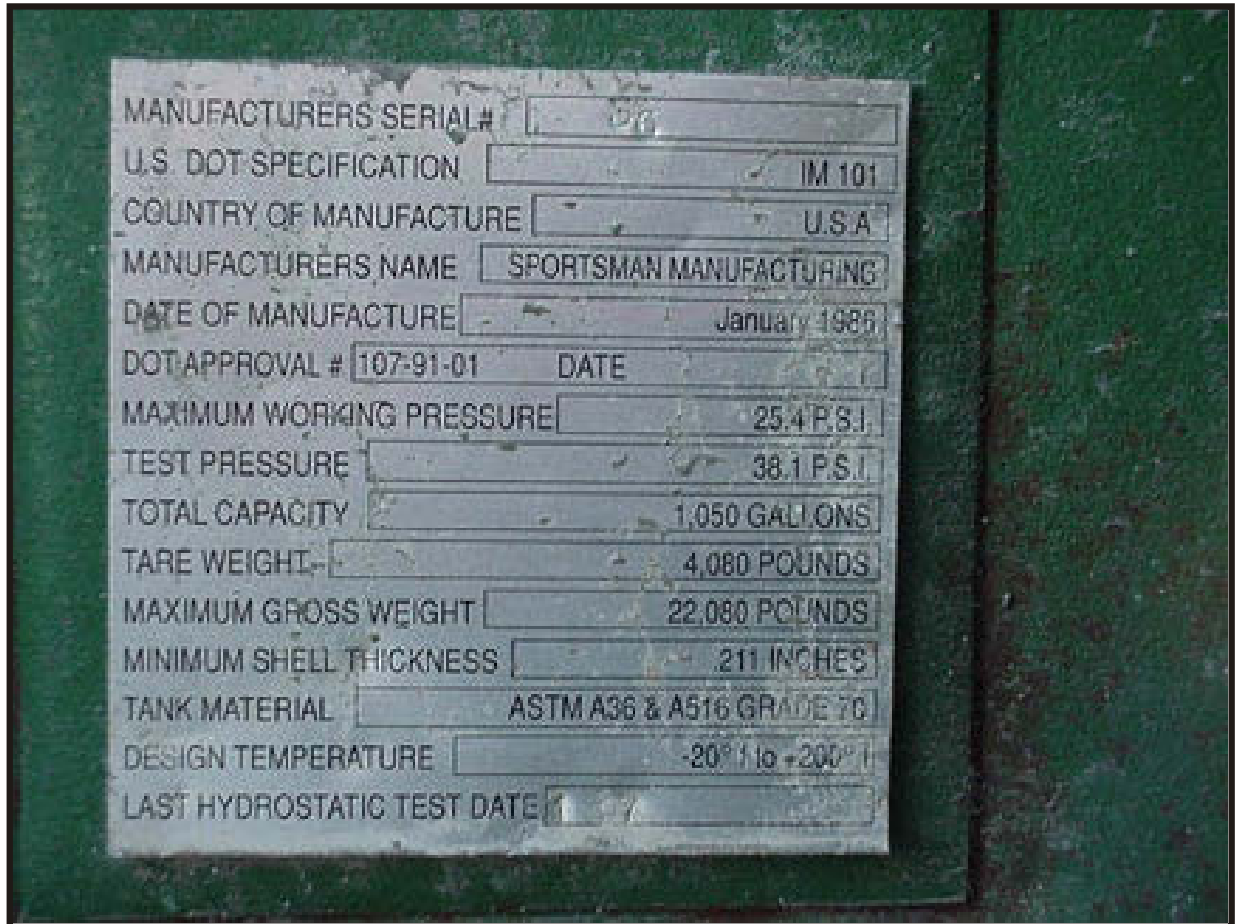
Photograph of Tote Tank Manufacturer's Identification Plate

For picture of the manufacturer's plate, see Attachment 5. At the time of the incident, the tank was filled with Calcium Bromide (CaBr₂). The density of the CaBr₂ was 14.2 pounds per gallon. This calculates to 14,910 pounds of CaBr₂ with a total weight of 18,990 pounds. The tank involved in this incident and other numerous pieces of equipment were not marked with the associated lift weight.
