Investigation of Riser Leak
Platform Elly, OCS-P 0300
Pacific OCS Region
September 13, 2002

*U.S. Department of the Interior
Minerals Management Service*

Catherine Hoffman
Ralph Vasquez

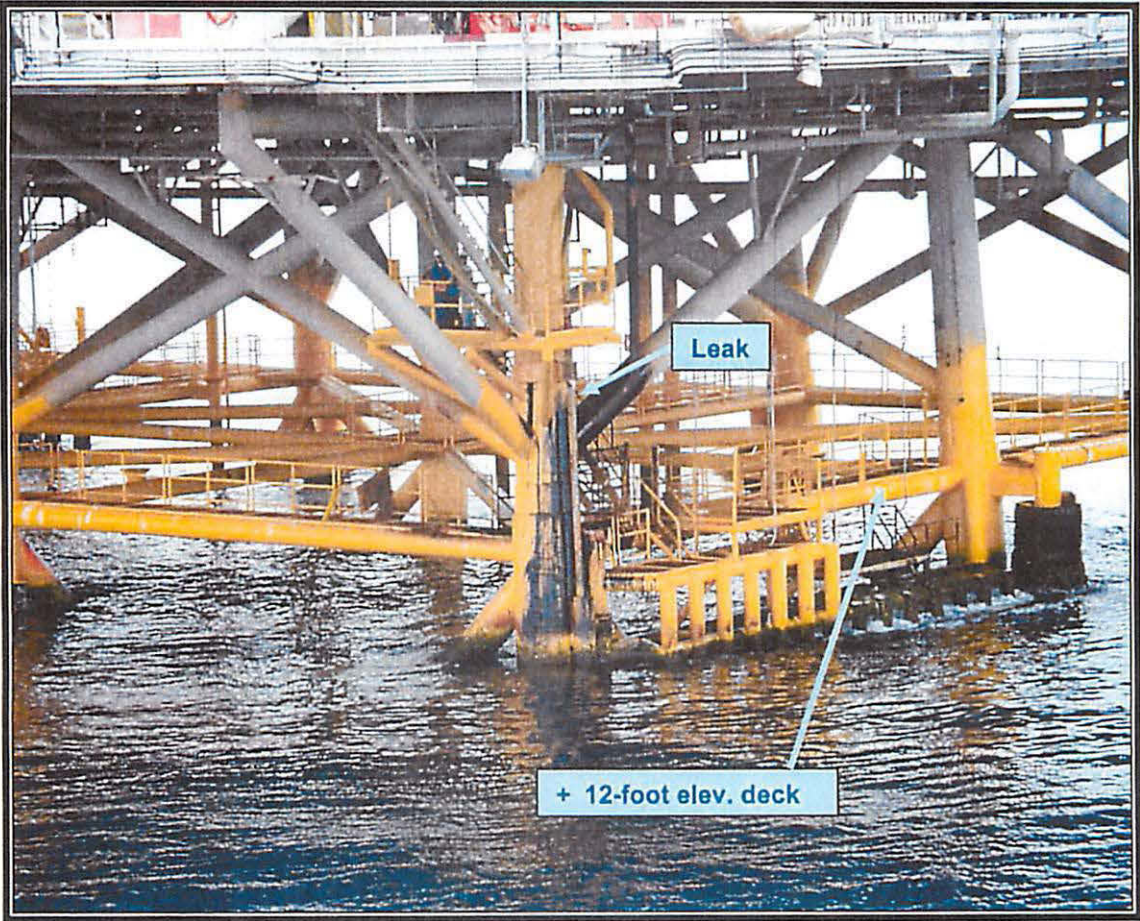
Attachment 1 – Platform Elly

On July 7, 2002, at about 11:35 p.m., a 6-inch diameter oil pipeline failed at the riser-to-flange weldment, resulting in a 9-barrel oil spill. The break occurred approximately 10 feet above Elly's (+) 12-foot elevation lower deck (Attachment 1—Platform Elly). The pipeline is used to transport oil from Platform Edith, operated by Nuevo Energy Company, to Platform Elly, operated by Aera Energy LLC. The pipeline is approximately one mile.

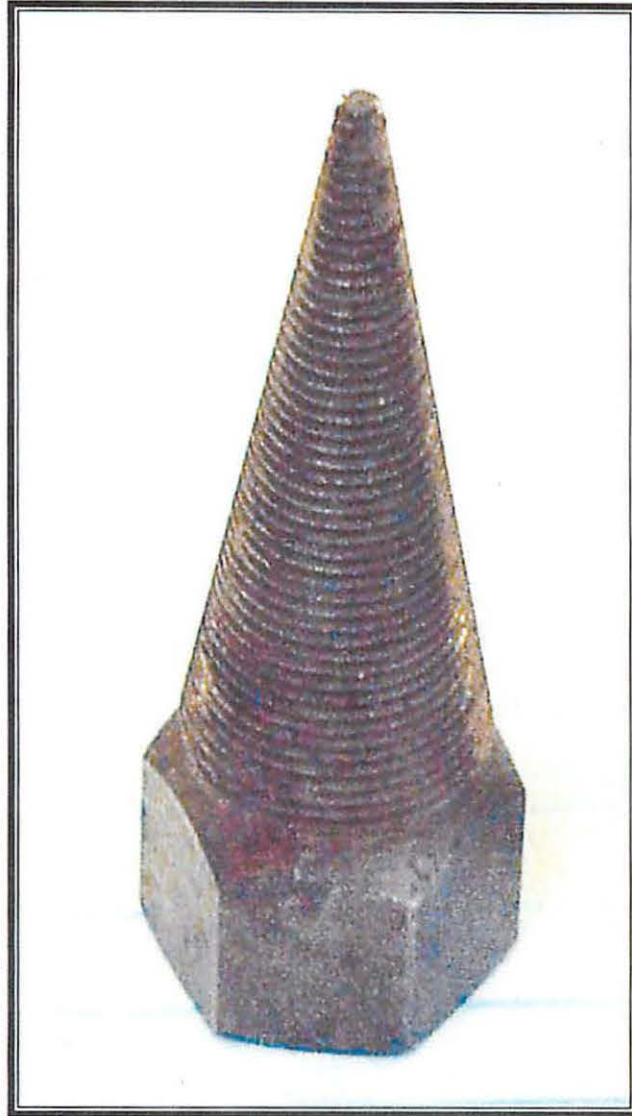
Attachment 2 -- Adam's Plug (Device Used to Seal ¼-inch Hole in Pipeline Riser)

After the pipeline was shut down, the flow from the riser decreased dramatically; however, some oil continued to escape. Elly personnel screwed an Adam's plug into the quarter-inch hole to completely abate the oil spill (Attachment 2—Adam's Plug).

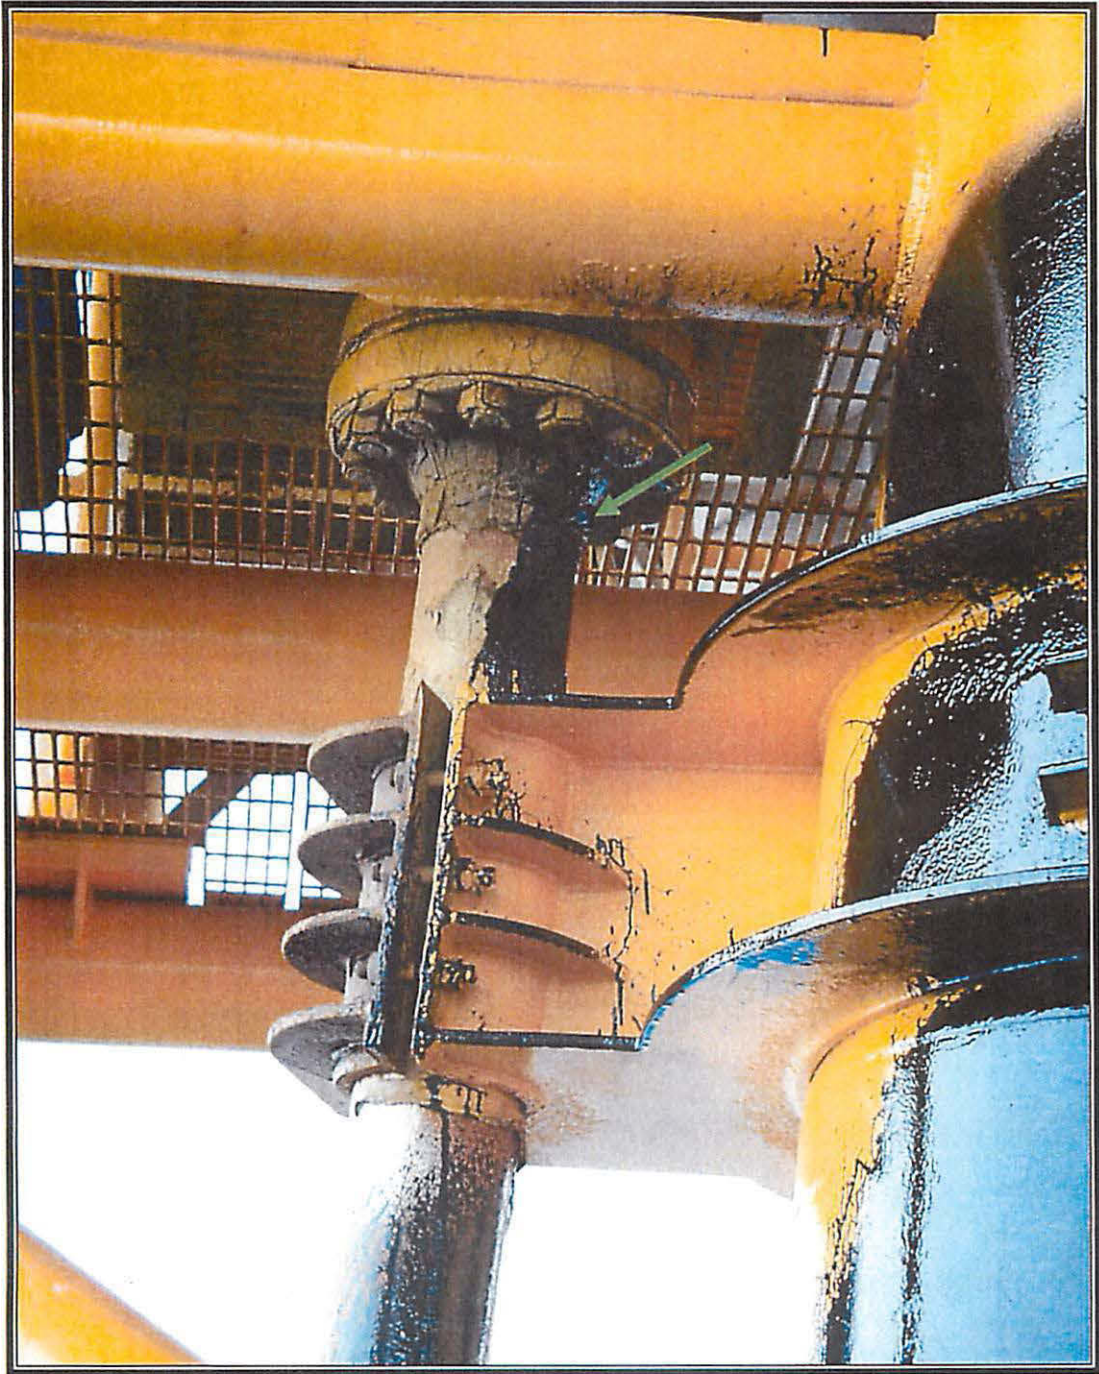
Attachment 3 -- Failed Riser

The MMS investigators first went to Platform Elly, operated by Aera, to examine the quarter-inch hole in the riser (Attachment 3—Failed Riser) and to interview Allen Knowles, the Aera operator who discovered the leak. The area around the riser was badly oiled. Oil was found to have sprayed as far as approximately 30 feet from the riser.

After review of the circumstances surrounding the incident we conclude that the probable cause of the riser leak was external corrosion. The riser had corroded to the point that it was insufficient to hold the maximum allowable operating pressure and ruptured.

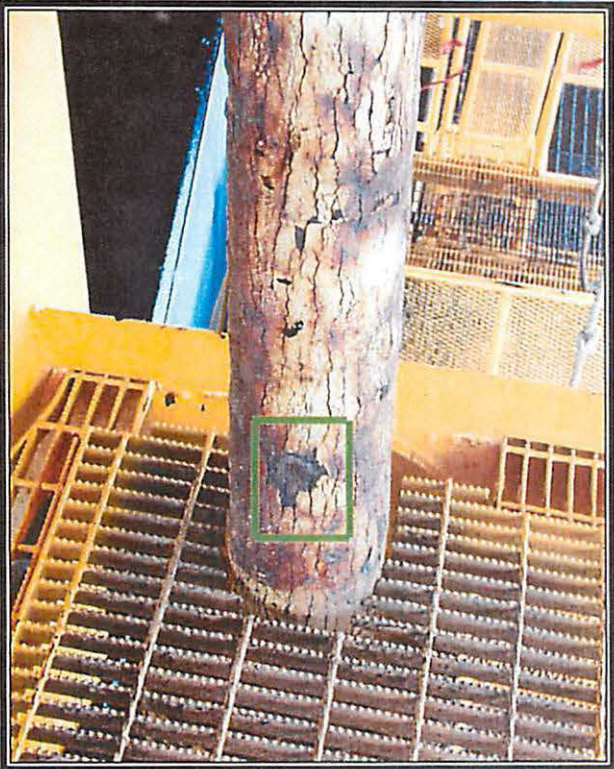
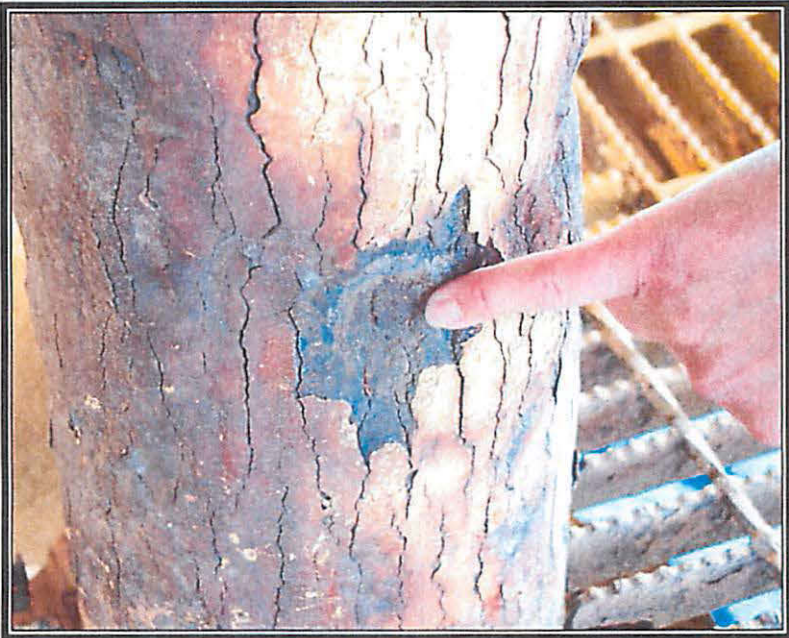
Attachment 5 -- External Corrosion on Riser

Some obvious external corrosion could be seen on the riser (Attachment 5—External Corrosion on Riser). Aera had just completed painting the Platform Elly structure; however, the riser was not repainted because it was operated by Nuevo. Mr. Knowles said that he was not aware of Aera notifying Nuevo of the riser's condition nor were there any procedures in place for Aera to regularly communicate any concerns related to Nuevo's pipeline on Platform Elly.

G-100: "Pipeline riser at Elly was found to be badly rusted and corroded, posing a danger to the environment and to personnel and equipment at Platform Elly."

On July 11, 2002, ultrasonic tests conducted on the riser indicated that there were two areas of "major concern." In the first area, the test found severe external corrosion on the section of pipeline beginning at a weld just above the surf sleeve and extending down to just below the water line. There was no apparent internal metal loss. The second area is located on the pipeline support at the center leg of the platform. The survey showed severe external corrosion/pitting. Damage in these areas was visually verified.

Nuevo should ensure that personnel performing visual inspections of piping and risers are adequately trained to identify corrosion or anomalies and can accurately assess their severity. Documenting the condition of the risers, including videotaping or photographing the risers, regardless of their condition, should be incorporated into the visual inspection program.

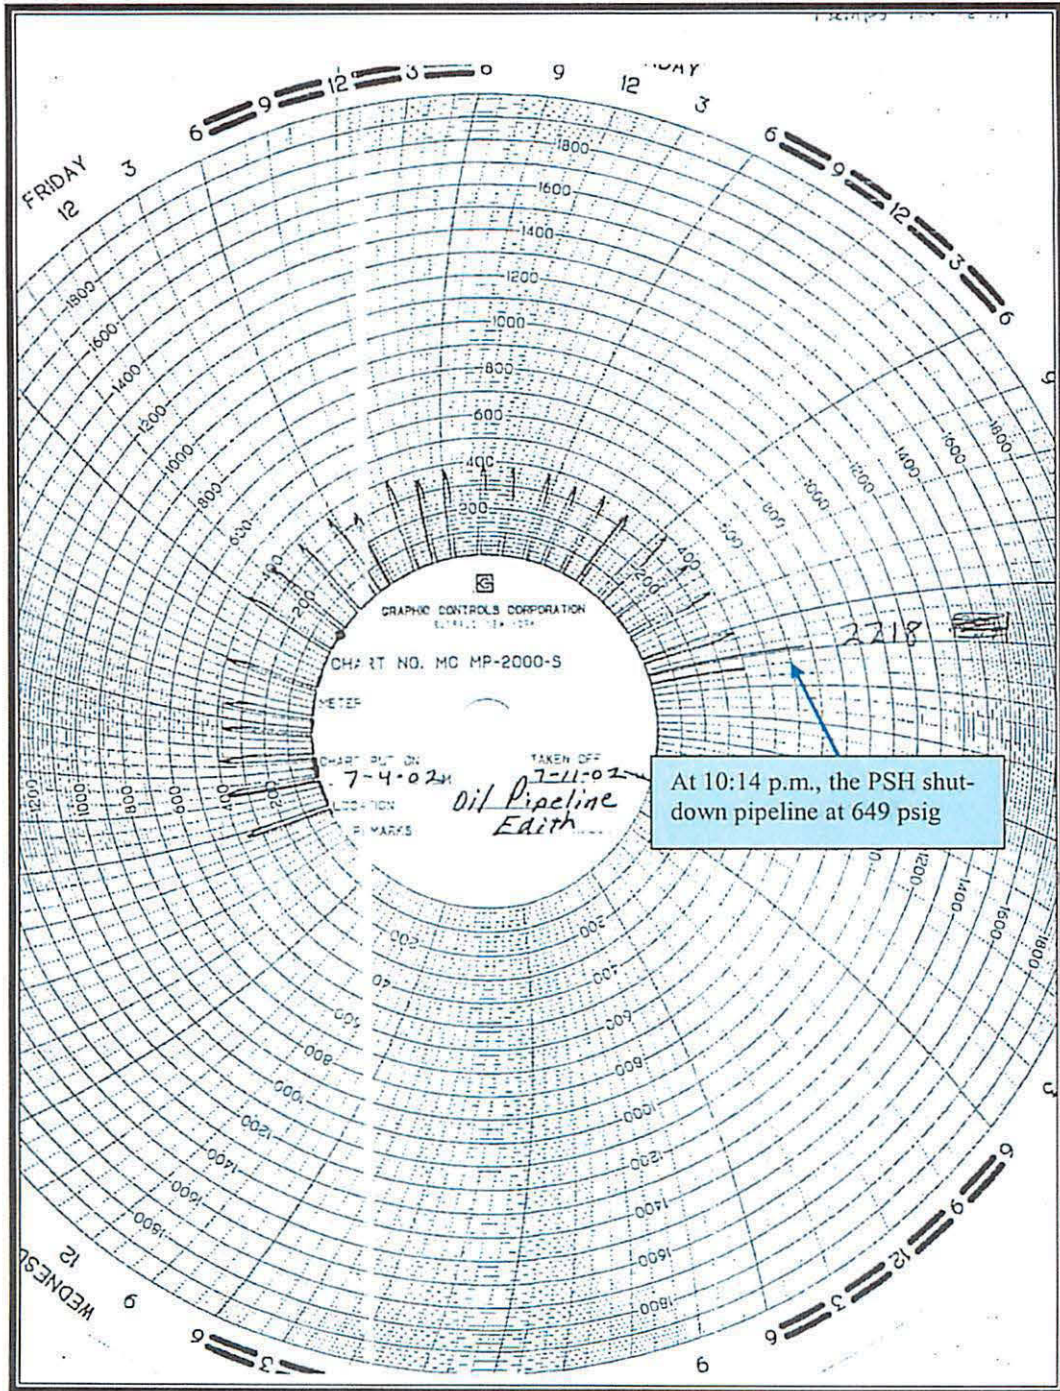
Attachment 6 -- Pipeline Pressure Gauge Chart from July 11, 2002

The July 4-11, 2002, chart from the pipeline pressure gauge on Platform Edith (Attachment 6—Pipeline Pressure Gauge Chart from July 11, 2002) shows that the normal operating pressure was 400 psig and that the pipeline shut in at 649 psig; substantially higher than 15% above the normal operating pressure. Upon further investigation, the MMS determined that the Pressure Safety High (PSH) sensors on pumps P-4 and P-5 were set too high, at 649 psig, and should have been set no higher than 460 psig, per MMS regulations at 30 CFR 250.1004(3).

The oil pipeline's high-pressure sensor located on Platform Edith was set higher than the 15% above the normal operating pressure range specified in our regulations, allowing the riser to experience higher pressures. As the normal operating pressure was approximately 400 psig, the high-pressure sensor should have been set at 460 psig instead of at 649 psig. Had the high-pressure sensor been set correctly, the pipeline pumps would have shut down at a lower pressure, a pressure that the riser's wall thickness may have been sufficient to hold.

Pressure Charts: Under PINC L-106⁵, carefully review the proof pressure charts to ensure that the normal operating pressure range has been correctly identified, that the PSH is set accordingly, and that the pipeline is operating at the normal operating pressure range.
