**Investigation of Blowout and Fire  
East Cameron Block 328  
Gulf of Mexico  
Off the Louisiana Coast  
April 1, 1997**

U.S. Department of the Interior  
Minerals Management Service  
Gulf of Mexico OCS Regional Office

**New Orleans  
March 1999**

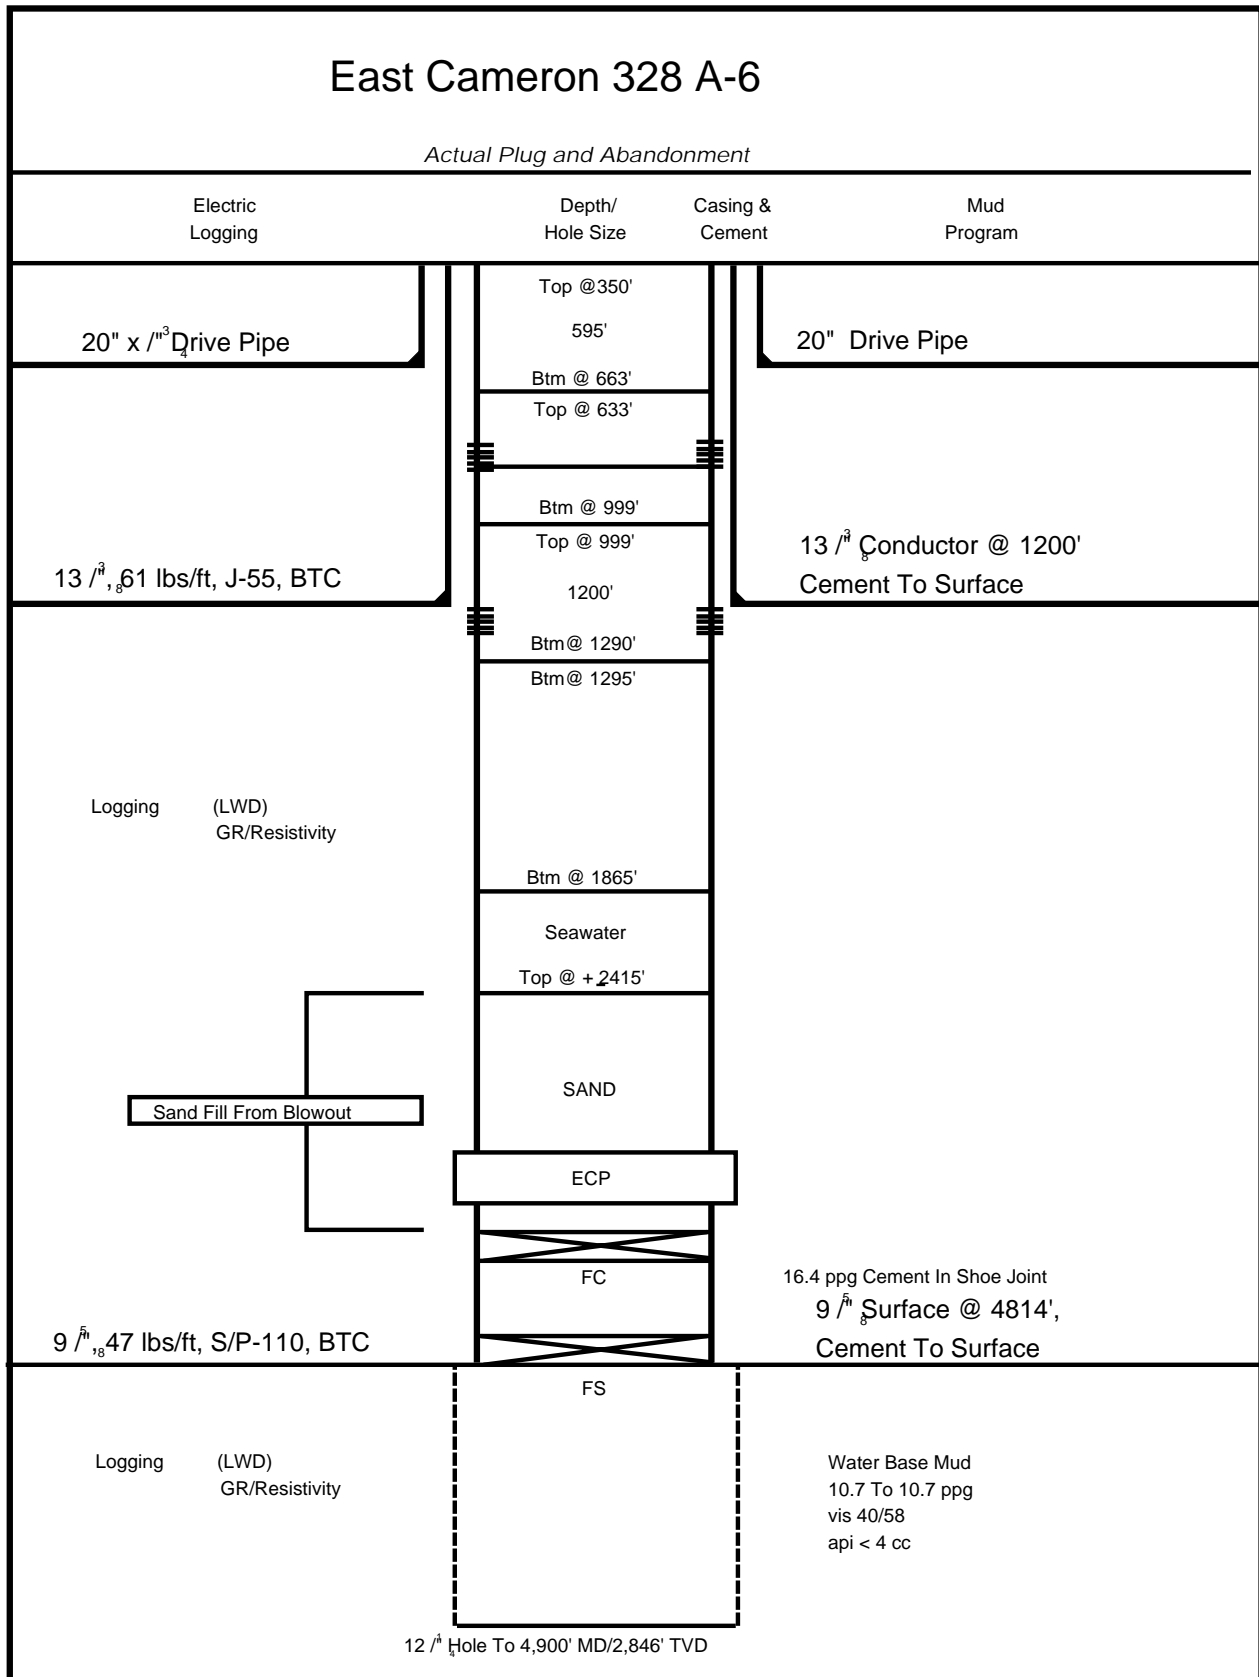
Well Bore Schematic

Formation gas migrated through the cement between the 9 $\frac{3}{8}$ -inch casing and the 13 $\frac{3}{8}$ -inch casing.

1. Temporarily losing returns, as well as noting that the first rubber cement bumped 40 barrels late, may have indicated problems with the cement job.
2. Because of the well being drilled horizontally, the casing may not have been properly centralized, resulting in a nonuniform cement job.
3. The effect, if any, of the ECP not behaving as expected, and presumably rupturing, is unclear.
