OCS Report  
BSEE 2012-01

# **Investigation of Fatal Fall West Cameron Block 643, Platform A Lease OCS-G 02241 18 April 2011**

**U.S. Department of the Interior  
Bureau of Safety and Environmental Enforcement  
Gulf of Mexico OCS Regional Office**

**New Orleans  
April 2012**

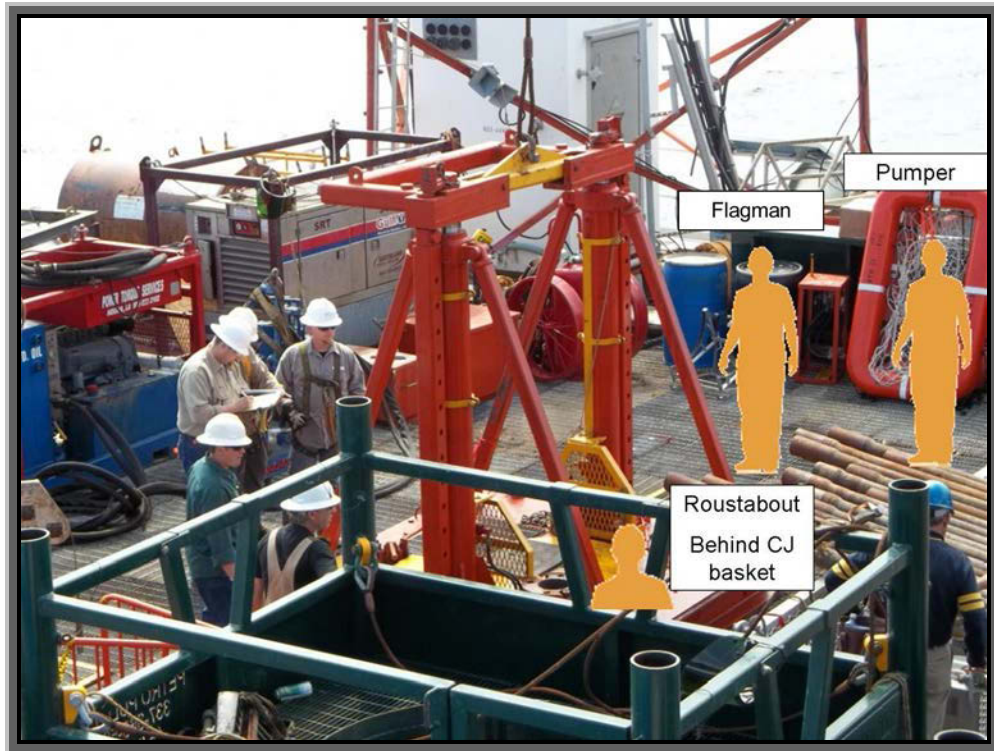
The Flagman was signaling the Crane Operator and was positioned on the far side of the PS, in the path of the direction of planned movement. The Pumper began moving hydraulic hoses out of the way of the lift from behind the Flagman. The Roustabout was positioned next to the PS on the crane-side of the PS, opposite from the direction of movement (*see figure 7*). None of the personnel were wearing fall protection gear.

**Figure 7 – Location of night shift crew at start of lift**

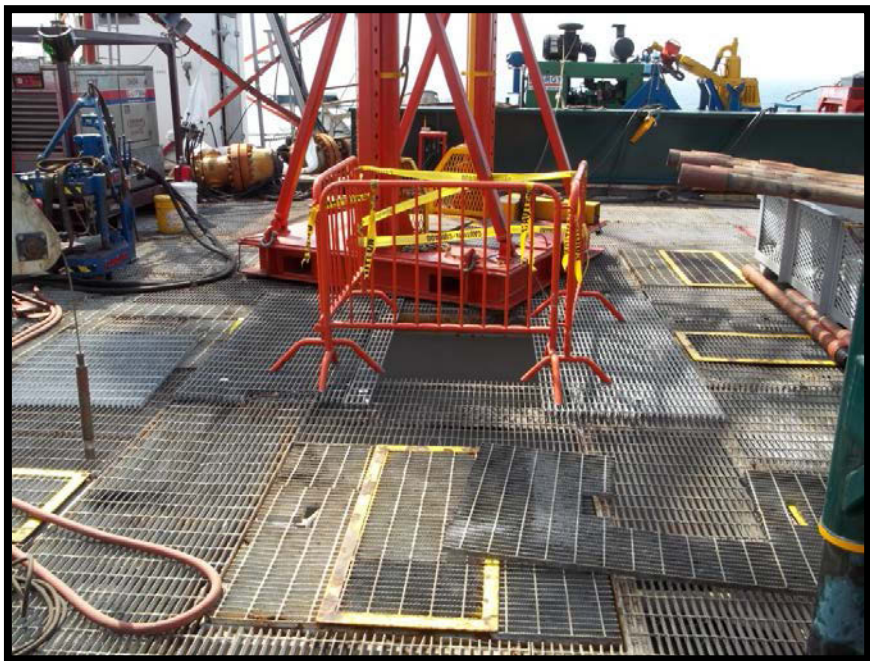
Prior to the Accident, the PS skid was positioned over the Well, fully covering an opening in the main deck that allowed access to the Well. This opening, or hole, had been created by removing deck grating. The access hole in the main deck observed by BOEMRE inspectors on 22 April was approximately 3-ft x 4.25-ft, the apparent original opening of approximately 7-ft x 4-ft being reduced in size by the addition of two sections of loose grating (see figure 9).

**Figure 9 – Main deck opening (hole) and barricades, morning, 18 April**

the existence, dimensions, and hazards of the hole were not discussed in the shift-change JSA meeting or in the pre-lift tool box safety meeting by the night shift, according to written statements. It is not clear if the Supervisor of the night shift inspected the work site prior to the lift.

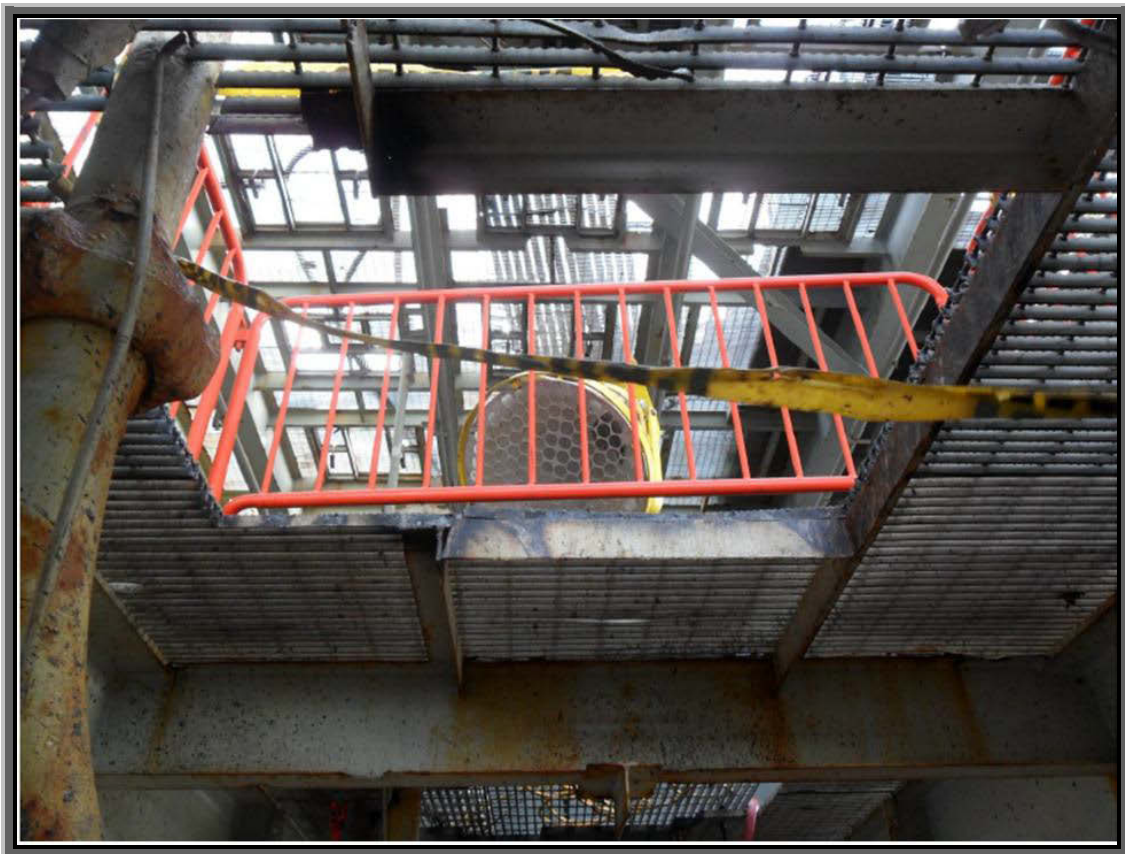
The production deck, located approximately 14-ft below the main deck, also had an opening created by removing grating. This hole was approximately 6-ft x 6-ft and according to statements, access to the opening from the production deck was entirely protected by barricades at the time of the accident (*see figure 10*).

***Figure 10 – Hole in production deck, Roustabout passed through this hole during fall***

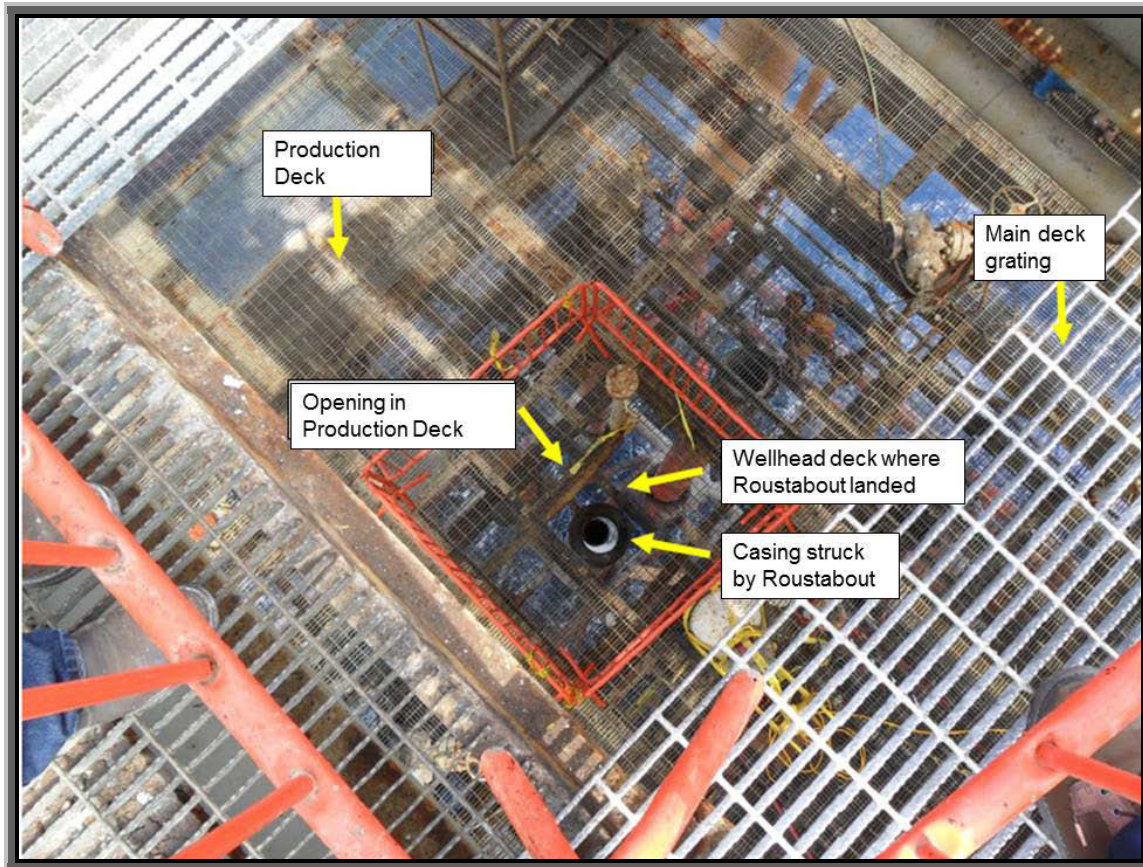
Approximately 15-ft below the production deck was the cellar or wellhead deck through which the stub of the Well protruded. Witness accounts and physical evidence indicates the Roustabout fell through the opening in the main deck, continued through the hole in the production deck and impacted the casing stub on the wellhead deck (*see figure 11*).

**Figure 11 – View through holes in main and production deck, fall path**

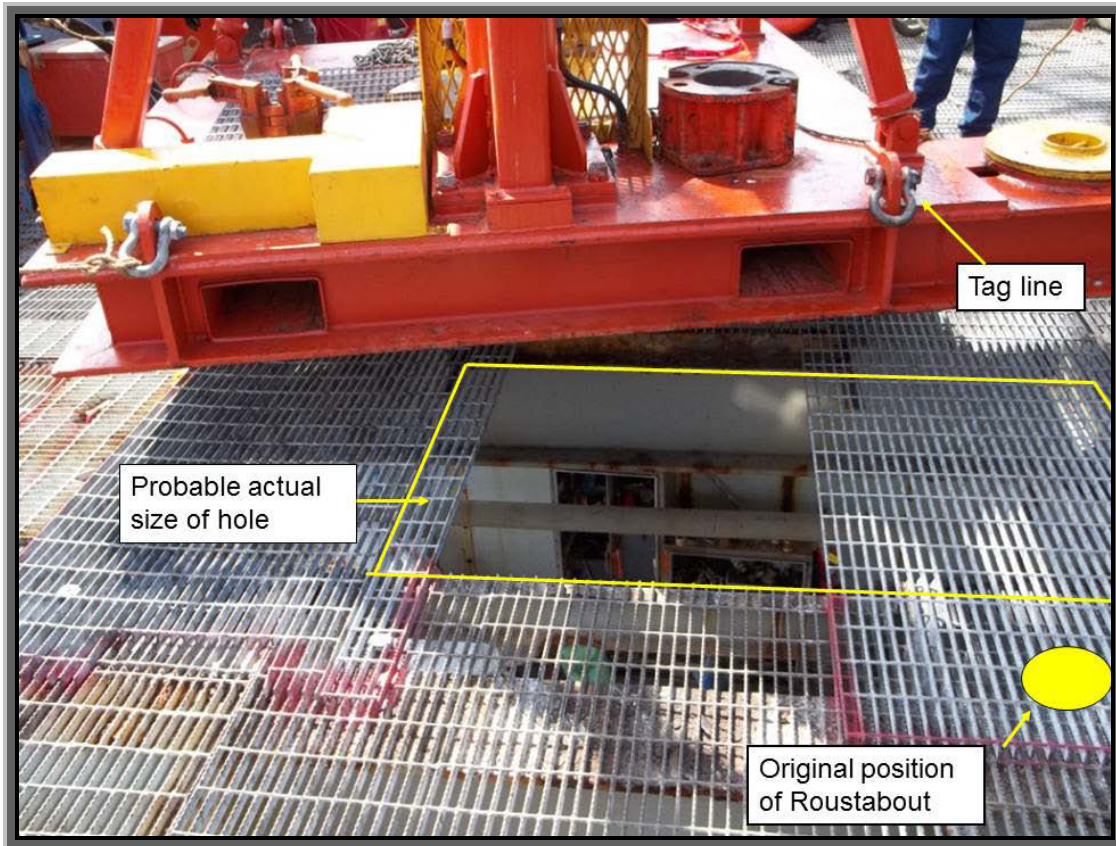
From statements by the Supervisor, the main deck opening had been barricaded immediately after the Accident. Statements from several of the crew and management were given that the reduced hole size 3-ft x 4.25-ft, was what existed at the time of the Accident. However, other statements were given that the hole at the time of the Accident was actually the larger 4-ft x 7-ft, and that the sections of new grating had been added to provide a base for the barricades. A statement was made that the number of barricades available on the Platform was limited, requiring reduction in the perimeter of the main deck hole to be covered by the barricades, hence the post-Accident added grating (*see figure 12*).

**Figure 12 – Probable size of hole in main deck beneath power swivel**

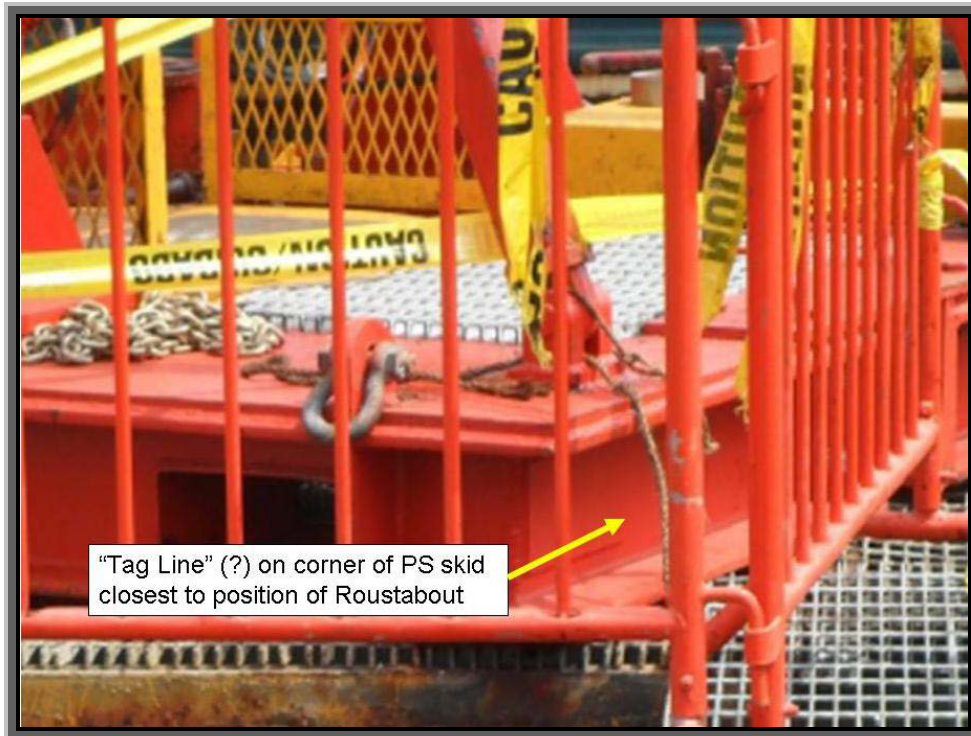
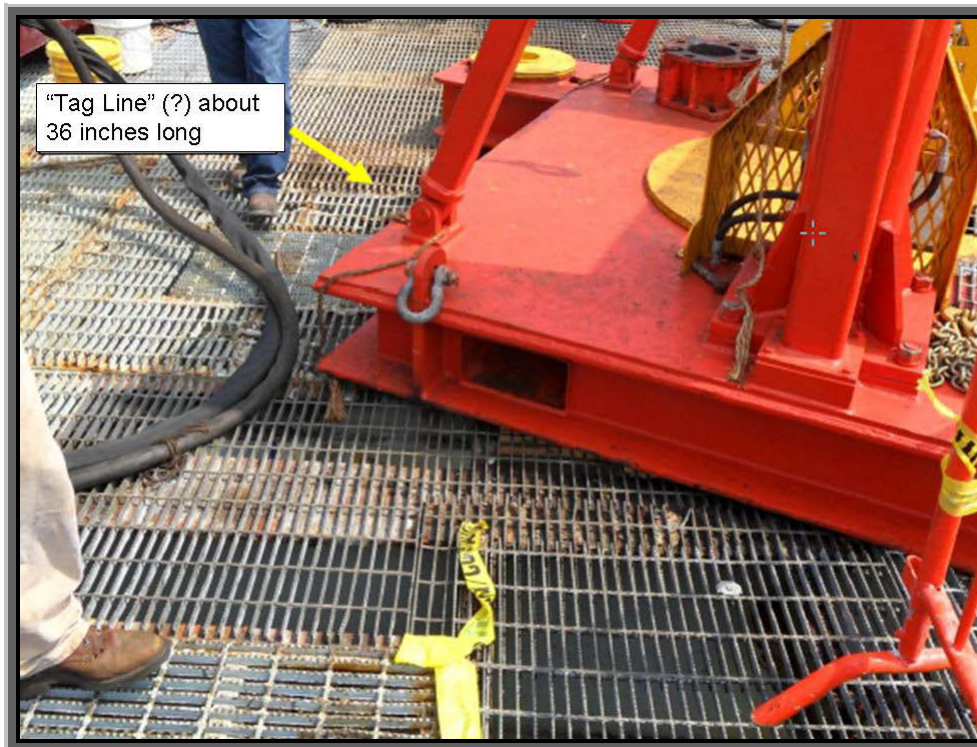
When photographed and examined four hours after the Accident, the PS skid was found to have two, 3-ft long pieces of rope with frayed ends, attached to opposite corners and used as tag lines to control the load. During the reenactment four days after the Accident, statements initially were made that the tag lines had been longer, 5-ft, when the Accident occurred, but that they “*had been cut when the PS was set down unexpectedly.*” These explanations were not repeated in subsequent interviews, nor were explanations offered how this “cutting” of the tag lines could occur (*see figures 13, 14*).

*Figure 13 – Original tag lines on power swivel, Roustabout corner*

*Figure 14 – Original tag lines on power swivel, Flagman corner*

(3) The load had only a 3-ft long tag-line, attached to the PS in an inherently dangerous location. Movement of the load caused the tag line to drag across the open hole.

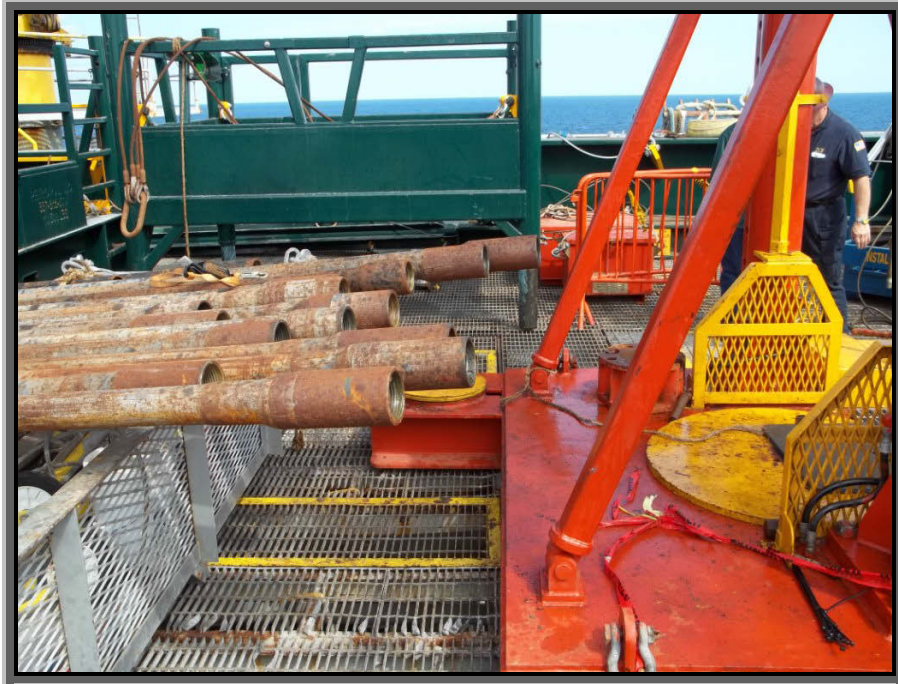
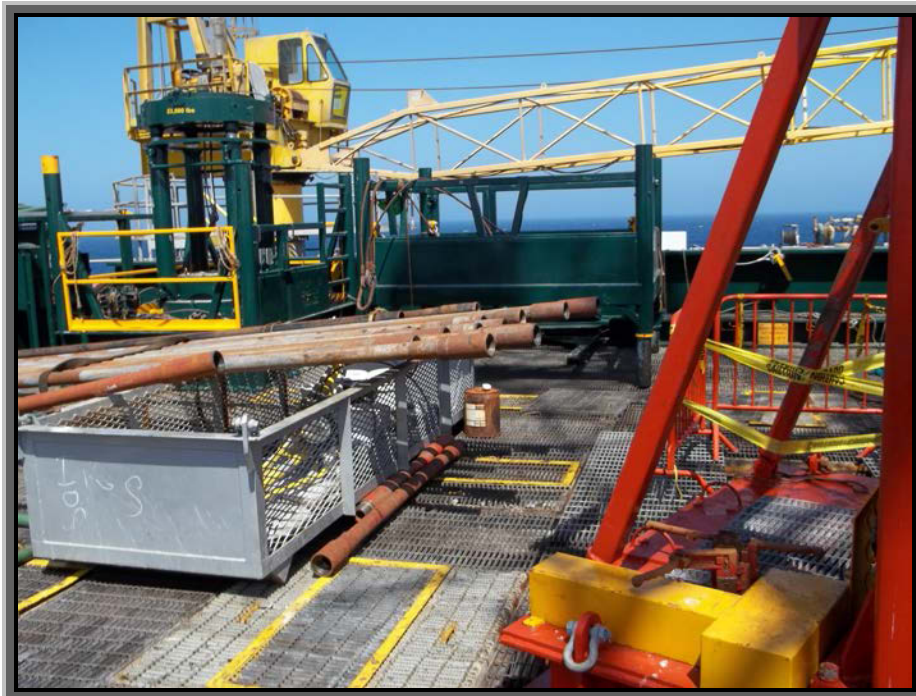
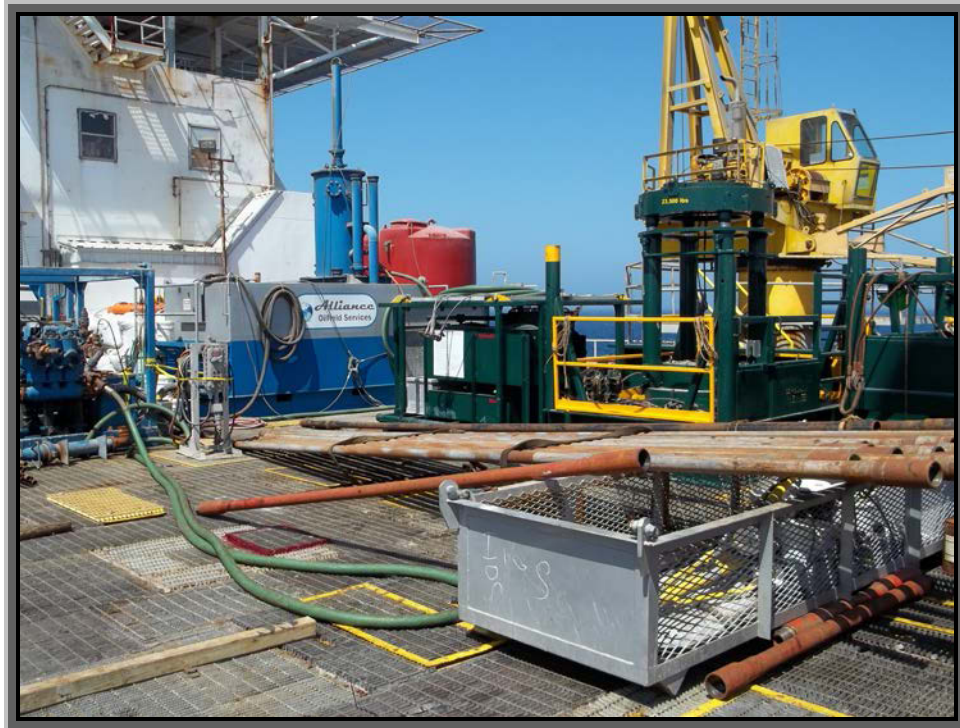
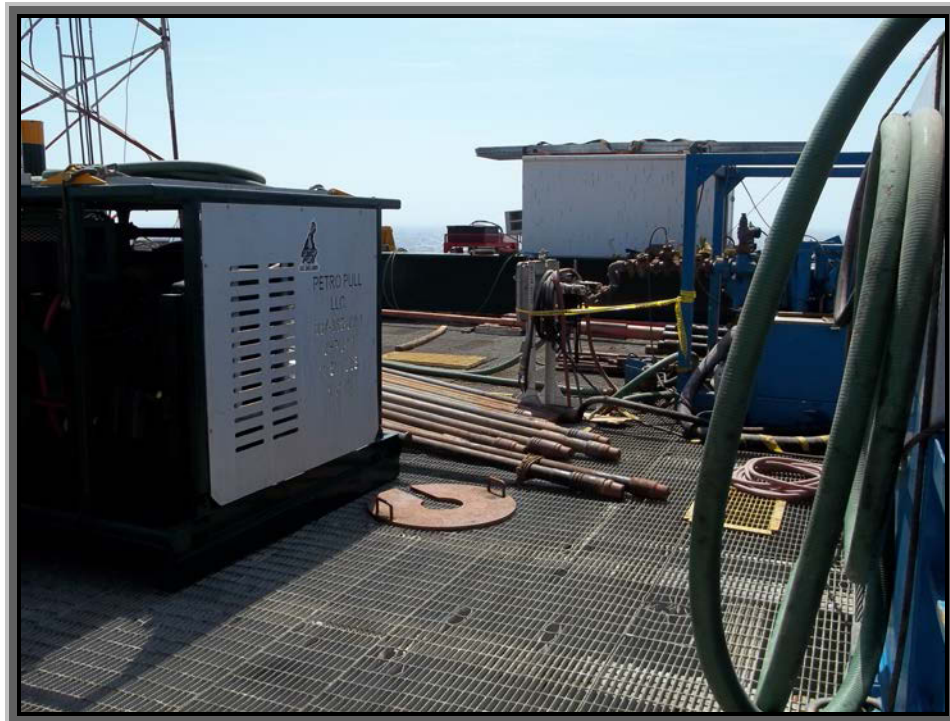
As individual joints of pipe from the work string were broken out, they were laid down across the equipment basket, box end toward the PS, pin end resting on the grating of the deck. There was no actual pipe rack skid. There were no stops on either side of the row of pipe to prevent joints from being rolled off the basket sideways, other than the approximately 2-in high pad-eyes on the ends of the equipment basket prop. There were no other side guards in the pipe rack area that would prevent the pipe from shifting laterally.

There was no “stop” at the end of the work string pipe lay-down area to prevent the laid down pipe from shifting lengthwise, contacting the tank. Apparently, each joint was “tailed” into position when being laid down. The “rack area” was further constricted by the location of a power control panel, hoses, and other equipment apparently associated with a skid-mounted pump that was situated about 25-ft behind the basket prop for the pipe. The positioning of this device required the pipe to be slightly angled on the basket-prop rather than being laid down at right angles.

The box end of the pipe in the “pipe rack” extended beyond the edge of the storage box-prop and overhung the base of the PS skid when it was emplaced over the hole in the main deck. This overhang of the racked pipe required the lift of the PS by the crane to be closely monitored and manually controlled to keep the PS skid from hitting the racked pipe (*see figures 15-18*).

*Figure 15 – Pipe in “pipe rack” overhanging PS skid*

*Figure 16 – End of pipe in rack overhanging hole in main deck*

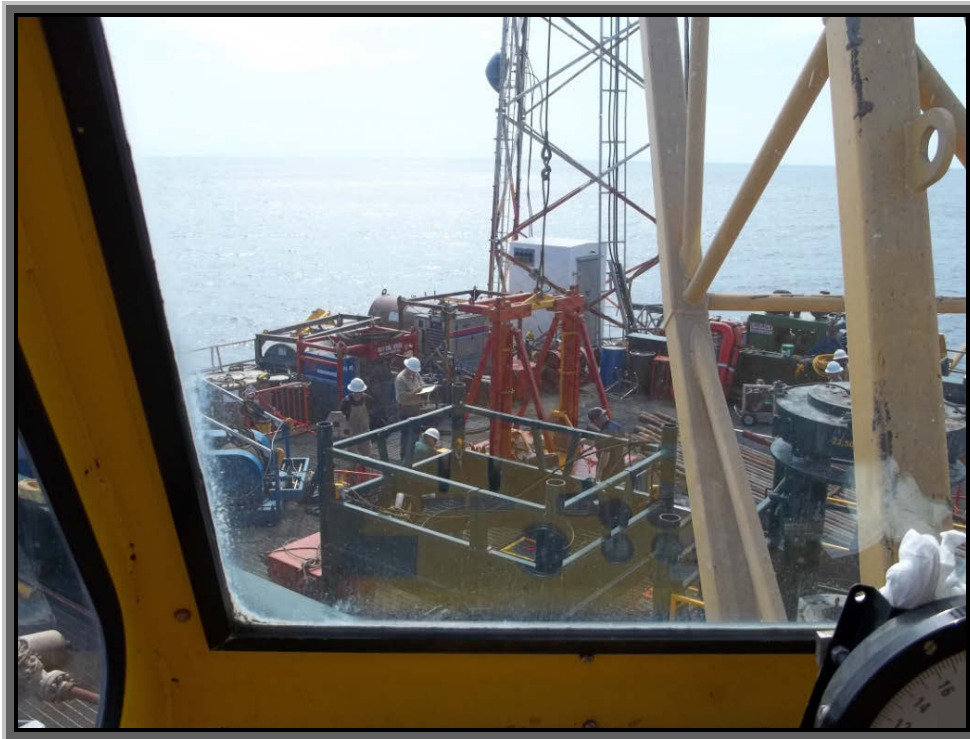
The storage position for the upper casing jack basket (UJB) on the Platform was directly between the crane control cabin and the A-2 Well work site. (See figure 19.)

**Figure 19 – View from crane**

From the crane cabin, the view of the lift site was restricted by the positioning of the UJB. The Flagman was positioned in clear sight on the far side of the PS. However, the Crane Operator's view of the Roustabout was partially hidden by the UJB. Neither the base of the PS nor the hole beneath the PS were entirely visible from the crane console.

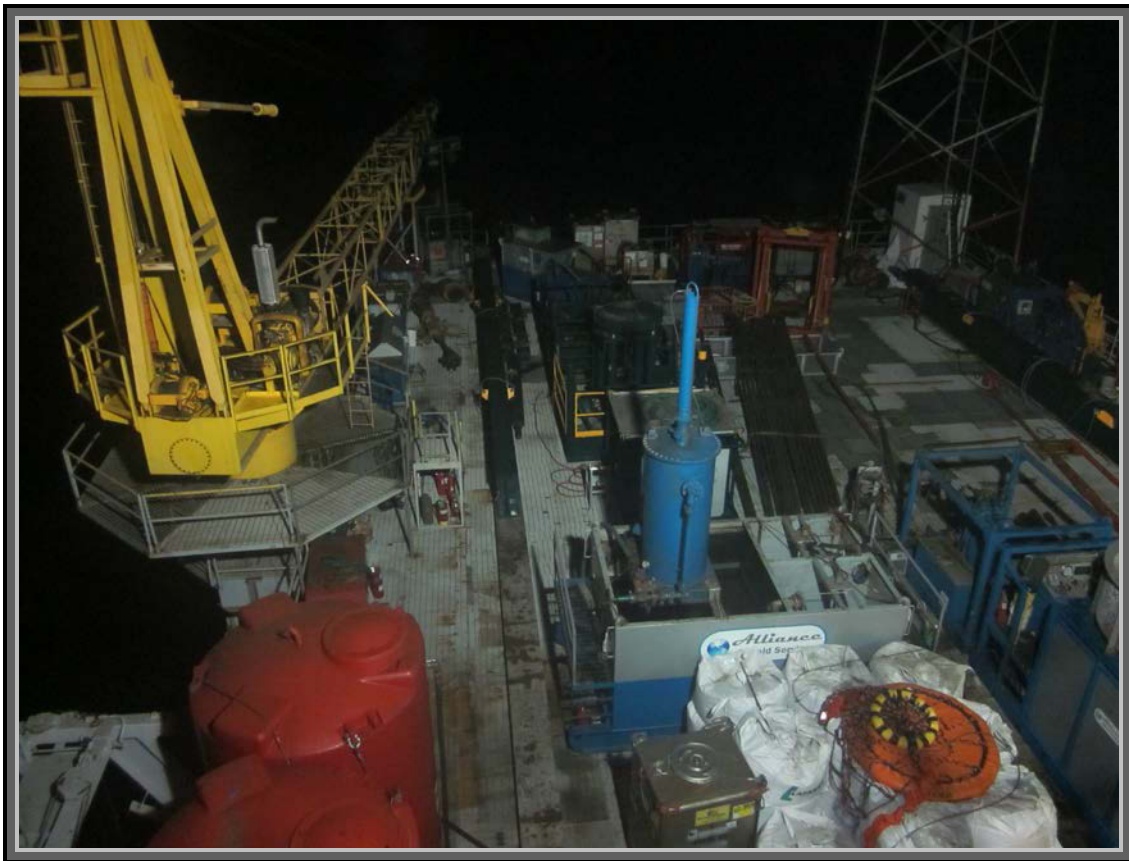
However, the lights were apparently not located in a 360-degree circle, but rather concentrated in two areas, directed from the stand in the northeast corner and from the west atop the living quarters. A night photo taken with just the lights on the living quarters indicates the illumination available from those lights without the addition of the four lamps on the stand. From observation in other venues, the primarily directional source of the lighting could create a significant shadowing effect across the main work deck.

*Figure 20 – View at night with only living quarters lights*

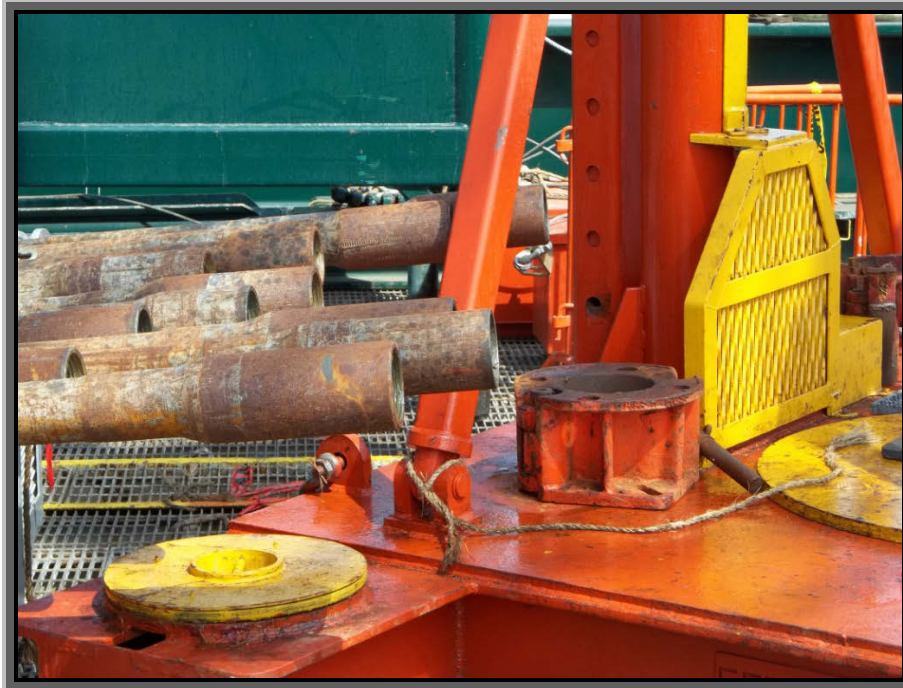
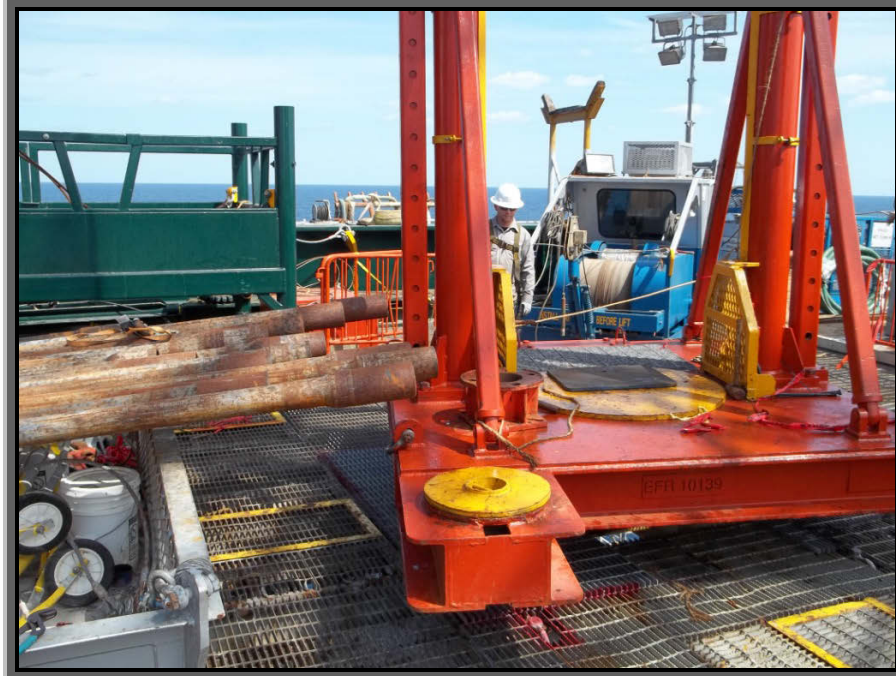
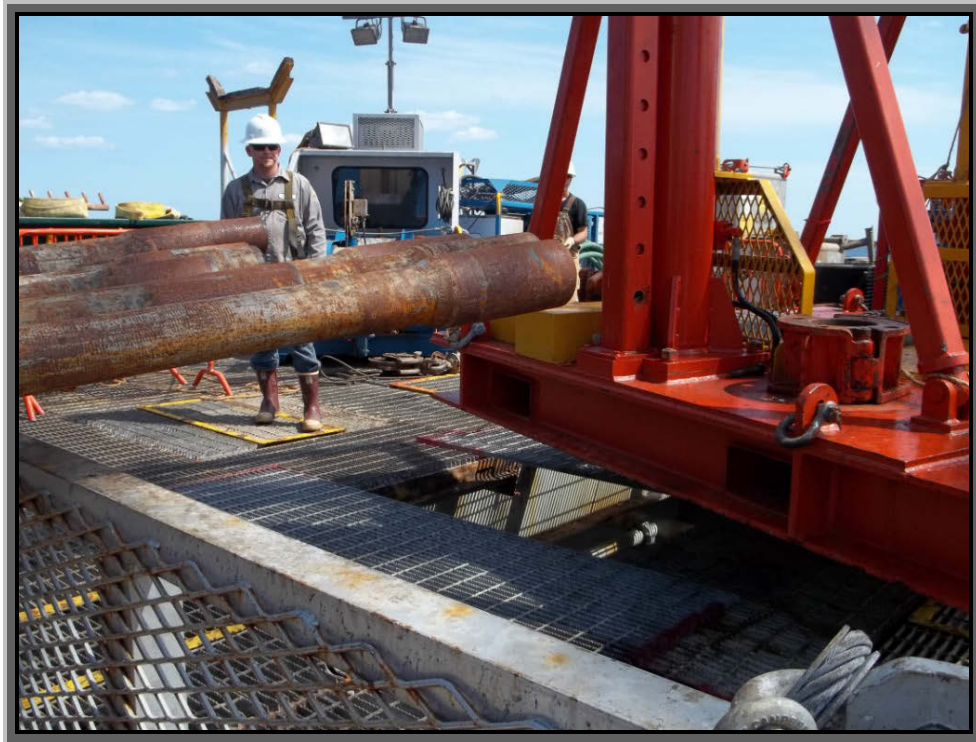
The Rigger signaled the Crane Operator who raised the load about a foot. Upon being signaled to boom up, the Crane Operator raised the load again about two feet and almost impacted the extended racked work string box ends laid in the “pipe rack area” (*see figure 29, p. 33*). With the help of the riggers on the tag lines, the load was maneuvered outside the racked pipe, and boomed down toward the intended storage area. It was then lowered back to the deck without incident.

*Figure 27 – Reenactment: PS & “pipe rack” obstruction during lift*

*Figure 28 – Reenactment: PS & “pipe rack” obstruction during lift (two)*

*Figure 29 – Reenactment: PS & “pipe rack” obstruction during lift (three)*

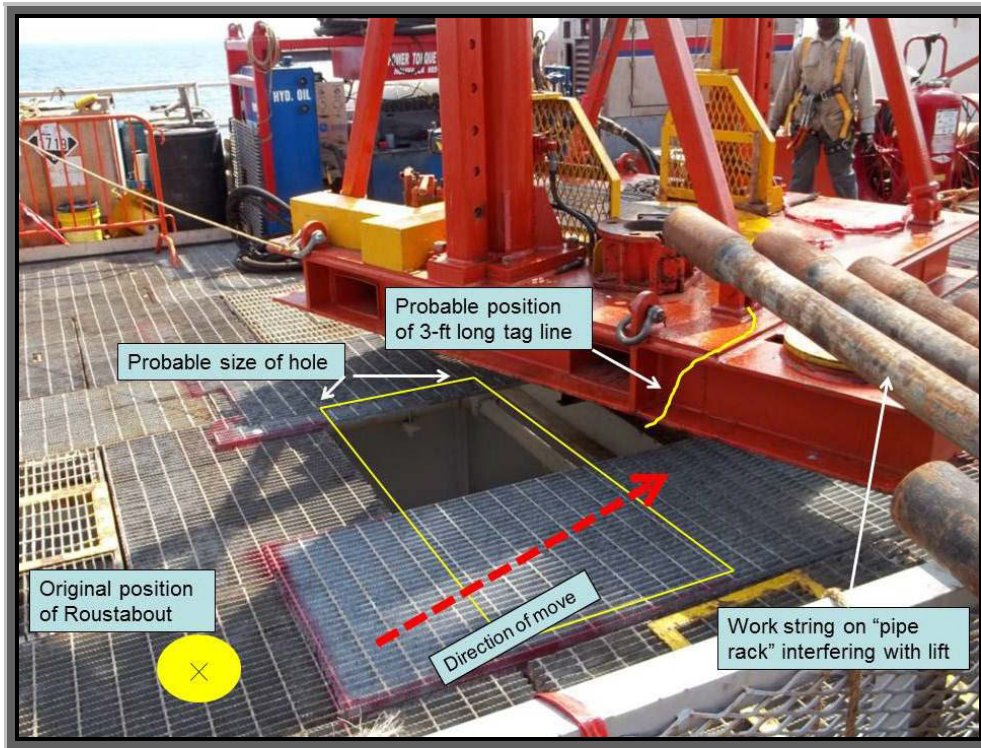
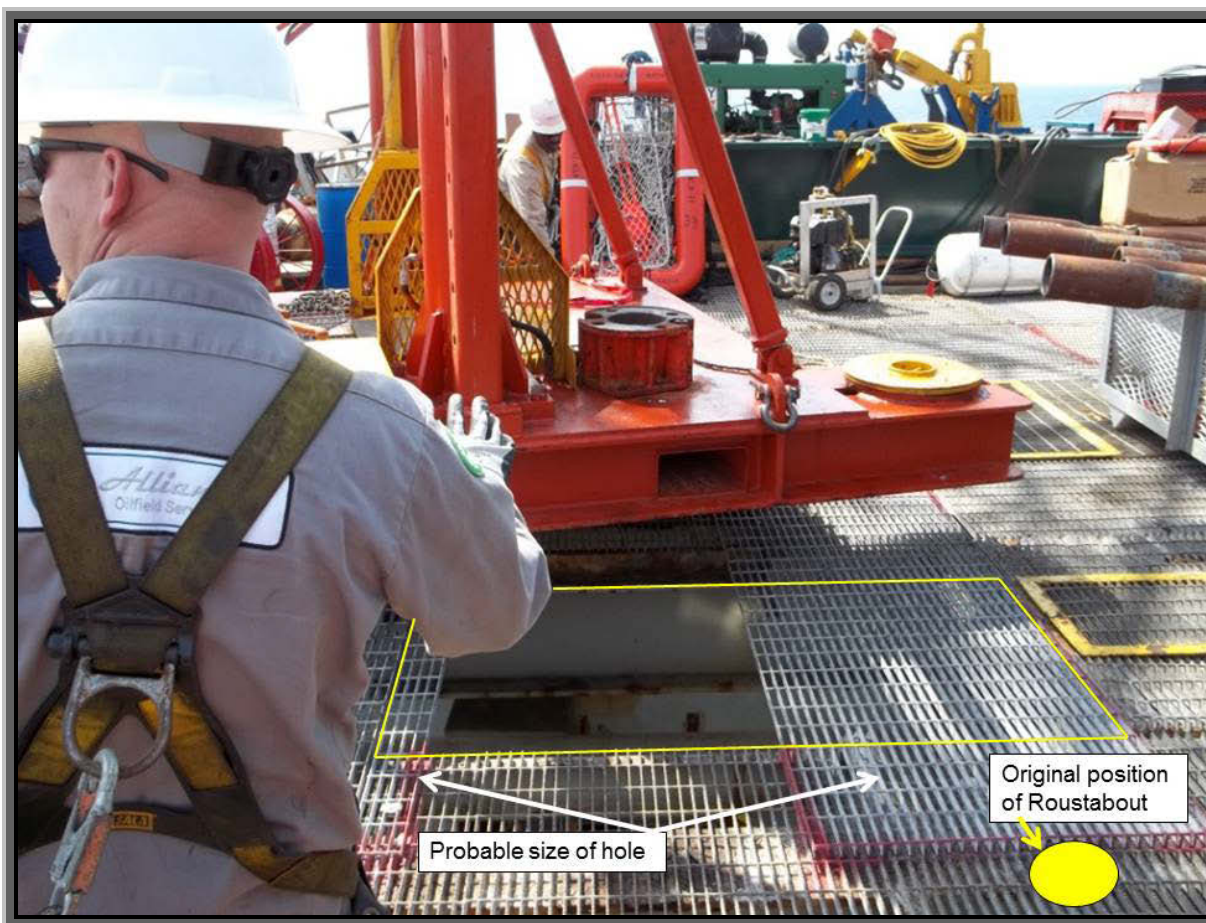
*Figure 30 – Reenactment: maneuvering PS and exposing open hole*

**Figure 31 – Reenactment: maneuvering PS and exposing open hole (two)**
