**Boom Hoist Wire Rope Line Failure Results in Fatality  
High Island Area Block A557, Platform “A”  
OCS-G 03484  
16 August 2011**

**Gulf of Mexico OCS Region**

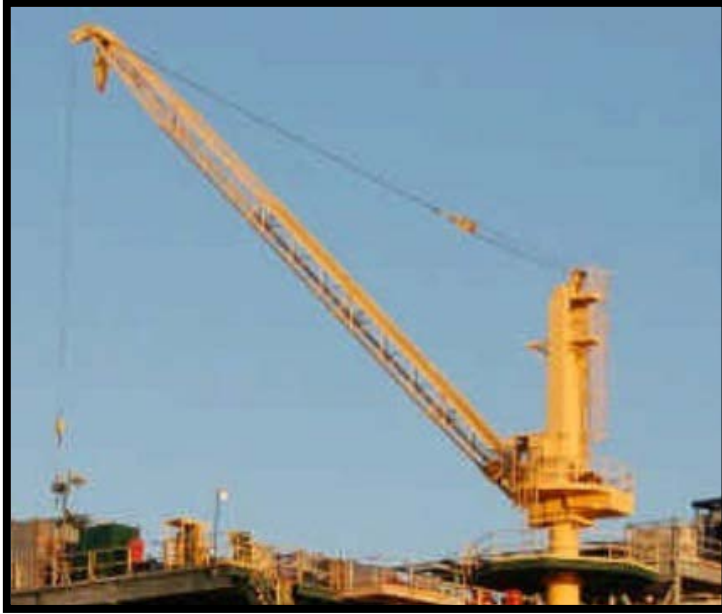
**Figure 6 – SeaKing Model 1400 Crane on Platform**

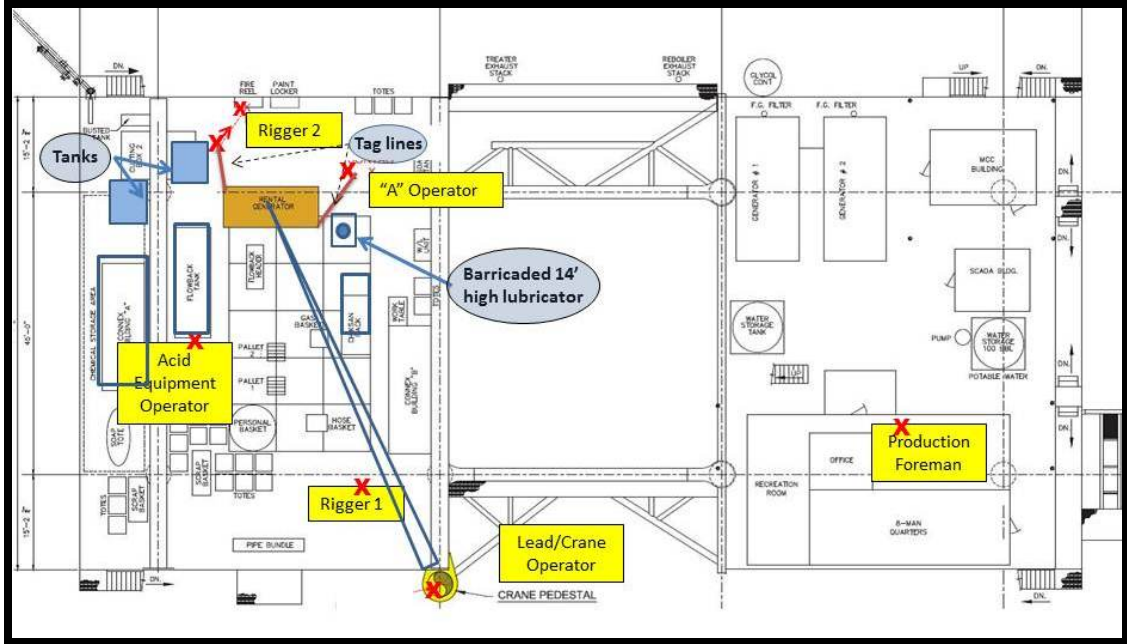
**Figure 12: Positioning of personnel and equipment during lift**

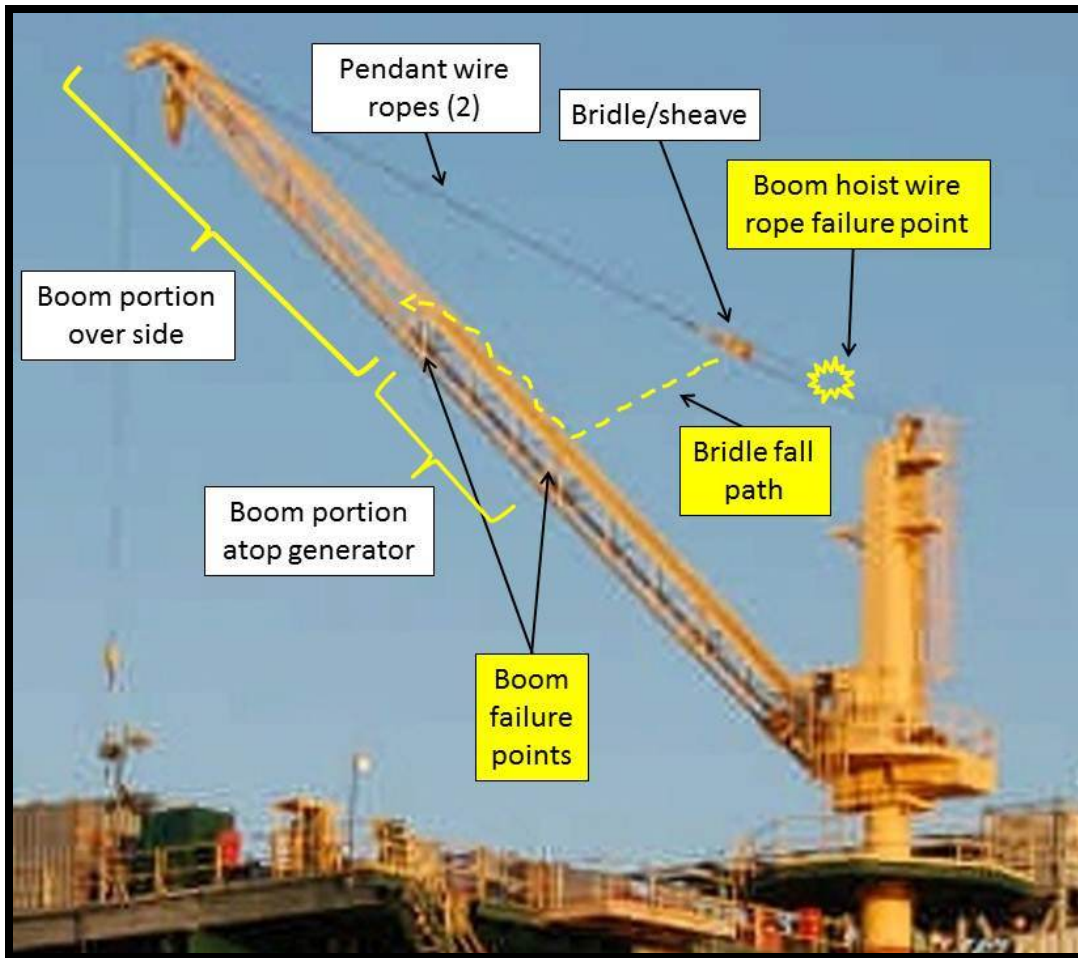
**Figure 20 - Crane and failure points**

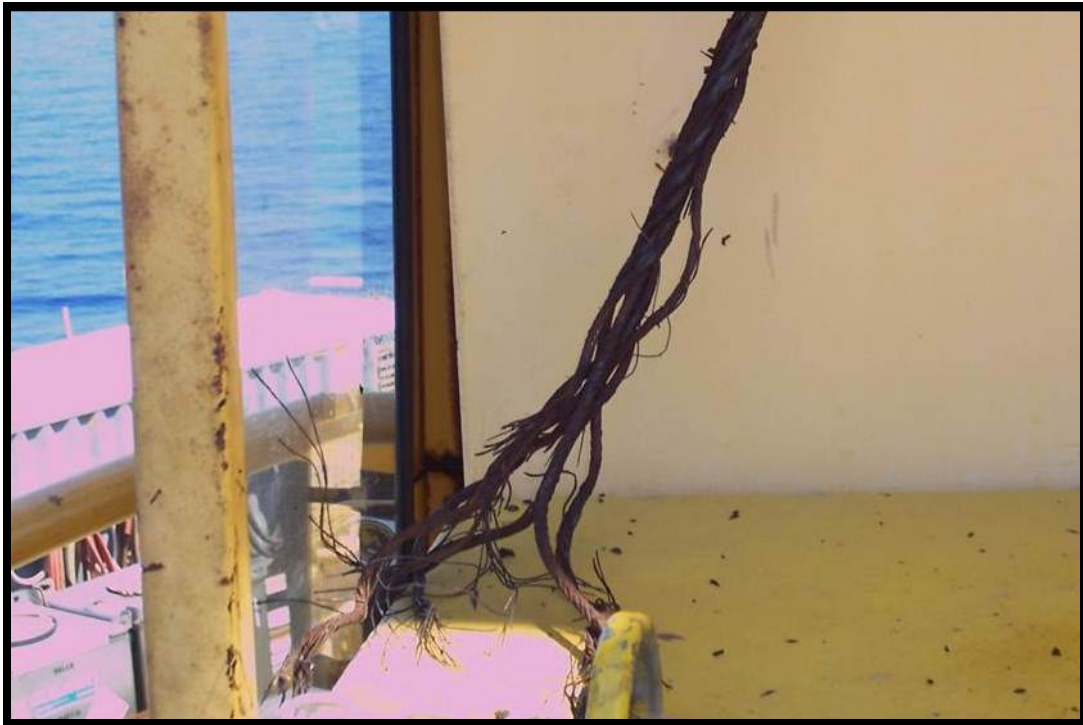
**Figure 24 – End section of failed boom hoist wire rope**

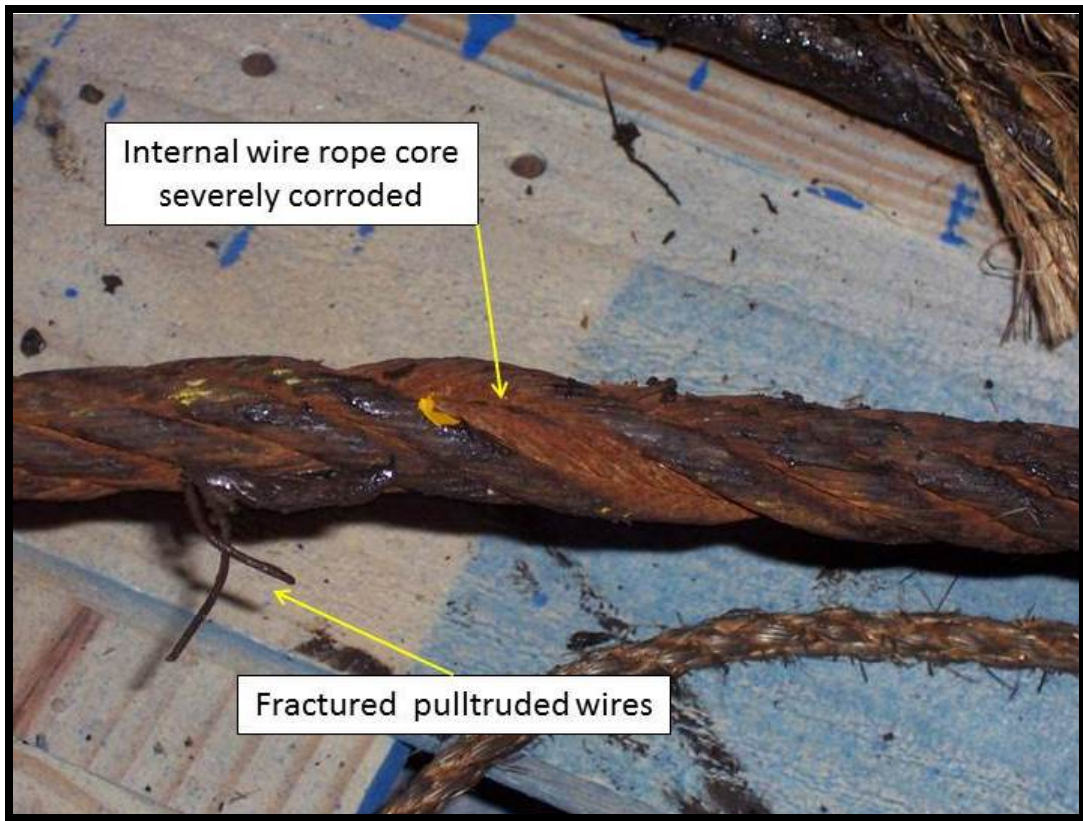
**Figure 25 – Section of failed boom hoist wire rope with evidence of severe oxidative corrosion to the core**

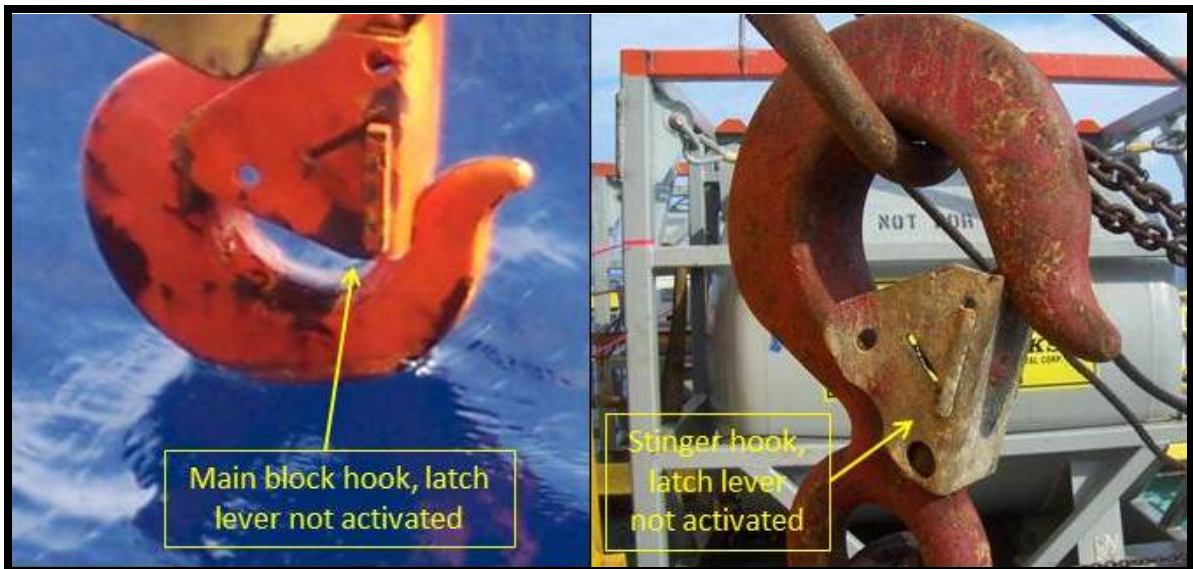
**Figure 29 – Crosby hooks post-Accident, “latching” levers not engaged**

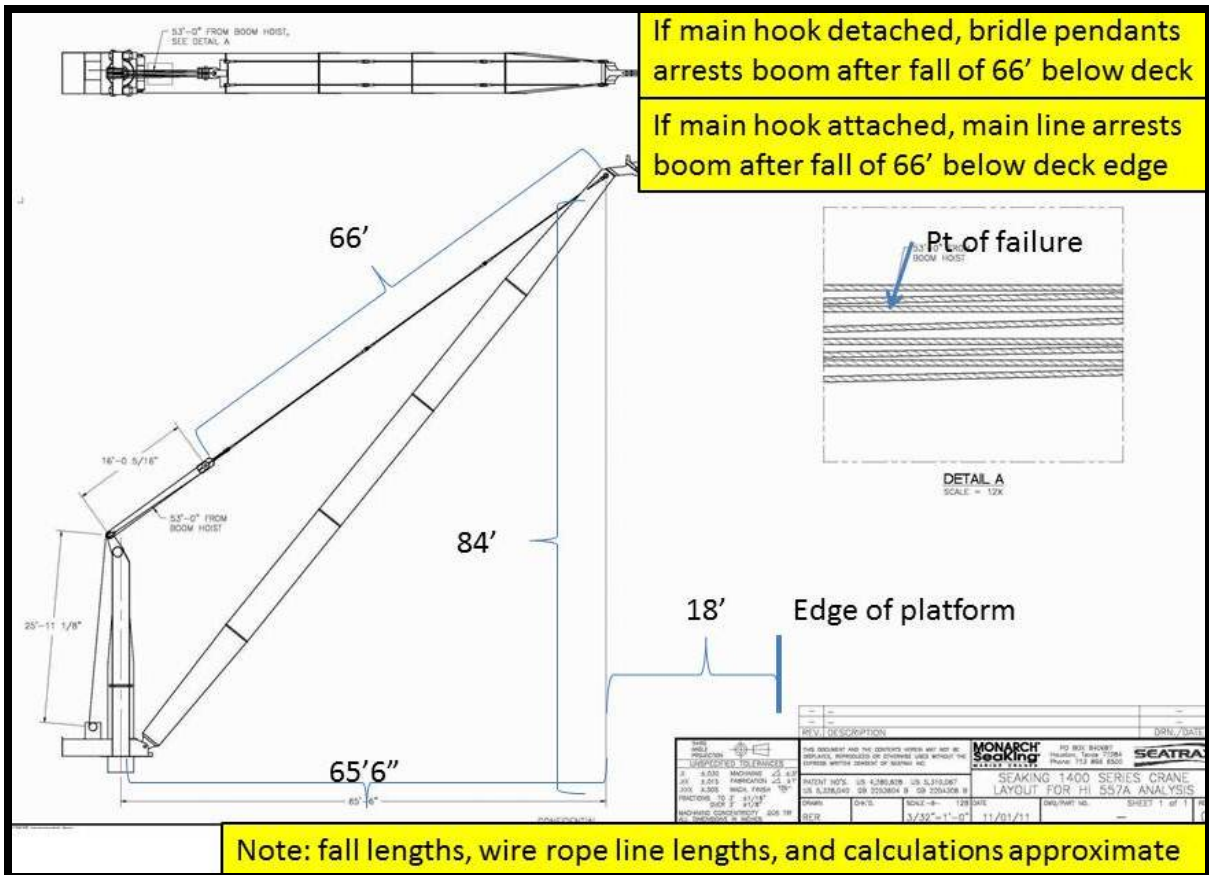
Figure 30 – Diagram: components, wire rope, edge of platform (base diagram from ERT)
