OCS Report
MMS 2005-017

**Investigation of Loss of Well Control and Oil Spill,
Platform Gail, Channel Islands Block 4661, Lease
OCS-P 0205, November 18, 2004**

**Pacific OCS Region
Off the Coast of California**

U.S. Department of the Interior
Minerals Management Service
Pacific OCS Region

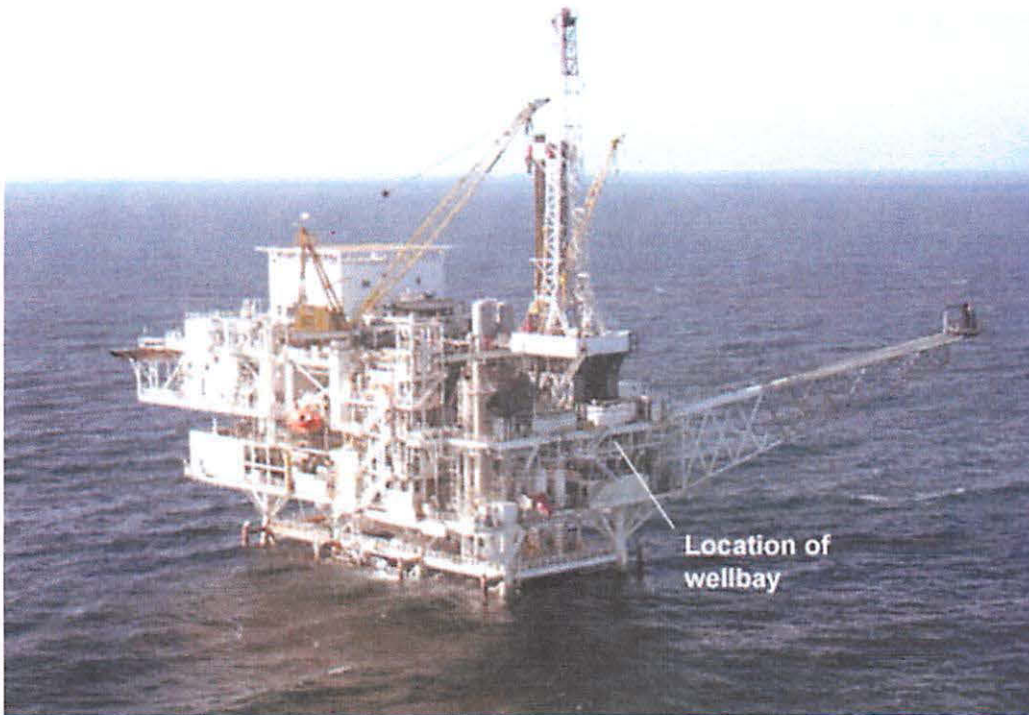
Platform Gail, showing location of wellbay.

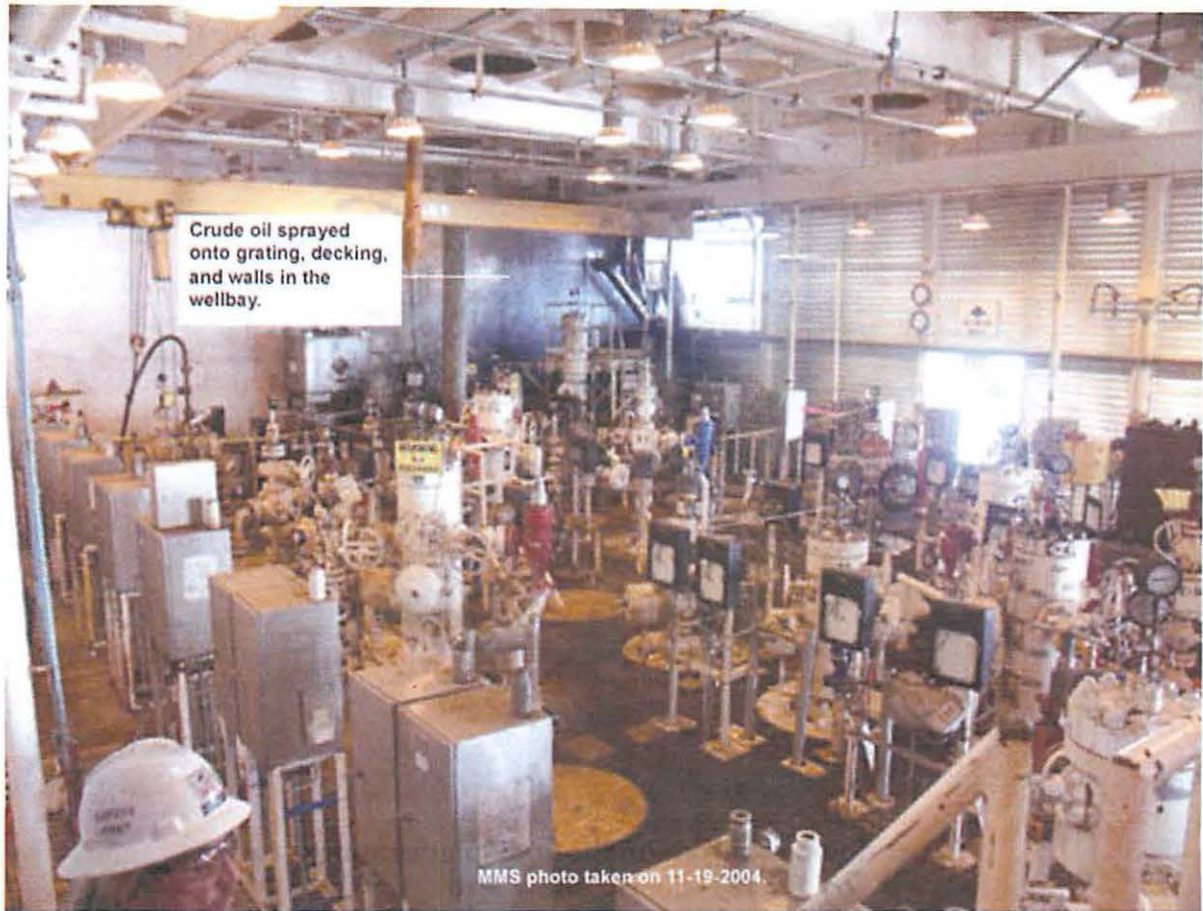
that were subjected to the oily discharge from the well. All surfaces in the immediate area of the well were covered with a thick, oily residue, but no actual damage to any of these components was found.

MMS offshore platform showing crude oil sprayed onto grating, decking, and walls in the wellbay.

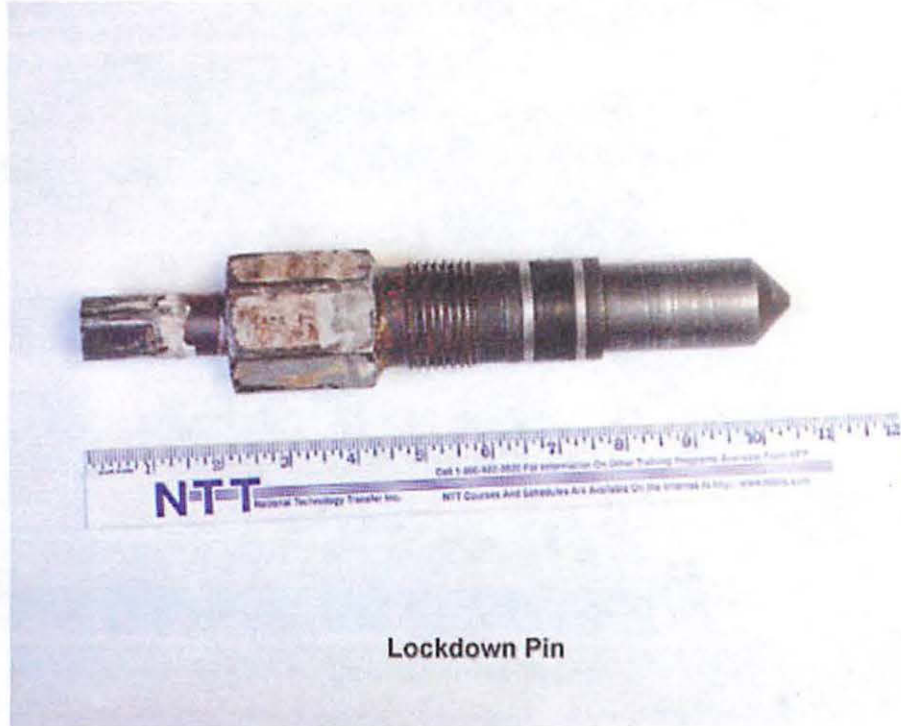
Lockdown Pin

Second, the tubing hanger lockdown pin was completely removed from the wellhead assembly. Removal of this pin circumvented the blowout preventer system and provided an exit point for the wellbore fluids.

Lockdown pin from offshore oil platform next to 12" ruler to show size.

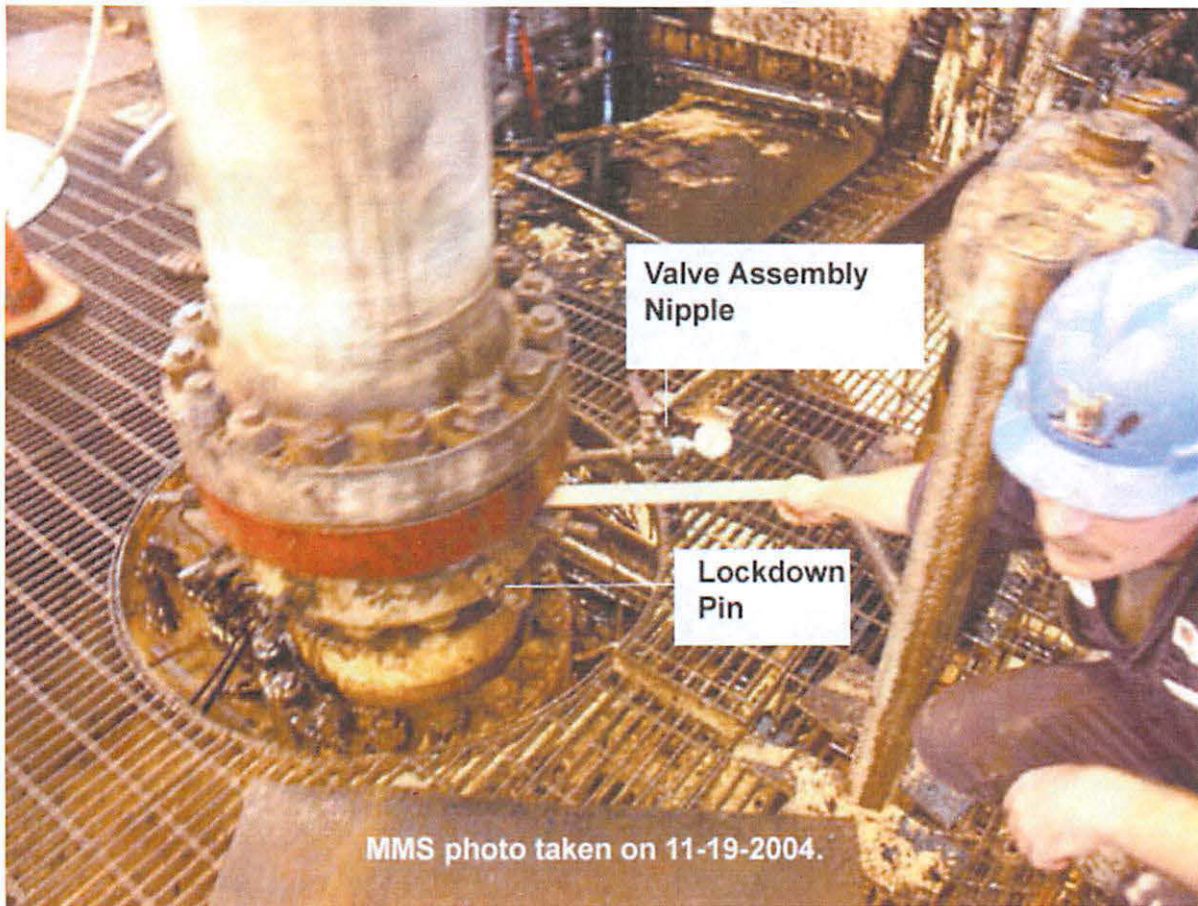
Photo showing valve assembly nipple and lockdown pin on offshore oil platform.

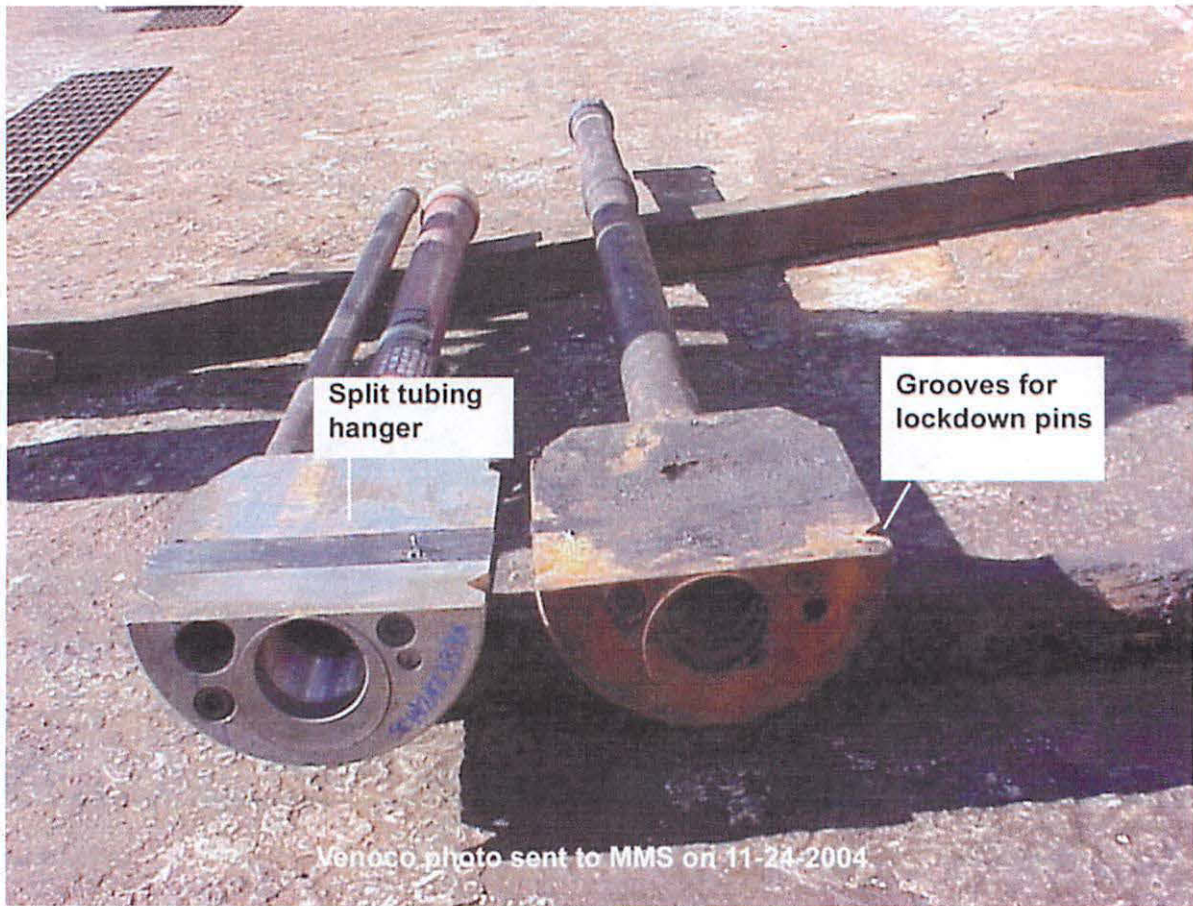
Photo showing split tubing hanger and grooves for lockdown pins on offshore oil platform.
