**Investigation of Fatal Accident  
Lift Boat-Coil Tubing P&A  
Main Pass Block 98, Well No. 3  
OCS-G 5694  
12 August 2005**

Gulf of Mexico  
Off the Louisiana Coast

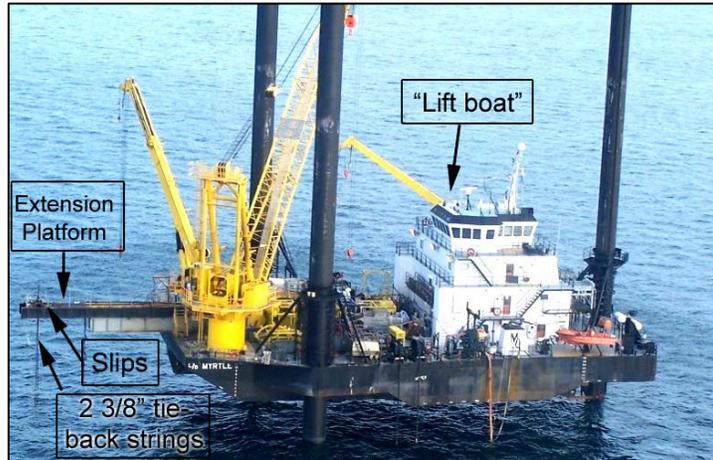
Figure 2: Lift boat, extension platform

platform (the Extension Platform) attached to the bow of the Lift Boat (*see figure 2*). A coil tubing unit was being rigged up on one of the tie-back strings above the Slip Bowl, preparatory to washing mud and testing the tie-back overshot connection.

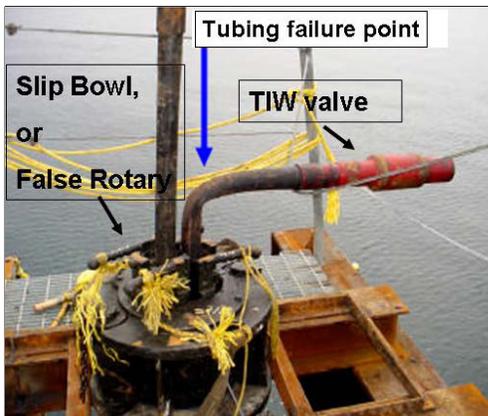
BOP Assembly being recovered from GOM

Approximately at 0012 hrs, 12 August 2005, after the CTU Blowout Preventor (BOP) stack and other equipment (the BOP Assembly) had been installed, the crane was disconnected from the BOP Assembly in preparation for the next lift in the CTU rig-up operation. The boat was felt to shake and the CTU BOP Assembly swayed. Then the tubing to which the CTU BOP Assembly was attached bent sharply. The CTU BOP Assembly broke free and fell overboard (*see figure 3*). A CTU technician (CT Tech) sitting on top of the CTU BOP Assembly and attached to that assembly by fall protection restraints was pulled into the Gulf of Mexico by his fall protection harness.

A diver was jumped within 13 minutes of the incident and located the CTU BOP Assembly on the seafloor. The CT Tech was freed from the CTU BOP's and raised to the Lift Boat deck within 45 minutes of the Accident. Life support first aid was performed on the CT Tech for approximately one hour, but the CT Tech did not respond. First aid was ceased at approximately 0145 hrs upon receipt of verbal concurrence of Coast Guard personnel.

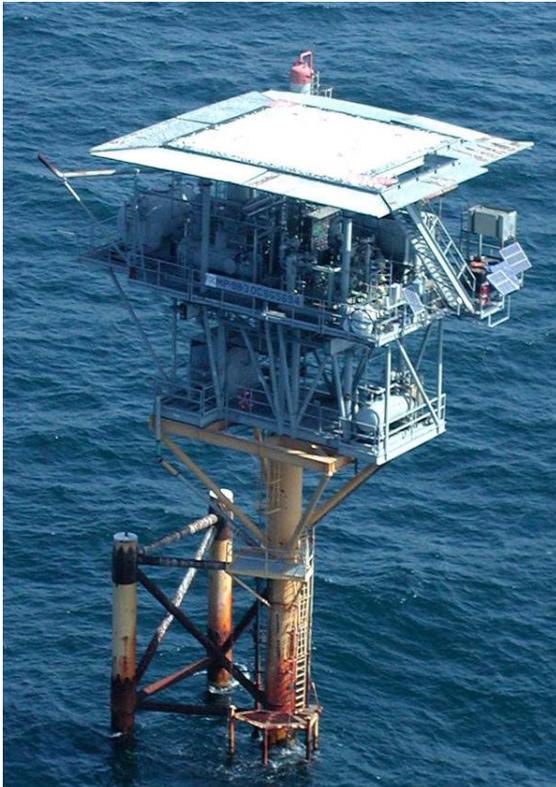
**Figure 4: MP-98 Well #3, pre Hurricane Ivan**

The Well was drilled from a three-well production platform set in 78 ft of water in 1986 and completed as a dual well with two strings of 2 3/8-inch production tubing, the “long string” (LS) and the “short string” (SS). In 1998, Hurricane George damaged the platform to the extent that two of the three producing wells on it were P&A’d with only the #3 Well being salvaged. On the #3 Well, the drive pipe was bent by the storm, but was straightened somewhat by using a derrick barge. A large overdrive caisson (the Caisson) was installed but found to be skewed. After two pin piles and braces straightened the Caisson to acceptable standards, production decks were welded on the Caisson and production equipment was spotted on the decks (see figure 4).

Prior to Hurricane Ivan, the Well was producing 1 to 2 million cubic feet of gas per day (mmcf) on the LS from a sand slightly deeper than 5,000 ft. The SS had ceased production some months earlier and was thought to be possibly sand plugged. Some casing pressure was evident on the annulus of the production-surface casing.

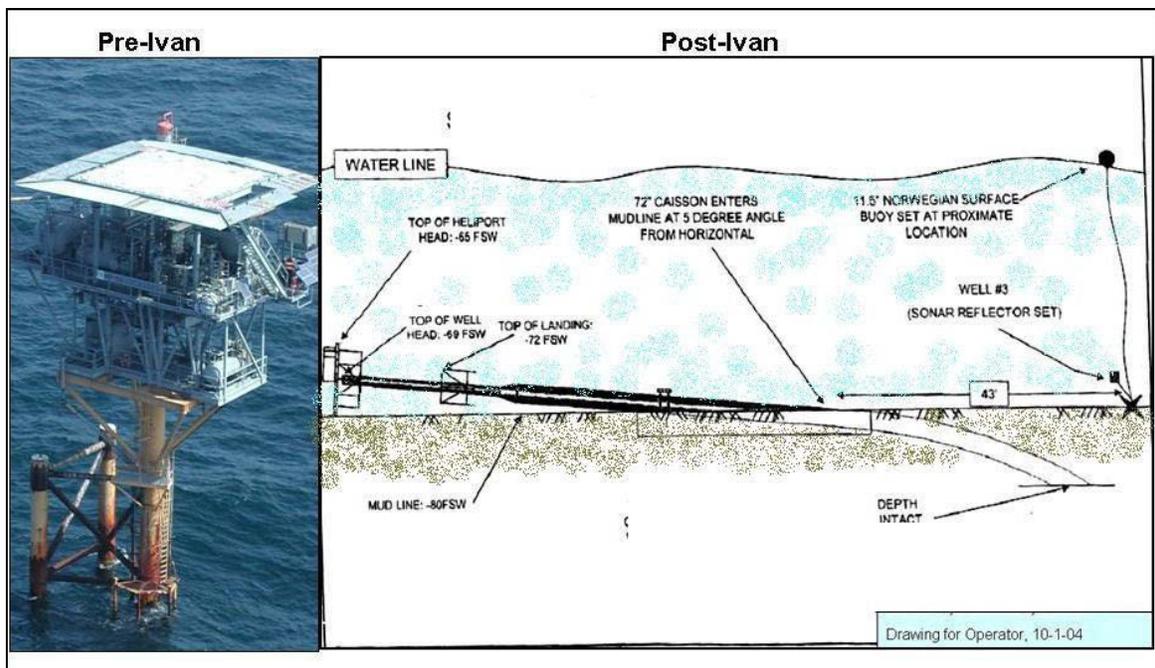
**Figure 5: Main Pass 98, Well # 3 caisson, pre-Ivan, post-Ivan**

The MMS estimated that 150 platforms were in the direct path of Hurricane Ivan. Industry reported to MMS that seven platforms were destroyed and six platforms had major damage. One of the destroyed platforms was the Main Pass Block 98 Well No. 3 Caisson. Hurricane Ivan toppled and bent the Caisson and casing almost flat onto the ocean floor (*see figure 5*).

An Operator survey of the damage sustained to the Well found the Caisson bent but intact as it entered the mud line at a 5-degree angle from horizontal. By jetting down to 9 ft below the mudline (BML), it was determined that the Caisson was probably intact with no buckles or tears. No gas bubbles were observed, which was interpreted as indicating that the downhole safety valves were containing well pressure.

Analysis of the post-Hurricane Ivan damage surveys caused the Operator to determine that the Well could possibly cause an uncontrolled flow of hydrocarbons should the surface controlled

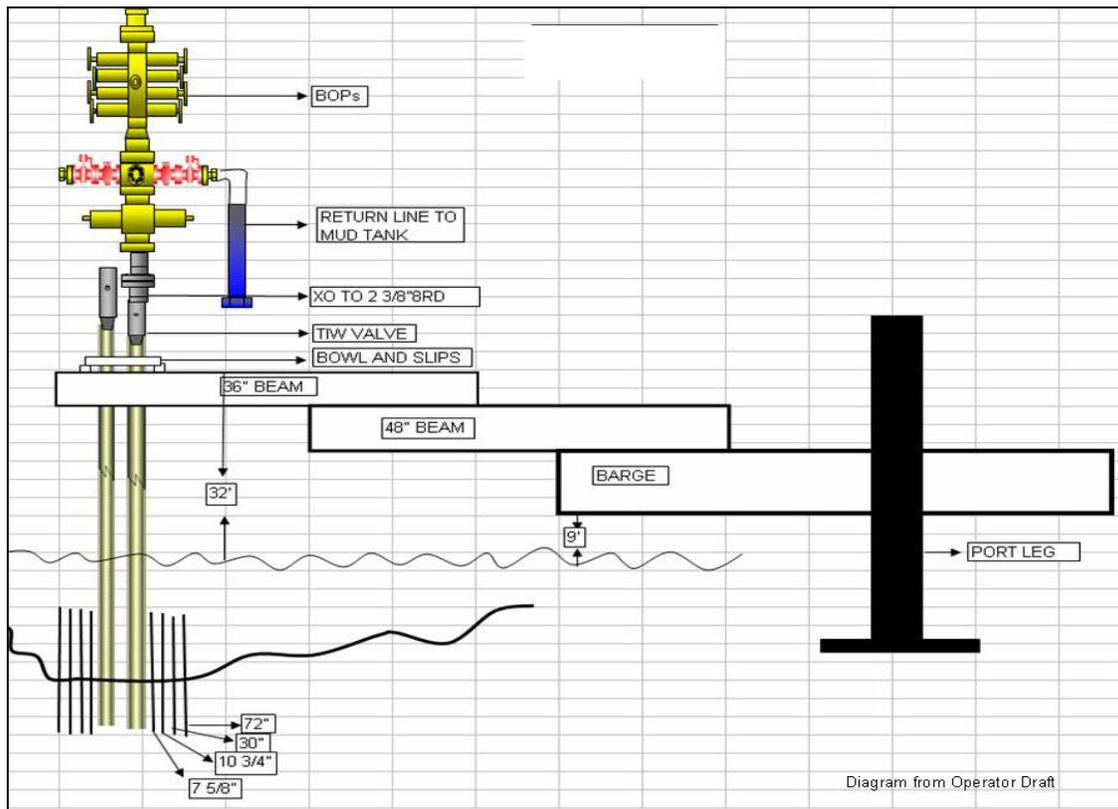
**Figure 6: Diagram of lift boat, tie-back tubing, well head**

- (6) Use a diver to guide the packoff overshots on the end of the two tie-back strings into place within the Caisson stub, and securely attach the overshots to the tops of the two production tubing strings.
- (7) Once the tie-back string overshots were securely attached to the production tubing, the tie-back strings were to be placed in 5,000-lb tension and hung off in the Slip Bowl. The connection and seal between tie back and production tubing were to be confirmed and pressure tested (*see figure 6*).

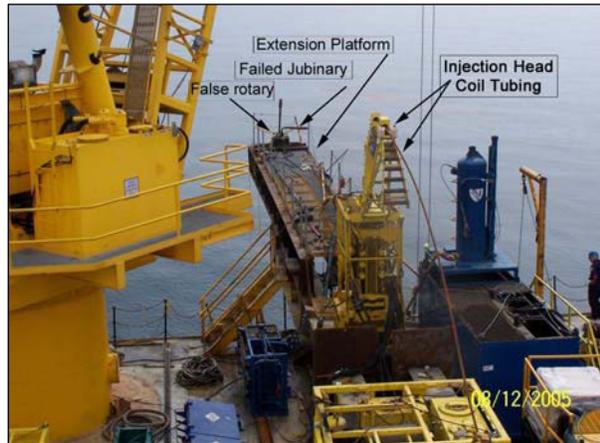
**Figure 7: Extension platform, CTU injection head**

The Operator assigned a Completion Engineer (CE) to design the Plan to P&A the Well and to solve the problem of direct vertical access to the Well. The CE spent considerable time solving the access problem. The solution approved by Operator review was to attach an extended temporary work platform (Extension Platform) to the bow of a large lift boat (*see figure 7*).

The end of the Extension Platform was equipped with a False Rotary, or Slip Bowl, to hold the tie back tubing in tension. The Lift Boat selected was equipped with two cranes, one of which was “oversized” [testimony] with a boom long enough to reach over the well center at the end of the Extension Platform. This crane acted in lieu of the traveling block of a conventional rig.

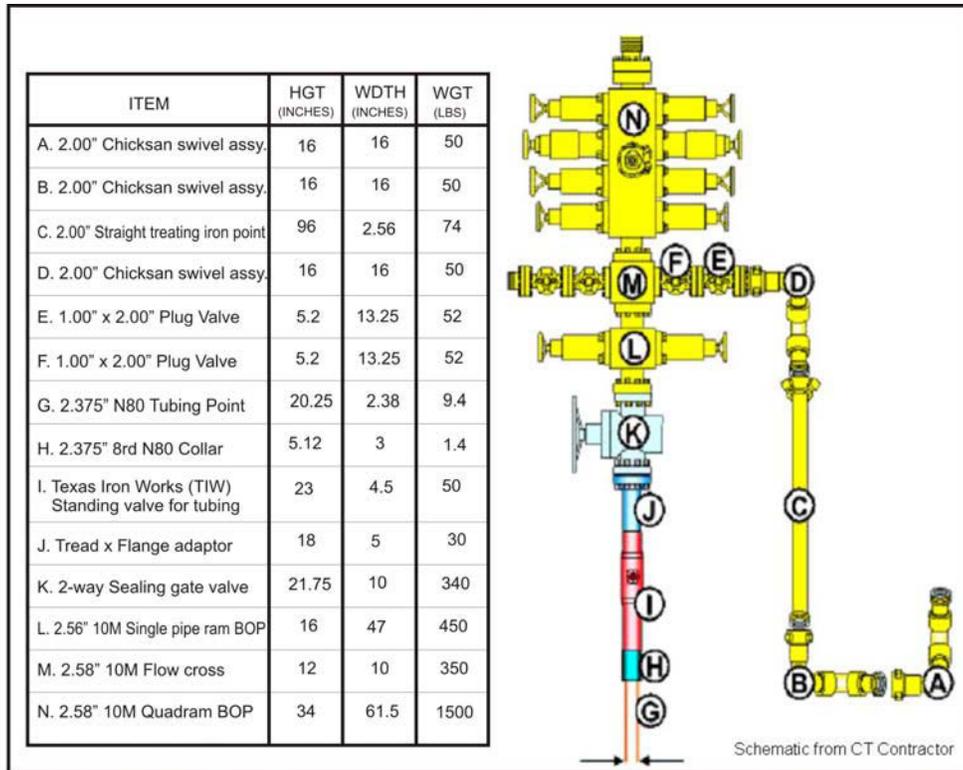
Figure 8: Coil tubing BOP assembly

- The CTU night shift began to rig up the CTU by installing all the well control equipment (the BOP Assembly).
- An 8-round thread by flange crossover was installed.
- A 10,000-psi rated manual gate valve was installed (made up) on top of the crossover.
- The CTU BOP stack was hoisted into place and made up to the rest of the previously installed BOP Assembly (See figure 8).

Using the data available (*see figure 8*), the calculated axial load on the tubing was between 3,000 and 3,500 lbs with the center of gravity estimated to be approximately 11 ft above the point where the 2 $\frac{3}{8}$ -in tie-back string was held in the slips. In this case, a static displacement of the center of gravity of the BOP Assembly of less than 1 ft could have resulted in plastic deformation and failure of the 2 $\frac{3}{8}$ -in tie-back. Any addition of a momentum force caused by movement of the load could have effectively added to the static load torque, or changed the torque effect to a dynamic modulus.

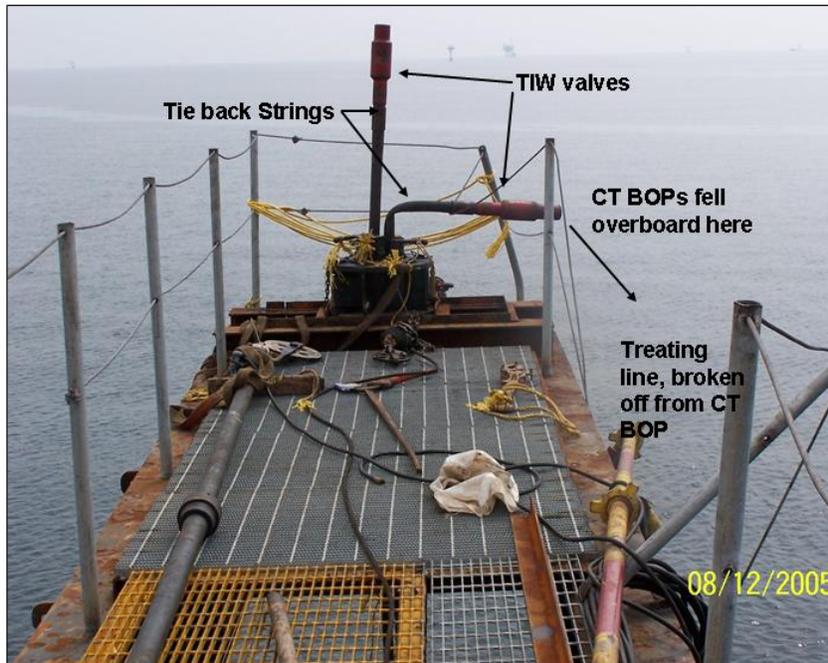
*Figure 9: Extension platform after accident*

- The BOP Assembly rapidly leaned to starboard, projecting over the side of the Extension Platform. The BOP Assembly broke free of the tie-back tubing string at the top of the TIW valve, and fell into the water, dragging the CT Tech, who was still connected to the BOP assembly by his fall protection harness, with it. The Assistant was struck by the treating chocksan pipe, which broke away from the BOP Assembly as it fell overboard (*see figure 9*). He was also thrown overboard.
