**Investigation of Fatal Accident
V-Door Guide Post Failure
Chandeleur Block 31, Well No. 1
OCS-G 27214
18 July 2006**

**Gulf of Mexico
Off the Louisiana Coast**

Jack Williams – Chair
Tom Perry
David Emilien
Kevin Langlinais

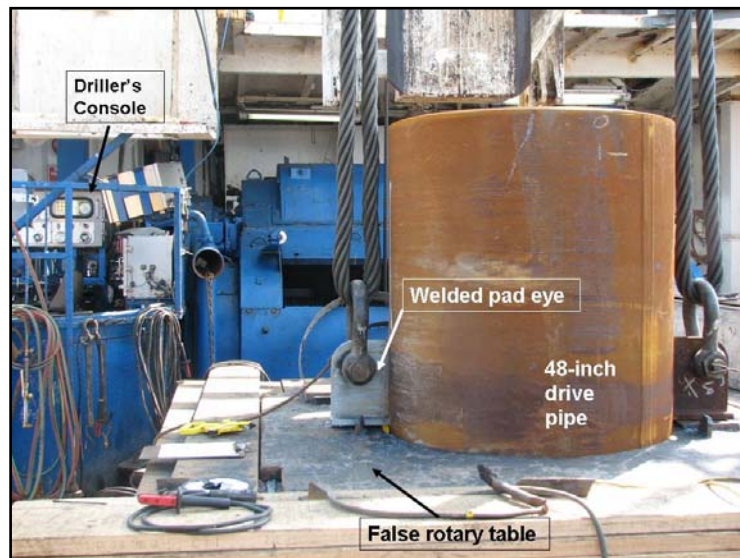
Figure 2: Drive pipe assembly and false rotary table.

On 18 July 2005, operations preparing to spud the subject Well were continuing on the jack-up drilling Rig, Nabors D-110. Three joints of 48-in drive pipe with two pup joints had been welded together and the pipe was suspended extending below the false rotary but not to the mud line. During the night shift, an additional joint of 48-in had been welded up and the entire string had been lowered until the drive pipe pad eyes contacted the top of the rotary table (*see figure 2*).

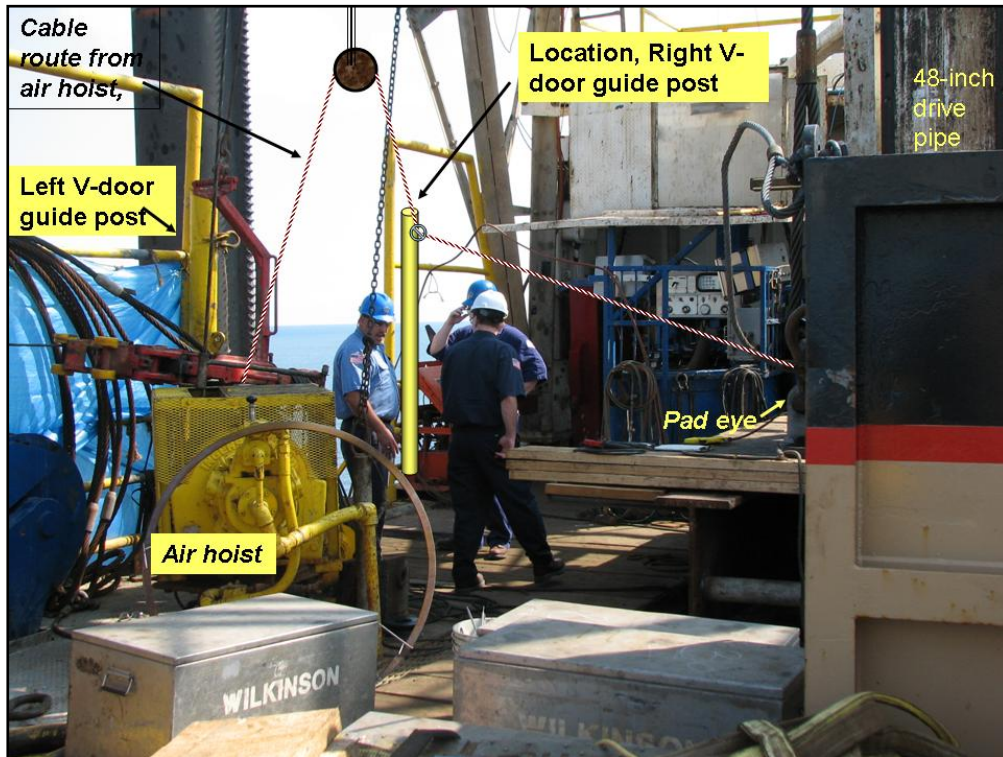
Figure 3: Method of rigging up to rotate 48-in drive pipe

An attempt was then made to rotate the drive pipe assembly to align the welded drive pipe pad eyes with the guides attached to the top of the rotary table. This operation was conducted by connecting an air hoist on the rig floor to a pad eye of the drive pipe, using a cable and pulley assembly and a shackle attached to the top of a V-door guide post (*see figures 3 and 4*).

According to testimony, the cable from the air hoist to the drive pipe pad eye was not looped around the drive pipe to assist in applying rotation force (torque). With the rig up method employed in this case, once the drive pipe had been rotated near its intended final position, the angle of the cable applying the force to the drive post was so reduced that the perpendicular distance from the center of the drive pipe to the plane of the rotating force, the “lever,” became nearly non-existent.

Without a “lever” element, no torque (turning force) can be applied to turn an object. Instead, additional applied force will simply act to pull that object in the direction of the applied force rather than turn it. From examination of the diagram (*see figure 11, p.16, below*) it is evident when the pad eye of the drive pipe was oriented into the position at the time of the Accident, little or no effective torque was being applied to the drive pipe despite any increase in applied force.

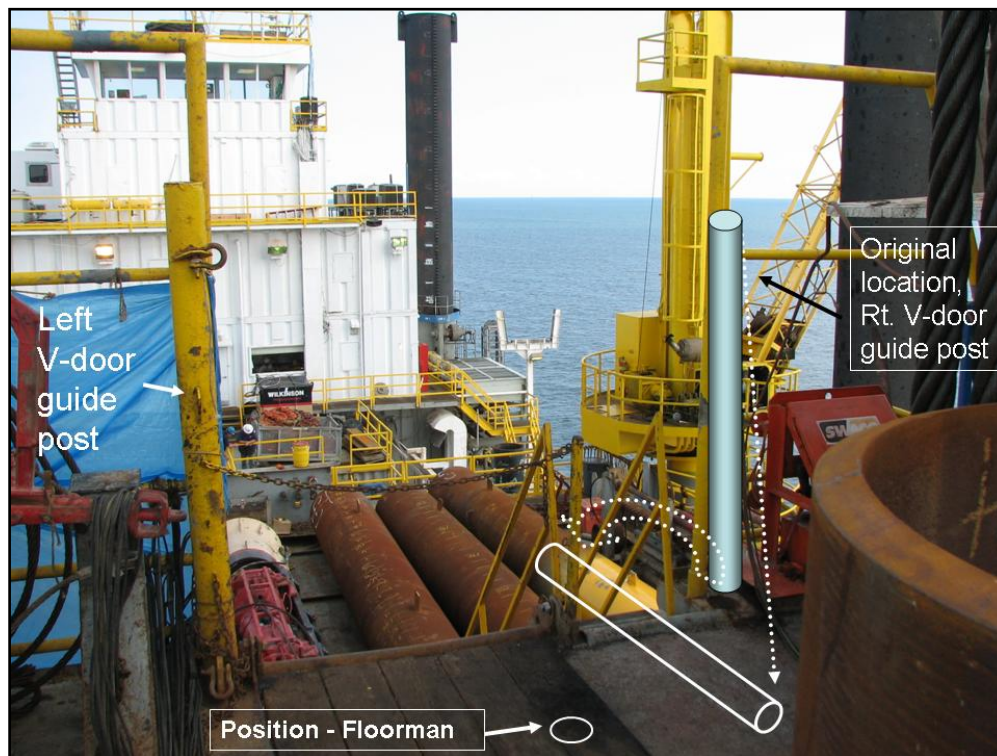
Figure 4: Path of V-door guide post after failure

When a bind was taken using the air-hoist, the drive pipe assembly rotated a short distance and stopped without reaching the final position required. A Floorhand approached the drive pipe and investigated the cable assembly. While the Floorhand was investigating the assembly, the V-door guide post suddenly broke free and was propelled across the floor by the tension of the cable assembly bind. The guide post struck the Floorhand in the forehead and chest.

As he checked the tension of the cable, a sound was heard as if the Driller slacked off the brake slightly. Suddenly the V-door post which formed the anchor of the drive pipe rotating assembly broke from the Rig floor. The post (*see figure 7*) was propelled across the floor by the tension held on the rotating assembly, and struck the Floorman in the head and chest.

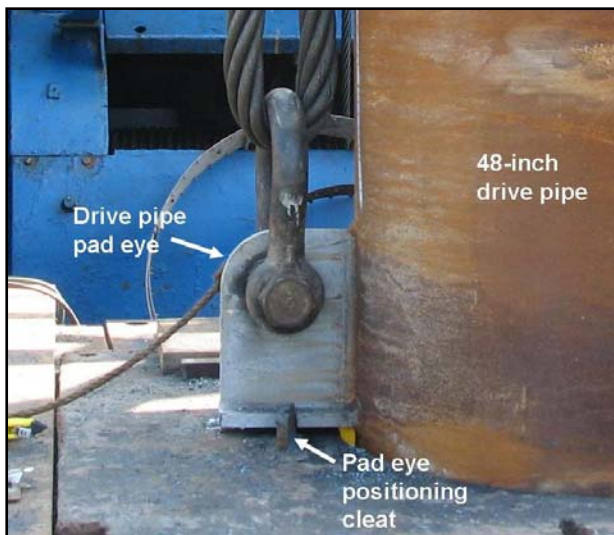
Figure 6: Pad eye and positioning cleat

18 Jul 2006, 0055 hrs - The drive pipe was rotated, but failed to fully align with the guides (cleats or stops) attached to the top of the rotary table (*see figure 6*). While the air hoist maintained tension on the rotating assembly, the Floorman approached the drive pipe pad eye connection to the rotating assembly, checked it and then backed off a few steps while continuing to examine the connection.

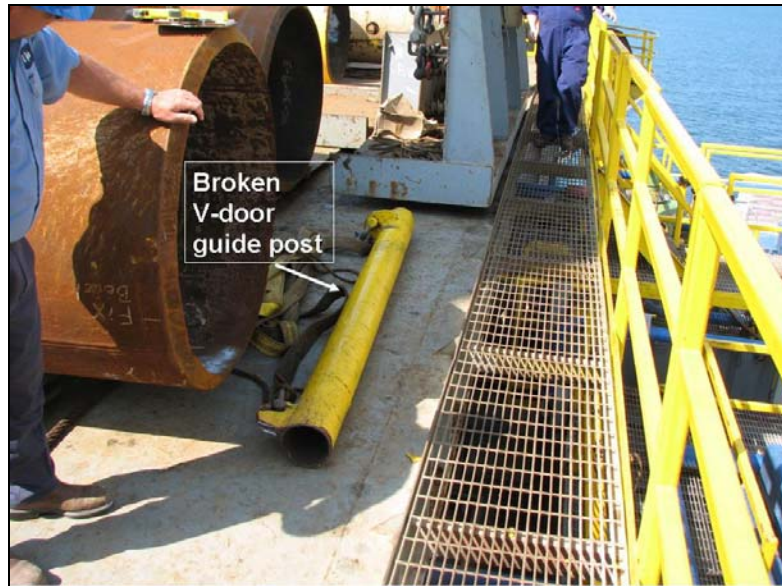
Figure 7: Broken right side V-door guide post

The torque applied to the casing ceased to turn the drive pipe when it was still not rotated far enough to be aligned properly. When the Floorman checked the tension on the line rigged up to turn the casing, the guide post anchoring the assembly broke free of its attachment to the Rig floor. The weld attaching the V-door post to the floor, and a portion of the pipe wall, failed under the load applied and subsequently the V-door post was propelled across the floor striking and fatally injuring the Floorman.

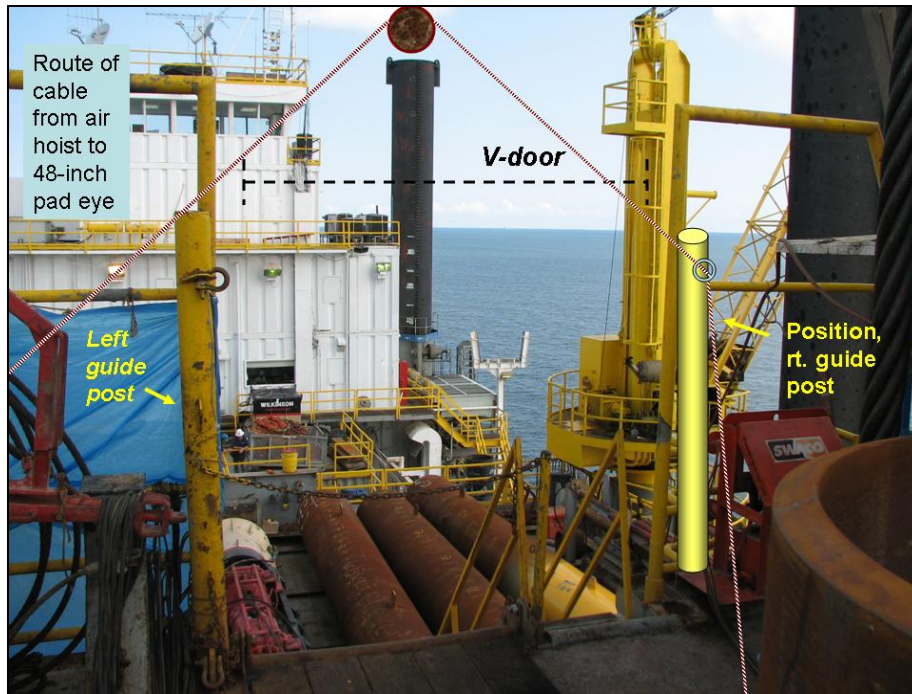
Figure 10: Rig-up method to attempt to rotate 48-in drive pipe

Testimony indicated that there were several ways to rotate the drive pipe string. In this case, a decision was made to use the air hoist to power the rotation of the string. A cable was run beginning at the air hoist on the left side of the V-door, up to a pulley and tackle assembly installed above the V-door.

The cable then was routed over the pulley and down through a shackle attached to the pad eye on the top of the right V-door guide post. After passing through the shackle, the cable made approximately a 90-degree turn, and then was routed across the rig floor and attached to the nearest pad eye welded onto the V-door side of the drive pipe (*see figure 10, p. 15, below*).

However, increasing “torque” was being applied elsewhere. An equal but opposite force to that being applied to the drive pipe was being applied to the top of the right V-door guide post. This force was being applied there because the cable had been routed through a shackle attached to a pad eye at that location. The force at the top of the V-door guide post was converted to a rotational “moment” on the bottom of the post, magnified by the approximate 7-ft distance from the shackle to the weld at the base of the post. This rotational force on the base of the post can be approximated by multiplying the force on the cable by the length of the post (lever distance). The torque on the base of the post was many times greater than that which would have been applied if the rotational assembly had been directly attached to the bottom of the V-door guide post.

2. Rigging up the rotating mechanism to the top of the V-door guide post rather than the bottom multiplied the force applied to the welds at the base of the post several times over. This probably contributed to the failure of the welds and/or pipe.

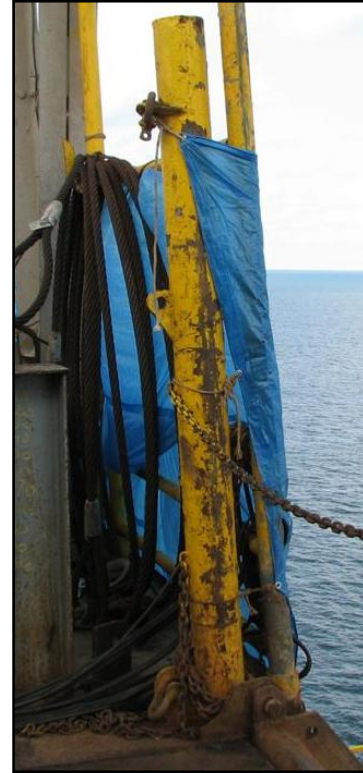
Figure 13: Left V-door guide post

The two V-door posts on the Rig were relatively thin walled 6.5-inch diameter, schedule 80 class B (or C). The posts were 7.2-ft long and were welded directly to the rig floor. Both posts had two relatively large pad eyes attached; one at the top of the post, and another large one on the

base of the posts where it was also welded to the Rig floor (*see figure 13*). The left hand V-door guide post also had additional smaller pad eyes welded in the middle of the post.

4. Failure to mark the guide post as a “no-load bearing” structural component, and the installation of pad eye connections on both guide posts, allowed and even encouraged the use of the guide post as a load bearing member.

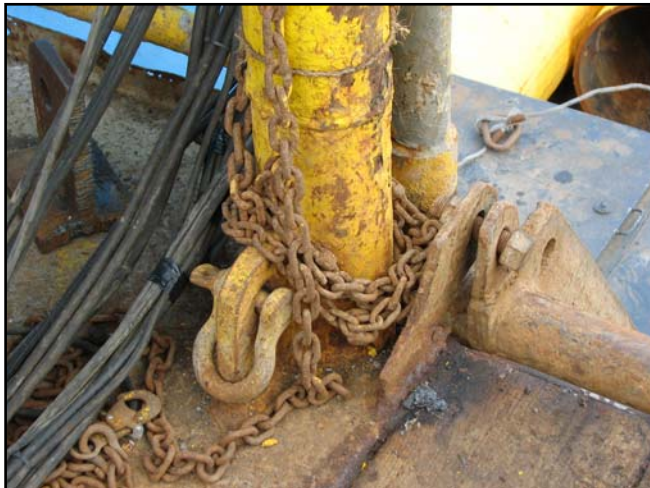
Figure 14: Base, left V-door guide post

Both of the guide posts had shackles attached to the pad eyes. The left post also had a large chain wrapped around the base of the post. The chain seemed to be stored in that manner to be available for future use. Both posts were originally painted yellow. However, both were heavily scarred from use with many dents, scrapes, and dings that revealed raw and-or heavily rusted unpainted metal. The posts also showed evidence of having been frequently cut off and re-welded into place. This was indicated by the multiple re-weld seams at the base of both posts (*see figure 14*).

Both V-door guide posts were attached to the rig floor in what appeared to be a temporary manner. They appeared to be simply “tack-welded” to the floor, and neither appeared to be welded using a bead that went completely around the circumference of the pipe and pad eye. Neither post seemed to be welded in a manner that attached the full pipe wall thickness to the Rig floor.

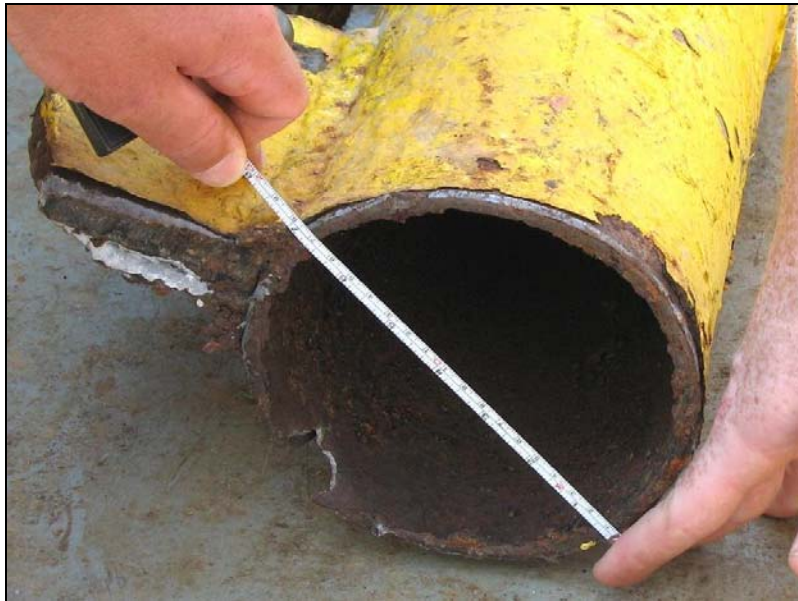
Figure 15: Base, broken right side V-door guide post

From examination of the post, it appeared as if the welds failed completely around the pipe circumference (where tack-welded) and around the lip of the lower pad eye. A portion of the pipe itself also seems to have failed. It appeared as if portions of the post were not welded to the Rig floor. Much of the exposed pipe wall thickness was rusted, rough-cut in appearance, and showed no sign of a recent failure. The pipe appeared to have been tack-welded so that only portions of the outside wall were connected to the deck (*see figures 15 and 16*).

- 1. Insufficient onsite oversight - No oversight of the rig-up process was given by the OIM, Tool Pusher, or by the Company Man. Therefore, no discussions of alternative methods of rigging up to rotate the drive pipe were made available to the personnel on duty when rig-up was initiated.*
- 2. The V-door guide post was not designed to carry any significant load. Use of the V-door guide post as an anchor point directly lead to the failure of the post and the subsequent fatal injury.*
- 3. Failure to rig up in such a manner that would allow the drive pipe to freely rotate through the full arc required for the operation, caused the force applied to the anchoring V-door guide post to exceed the critical failure point of the pipe and/or the weld .*
