Investigation into the January 30, 2014 Loss of Well Control
Lease OCS-G 17921, Vermilion Block 356, Well A-007

Gulf of Mexico Region
Off the Louisiana Coast

U.S. Department of the Interior
Bureau of Safety and Environmental Enforcement

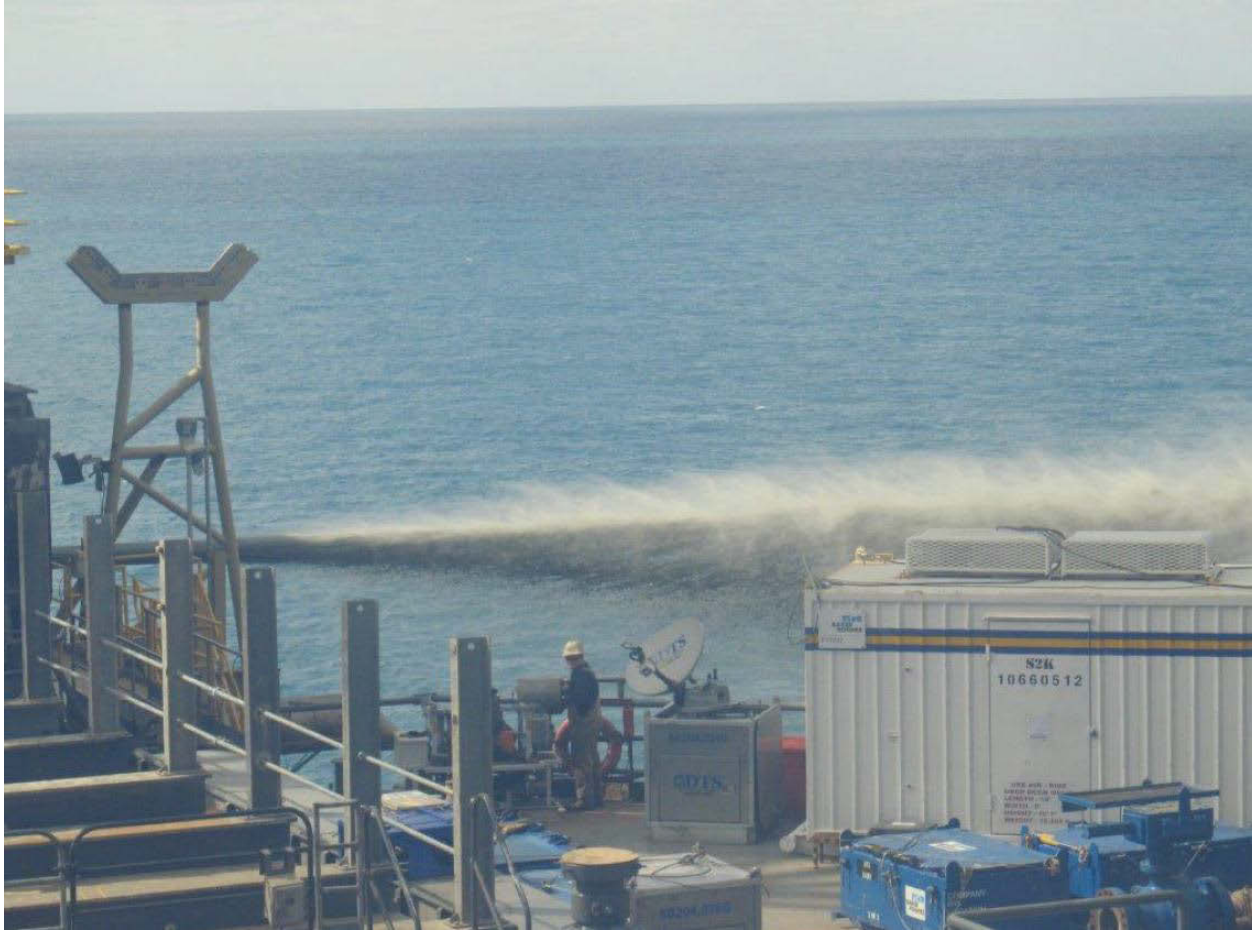
The company representative, identifying the early detection of "swabbing", decided to have the Driller rig up and connect the Top-Drive System (TDS) to the drill pipe and begin circulating. The Driller made the connection, slacked back down 20-30 feet, and began circulating mud by pumping approximately 15 strokes a minute with 300-400 psi pressure. After pumping approximately 400 strokes, or 15 minutes, the well came in shooting mud "about 8 feet above the rotary". The Driller closed the annular and placed the rig on diverter directing the unexpected flow through the port and starboard diverter lines then overboard. Once wind direction was determined, the starboard diverter line was closed subsequently diverting the entire flow overboard through the port line. (Figure 2)

Figure 2: Picture of active port diverter line during the January 30, 2014 Incident

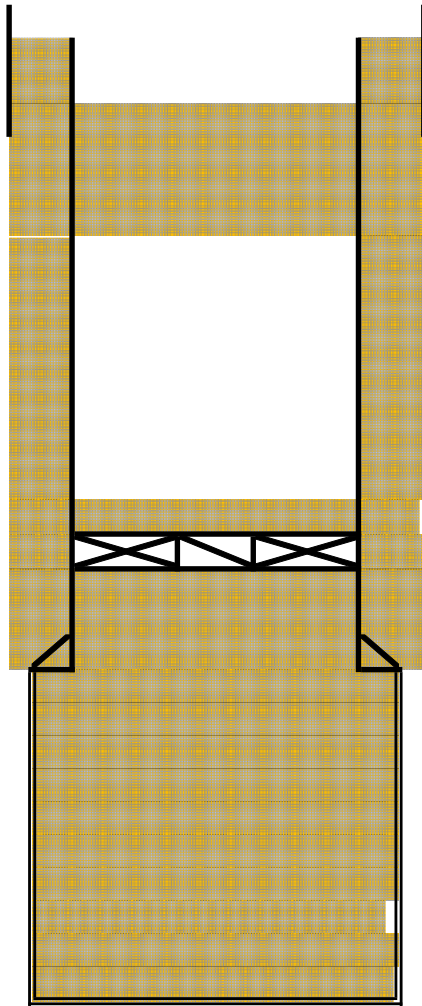
Figure 3: Final VR 356 Well A-007 wellbore schematic

The OIM responded to the rig floor and observed the well on diverter. He consulted with the company representative and ordered another 100 pounds per square inch (psi) of pressure to be added to the diverter bag which put more pressure around the drill pipe preventing fluid from coming through the annular. The rig had three pumps, but only two pumping at one time. The rig pumped approximately 300 bbls of 14.2 pounds per gallon (ppg) kill mud back into the well without stopping the flow of gas and sand from the formation. After pumping all the kill mud onboard, the rig began pumping seawater. The OIM also ordered any extra engine cooling water diverted to the mud pits, instead of going overboard, so that they could have more volume at a faster rate. The operators immediately activated the VR 356 “A” platform’s Emergency Shut Down (ESD) system shutting in all the wells. All platform personnel were evacuated to the rig and later both rig and production non-essential personnel were evacuated to the Motor Vessel (M/V) Kristi and M/V Margaret Lab. A well control consultant was then brought on location as well as a resupply of kill weight mud. The well control crew used a process that is commonly referred as a “Dynamic Kill Procedure” by fluctuating kill weight mud and pumping sea water into the wellbore at high rates and various pressures in order to stop the flow. The well subsequently stopped after flowing on diverter for approximately 36 hours. The wellbore was then secured using a cement retainer, and by squeezing cement below and placing cement above the cement retainer. (Figure 3)

Mudline at 384'

24" cut & pulled at 457' (73' Below Mud Line)

13-3/8" cut & pulled at 467' (83' BML)

24" x 3/4" wall at 612' (228' BML)

Surface cement plug set at 540' - 725'
(168 cu ft.) Weight tested surface
plug to 20,000#

Pressure tested surface plug to 1000 psi

Casing tested to 1000 psi

TOC at 930' - weight tested to 20,000#

13-3/8" cement retainer at 1050'

"Retainer pressure tested to 1000psi"

13-3/8", 68ppf, HCN-80 BUTT at 1217' MD
(1200' TVD)

Squeezed 954 cu ft. cement below retainer
Sufficient to fill open hole
