**OCS Report
BSEE 2014-02**

**Investigation of October 27, 2013, Fatality
Vermilion Area Block 200 Platform “A”
Lease No. OCS-G 09500, Complex ID No. 24098-01**

**Gulf of Mexico
Off the Louisiana Coast**

**U.S. Department of the Interior
Bureau of Safety and Environmental Enforcement**

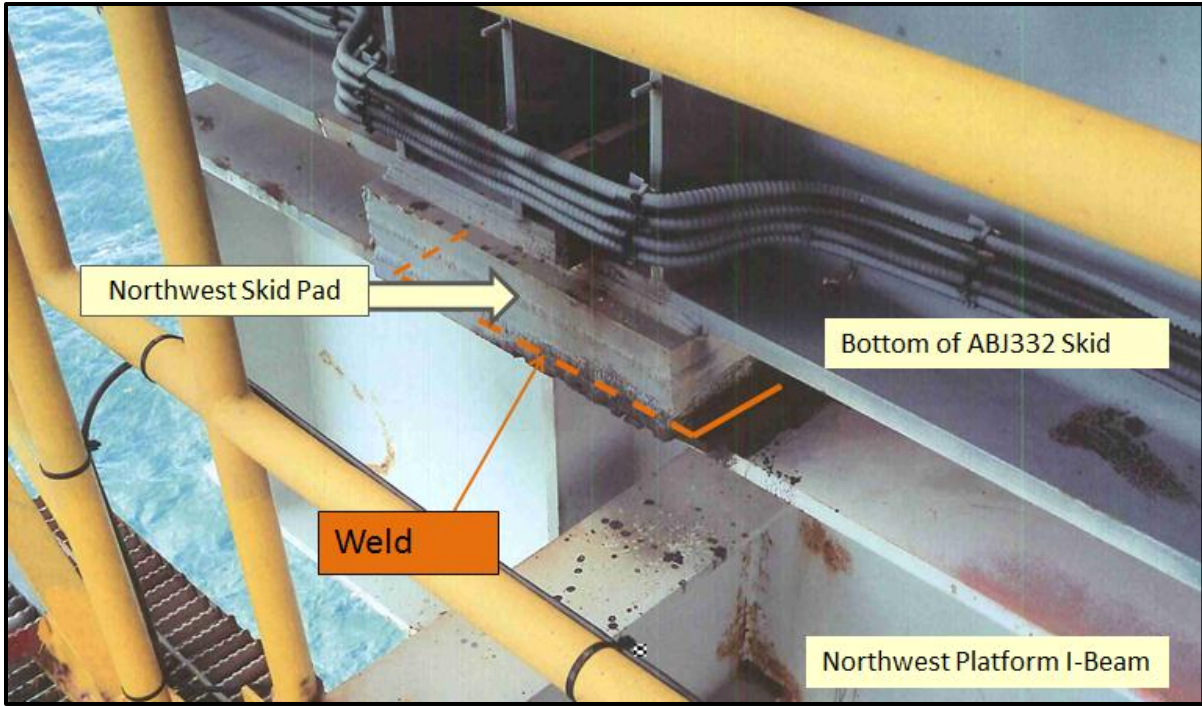
The dry oil storage tank ABJ332 skid assembly consisted of one (1) 16 foot diameter x 85 foot long horizontal cylindrical tank (designated ABJ332), two (2) 83 feet long flare booms mounted to and extending away from the skid at a 17-degree angle, and miscellaneous process piping and catwalks. The skid assembly was anchored on each end to the platform’s steel I-beams extending out from the north side of the superstructure. The main connection points that held the skid assembly in place were 4 rectangular steel pads. The pads consisted of three 2 inches thick plates stacked and welded together. Each plate measured 24 inches long by 20 inches wide. The pads were welded to the I-beams and the skid sat on top of the pads attached by additional welds. Process piping and catwalks that were welded to the tank and platform also provided some additional anchorage of the skid to the platform (see Figure 3 for a pre-incident photograph of one of the steel pads). The horizontal cylindrical tank had been emptied, cleaned, and opened to atmosphere by decommissioning work that occurred prior to the mobilization of the DB *William Kallop*.

Figure 3: Pre-Incident Photo of One of the Rectangular Steel Pads Supporting the Dry Oil Storage Tank ABJ332 Skid Assembly at Vermilion Block 200 Platform "A" (Photo provided by Talos/ERT)

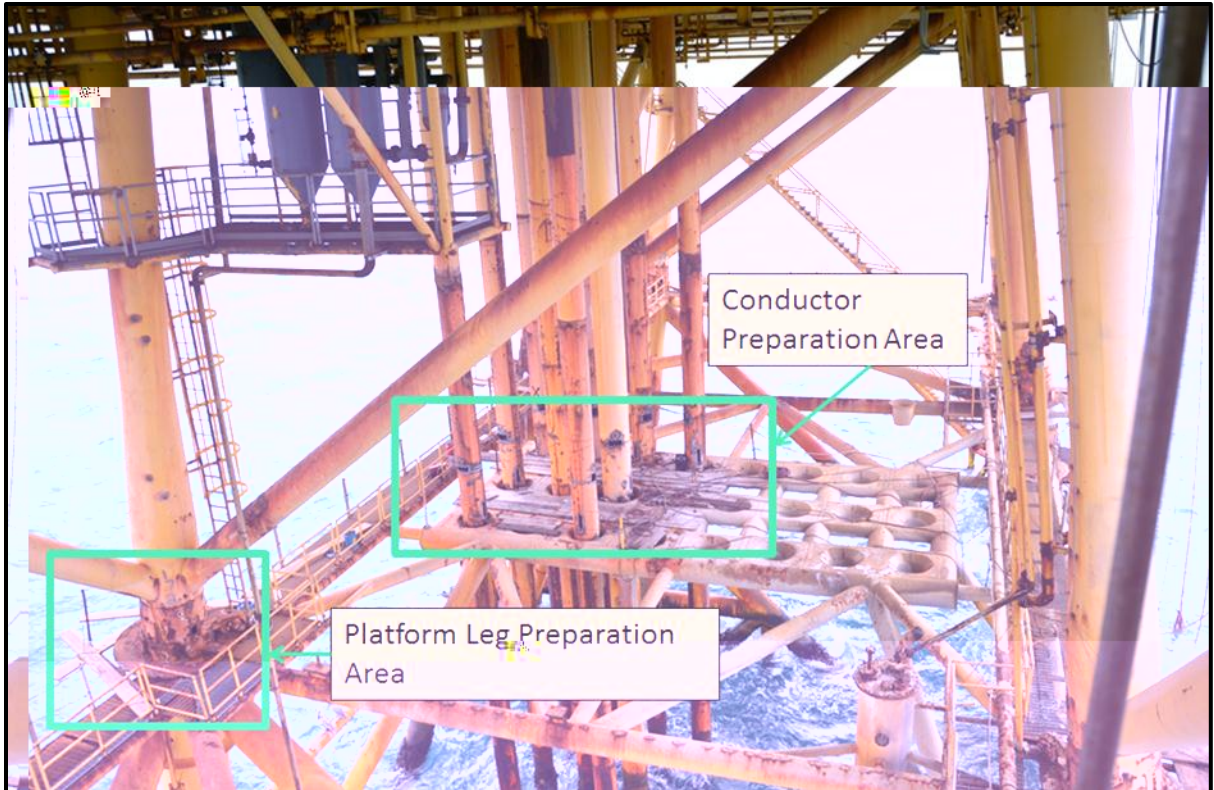
After the safety meeting, the DB crew for the 12p/12a shift broke into 2 main welding teams; one team was to work around the ABJ332 skid assembly, the second welding team reported for work at the top of platform jacket area for cutting of the well conductors (Figure 4).

Figure 4: Platform Jacket Work Area (Post-Incident Photo taken by Panel Site Visit on November 14, 2013)

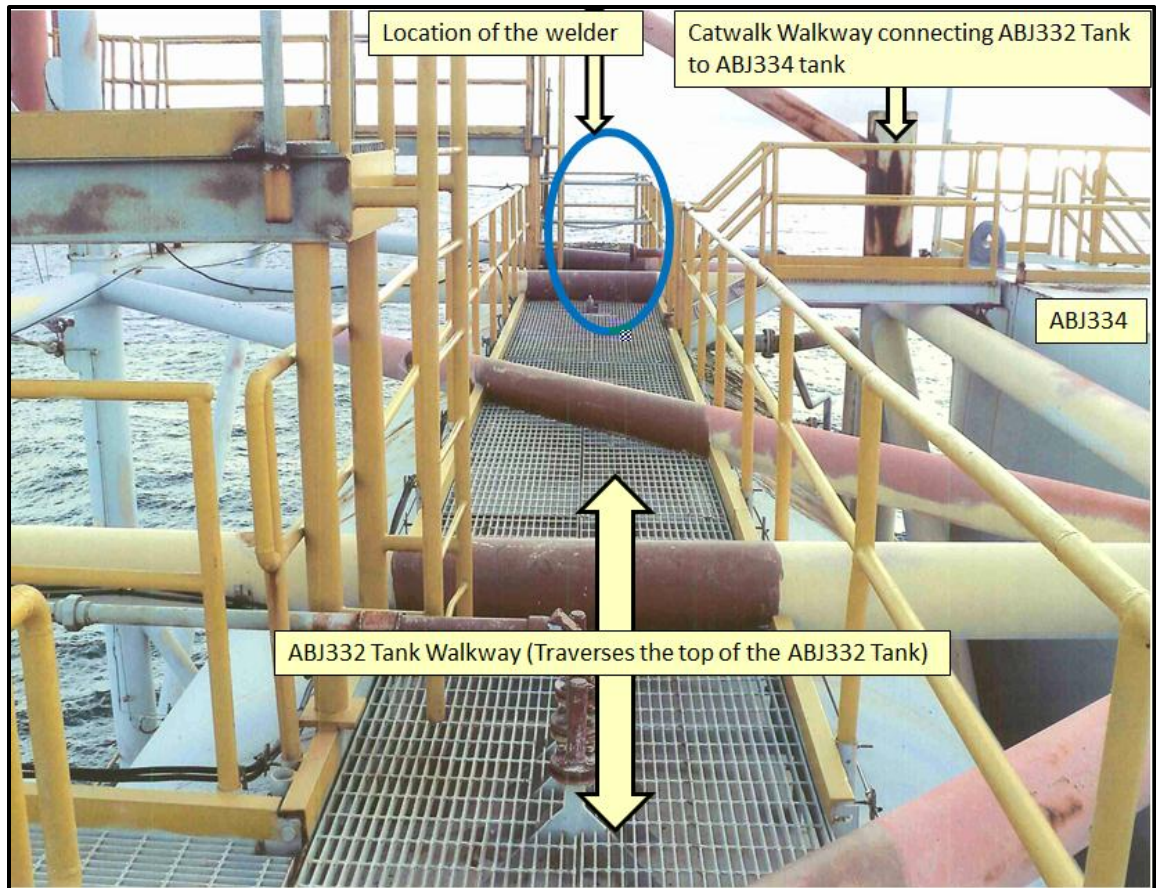
Figure 5: Pre-Incident Photo of the walkway on top of the ABJ332 Tank skid at Vermilion Block 200 Platform “A” (Photo provided by Talos/ERT)

At approximately 7:05 p.m., the welder was standing on the walkway of the ABJ332 tank (outboard side of the catwalk) and began cutting the base of the catwalk’s handrail where it attached to the tank (Figure 5). The welder cut one side of the catwalk’s handrail completely. As he made the final cut to the remaining contact point, the catwalk and the dry oil storage tank ABJ332 skid assembly began to vibrate. The entire skid package, including the flare booms rotated outward away from the platform and fell 115 feet into the water below. (see Figure 6 for an aerial Before & After of the platform structure). The welder was last seen by the deck foreman still standing on the tank as it rotated away from him.

This incident was caused by the failure to recognize that the dry oil storage tank ABJ332 skid assembly, with the two vent booms still attached, represented an unstable configuration if not secured by multiple welded connection points. The removal of the welded connection points directly led to the skid assembly rotating on the two outboard pads and falling 115 feet into the Gulf of Mexico when the last connection point, the base of the catwalk handrail, was severed. The welder, who was standing on the catwalk that traverses the top of the ABJ332 tank, was carried overboard with the skid assembly. Although the welder was wearing a fall protection harness, he was not required to anchor to a secure point as he was working within the handrails of the catwalk. The Panel concluded that the use of fall protection equipment would not have prevented the individual being carried overboard as the entire tank skid assembly, including the tank walkway toppled overboard (refer to Figure 5 for the location of the welder).

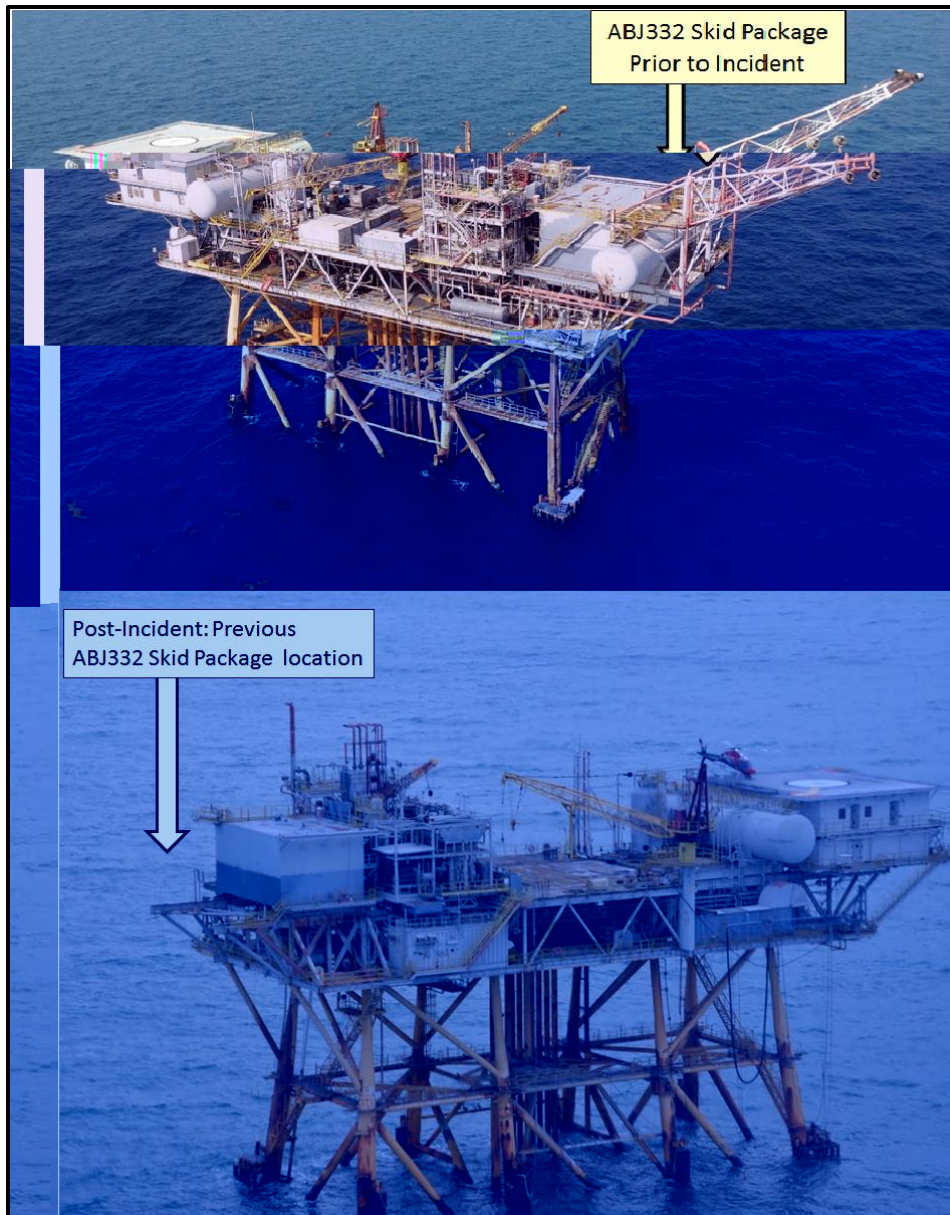
The man overboard emergency plan was initiated and all crewmembers were mustered for a head count. The welder was identified as being only person missing. The tank package was observed floating for a brief time after hitting the water before sinking. The welder however, was not observed at or around the tank. Service vessels in the area began a search, and were ultimately joined by assets from the USCG. Despite these efforts, the welder was not located. After two days of surface and underwater searching, the divers recovered the body of the welder from amidst the tank wreckage on the seafloor.

Figure 6: Aerial Before & After Photos of Vermilion Block 200 Platform "A" (Top Photo from Talos/ERT-OFS June 28, 2012 Site Visit; Bottom Photo from Panel Site Visit, November 14, 2013)

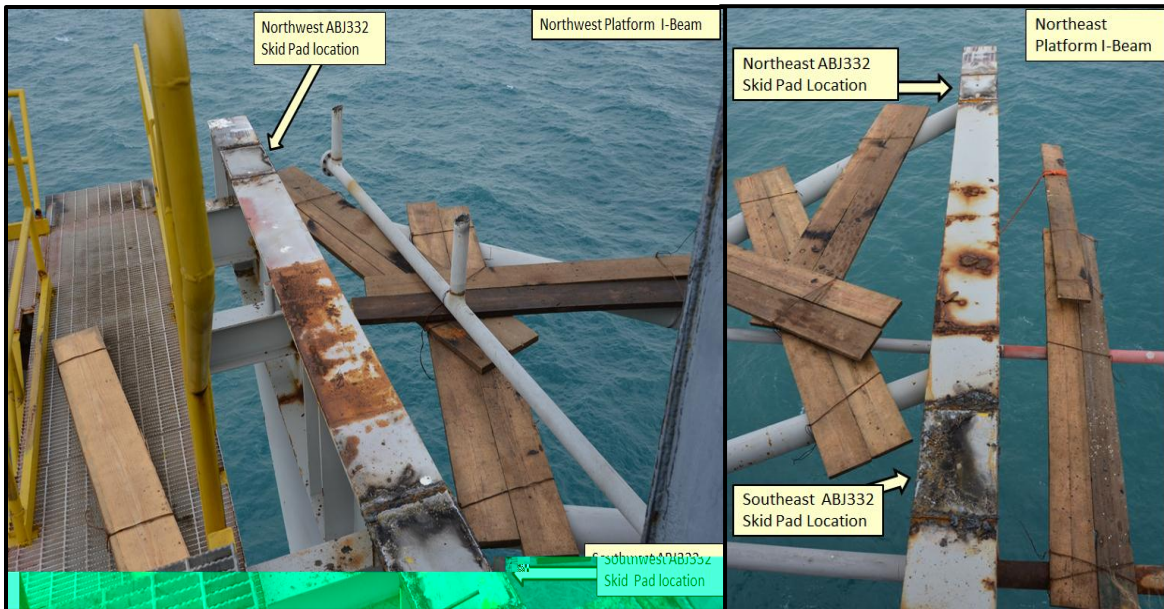
Figure 7: Post-Incident Photos of the Wood Scaffolding. Northwest Platform I-Beam (Left) and Northeast Platform I-Beam (Right) that Supported the Dry Oil Storage Tank ABJ332 Skid Assembly at Vermilion Block 200 Platform “A” (Photo from Panel Site Visit, November 14, 2013)

- The condition of the scaffolding was recognized as being less than what Talos/ERT would publically claim as their standard in an internal Talos/ERT email (November 9, 2013) discussing the upcoming visit by BSEE to the incident site. When discussing the visit, the Talos/ERT employee states “ the platform is not in the shape we would have it to prepare for a BSEE Inspection as far as housekeeping and the way boards are set up for access to platform piles for workers” (i.e., temporary scaffolding). The standard of scaffolding installed at the platform (Figure 7) was not consistent with the standards for safety (e.g., OSHA) promoted by both Talos/ERT and OSF throughout their SEMS policy documents.

- The Panel concluded that the condition of the scaffolding/temporary work platforms was an indicator of the safety culture at the work site.
