Investigation of October 20, 2015 Fatality During Pipe Handling

Lease OCS-G 33531, Keathley Canyon Block 96
Drillship Pacific Santa Ana

March 3, 2017

U.S. Department of the Interior
Bureau of Safety and Environmental Enforcement

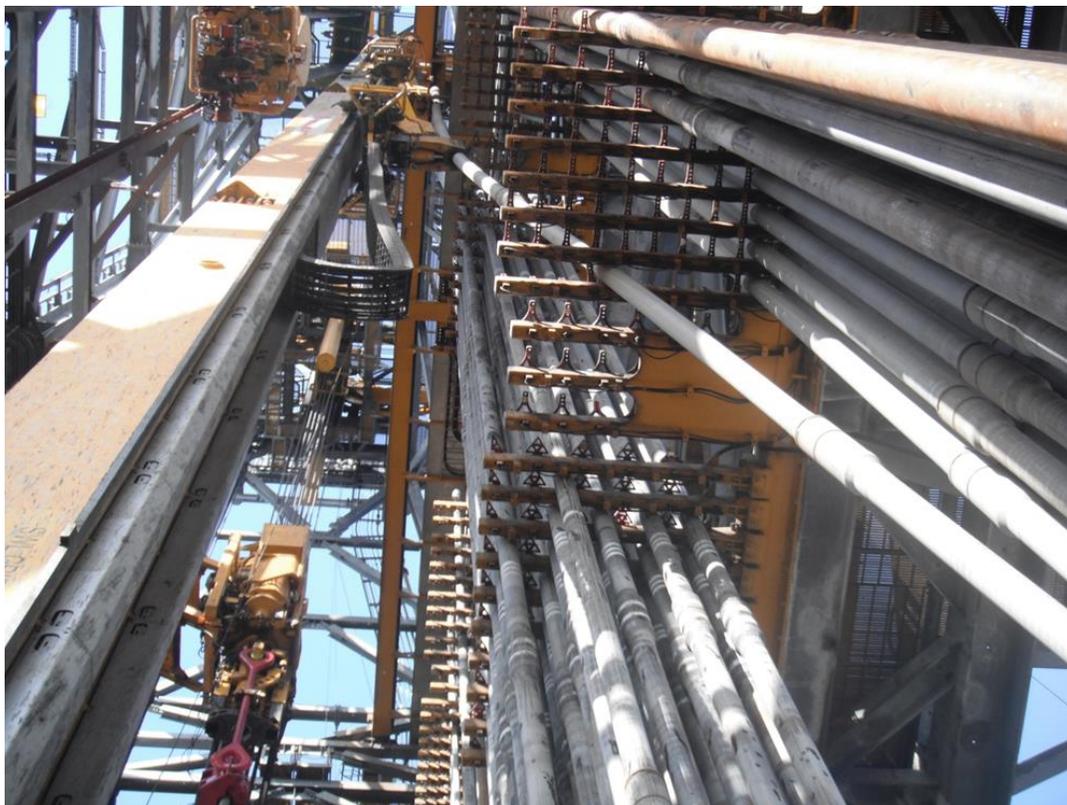
Figure 6 - View from drill floor. Stand #32 is obstructed by latch on lower finger board.

By approximately 10:10 AM, 31 stands had been moved to the main well drill center. The AD was retrieving stand 32 from row 46 of the finger boards after receiving verbal confirmation over the radio from the victim that the latches were open (Figure 6). At some point during the movement of stand 32, the fourth latch from the opening of the row on the lower finger board dropped into the closed position blocking the moving stand. Despite this obstruction, the arms of the MHR continued to retract. Claws around the pipe on the lower guide head remained closed during this retraction and the pipe began to bow. As the bow in the pipe increased, the bottom of the pipe was pulled in an upward direction against the inside of the claws.

The lower guide head had retracted approximately four feet from directly under the obstructing latch. Under the strain of force the lower guide head aft gate opened freeing the pipe. The stored energy from the bowing of the pipe was suddenly released. The victim by this time had moved directly into the path of the pipe between the MHR and the setback area. The pipe struck him before it impacted other pipe stands and a horizontal steel beam at the rear of the setback area.

As stand 32 was being retrieved, latch 4 closed. The force applied to the latch by stand 32 caused the latch to twist on its mount, but it did not break free or open. At the conclusion of the onsite visit to the PSA by the BSEE Panel, latch 4 was removed for testing.

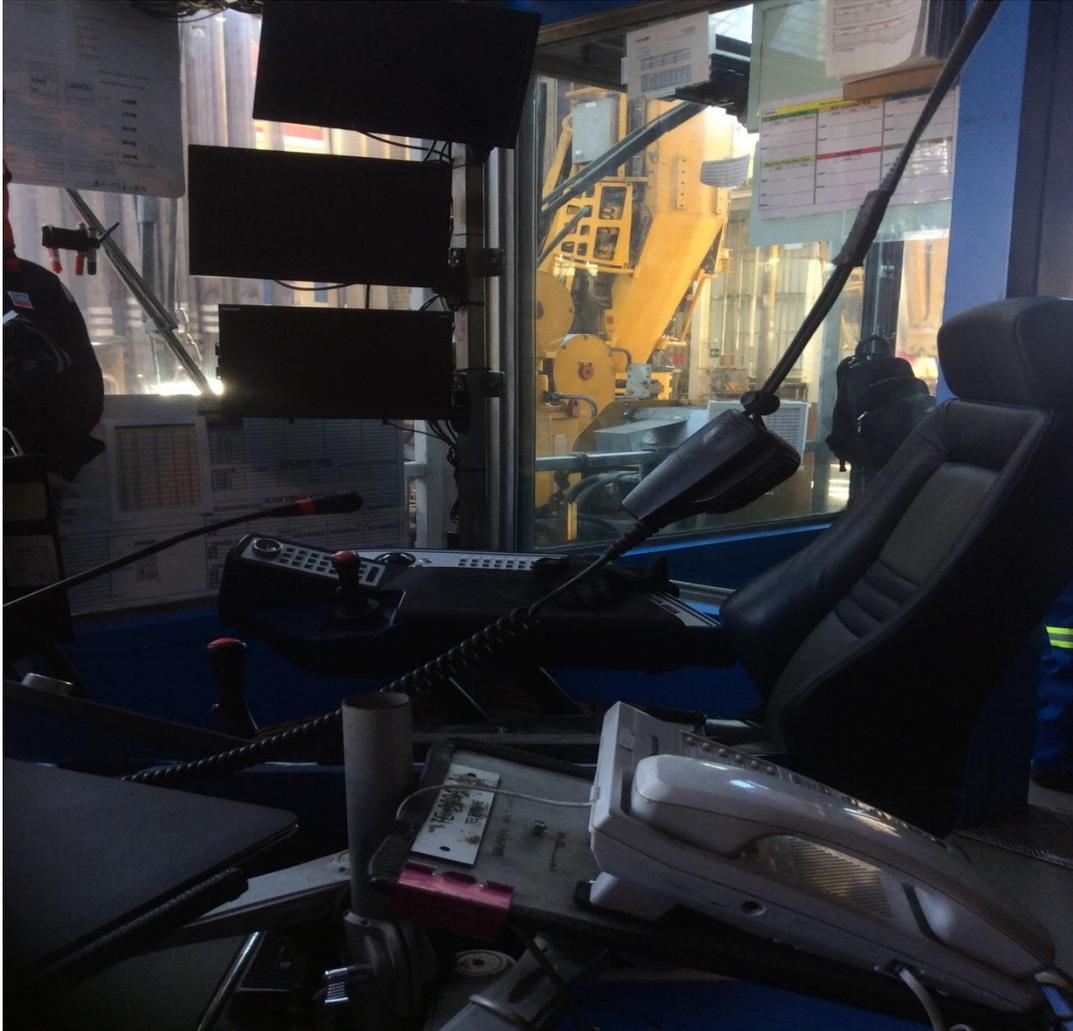
Figure 7- The view from the Main Side AD control chair, looking towards the auxiliary setback area. During TIH operations the driller would be occupying the other chair.

During the operation, both the Driller and AD were in the chairs facing the main drill center. Pipe stands being run through the main drill center were stored in the auxiliary setback area and not in the direct line of sight of either the Driller or AD (Figure 7).

Neither the AD nor other floor hands had a direct line of sight to where the victim was working, and communication between the crew was conducted by using hand held radios. The AD, Driller and other floor hands stated to the Panel that they heard the victim say over the radio that the latches were open prior to hearing the sound of the recoiling pipe.

Finger Board Spotter: The BSEE Panel recommends that operations which use a spotter to verify the position of finger board latches review where that task is performed. Consideration should be made to the positioning of the spotter and their proximity to the moving pipe stands. No tasks should be assigned to the spotter that places them in setback areas during pipe handling operations.

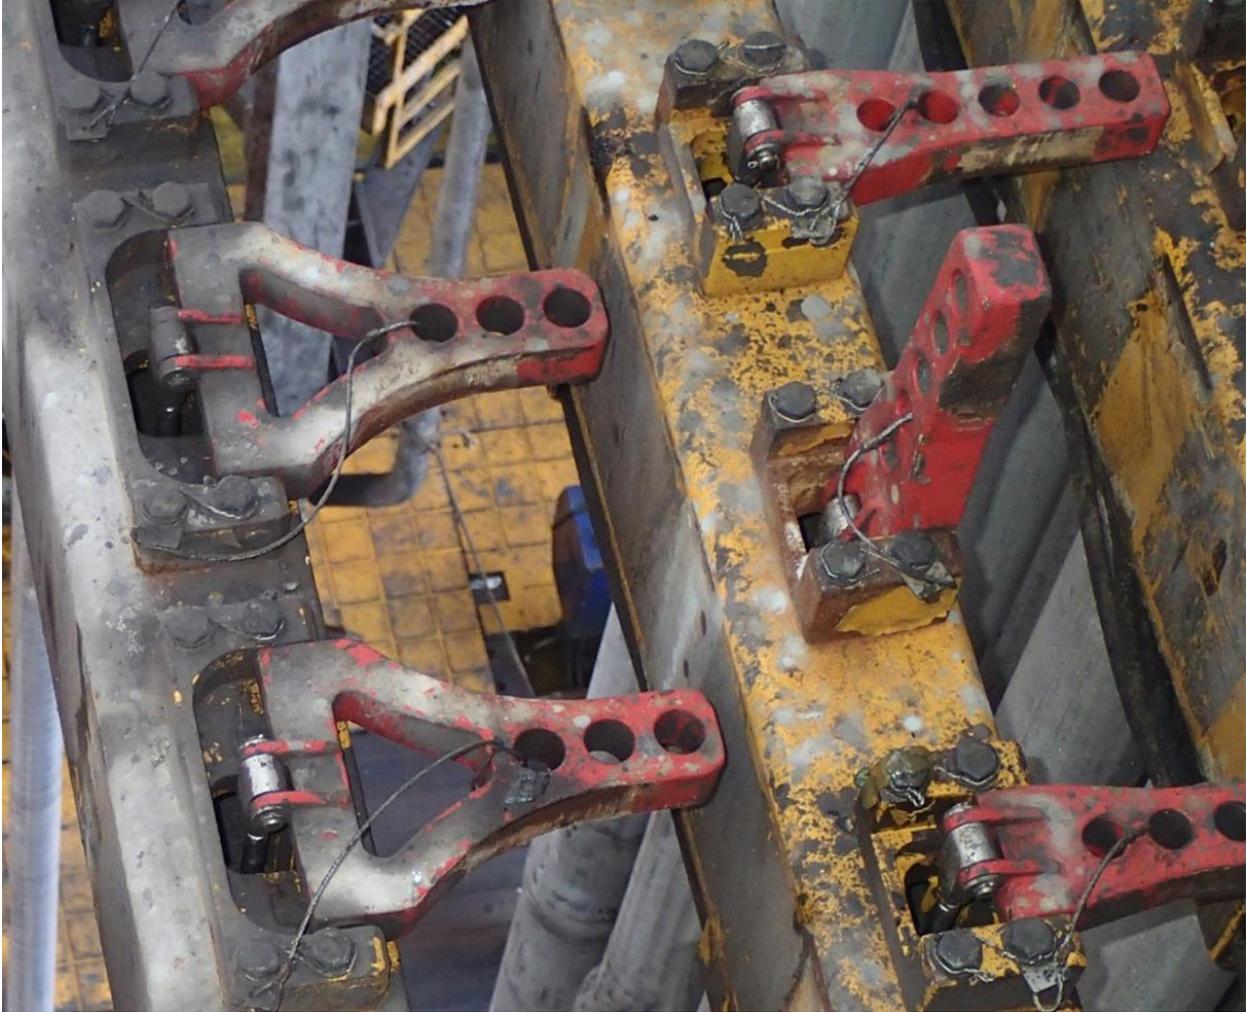
Figure 8 – Fingerboard latches. Note the latch in the up (open) position. The silver top of the piston rod can be seen pulled down.

The fingerboard latch assembly consists of a spring loaded piston that when air pressure is applied, pulls a rod into the cylinder body raising the latch (Figure 8). When there is insufficient pressure on the rod end of the piston to overcome the force of the spring the latch will close. This means that if there was a loss in air pressure, the latches would remain closed and the pipe stands will be secured (Figure 9).

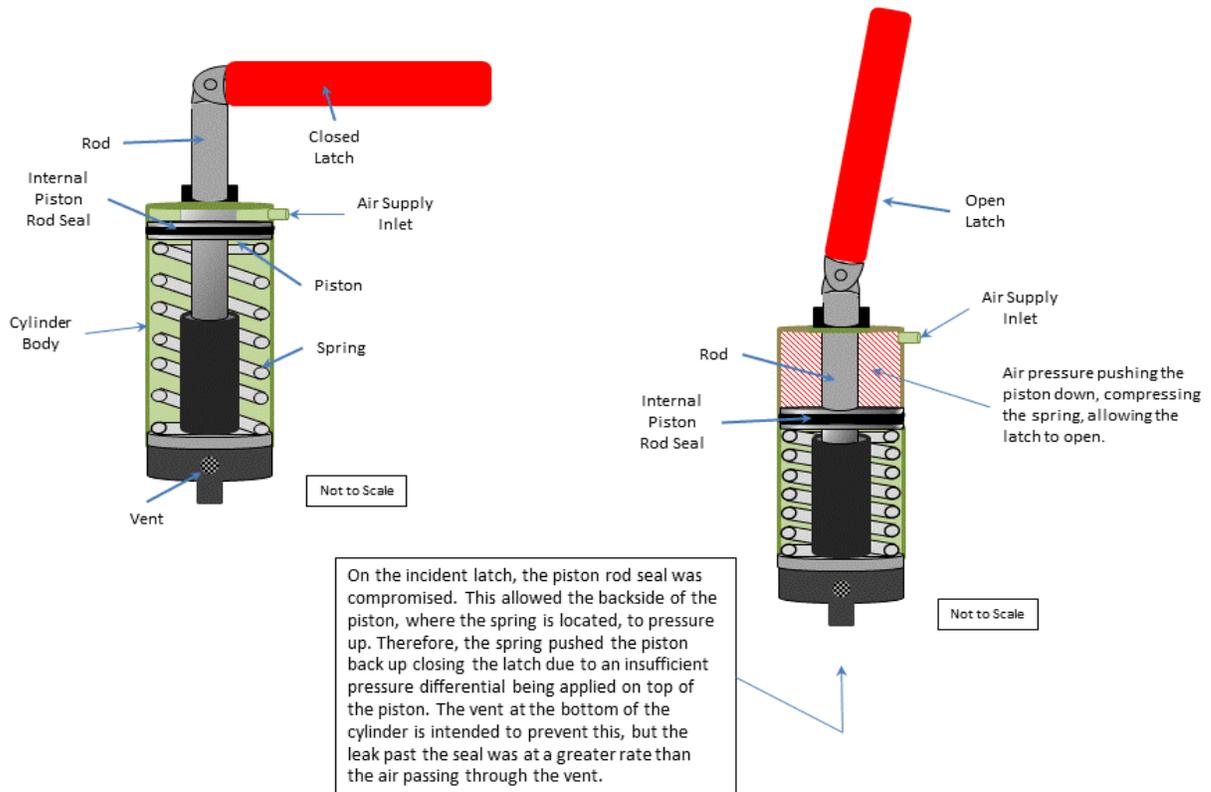
Figure 9 – Latch Cylinder Drawing

After the tests, it was concluded the latch initially opened when air pressure was supplied; then immediately closed due to a leaking rod seal and pressure building up on the backside of the piston. During testing of the incident latch, it was found that air was flowing through the vent on the cylinder when air was supplied. This means air was flowing by the piston, due to the rod seal leak, at a faster rate than air flowing out of the vent. The vent on the cylinder is there to prevent pressure building up on the backside of the piston. When there is not significant pressure build up on the rod end of the piston the spring will extend the rod out of the cylinder, closing the latch.

Post incident testing of the latch did show that a faulty seal on the latch cylinder allowed the latch to drop back into the closed position. However, if the victim had not moved into the setback area at the critical time, he would have been clear of the pipe when it recoiled from the lower arm of the HR.

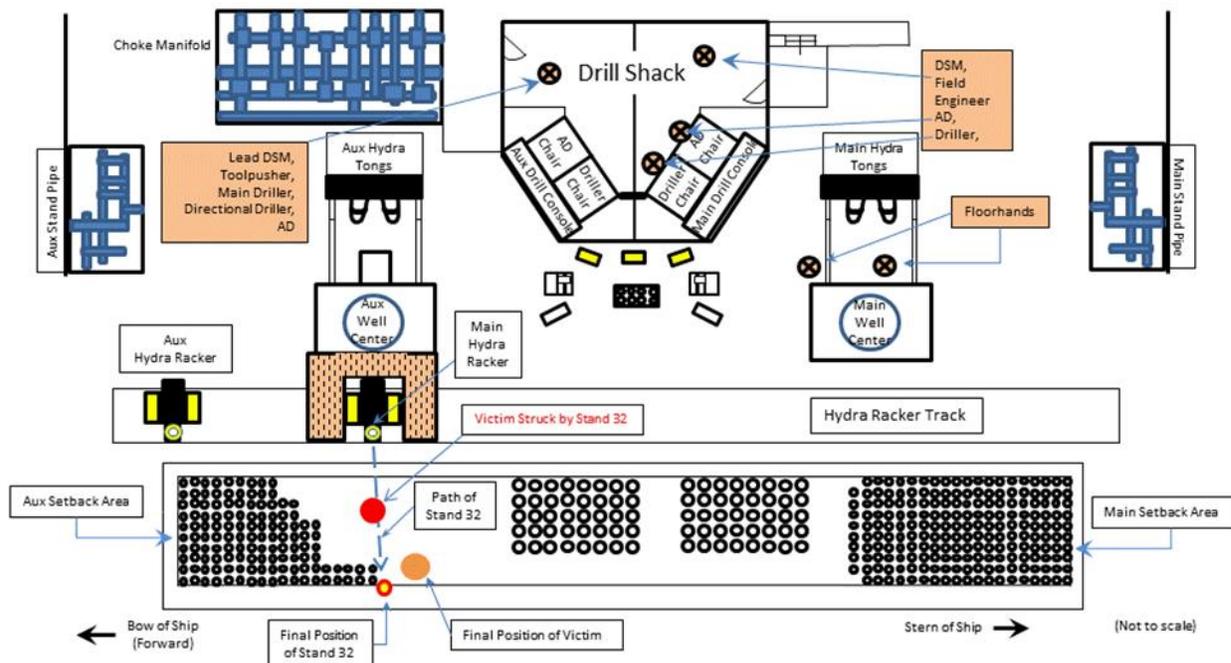
Figure 10 – Incident Location Plan View

Taking into account the totality of circumstances, the Panel concluded that the death of the victim was the direct result of moving into the setback area and into the path of the pipe stand being held under tension when a latch on the lower fingerboard closed.
