QC-FIT
EVALUATION of
FASTENERS
FAILURES
ADDENDUM II

Office of Offshore
Regulatory Programs

QC-FIT Report # 006
July 2017

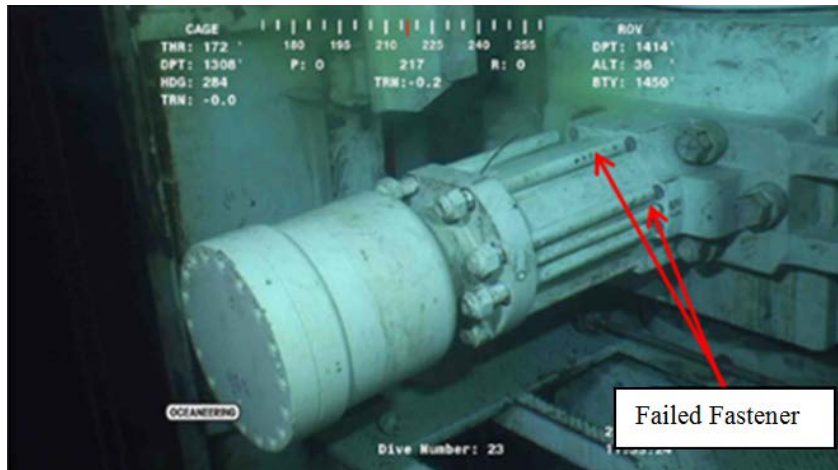
FIGURE 3: DOOR INTERFACE FASTENER FAILURE - BOP BSR ASSEMBLY (OEM RCA)

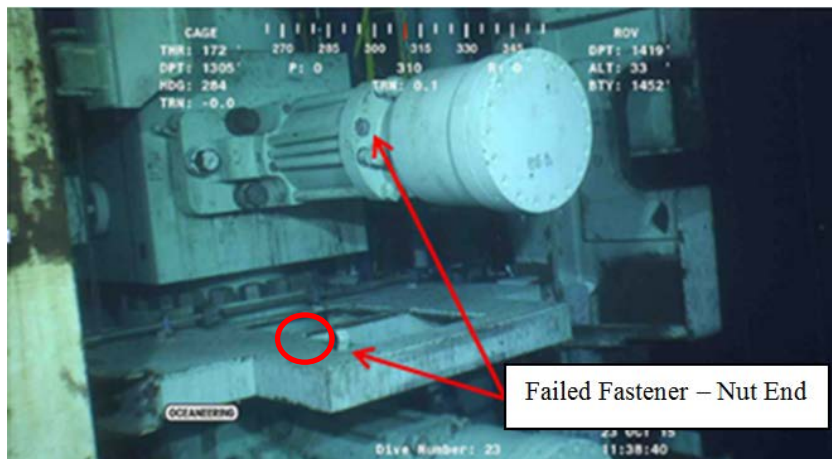
FIGURE 4: NUT END FASTENER FAILURE - BOP BSR ASSEMBLY (OEM RCA)

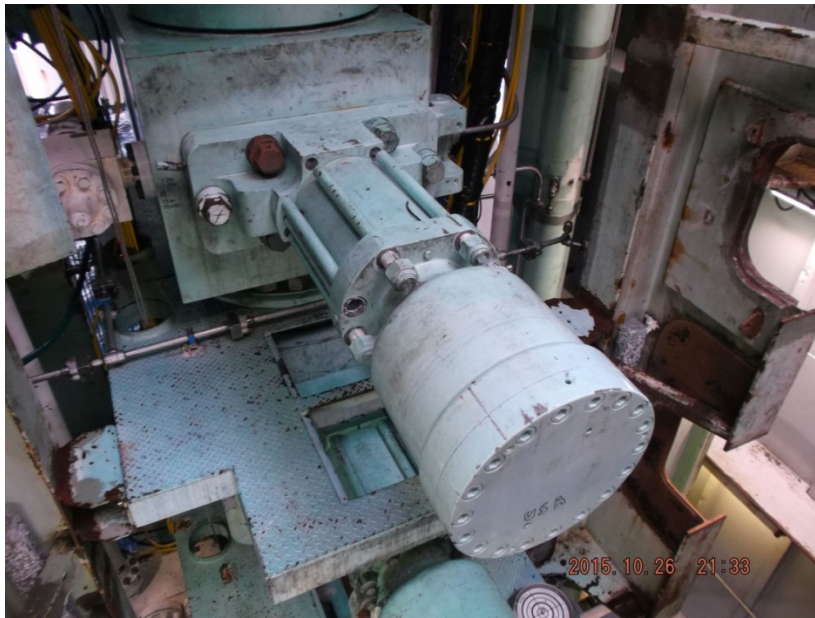
FIGURE 5: UPPER BSR FASTENER FAILURES

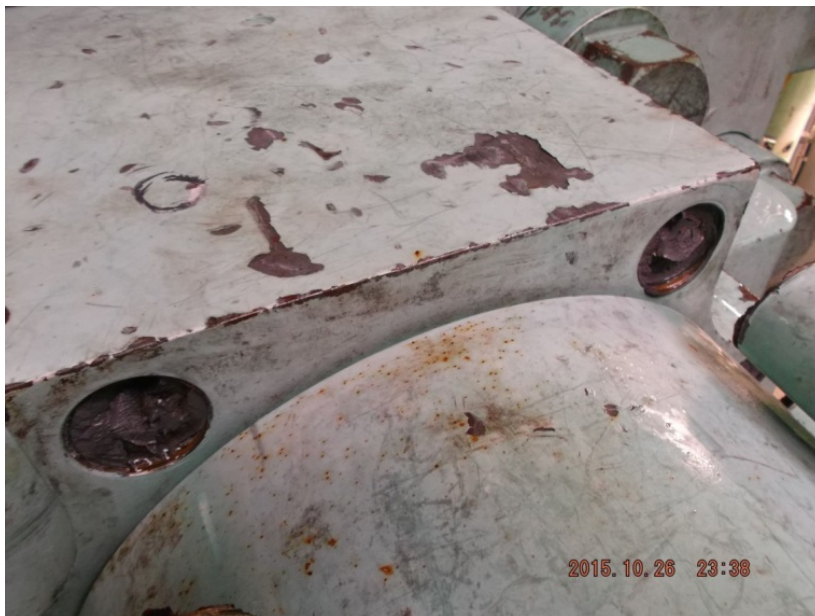
FIGURE 6: UPPER BSR FASTENER FAILURES – CLOSE-UP OF SHEARED THREADS

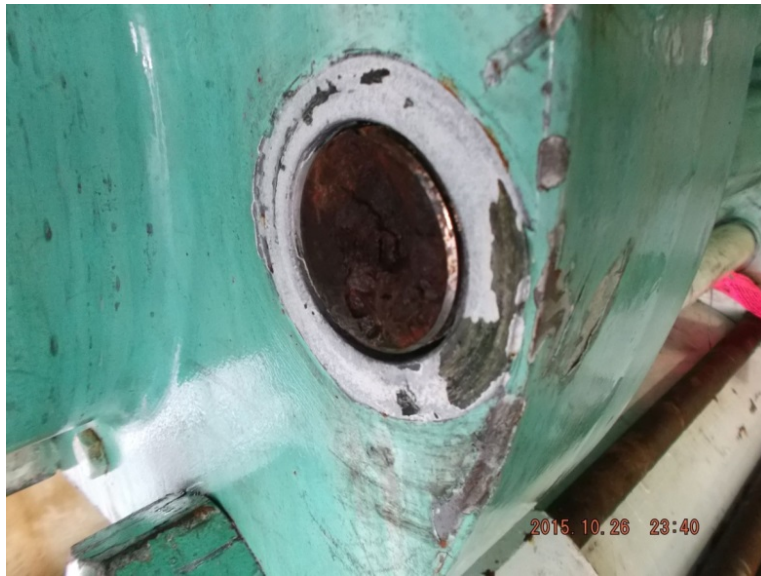
FIGURE 7: UPPER BSR FASTENER FAILURES – CLOSE-UP OF SHEARED FASTENER

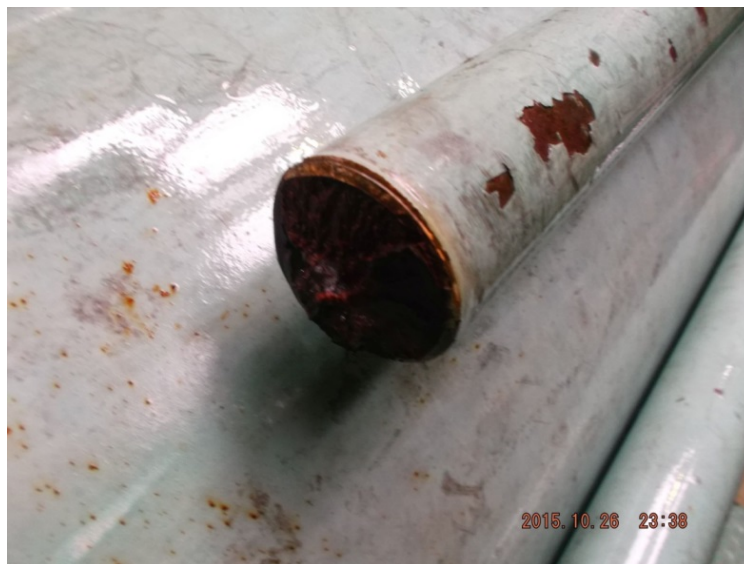
FIGURE 8: UPPER BSR FASTENER FAILURES – CLOSE-UP OF FRACTURED FASTENER

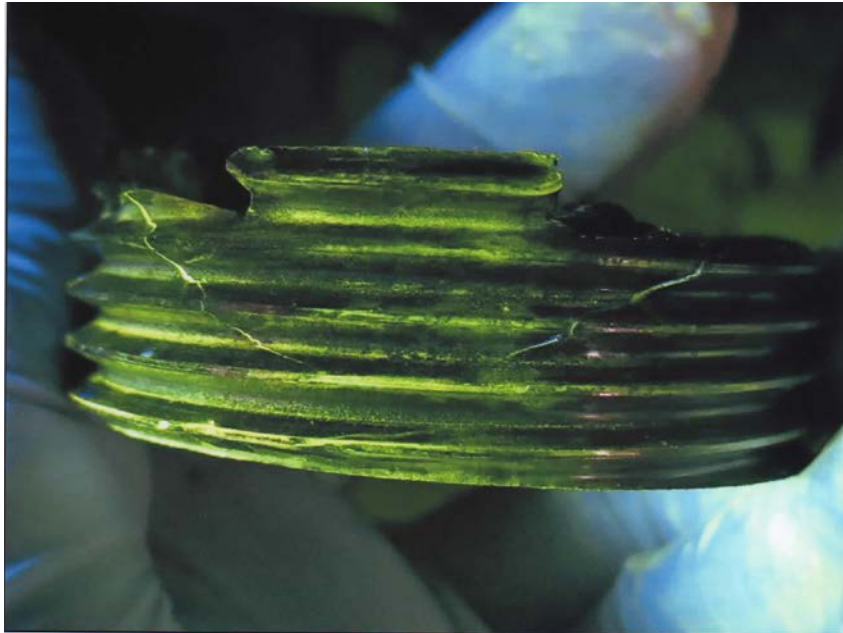
- Figure 9 shows fluorescent dye penetrant test identifying the crack propagated across multiple threads of the fastener. Cracks in the fastener indicate that the in-service load exceeded the fastener material design requirements.

FIGURE 9: CRACK PROPAGATION THAT EXTEND INTO MULTIPLE THREADS BELOW THE FRACTURE FACE (OEM RCA)

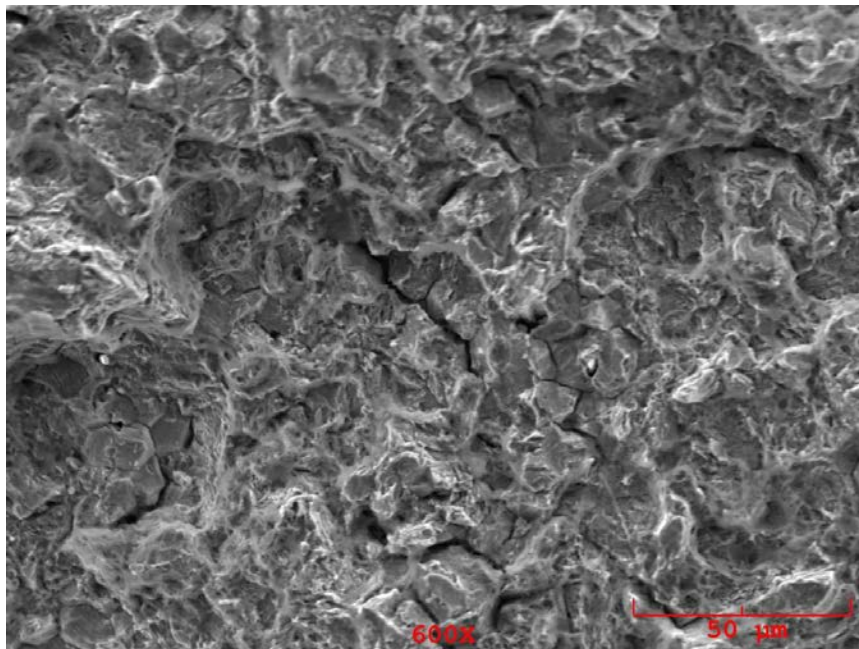
- Figure 10 shows a microscopic image of an intergranular ‘Rock Candy’ style fracture surface with micro-pores and grain separation typical of Hydrogen Embrittlement.

FIGURE 10: SEM IMAGE OF INTERGRANULAR FRACTURE SURFACE (OEM RCA)

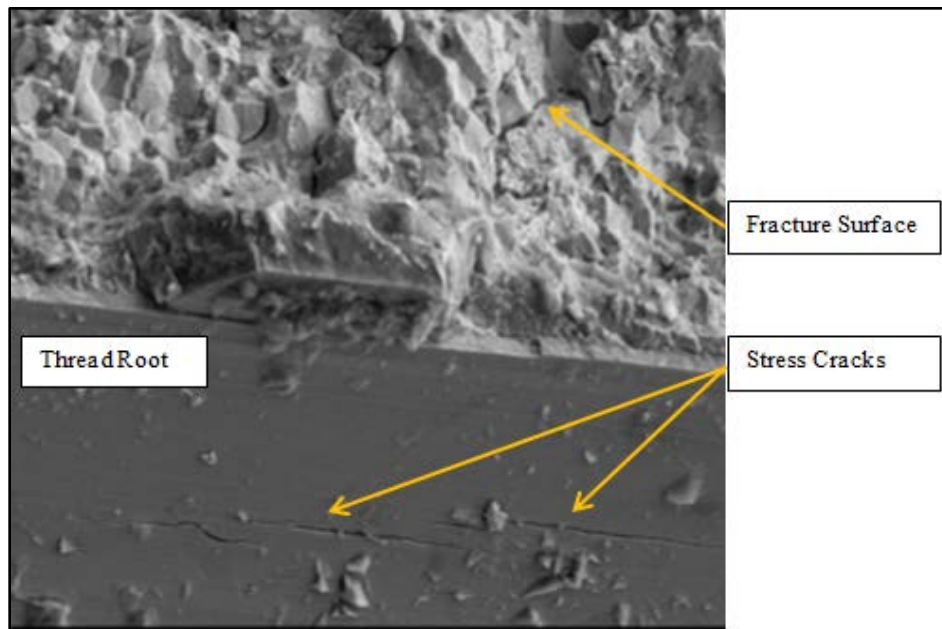
- NASA conducted a metallographic evaluation by macroscopic and microscopic optical and scanning electron microscopy (SEM) observation methods to identify the failure mechanism for the fasteners' failure. Optical microscopy was used to characterize the microstructures of the failed fasteners' fracture surface, multiple threaded areas, and thread root.
 - Figure 11 shows a microscopic image of a failed fasteners' thread cross-section. Stress cracks were observed in the thread root areas identified by yellow arrows indicating the load exceeded the fastener material design requirements. These cracks are prime sites for hydrogen diffusion into the material grain boundaries leading to failures due to hydrogen embrittlement. The fracture surface in Figure 11 was further evaluated under a higher magnification.

FIGURE 11: PARALLEL CRACKS OBSERVED IN THREAD AND THREAD ROOT NEAR FRACTURE (NASA RCA)

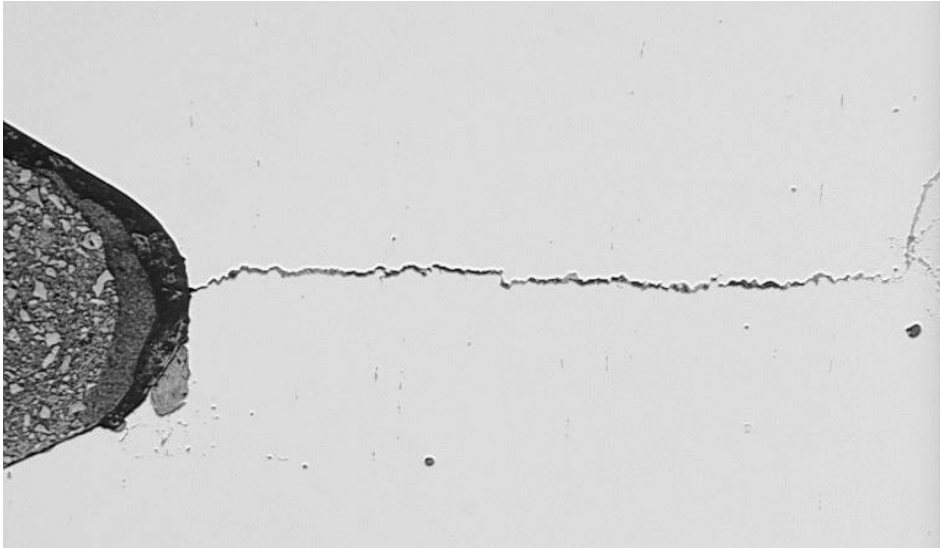
- Figure 12 shows a microscopic image of a failed fastener cross-section with a crack at the root of a thread. High material strength properties and inadequate heat treatment can lead to pre-existing cracks at the root of the threads. Thread root cracks can continue inwards towards the centerline of the fastener's diameter, resulting in

premature failure of fasteners under normal loading conditions. The measured crack length was 0.336 inches of the 1.852 inch fastener diameter.

FIGURE 12: CRACK INITIATION AT THE THREAD ROOT (INTACT OTHER END OF THE FRACTURED FASTENER – NASA RCA)

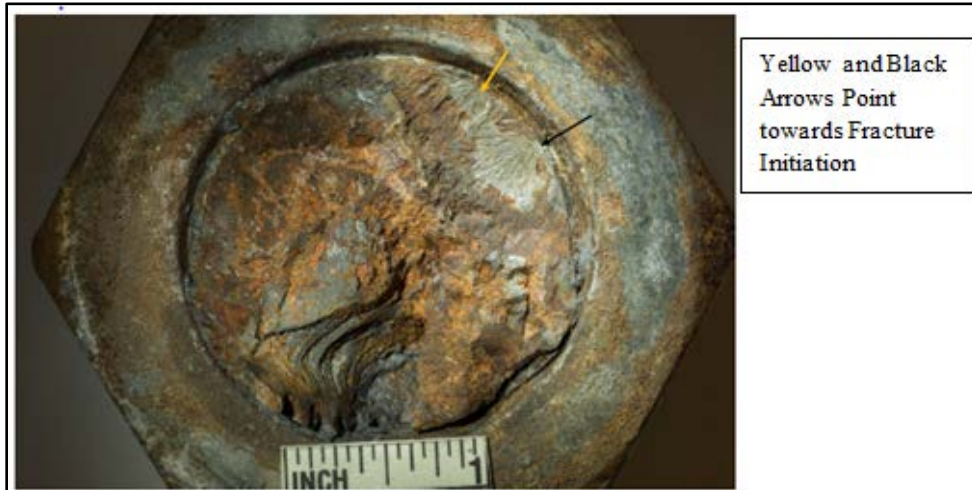
Figure 13 shows a macroscopic image of the failed fastener on the nut end. Tear lines indicate two primary fracture crack initiation locations, identified by the black and yellow arrows. The black arrow points to the tip of the chevron pattern (primary crack initiation location) indicating a higher stress area which lead to the initiation of the fastener fracture.

FIGURE 13: FRACTURE INITIATION AT NUT END (NASA RCA)

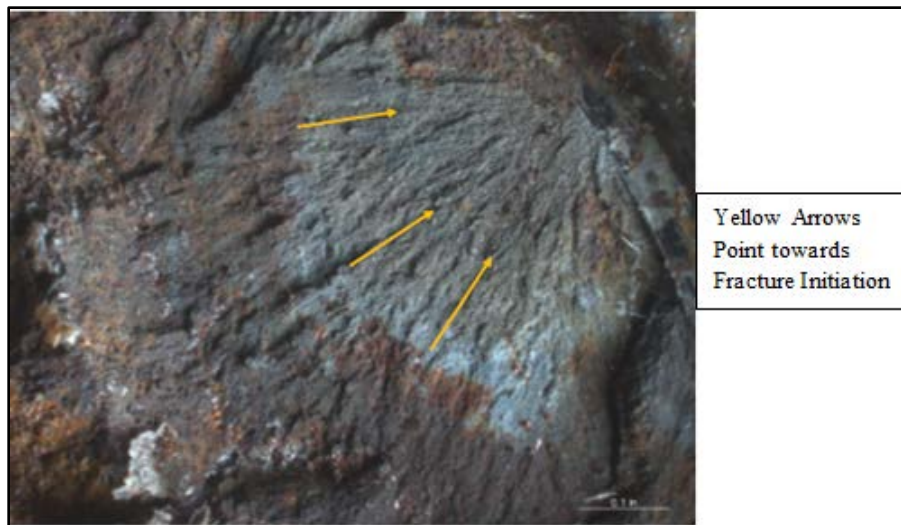
Figure 14 shows the direction of the crack resulting in a fan shape propagation (chevron pattern) as indicated by the yellow arrows. The fractography and chevron patterns indicate that the macro fracture feature is brittle fracture. Once the crack initiates as shown in figure 8, crack propagation will continue under lower load conditions until failure occurs.

FIGURE 14: CRACK PROPAGATION THAT EXTENDED INTO THE THREAD (NASA RCA)

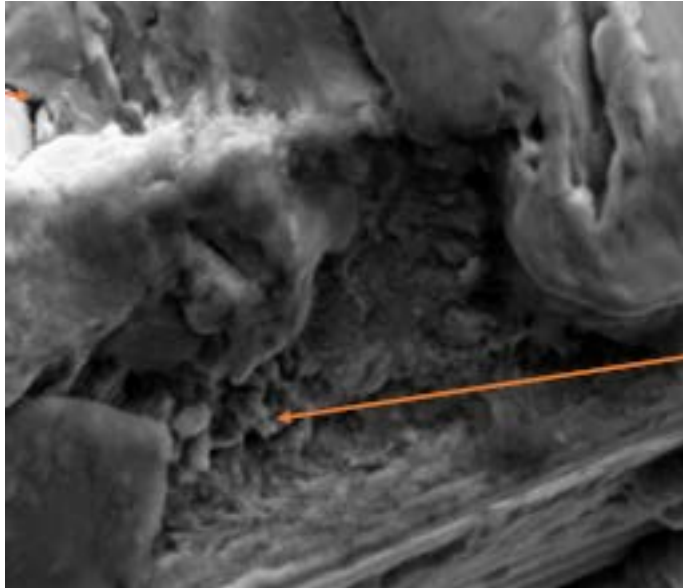
Figure 15 shows a microscopic image of the ductile dimple structure (orange arrow) indicating an overload condition in the fracture next to the thread root surface.

FIGURE 15: SEM IMAGE OF INTERGRANULAR FRACTURE ADJACENT TO THE THREAD ROOT (NASA RCA)

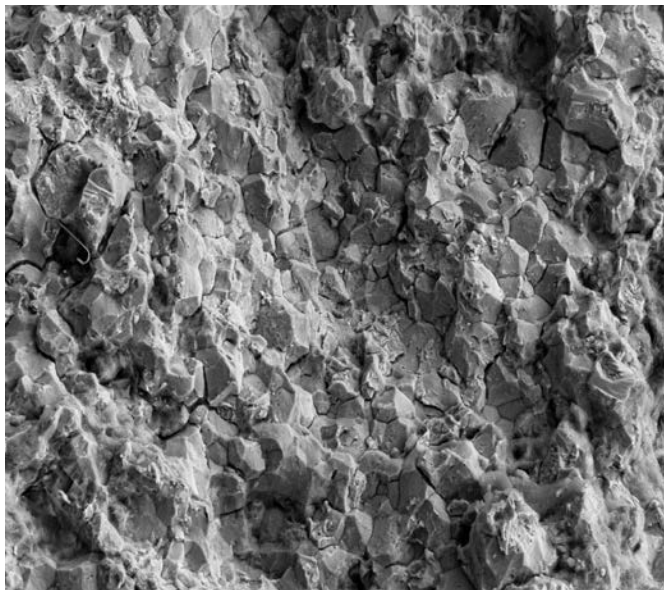
Figure 16 shows intergranular fractures, typical of hydrogen embrittlement. This SEM image indicates that the material is susceptible to hydrogen embrittlement or hydrogen induced stress cracking (HISC) in the presence of hydrogen ions. Hydrogen remains trapped in the material if improper post electroplating bake heat treatment is performed or during service where hydrogen could be generated due to the cathodic protection. When stresses are applied to the fasteners during installation, i.e. fastener torquing, or the system load condition, this entrapped hydrogen could lead to HISC.

FIGURE 16: SEM CLOSE-UP IMAGE OF THE INTERGRANULAR FRACTURE SURFACE (NASA RCA)
