QC-FIT EVALUATION OF SHEAVES FAILURES

Office of Offshore
Regulatory Programs

QC-FIT Report #005
May 2017

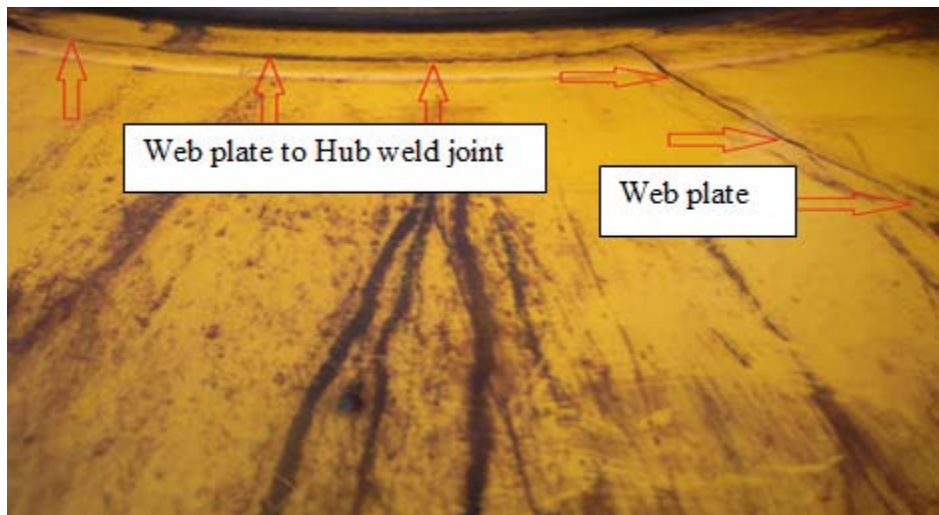
The dual web design sheaves can be interchanged with the single web design sheave. The RCA conducted by the OEM stated that the dual web design sheave prevented weld filler metal from penetrating deep enough to fill the gap on the inside of the hub-web weld joint. Thus, a crack initiated at the gap of the root of the weld and propagated through the weld seam into the web plate (Figures 5 and 6).

FIGURE 5: CRACKS IN WELD JOINT AND WEB PLATES INDICATED BY RED ARROWS (OEM PIB#87819987)

- The OEM verified that the sheave failure was due to high nominal stress levels in the sheave hub-web connection in combination with the additional stress concentration caused by the dual web design, which prevented welding of the inside of the hub-web weld joint and resulted in a gap. This stress concentration caused the crack initiation at the gap of the weld, which propagated through the weld into the web plates (Figures 5 and 6).

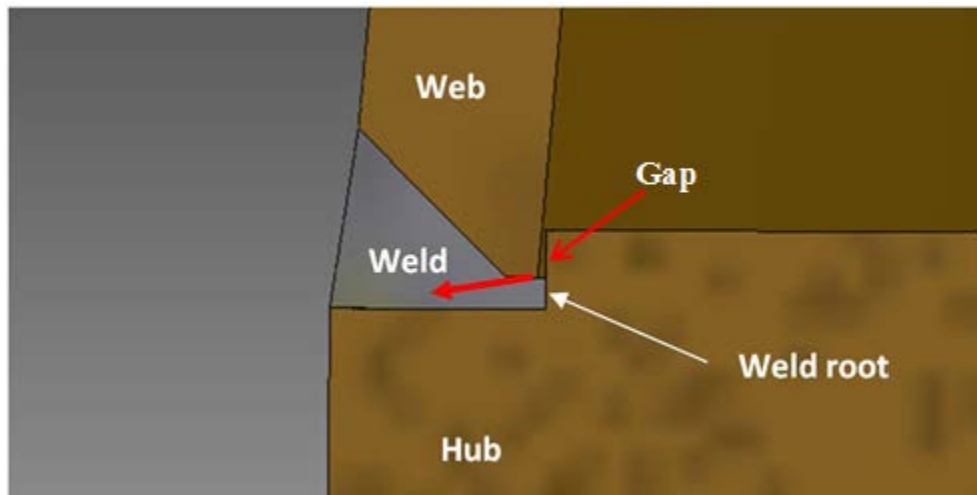
FIGURE 6: DETAILED CROSS-SECTION OF WEB PLATES TO HUB WELD SECTION CRACK INITIATION AT THE GAP AND PROPOGATION PATH SHOWN BY THE RED ARROW (RCA REPORT)

- The OEM specified a hand weld root pass procedure, followed by an automated SAW technique welding procedure. This procedure did not allow for a full penetration depth of the weld filler metal on the inside of the hub-web weld joint, creating a stress concentration.

- The Metallurgical RCA investigation attributed the sheaves' failure to the dual web design of the sheave. The dual web design prevented welding on the inside of the web plates to the hub. The OEM specified a manually welded root pass, followed by an automated SAW technique welding procedure. This procedure did not allow for a full penetration depth of the weld filler metal, which resulted in a gap between the inside of the web plate to the hub weld joint. This gap between the inside of the web plate to the hub weld joint allowed for stress concentration and crack initiation at the gap of the root of the weld (Figure 6).

In the case of this evaluation, the OEM’s welding parameters should have specified that sufficient heat be applied to achieve a wider, deeper penetration along the backing surface gap of the root of the weld. This would have enabled the weld to be more resistant to crack initiation.

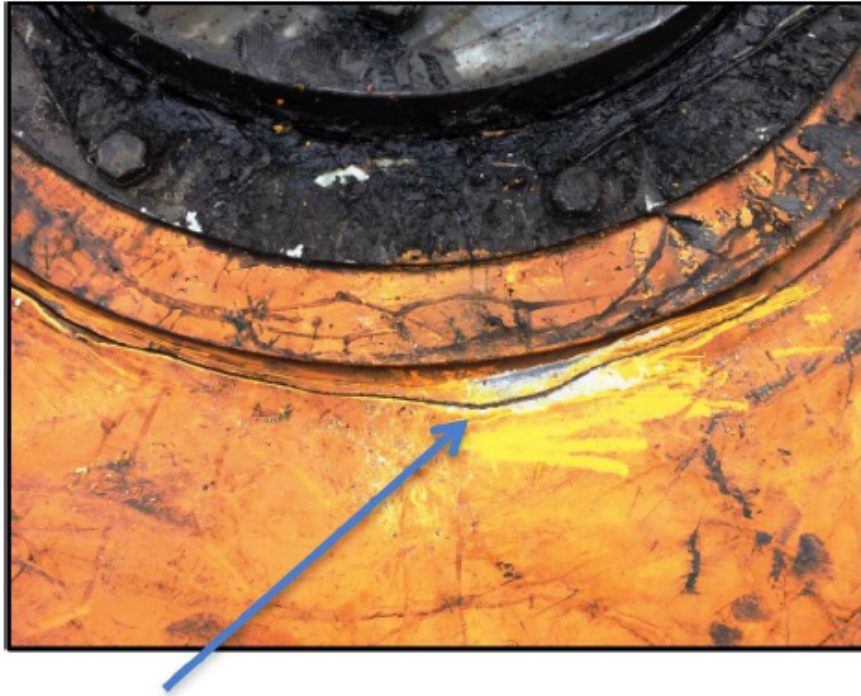
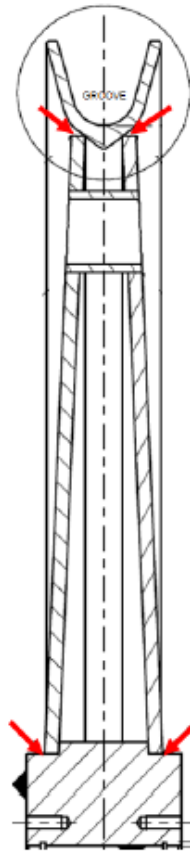
- Issue:** Hub weld cracking incidents have been reported for the CMC's 78" fastline jockey sheave (the middle of the three sheaves in the fastline linkage arm assembly). These cracks propagate from weld defects near the root of the weld between the web plates and the hub.

Illustrations: Above: Example of crack at hub of old fastline sheave. Right: Cross-section of typical sheave. The red arrows are pointing at the welds that supplier defines as "critical".

- Solution:** NOV recommends that the present fastline jockey sheave be replaced with a single-web sheave. Until replacement is performed, the critical welds of the sheaves in the fastline linkage arm assembly should be visually inspected for cracks on a weekly basis. The Critical Welds are shown in the Maintenance Instructions and in the figure below. Additionally, users should ensure that appropriate fastline stabilizers are installed, as these significantly lower the dynamic high-frequency side loading on the sheaves.

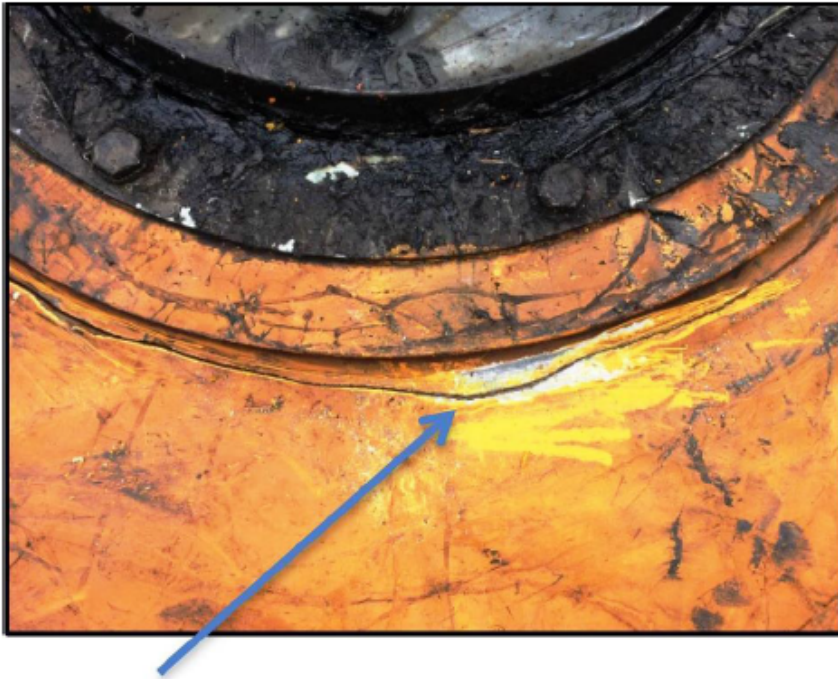
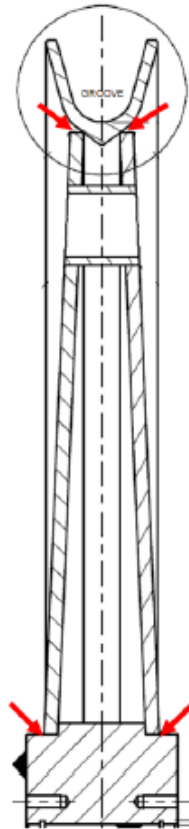
Subject:	Incidents Reported for CMC Wire Sheaves
Product Models:	Crown Mounted Compensator (CMC), CMC-1000-25 / 2500, using 78" wire sheaves with NOV item no. 207785 and 207786.
Affected Assemblies:	Crown block sheave block D1104-A2700, with seven regular sheaves. Fastline and deadline linkage arm assemblies D1104-A4000/A4001/A4002; - each assembly with one regular sheave and two light-weight sheaves.
Objective:	To inform the user about the reported CMC 78" sheave incidents, to stress the importance of frequent sheave inspections according to the Maintenance Instructions, and to recommend replacement of the sheaves. Compared to the previous revision of this bulletin, this revision extends the coverage to include the cluster sheaves in addition to the originally covered jockey sheave position.
Issue:	Hub weld cracking incidents have been reported for the fastline jockey sheave (the middle of the three sheaves in the fastline linkage arm assembly) and among the crown block sheaves. The cracks propagate from weld defects near the root of the weld between the web plates and the hub.

Illustrations: Above: Example of crack at hub of old fastline sheave. Right: Cross-section of typical sheave. The red arrows are pointing at the welds that supplier defines as "critical".

Solution:	NOV recommends that all 78" CMC wire sheaves with item no. 207785 and 207786 be replaced with single-web sheaves. Until replacement is performed, the critical welds of the sheaves should be visually inspected for cracks on a weekly basis. The Critical Welds are shown in the Maintenance Instructions and in the figure below. Additionally, users should ensure that appropriate fastline stabilizers are installed, as these significantly lower the dynamic high-frequency side loading on the sheaves.
