QC-FIT EVALUATION OF WING VALVE FAILURES

Office of Offshore
Regulatory Programs

QC-FIT Report #004
February 2017

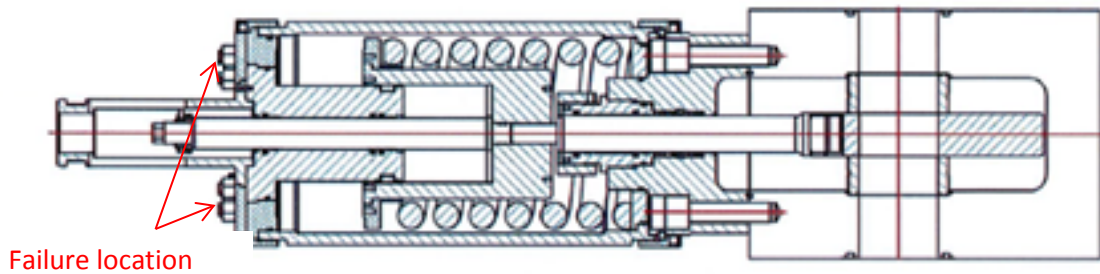
Figure 4: Failed wing valve

Horizontal subsea trees (Figure 3) use many of the same components as vertical trees; however, some of the equipment differs significantly from that used in vertical trees. Horizontal tree arrangements offer different benefits in regards to installation, retrieval, and maintenance. Horizontal trees may also be used with mudline suspension equipment and drill-through mudline suspension equipment and may be configured for artificial lift completions such as electric or hydraulic submersible pumps. The wing valve evaluated in this report is a failsafe valve used on a horizontal subsea tree. Figure 4 shows a schematic of the wing valve with the location of the failed fasteners.

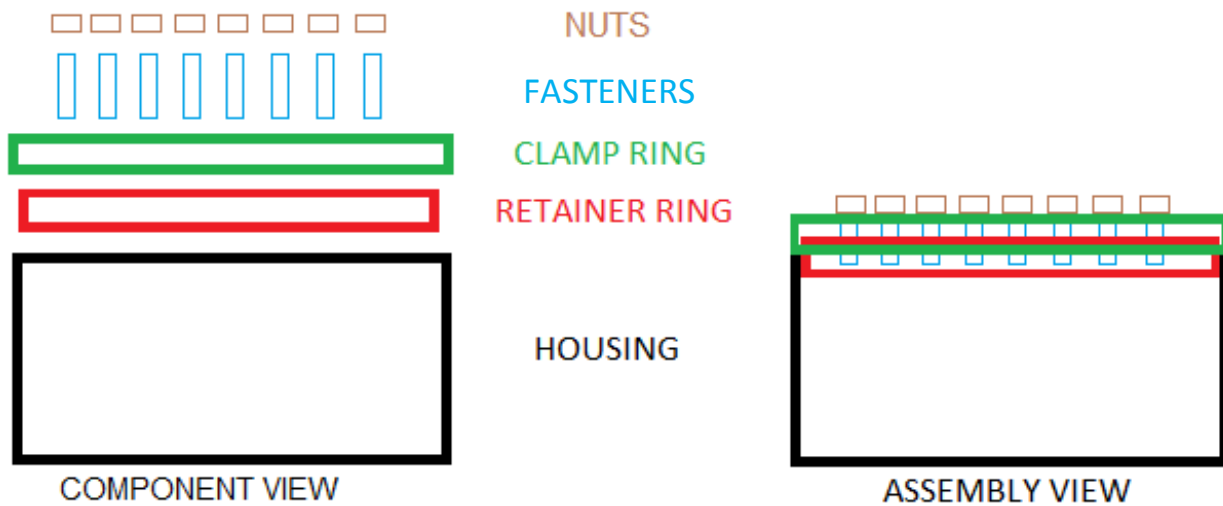
Figure 5: Wing Valve and Terminology

- 1) There was a large difference in the material property values between the fasteners and the retainer ring (Figure 5). The fasteners had a material yield strength value of 105 ksi, while the retainer ring's material yield strength value was 35 ksi (a difference of 70 ksi). As a result, in an over-pressurization situation, the contact area between the fasteners and retainer ring (i.e., the thread engagement of the fasteners into the retainer ring) could cause the retainer ring material to fail first. This failure would result in the retainer ring threads becoming stripped while the fasteners' threads remained intact (Figures 6 & 7). The OEM confirmed the large difference in yield strength values between the fasteners and the retainer ring. The OEM also noted that the difference in material yield strength values did not play a role in the failure because the material properties were sufficient for the anticipated load rating of the wing valve. Since the time the third party reported the incident, the OEM communicated to BSEE that the retainer ring's material yield strength value was increased. They noted that a closer match in yield strength values between the retainer ring and fasteners was a standard practice for other wing valve designs they manufacture. The new material yield strength value for the retainer ring was not provided by the OEM to BSEE. If the increase in material yield strength is not adequate, there is still a potential for hazardous failures if the fastener's threads are stripped from the retainer ring.

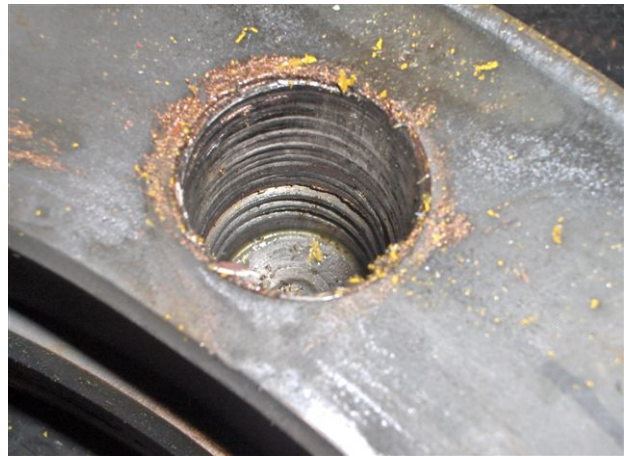
Figure 6: Stripped threads in the retainer ring and depth of thread engagement

The wing valve was designed to function normally with a 3,000-psi operating pressure. The test pressure required by the OEM during manufacturing qualification testing was at least 1.5 times the rated working pressure, in accordance with API 17D First Edition. This equated to a minimum test pressure rating of 4,500 psi (the OEM used 4,700 psi). The OEM calculated their test rating using a worst-case scenario in which all eight fasteners had a thread engagement of 0.5 inches and determined that a pressure greater than the qualification test rating of 4,700 psi was required to strip the threads, as seen in figure 6. The OEM was unable to determine the range of over-pressure required to fail the wing valve.

The fasteners involved in this failure had an outside diameter of 0.875 inches and witness marks showing thread engagements ranging between 0.56 and 0.793 inches. The failure indicates that this wing valve's thread engagement did not meet the requirements of API 6A Nineteenth Edition, or API 17D First Edition. The OEM design provides for a minimum thread engagement of 0.875 inches into the retainer ring, however, during manufacturing the fastener was not threaded to this minimum thread engagement depth requirement. Following the failure, the OEM made design changes to the wing valve which included an increased material strength for the retainer rings, revised tolerances on the housing and clamp ring, and increased fastener length on the nut end. The OEM notified operators using this design wing valve about the failure during qualification testing.

1. The OEM should consider increasing the required amount of thread engagement into the retainer ring as specified in API 6A, Nineteenth Edition, and required per BSEE regulations in §250.806, to ensure proper closure bolting.

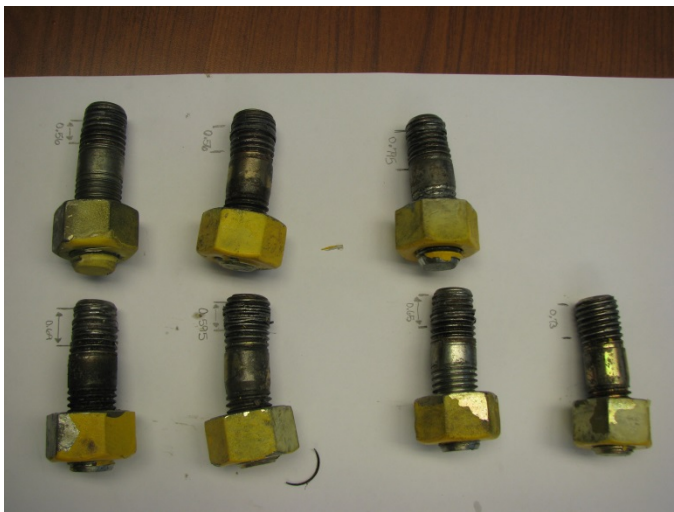
Figure 7: Failed Fasteners and stripped threads

In this case, the safety factors were calculated with the material yield shear strength rather than with the material ultimate shear strength. If safety factors with respect to yield shear strength were less than 1.0, then the threads would yield but not necessarily fail. Conversely, if the safety factors with respect to ultimate shear strength were less than 1.0, the threads would fail. The failed fasteners can be seen in Figure 7. In both cases, the safety factors should be greater than 1.0, as an appropriate engineering measure of safety, to ensure that the equipment can withstand the required pressures.
