BSEE Panel Report 2021-001

# **Investigation of May 29, 2019, Fatality**

Lease OCS-G02116, Eugene Island  
Area Block 331

Gulf of Mexico Region, Lafayette District  
Off Louisiana Coast

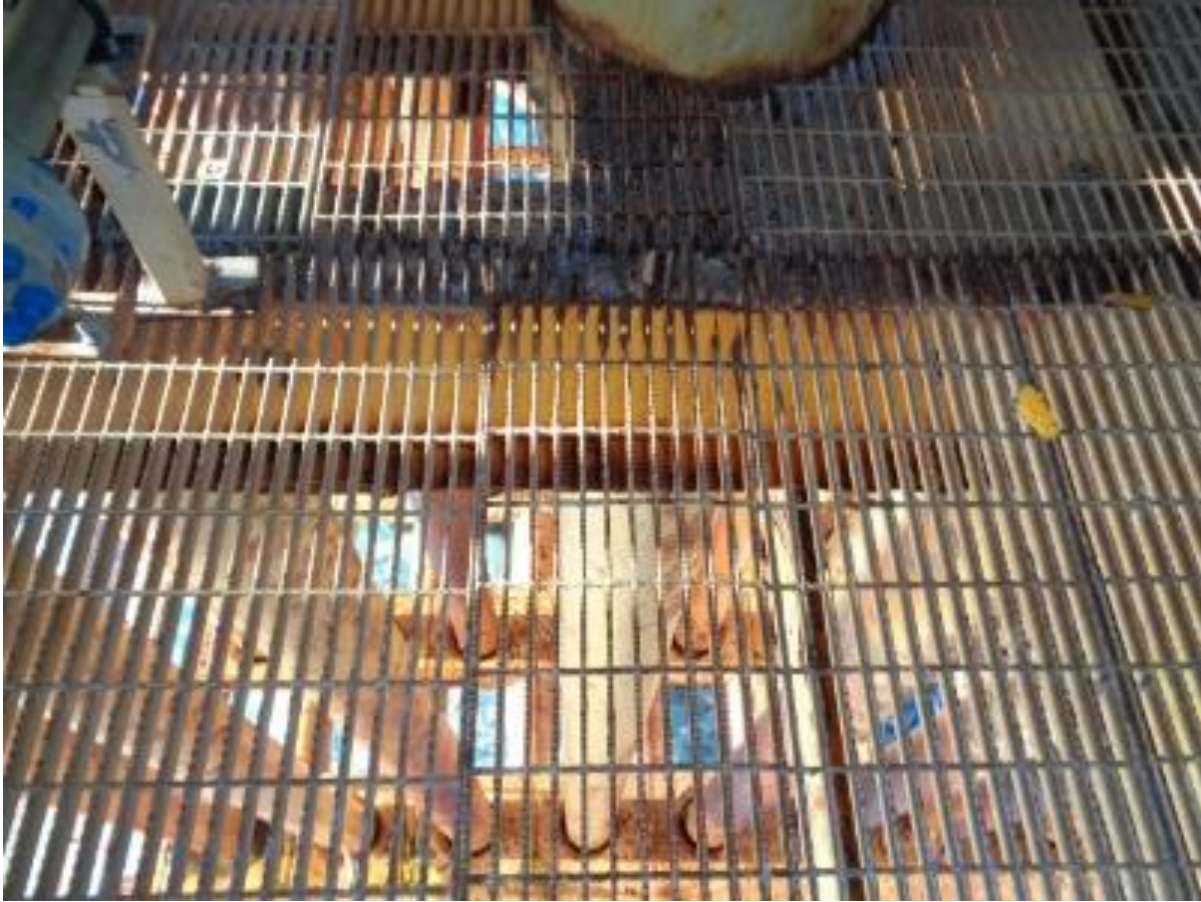
*Figure 4- Initial Pre-Incident Photograph of Hazardous Grating Section*

At 0733, according to the *Figure 4* time stamp, the UWA photographed a facility structural member that needed repair and noticed an approximately 13¾- by 91-inch section of grating, on the north side of the lower deck wellbay perimeter that felt, “spongy” underfoot. Upon examination, the UWA found that bearing bars at one end of the grating section had deteriorated and took a photograph of the deteriorated condition of the grating section (*see Figure 4*).

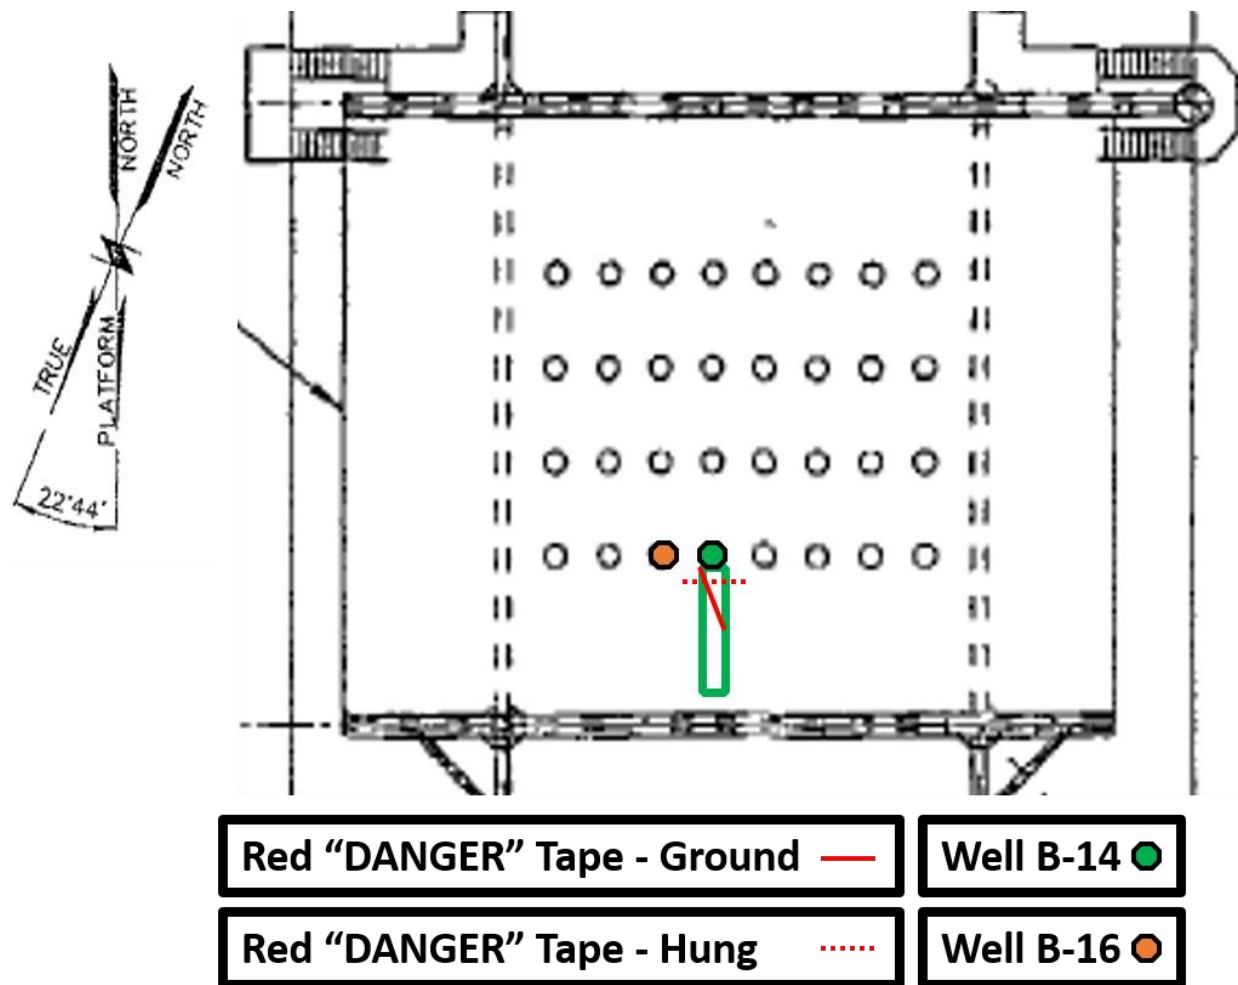
Figure 5- Representation of Lower Wellbay (Hazardous Grating and Red "DANGER" Tape Locations)

The UWA then showed the section of hazardous grating to the lead PO, construction consultant and construction crew supervisor. Despite having the available resources and materials onsite, to immediately barricade and correct or repair the hazardous grating section, the UWA made the decision that the section of hazardous grating would be replaced the next morning after the “pressing” hatch cover task was completed. The UWA then directed the construction crew supervisor to retrieve red “DANGER” marking tape to mark the hazardous grating section. Together, the UWA and construction crew supervisor affixed a strand of red “DANGER” marking tape to the section of hazardous grating. A second strand of red “DANGER” marking tape was strung approximately four-foot high, between a nearby metal post and a process pipe at the north side perimeter of the wellbay, proximal to well B-14 (*see Figure 5*). The construction crew supervisor stated the following during an interview with the Panel:

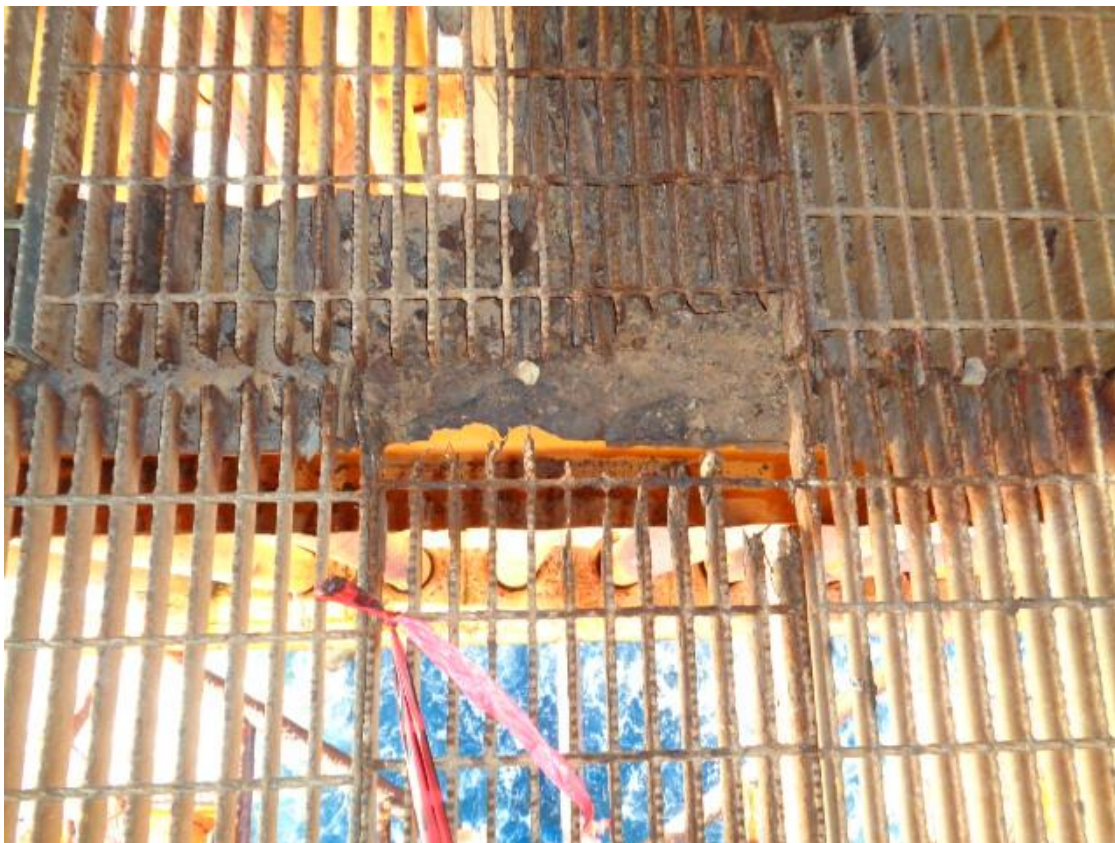
*Figure 6- Pre-Incident Photograph of Hazardous Grating Section with Red Danger Marking Tape Affixed and After Impact from Sledgehammer Strikes*

Prior to 0752, according to the *Figure 6* time stamp, the UWA returned to the section of hazardous grating to assess the severity of the corrosion by striking it with a “small sledgehammer.” After assessing the end of the section of hazardous grating with the sledgehammer, the UWA took another photograph of the condition of the grating (*see Figure 6*). The UWA gave the camera used to take the photographs to the lead PO so that an ALMS entry could be created for the hazardous grating section.

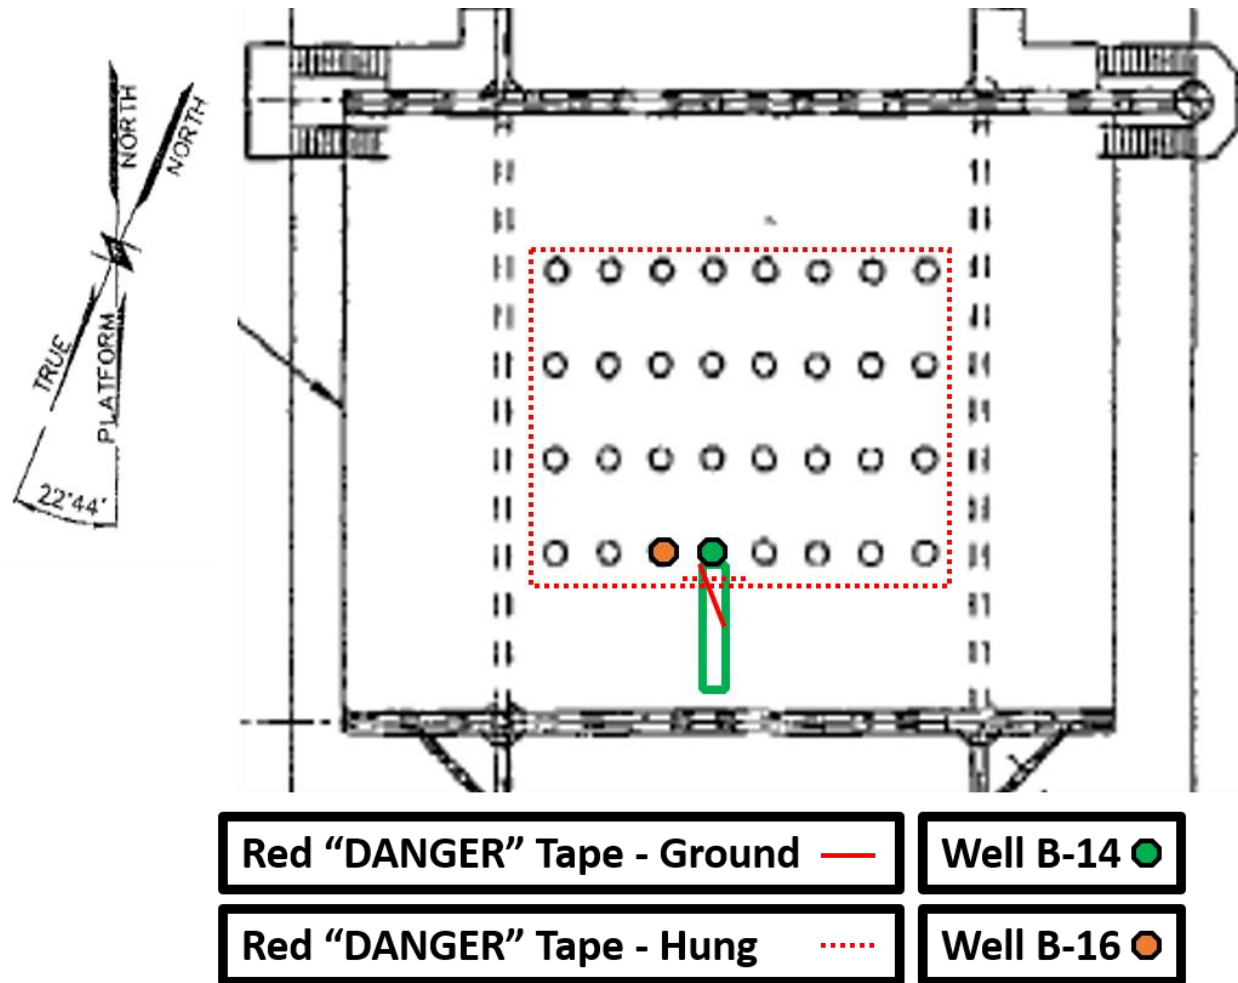
Figure 7- Representation of Lower Wellbay (Hazardous Grating and Red "DANGER" Tape Locations) After Hotwork Preparations

At approximately 1500, the hot work preparations were completed for the hot work on the upper deck to cut out and replace the well access covers. Tarps had been hung over the wells located below to prevent slag from falling into the lower deck wellbay area and red “DANGER” marking tape was hung around the perimeter of the entire wellbay (*see Figure 7*). When hot work commenced, firewatch personnel were exposed to the hazardous grating danger area when monitoring the lower deck wellbay area for falling slag. The mid shift PO stated the following during an interview with the panel:

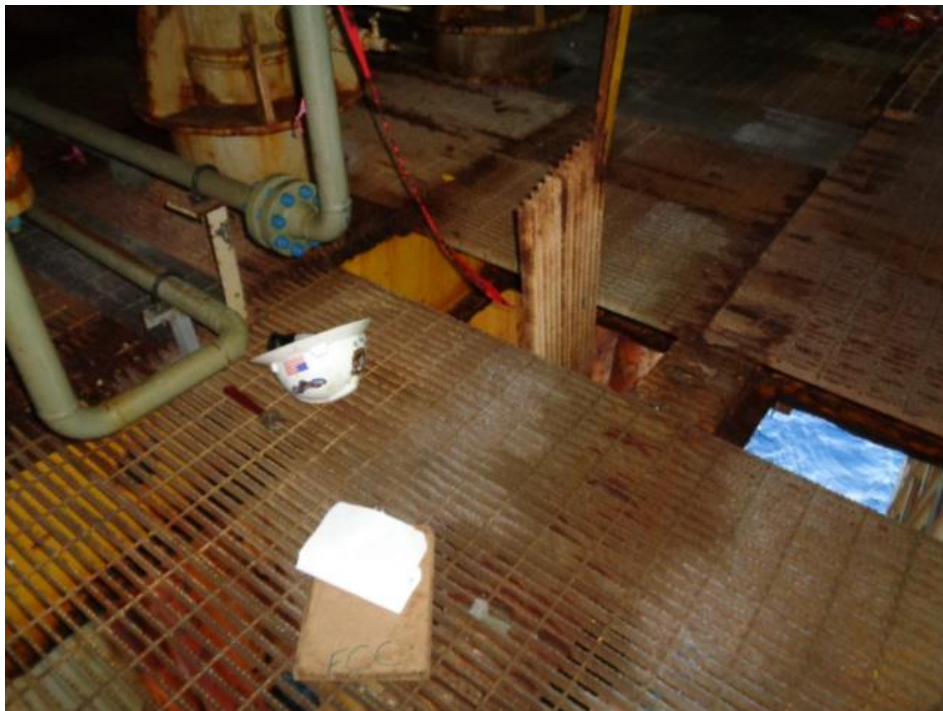
*Figure 10- Post-Incident Photograph of Hazardous Grating Section Suspended in Open Hole with Victims Hardhat, Wrench, and Clipboard*

At approximately 0550, the lead PO noticed the victim had not come to his office to report his night work as usual. The lead PO called for the victim on the facility intercommunication system. The victim did not respond so the lead PO went to look for him. The lead PO discovered that the previously identified and uncorrected hazardous grating section had been displaced and was suspended in the resultant open hole. The open hole measured approximately 14½ by 40 inches and is approximately 45 feet above the water's surface (*see Figures 8 and 9*). The victim's hard hat, wrench, and clipboard were observed on the deck near the open hole (*see Figures 10 and 11*).

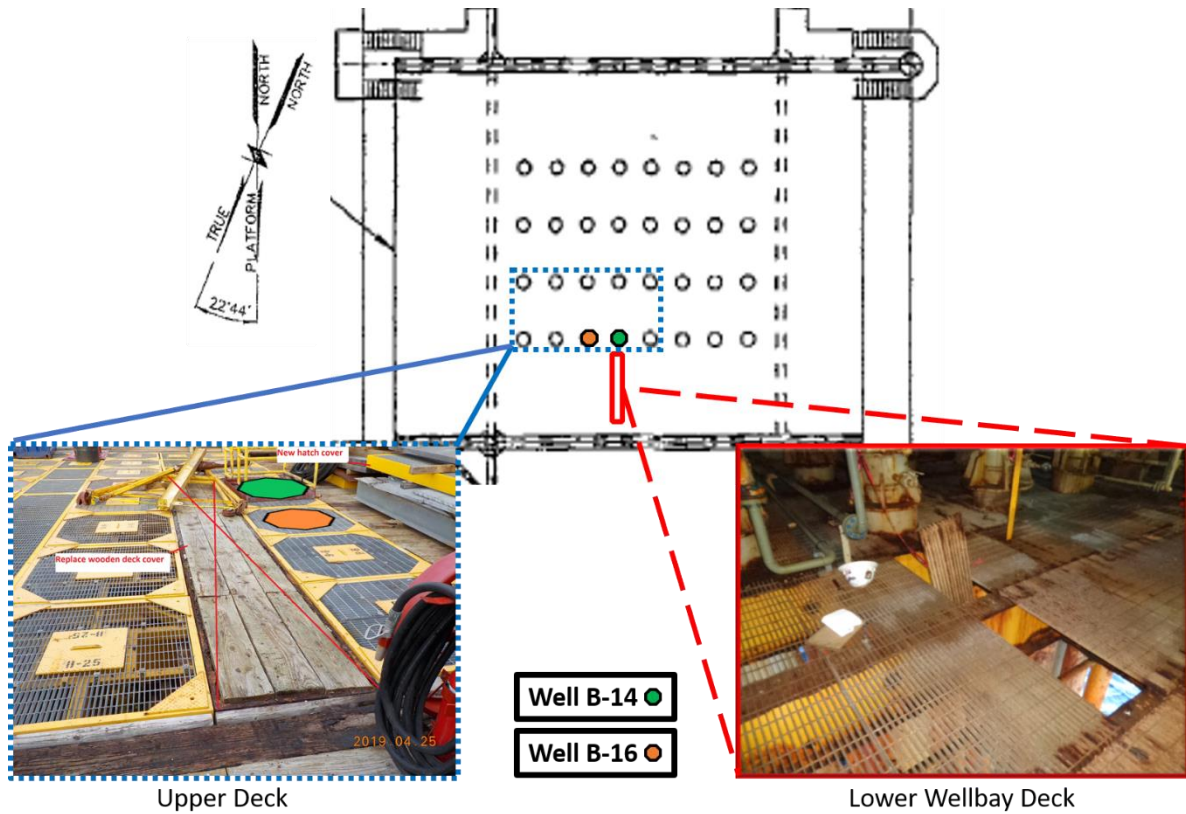
Figure 12- Representation of Upper Deck (Hot Work Location) and Lower Wellbay Deck (Wells B-14, B-16, and Hazardous Grating Locations)

The incident scene is located at the north side of the wellbay perimeter area. Based on the documentation used to record casing pressures, the victim had completed recording casing pressures for well B-14 and recorded one of two casing pressure readings for well B-16. The following images were selected by the panel to provide a general overview of the incident scene.

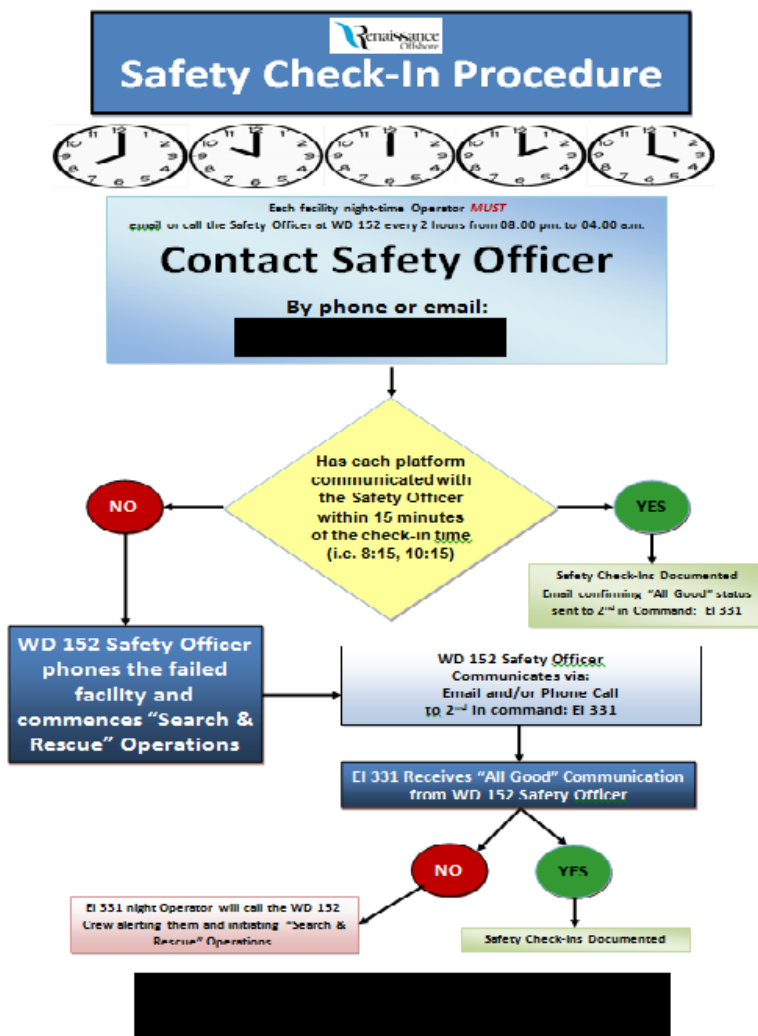
Figure 18- Redacted copy of Renaissance Safety Check-In Procedure Flow Diagram

The panel interviewed the CSO who stated that he had recently moved to WD-152 from another Renaissance platform where his sole responsibility regarding the check-in procedure was to send an email to check-in. When the CSO began work at WD-152, as a night shift PO, he did not receive any formal training on the check-in procedure and CSO responsibilities. The CSO also said he was not aware that he had the title of CSO. As a result, his stated pre-incident understanding of his responsibilities were not commensurate to those outlined in Renaissance's check-in procedures. The Panel showed the *Safety Check-In Procedure* flowchart to the CSO and asked if he had seen this document prior to the incident (see Figure 16). In response, the CSO explained that he did not remember seeing the procedural flowchart, adding that if he had seen it, it was years ago. Additionally, when the panel showed the *Safety Check-In Procedure* flowchart to the EI-331 lead PO, he stated that he did not recall seeing the procedural flowchart prior to the incident either.
