BSEE Panel Report 2020-002

# Investigation of June 1, 2019 Fatality

Lease OCS-G05911  
Green Canyon Area Block 205-A  
Genesis Spar  
Gulf of Mexico Region,  
Houma District - Off Louisiana Coast

December 1, 2020

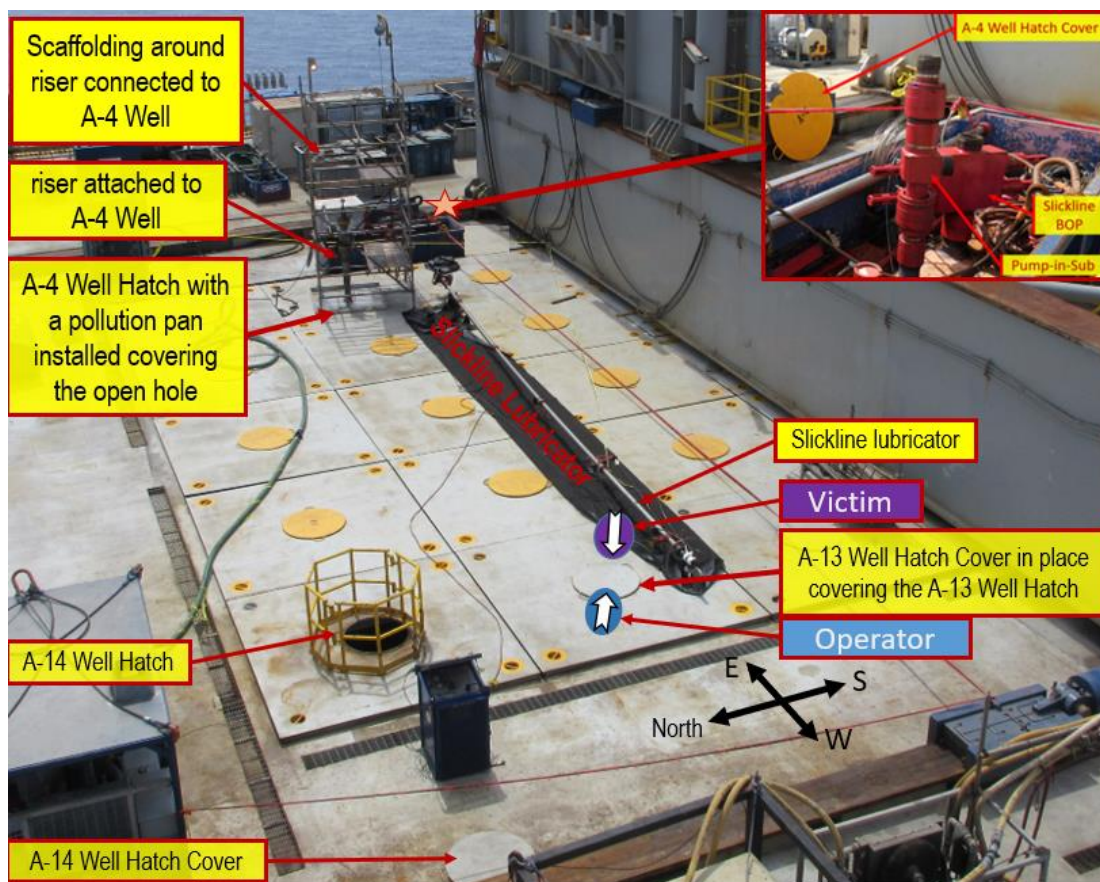
Figure 3: Well Bay Area and surrounding area (June 4, 2019)

The construction crew then notified the QES Supervisor when they completed the scaffolding. With the A-4 Hatch Cover removed, the scaffolding and a drip pan installed around the riser then served to protect the crew from open hole hazards on the A-4 Well Hatch. See Figure 3 for the approximate locations of the relevant items and structures.

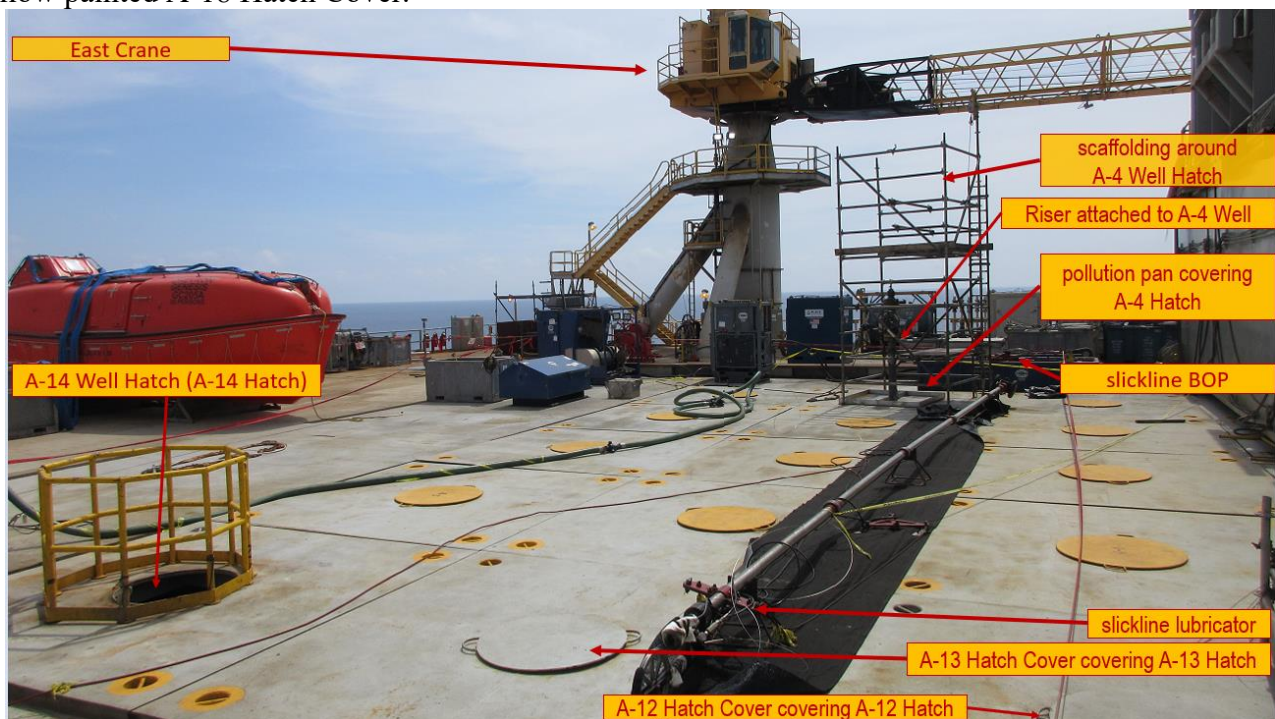
Figure 4: Eye-level view of Well Bay Area (facing east)(June 4, 2019)

With a job scope of rigging up the pump-in-sub and slickline BOP’s on the riser attached to the A-4 Well, the QES Operator, QES Helper and Victim began walking toward the A-4 Well Hatch. They all took a path to this location which included walking onto the Well Bay Area from the west to east. A camera installed on the West Crane Boom positioned above the Well Bay Area recorded the QES crew (see figure 5). They walked between the barricade on the A-14 Well Hatch (to the north) and the lubricator that had been laid down just south of the A-13 Well Hatch (see Figure 4, from the approximate vantage point of QES personnel as the crew walked from the smoking area to the Well Bay Area). They all walked past the A-13 and A-14 Well Hatches, seemingly each stepping on the gray A-13 Hatch Cover which was covering the A-13 Well Hatch. The QES Helper also seemed to step on the yellow painted A-18 Hatch Cover.

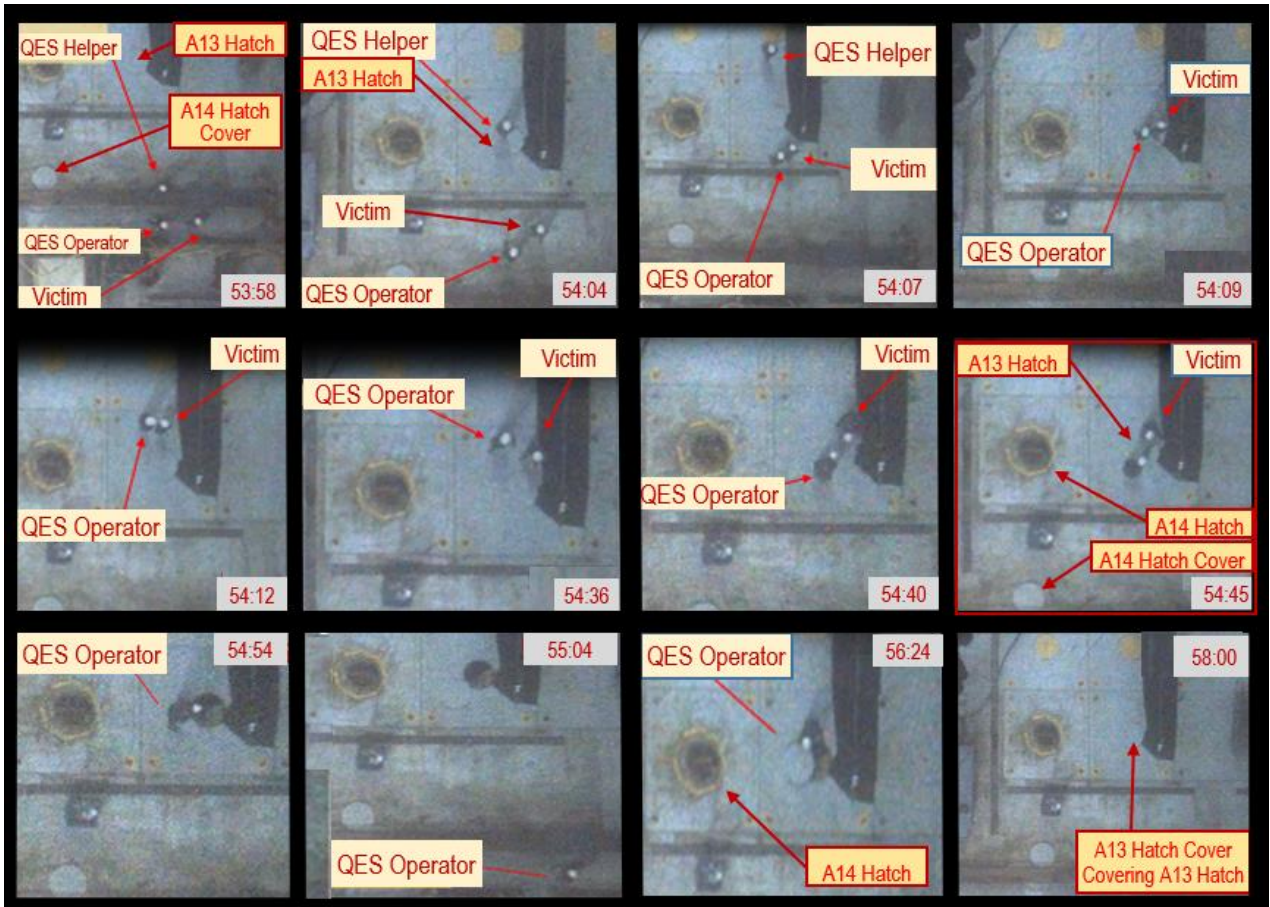
Figure 5: Still images of the Genesis camera located on the West Crane Boom (June 1, 2019)

Without realizing the A-14 Hatch Cover was located off the Well Bay approximately 15 ft away from the barricaded A-14 Well Hatch to their northwest, the QES Operator and Victim then took a few steps and stood on opposite sides of the A-13 Well Hatch Cover (see Figure 5). Mistakenly thinking the A-13 Well Hatch Cover was the removed A-14 Hatch Cover, the QES Operator, identified by the **Blue circle** (see Figure 3), stood to the north side (closer to the A-14 Well Hatch) and the Victim, identified by the **Purple circle**, stood to the southeast (adjacent to the lubricator) to position themselves to pick up the hatch cover.

At approximately 10:49 p.m., the QES Operator and the Victim crouched down and lifted the A-13 Hatch Cover. The QES Operator described that he picked it up to where he was able to look towards the A-14 Well Hatch, and when he saw the actual A-14 Hatch Cover, he yelled. However, by the time he noticed their situation and yelled, with the intention of moving toward the A-14 Well Hatch, the Victim had already taken an initial step into the A-13 Well Hatch. This action caused him to fall

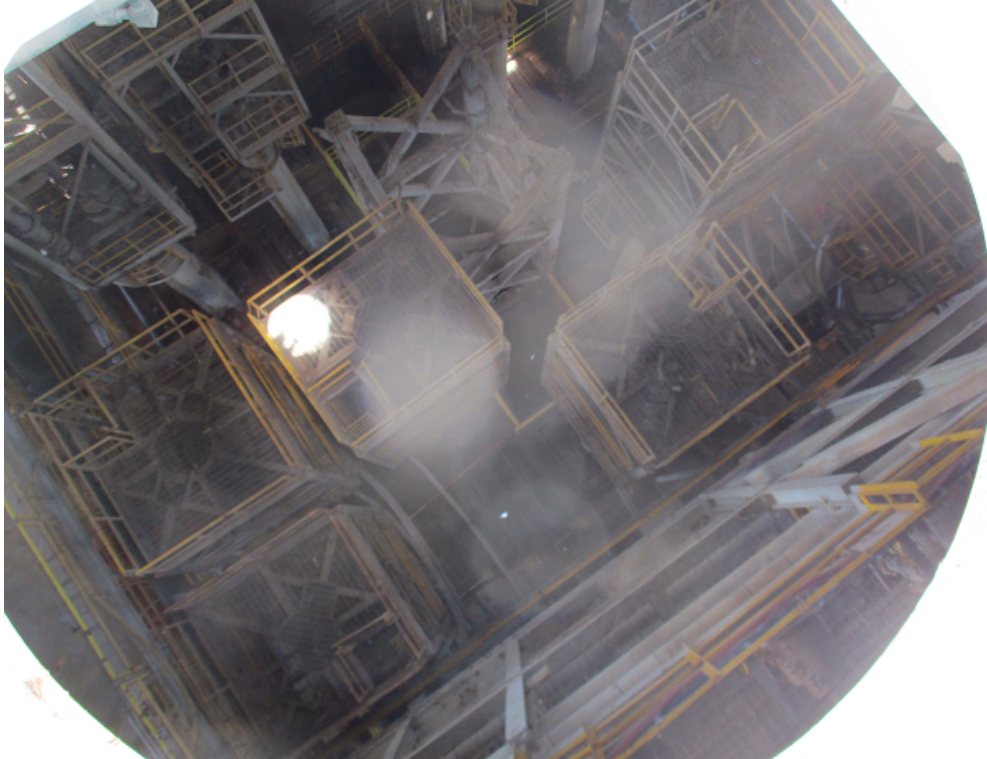
Figure 6: Viewpoint looking down A-13 Hatch to Deck 10 (June 4, 2019)

At the time of the incident, the QES Helper stood with his back to the Victim on the scaffolding deck while removing the lifting cap on the riser attached to the A-4 Well. He then heard the QES Operator calling for him from across the Well Bay Area, who told him the Victim had fallen. The QES Helper told the QES Operator to notify the QES Supervisor. The QES Helper then ran to look down the A-13 Hatch (see Figure 6).

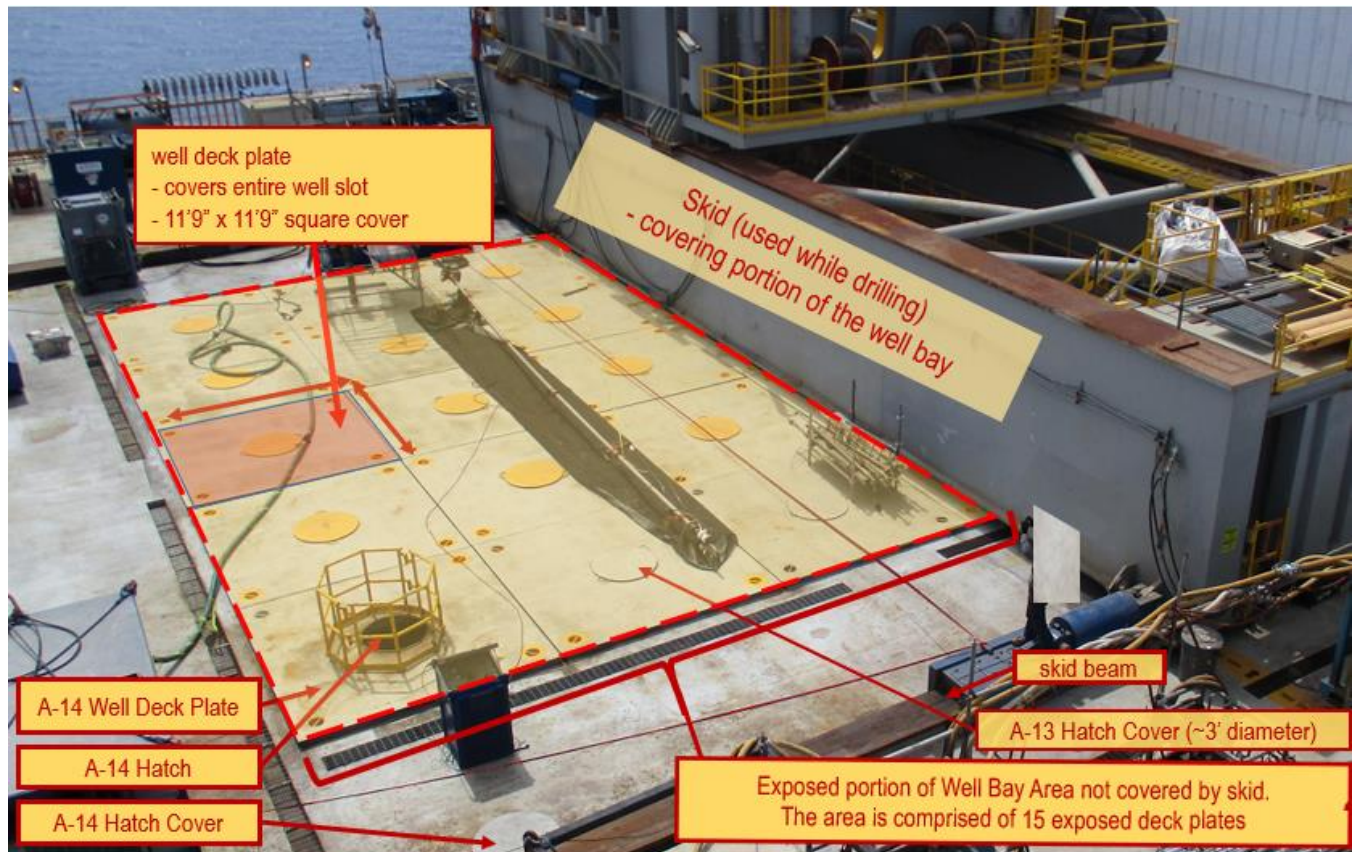
Figure 7: Overhead view of Well Bay Area (facing east) (June 4, 2019)

The exposed Well Bay Area where the QES crew was working was laid out with 15 square deck plates. The deck plates covered the entire well slot. The heavy deck plates required a crane to lift and included a pad-eye in each of its four corners to facilitate lifting utilizing a 4-part sling. Ten additional deck plates with hatches and hatch covers laid behind the drilling skid on the south side of the Well Bay Area.

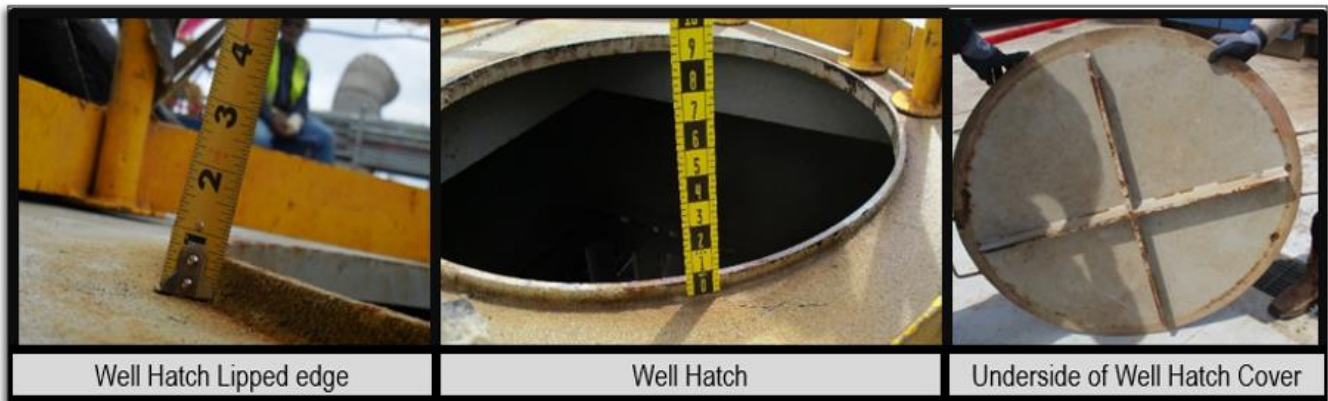
Figure 8: hatches and hatch cover (June 4, 2019)

The diameter of the circular well hatch openings (well hatch) spanned approximately 36-inches from its inner edges. The round hatch covers were slightly larger than the well hatches, so they would not fall through the hatch. The hatch covers were approximately 0.25-inches thick.

In order to keep the hatch covers from sliding on the deck plates of the Well Bay Area, the underside of the hatch covers had a two-inch tall metal frame that fit inside the approximate 0.75-inch lipped edge of the well hatch (see Figure 8). The metal frame was welded to the underside of the circular cover in an 'X' pattern.

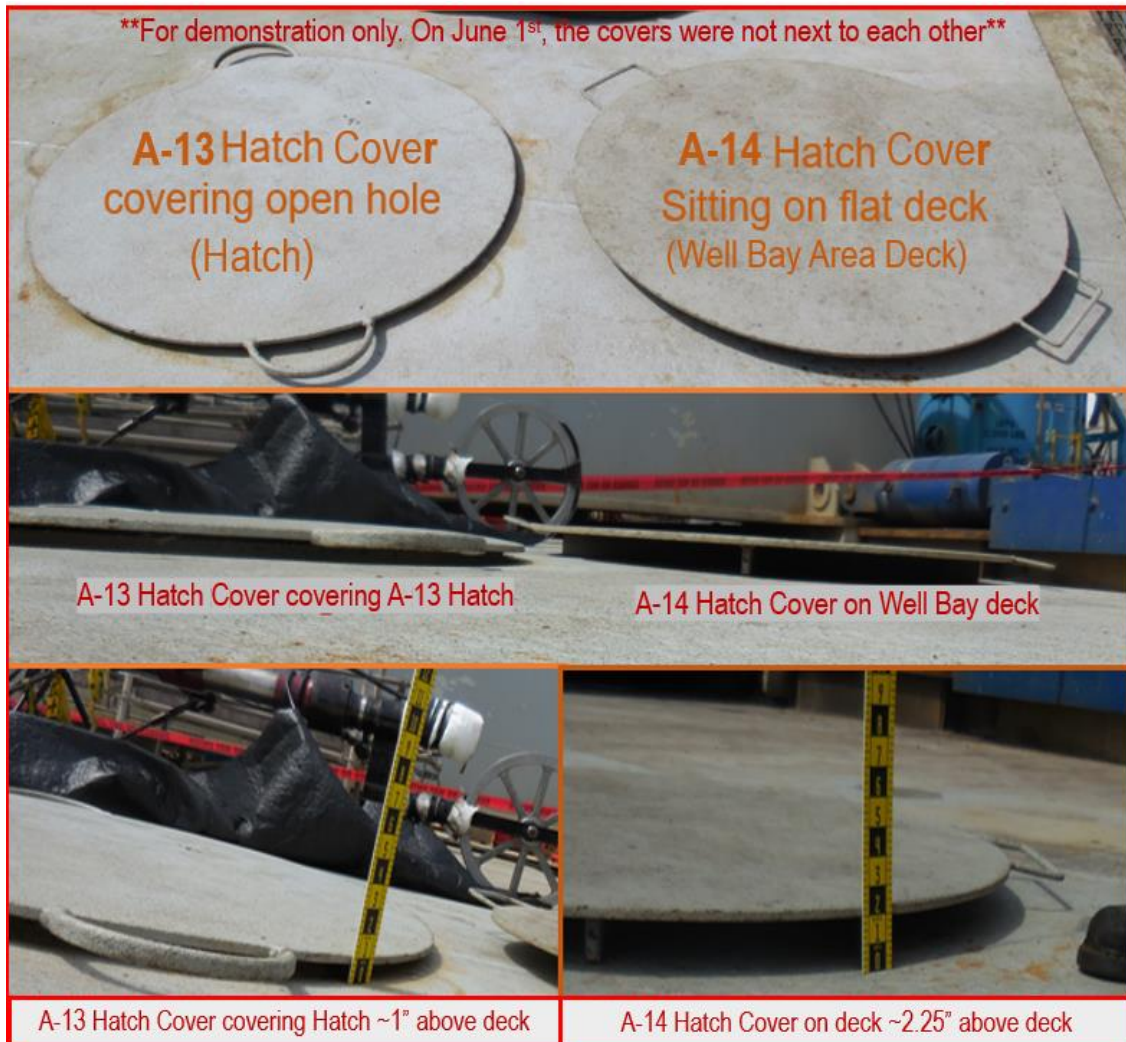
Figure 9: Hatch cover on hatch (left) and hatch cover on the Well Bay Area Deck (right) (June 4, 2019)

The topside of the A-13 Hatch Cover that was sitting over the A-13 Hatch was approximately one-inch above the deck. The topside of the A-14 Hatch Cover laying on the deck plate was approximately 2.25-inches above the deck. Therefore, the hatch cover laying only on the deck plate was approximately 1.25-inches higher than the one that was covering the A-13 Well Hatch. In neither case would the hatch cover be flush with the deck. Each hatch cover had two handles, one on either side, to assist with lifting (see Figure 9).

Figure 9 (below) shows the difference in these heights off the deck plates for demonstration. It is important to note they were not next to each other like this on June 1, 2019. As shown in Figure 9, the visible difference between a hatch cover covering a hatch vs. laying on the deck may not be obvious to personnel walking by.

- Incorporate a hatch cover design that allows personnel to clearly identify a hatch cover in a well hatch, as opposed to one laying on the deck.

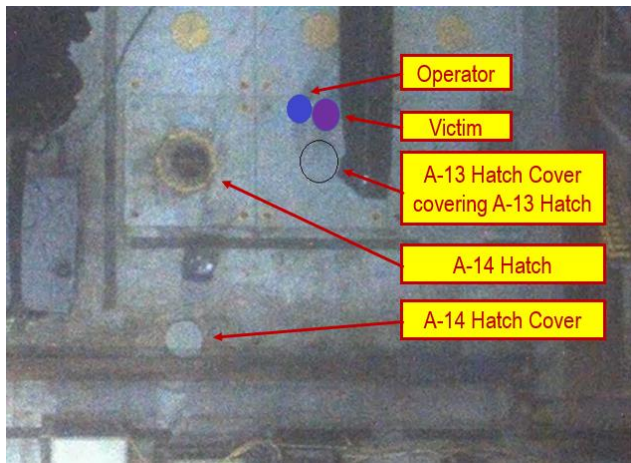
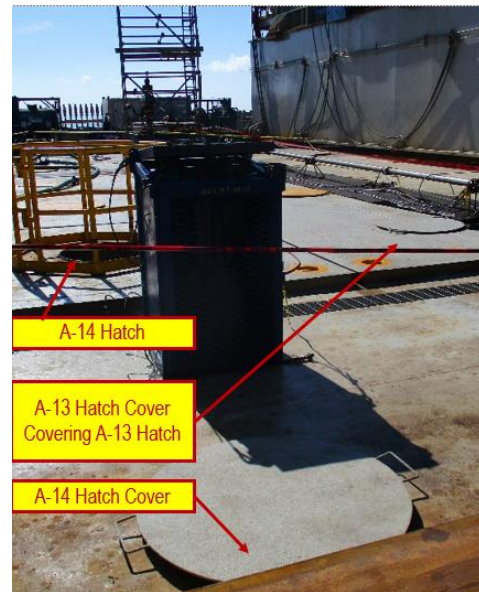
The Operator and Victim could have seen the A-14 Hatch Cover when they walked into the Well Bay Area or from where they discussed replacing the hatch cover. However, they may not have been facing it at times or they may have had a partially obstructed view of where the actual A-14 Hatch Cover was located due to a blue QES control box that was adjacent to the A-14 Well (Figures 10 and 11).

Figure 10: Operator and Victim speaking less than one minute prior to the incident (June 1, 2019) (location of A-13 Hatch Cover outlined by BSEE)

Figure 11: View of Well Bay Area from approximate location of A-14 Hatch Cover (June 4, 2019)
