**Investigation of Blowout
Eugene Island Block 28 Well No. 4
OCS-G 05479
December 03, 2007**

**Gulf of Mexico
Off the Louisiana Coast**

**OCS Report
MMS 2008-049**

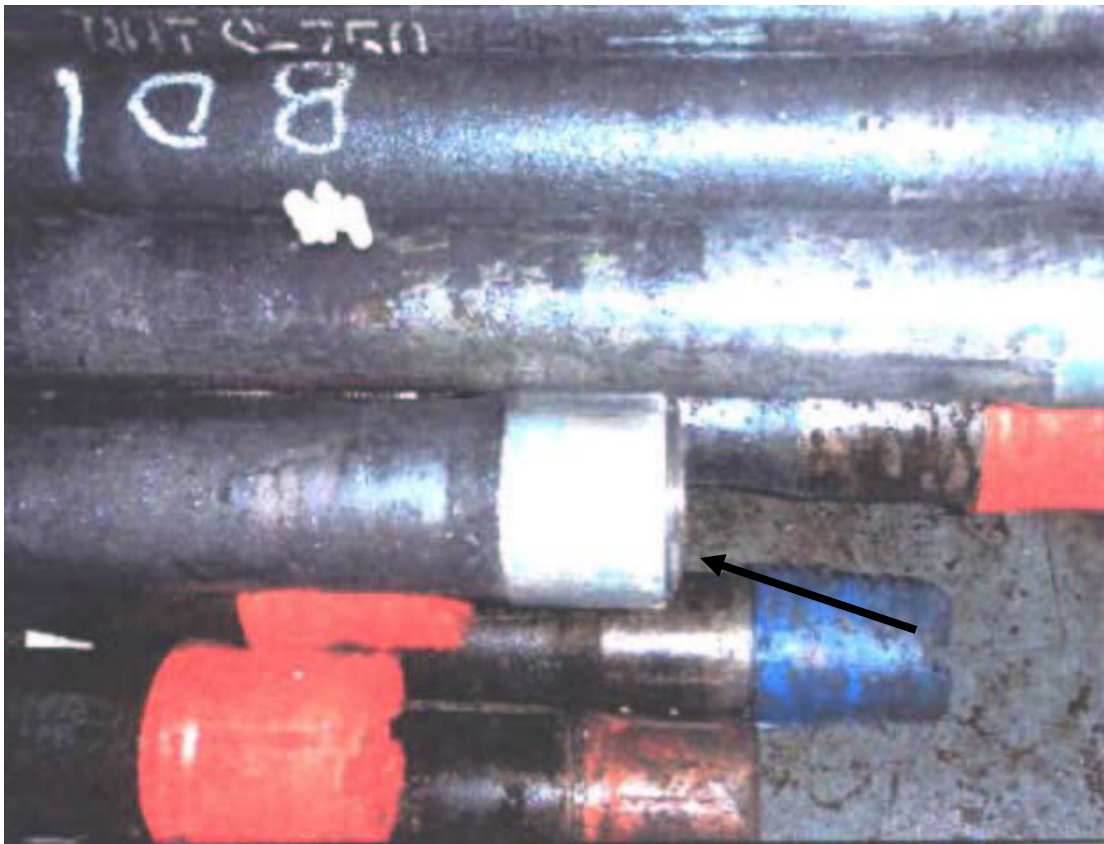
Side View of Broken Connection

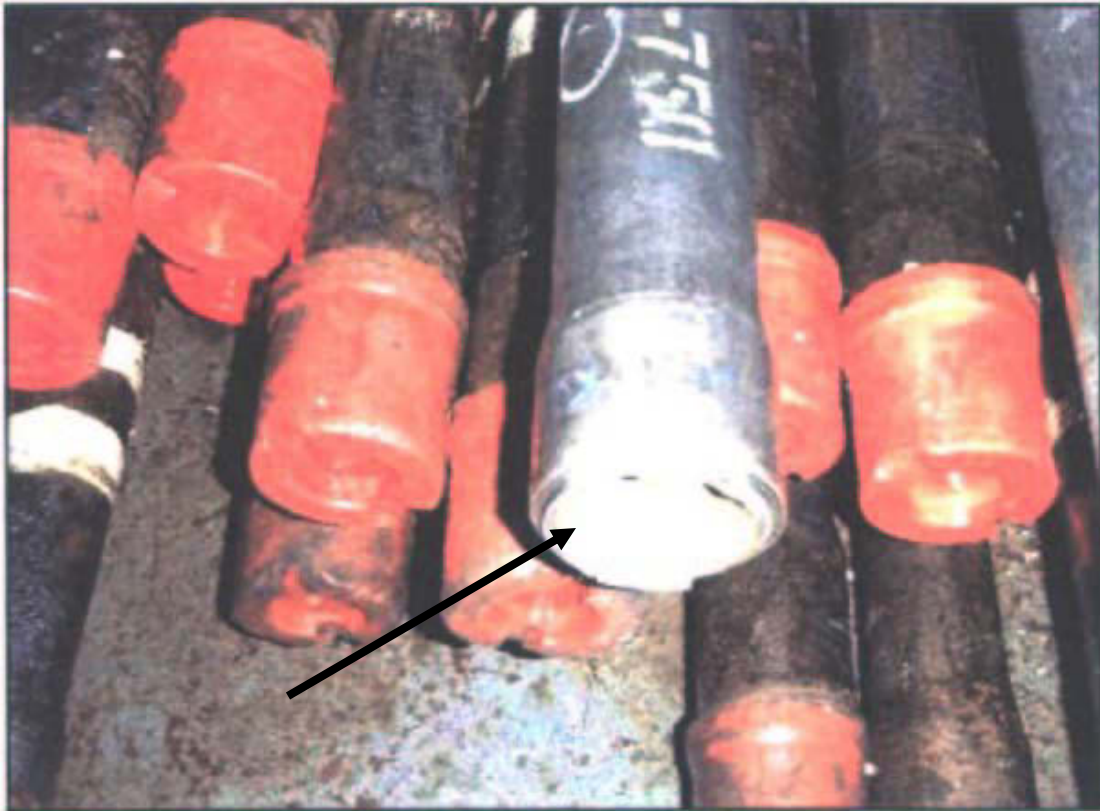
End View Showing Pin Twisted Off

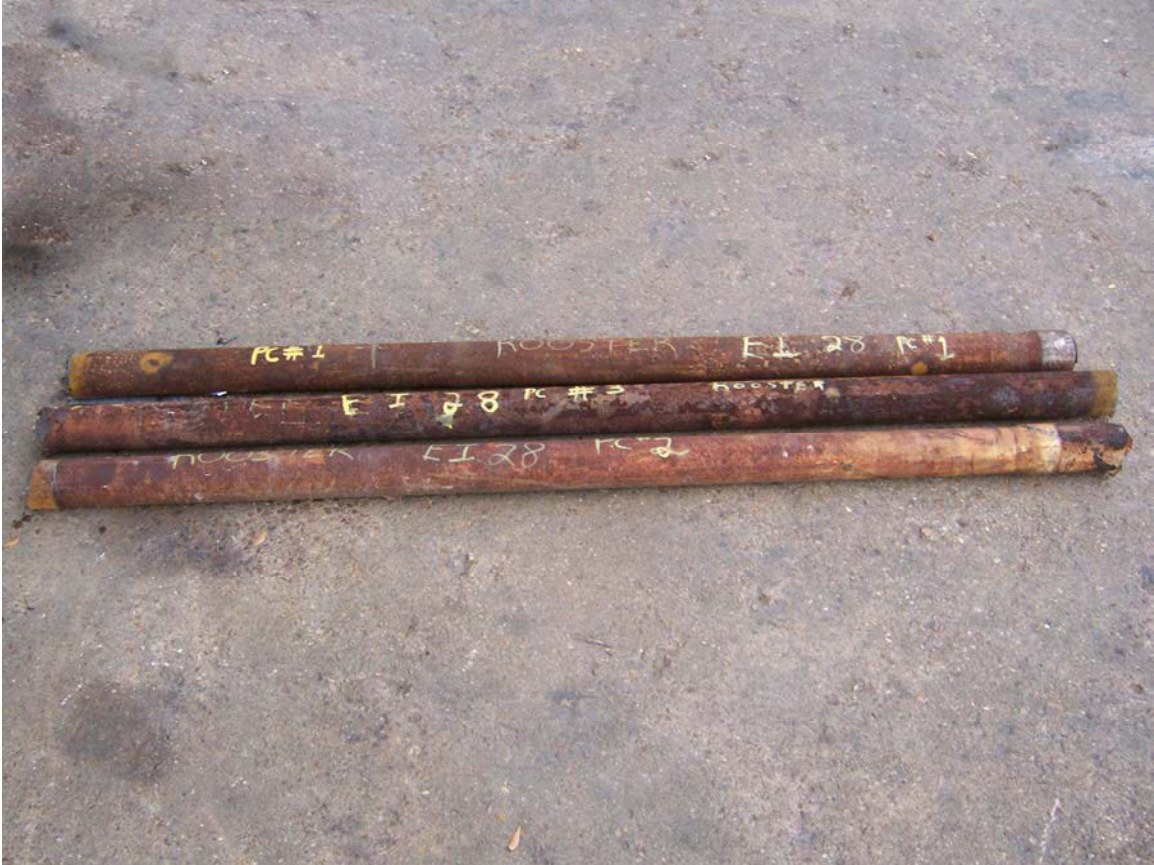
Photograph 1

Photograph showing the as-received tubing sections.

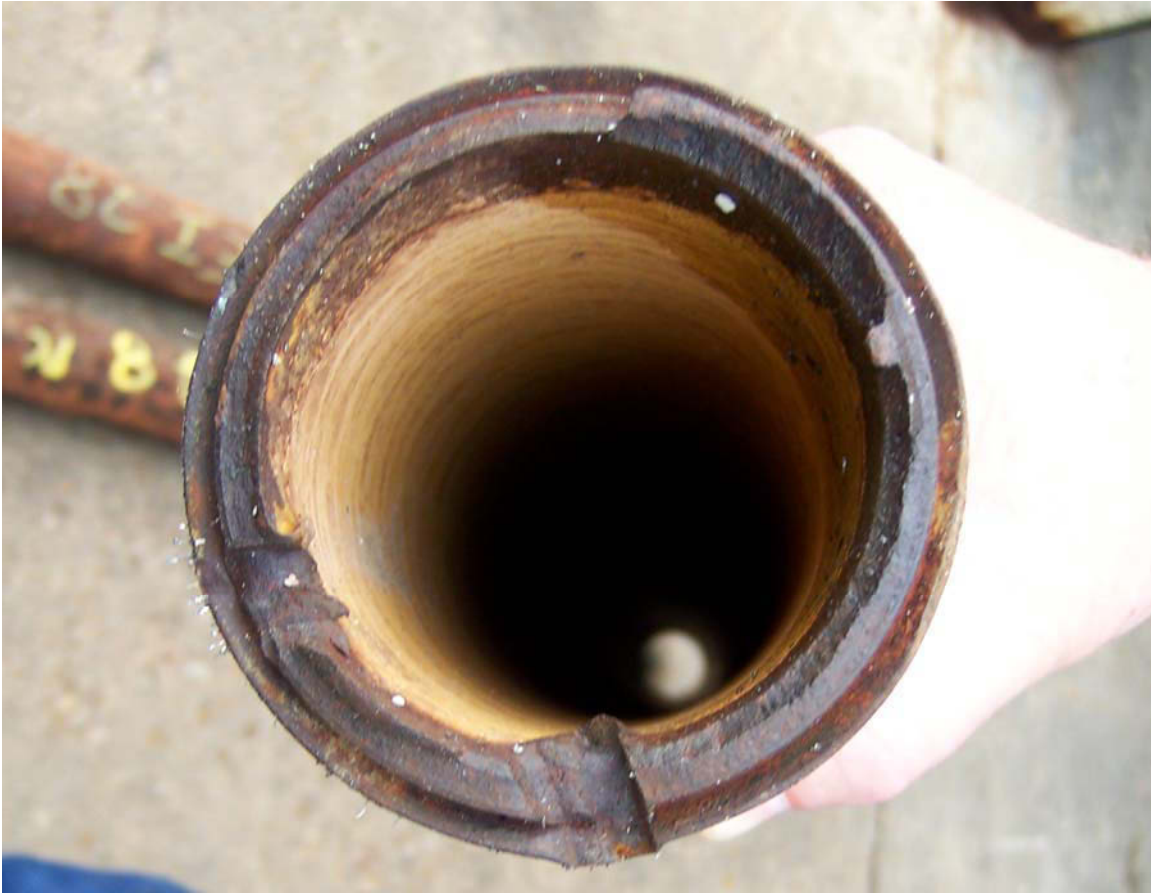
Photograph 2

Photomicrograph showing the failure surface of the first failed tube prior to cleaning. Note the deep indentations most likely the caused by the fishing operation.

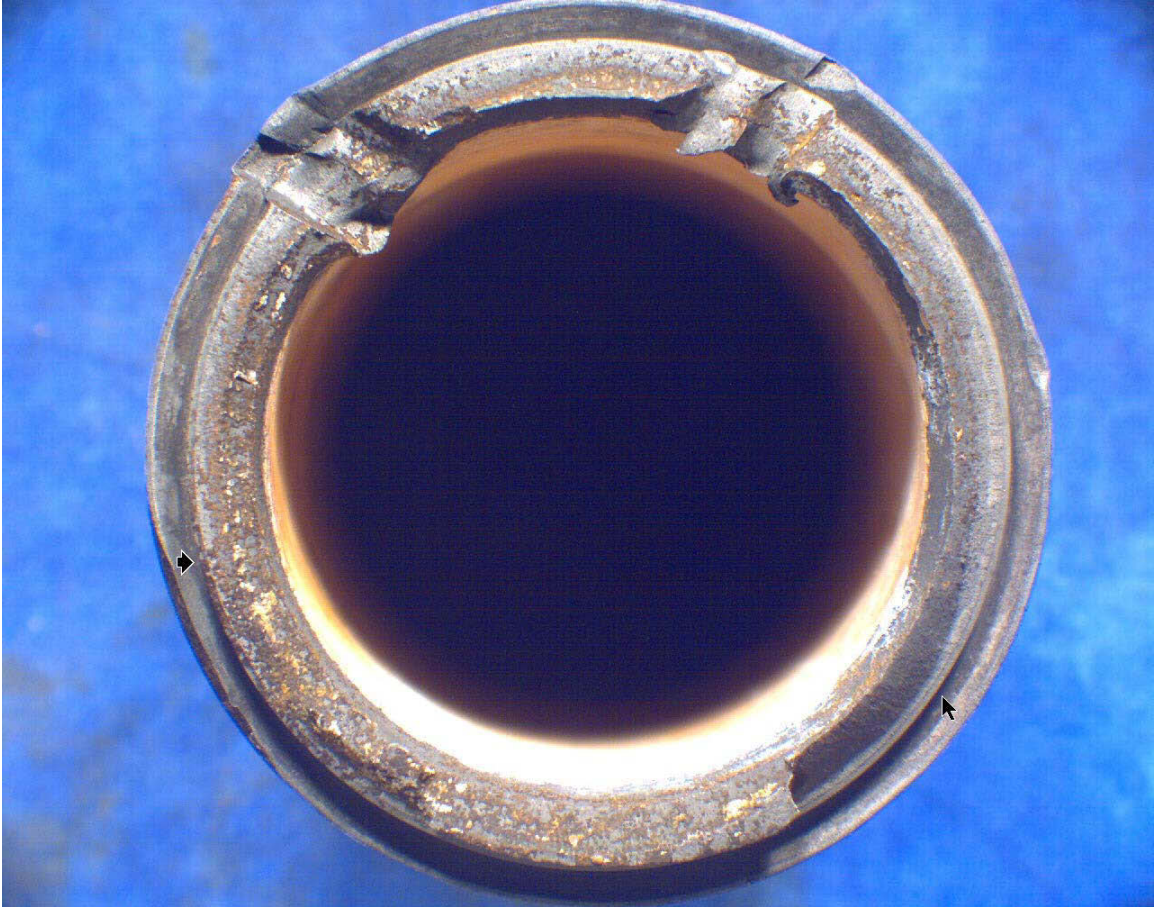
Photograph 3

The fracture surface of the first tubing section was cleaned using a mild caustic solution to remove all traces of surface contamination/oxidation and staining. This surface was then examined using an optical microscope at magnifications up to 20X. The fracture exhibited a relatively flat, fine-textured area for approximately 1/2 of the circumference and 45° shear for the remaining surface area. There was evidence that progressive crack growth had occurred prior to failure. There was also evidence of deep surface gouges mostly likely the result of subsequent fishing operations. All of these features are suggestive of a fatigue type failure. Reference photographs are attached to this report.

Based on available information and laboratory observation the first tubing most likely failed as a result of fatigue cracking that would greatly reduce the load carrying capacity of the tubing. Final failure was the result of ductile tensile overload. The second tubing section failed as a result of ductile tensile overload most likely because the load carrying capacity was decreased as a result of the extreme flow cuts.

Photomicrograph showing the fracture surface of Piece# 1 shown in Photograph# 2 after cleaning. Note the flat fine textured area between the arrows. This feature is typical of fatigue type cracking which would greatly reduce the load carrying capacity of the tubing.

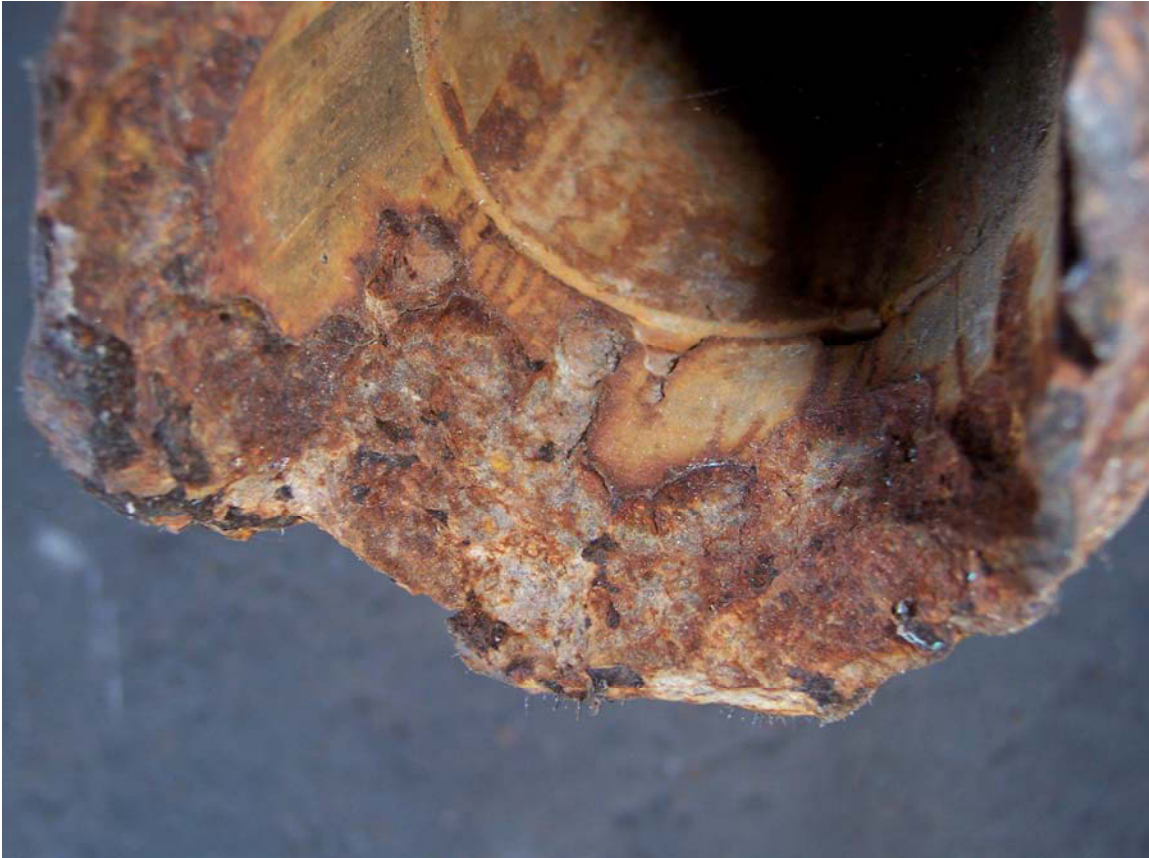
Photograph 4

The sections 2 & 3, which represent the second failure, were examined and found to exhibit extreme wall thinning the result of flow cuts. Reference photographs are attached to this report.

Photomicrograph showing the fracture surface of Piece#2. Note the extreme flow cut areas which caused extreme wall thinning. This would also greatly reduce the load carrying capacity of the tubing.
